工程名稱：觀塘裕民坊

URA KWUN TONG
TOWN CENTRE
REDEVELOPMENT AT
NKIL 6514 (AREA 2&3),
KWUN TONG,
KOWLOON

Factory Inspection Report 01

Issue Date: 24th July 2019
Inspection Date: 10th July 2019

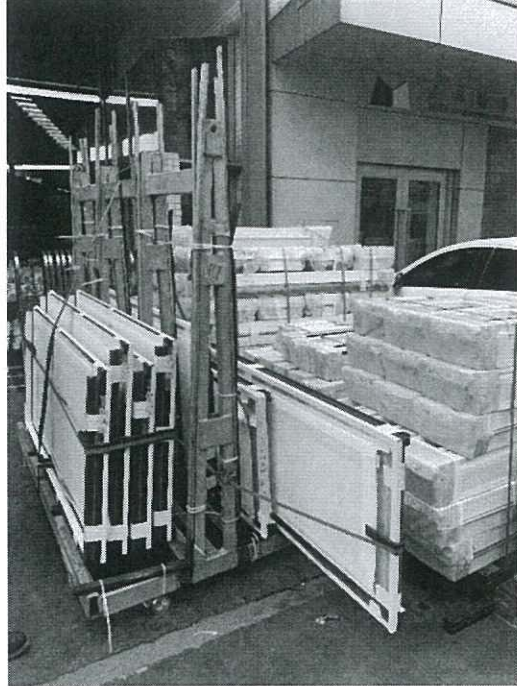
<p>Photo 1</p>	<p><u>Item:</u> Material storage</p> <p><u>Description:</u> Materials storing at outdoor area without cover is observed.</p> <p><u>Action:</u> Midi is urged to store the material at indoor area with label of project name attached.</p>

- The materials were found stored factory outside. Midi must ensure project material stored in covered independent zone with project label attached;
- Midi is reminded to improve its document control;
- Midi is reminded to fully seal the gap by weather sealant between aluminium extrusions;
- Midi is reminded to update its checklist immediately after the material inspection or fabrication stage;
- Midi is reminded to use calibrated instrument for colour checking;
- Midi is reminded to check and ensure all equipment is calibrated within a valid date.

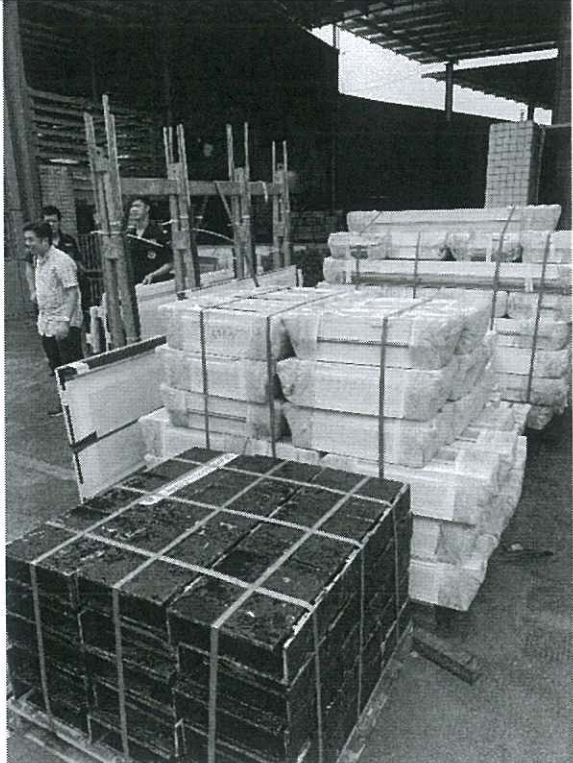
<p>物料存放在 室外時沒有 遮蓋好</p> <p>物料應儲存 在室內，以及 有清楚標示 項目</p>
<p>Photo 2</p>	<p><u>Item:</u> Material storage</p> <p><u>Description:</u> Materials storing at outdoor area without cover is observed.</p> <p><u>Action:</u> Midi is urged to store the material at indoor area with label of project name attached.</p>

<p>同上</p> <p>同上</p>

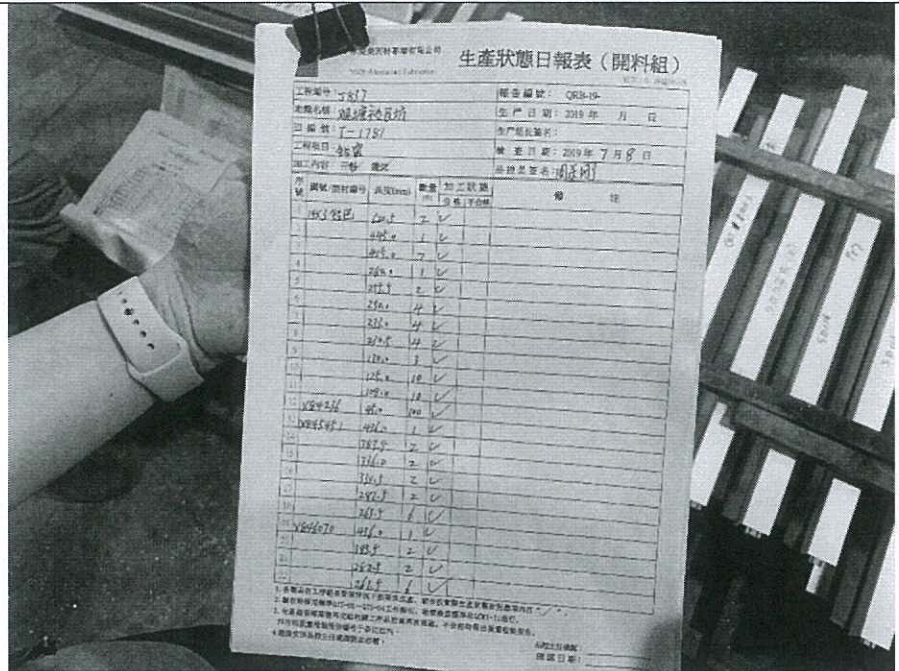
Photo 5

Outdated check list for incoming aluminium extrusion observed.

日報表已過期
不是最新報表

Updating check list immediately after material inspection or fabrication.

當進行檢查QC
應馬上填在報表上

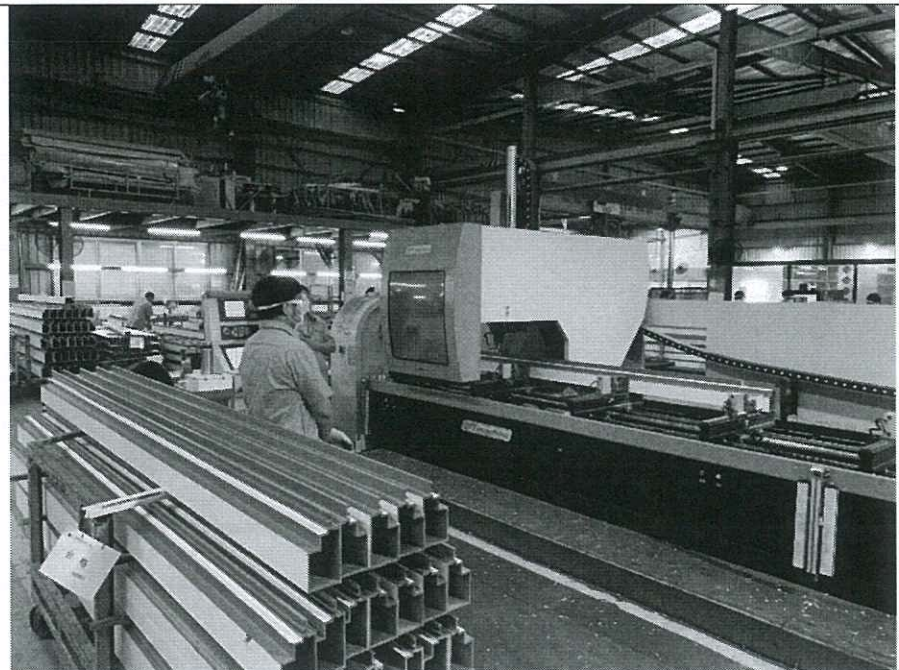
Photo 6

Hole drilling on alum. extrusion by auto-drilling machine is observed.

OK

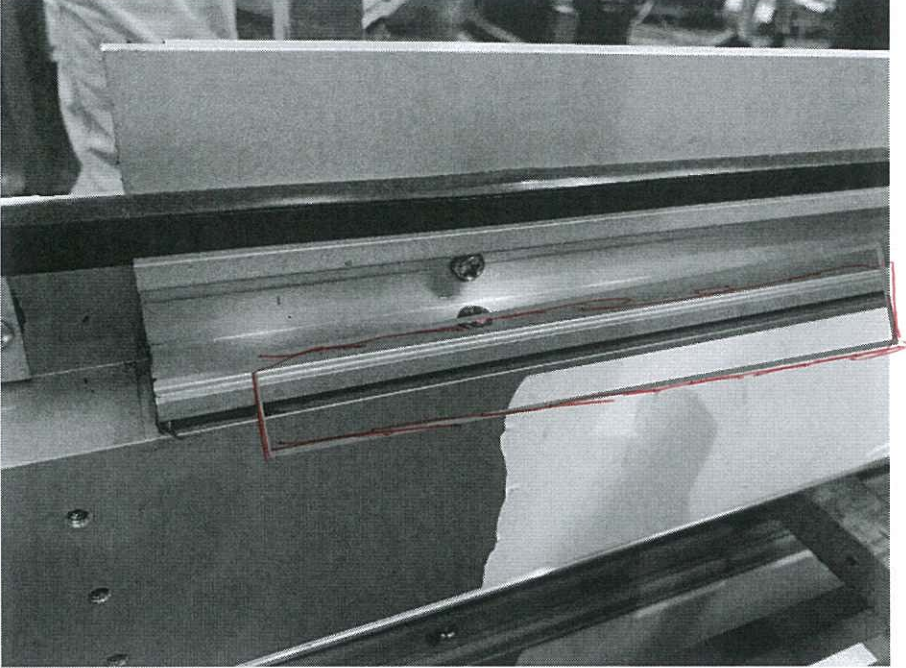
<p>Photo 7</p>

<p><u>Item:</u> General workmanship</p>	
<p><u>Description:</u> The gap is not fully sealed. 副框位置 要立即修 (俾定)</p>	
<p><u>Action:</u> Midi is urged to seal up the gap fully according to ACF's comment to shop drawings.</p>

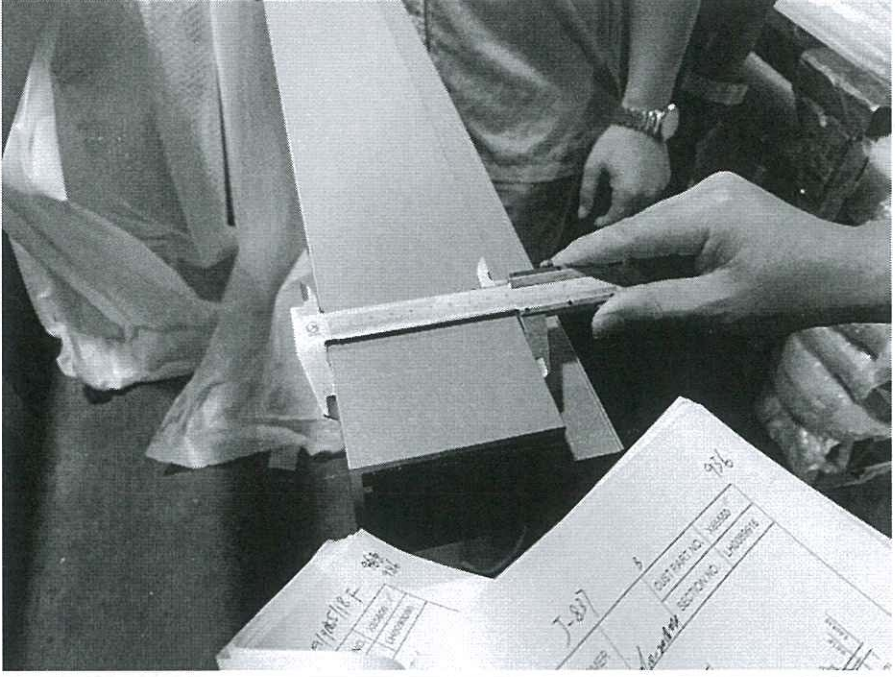
<p>Photo 9</p>

<p><u>Item:</u> Incoming material inspection</p>	
<p><u>Description:</u> Inspection for the extrusion dimension is observed.</p>	
<p><u>Action:</u> -</p>

OK

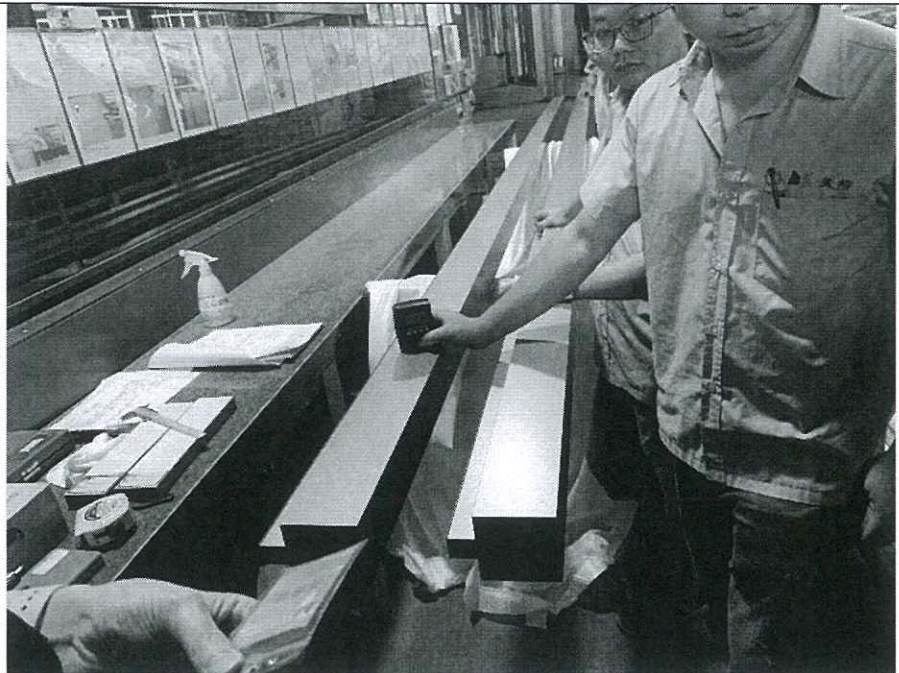
Photo 11

Description:
The measurement of extrusion coating thickness observed; the measured value was found satisfactory.

OK

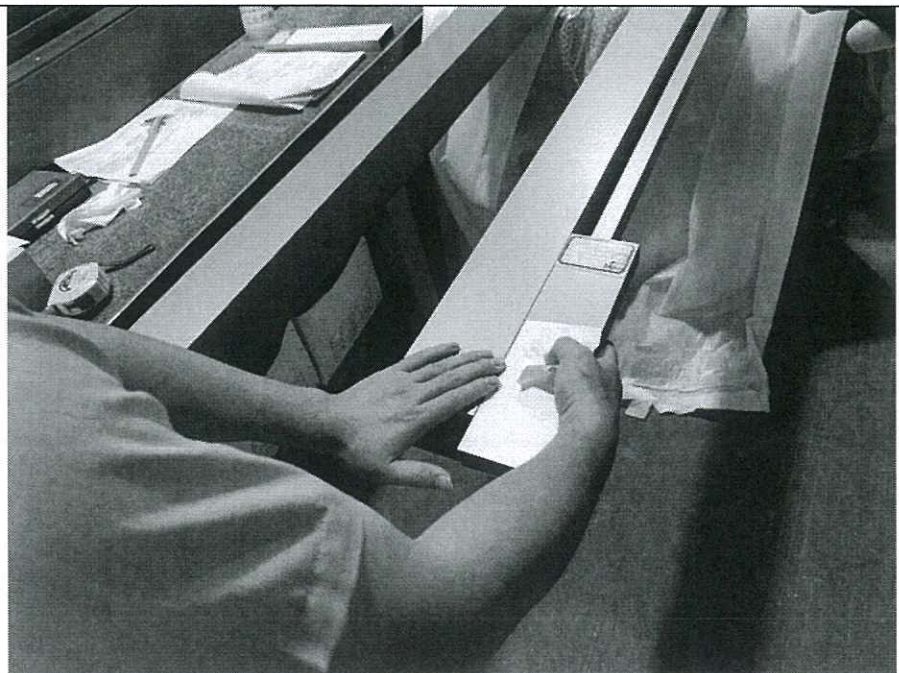
Photo 12

Description:
Visual colour checking with control colour sample observed.

Action:
Using calibrated equipment for colour checking

要用色差儀
核對顏色

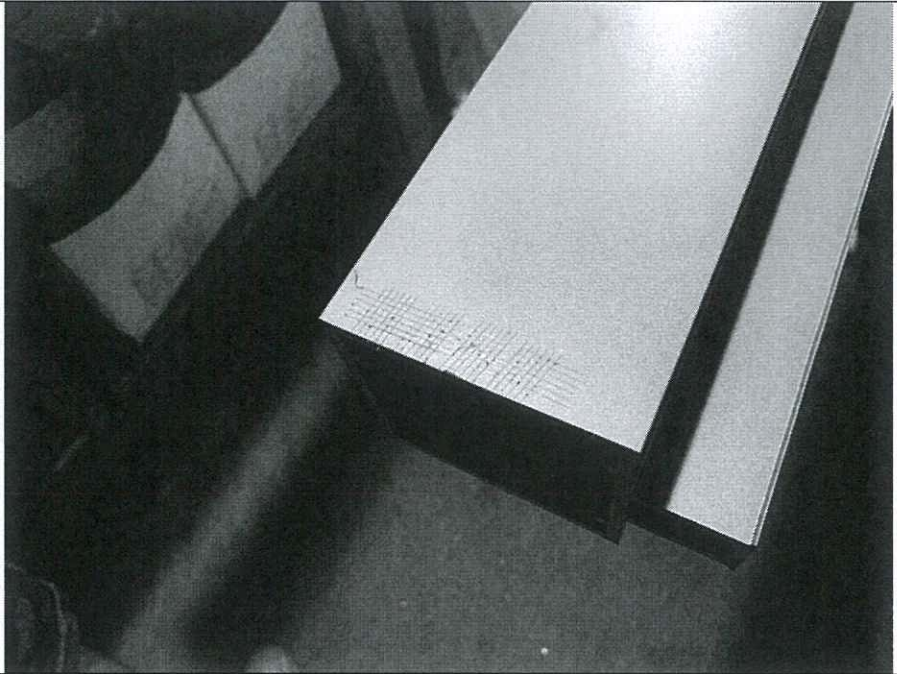
Photo 13

Description:
Cross-cut test for PVFD coating on aluminium extrusion observed, the test results was satisfactory.

OK

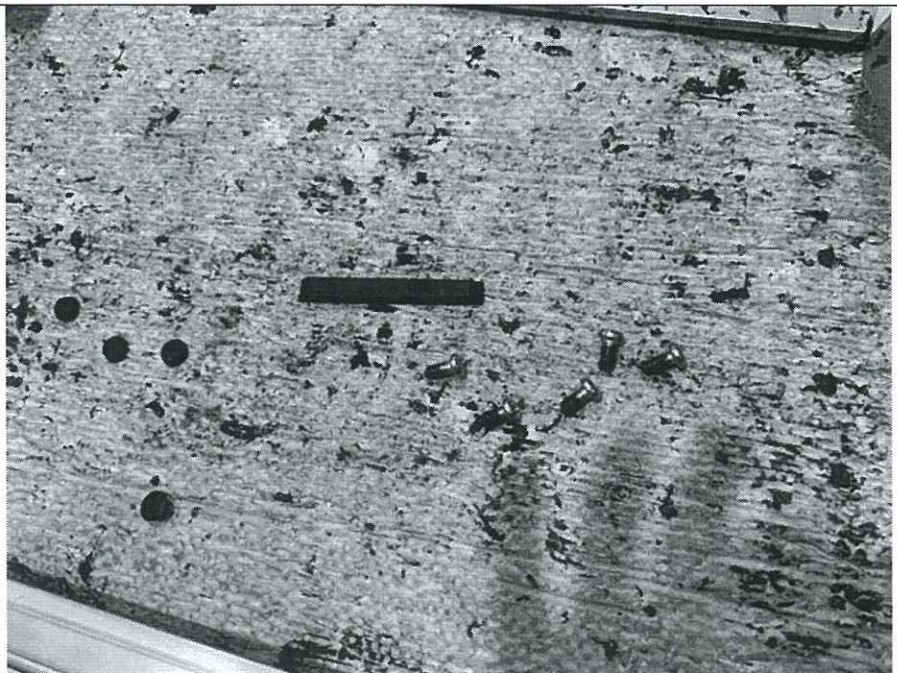
Photo 14

Description:
Screws with residual weather sealant is observed.

OK
