工程指示編號：EI / 0814 / 19

工程名稱：觀塘裕民坊

Factory Inspection Report 12

Factory Inspection Report 13

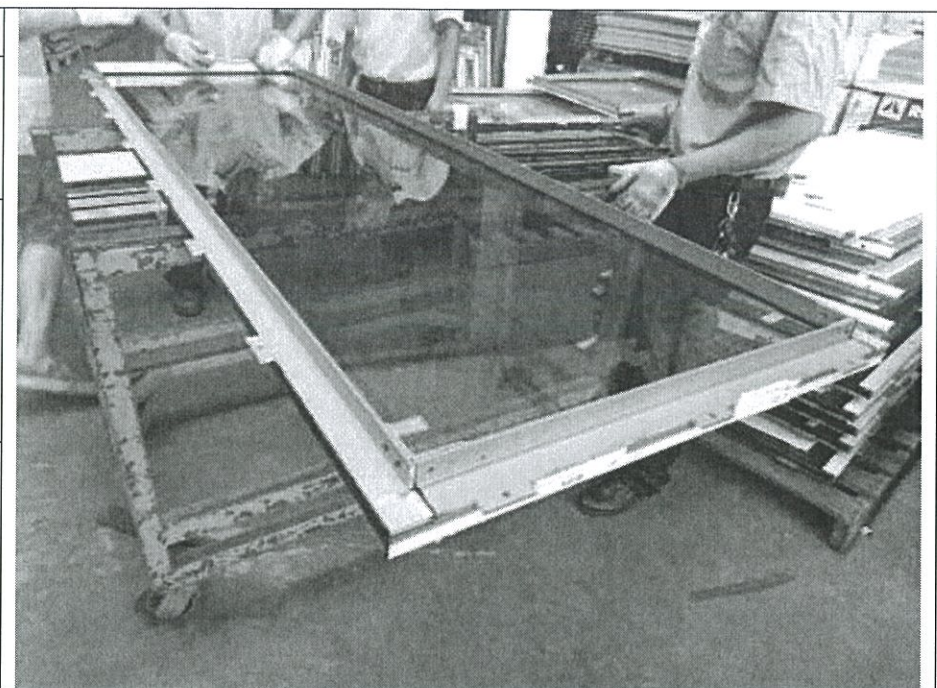
Photo 1

<u>Item:</u> Structural sealant deglaze test	
<u>Description:</u> Sample ready to have deglaze test observed.	
<u>Action:</u> -

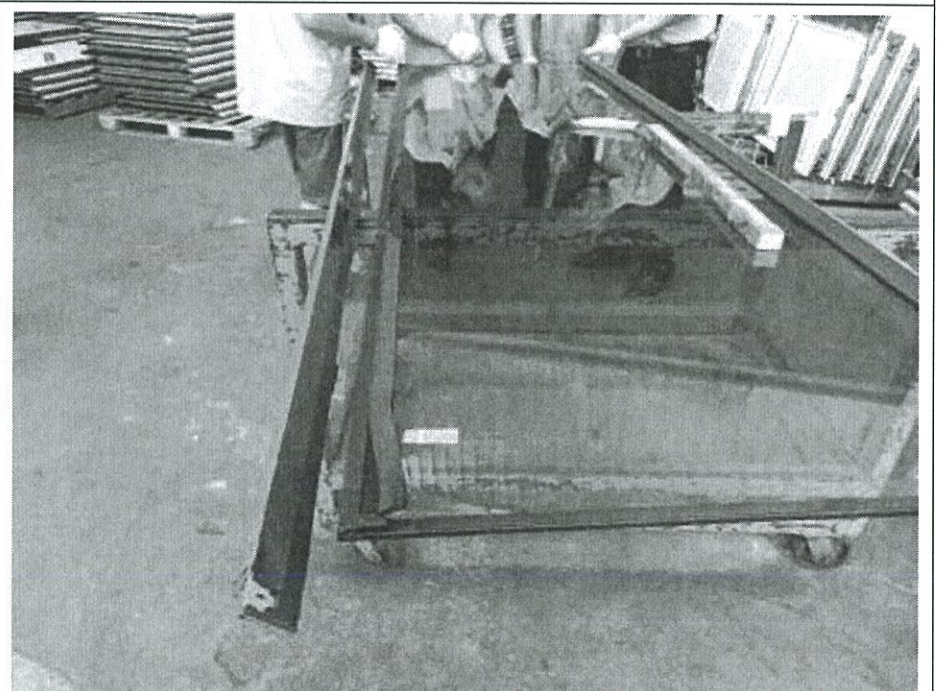
Photo 2

<u>Item:</u> Structural sealant deglaze test	
<u>Description:</u> Aluminium component dismantled for test.	
<u>Action:</u> -

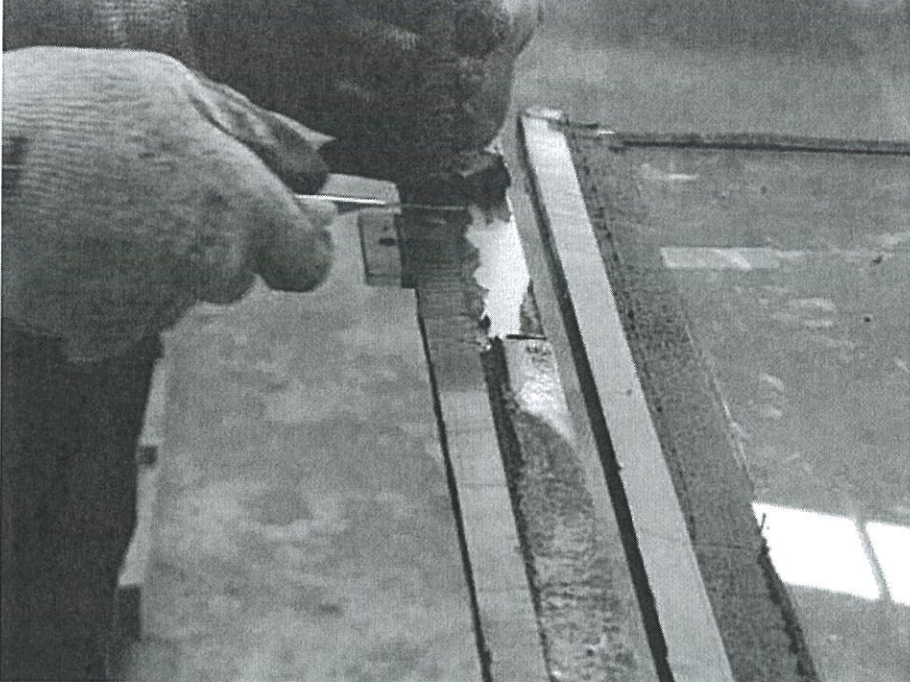
Photo 3

<u>Item:</u> Structural sealant deglaze test	
<u>Description:</u> Deglazed sealant on aluminium member observed. Test result was satisfactory.	
<u>Action:</u> -

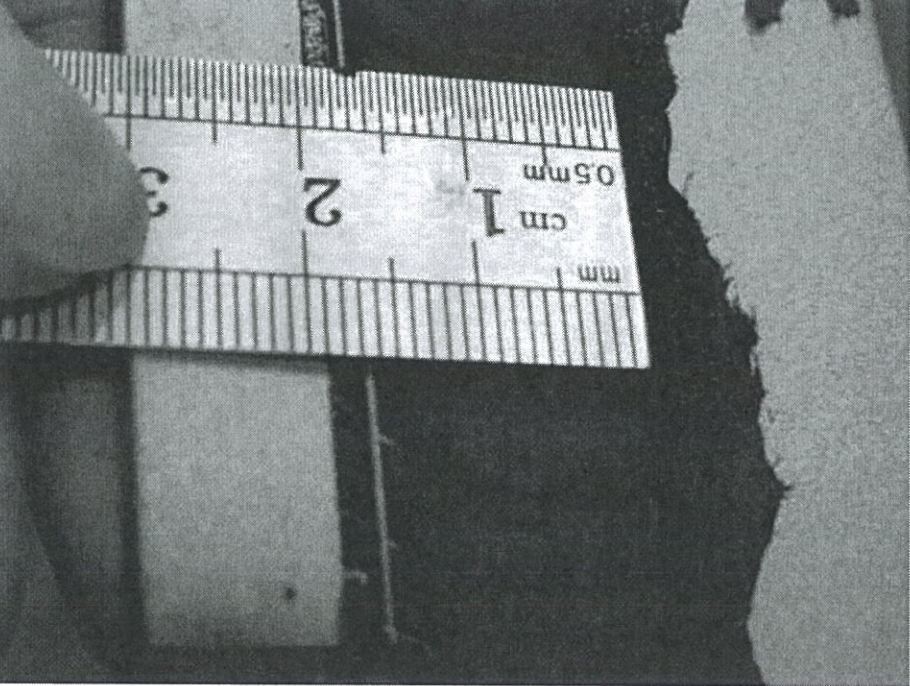
Photo 4

<u>Item:</u> Structural sealant deglaze test	
<u>Description:</u> Structural bite was measured and the value fulfilled the requirement (15mm, referred to Photo 5) in accordance with approved shop drawings.	
<u>Action:</u> -

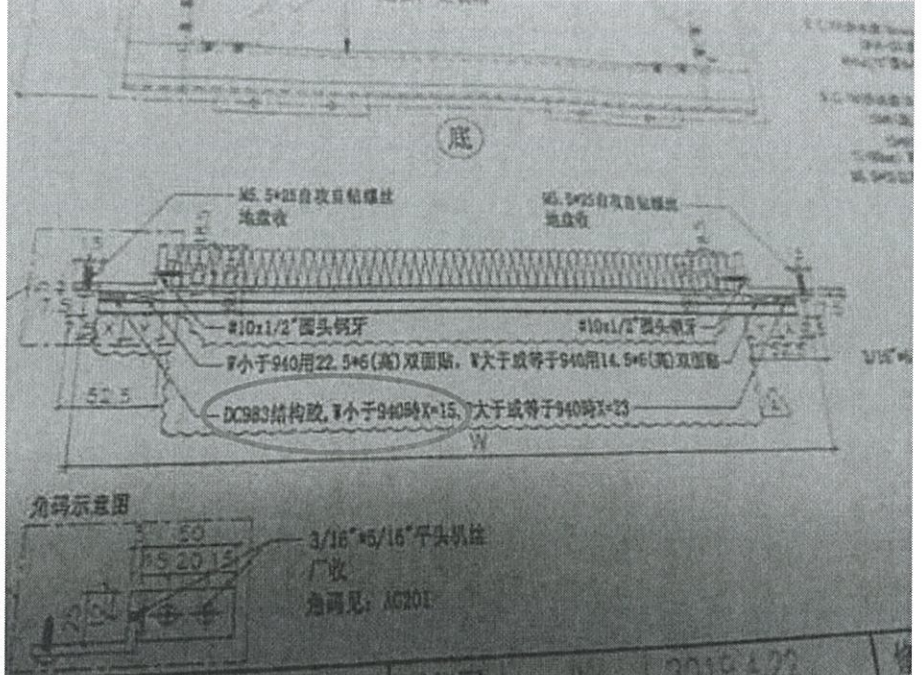
<p>Photo 5</p> <p><u>Item:</u> Structural sealant deglaze test</p>

<p><u>Description:</u> As per the requirement, the sealant bite should be 15mm.</p>	
<p><u>Action:</u> -</p>

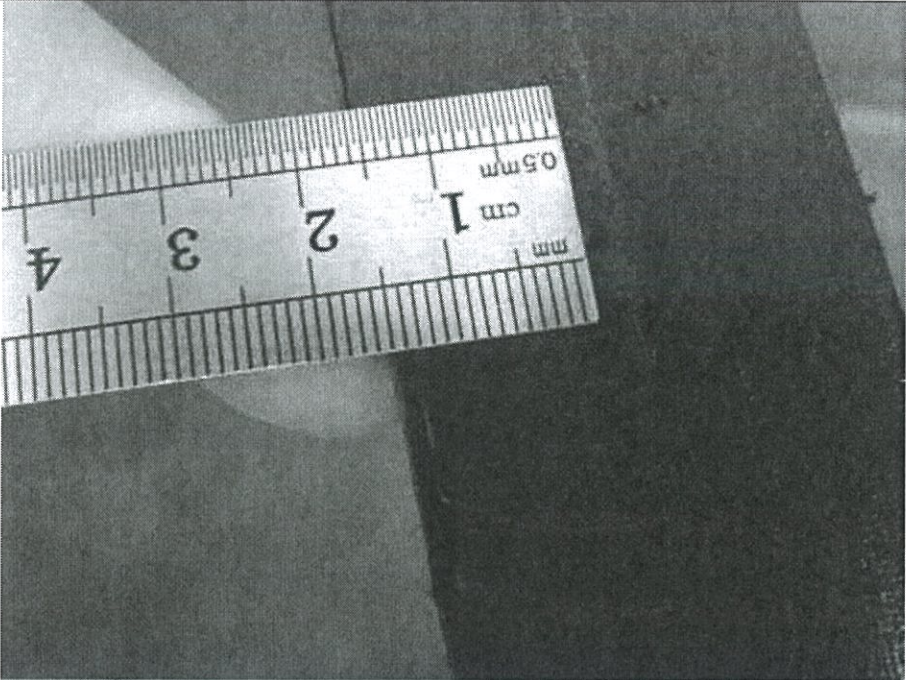
<p>Photo 7</p> <p><u>Item:</u> Structural sealant deglaze test</p> <p><u>Description:</u> Structural bite was measured and the value fulfilled the requirement (15mm) in accordance with approved shop drawings.</p> <p><u>Action:</u> -</p>

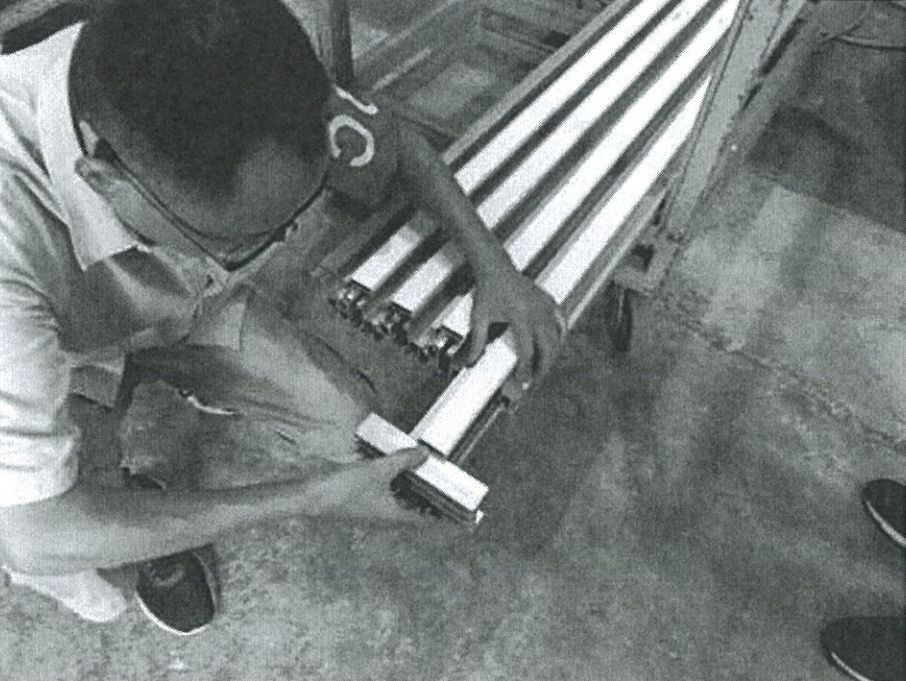
<p>Photo 8</p> <p><u>Item:</u> Fabrication condition</p> <p><u>Description:</u> Checking the cut portion with a control component by QC personnel observed.</p> <p><u>Action:</u> -</p>

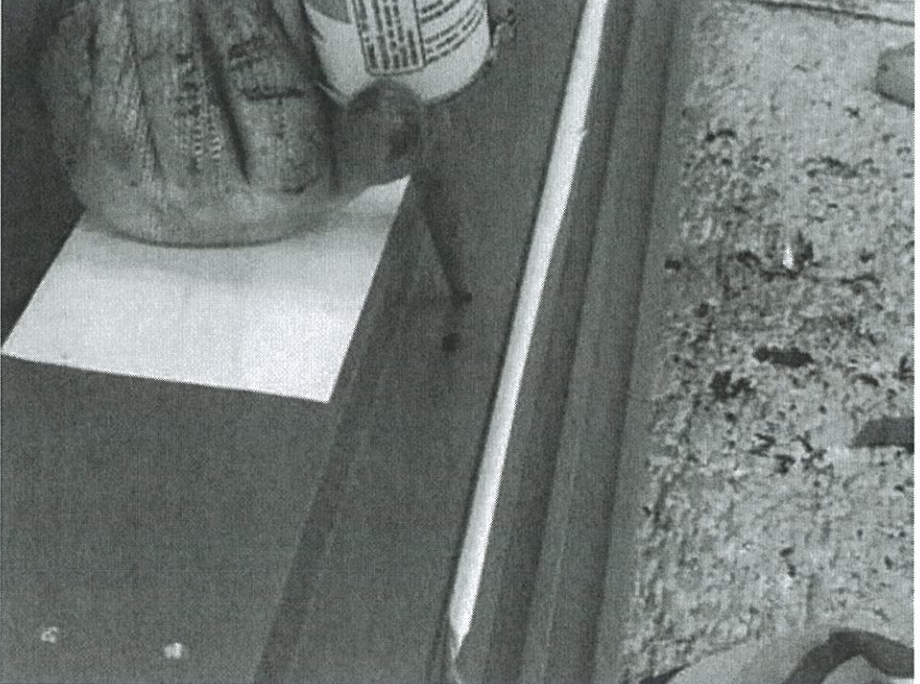
Photo 10

<u>Item:</u> Installation condition	
<u>Description:</u> Sealant applied before installing components with screws observed.	
<u>Reminder:</u> -

- Midi is reminded to apply sealant at **all** screws and screw holes;
- Midi is reminded to seal **all** openings for screw fixings;
- Midi is reminded to drill air holes and weep holes on alum. extrusion;

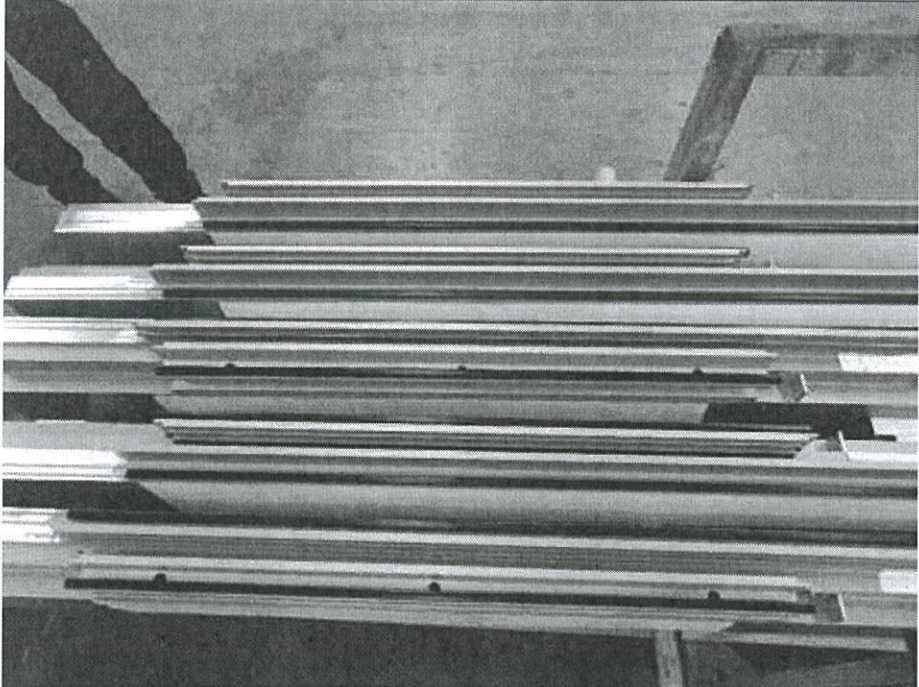
<p>Photo 11</p>

<p><u>Item:</u> Installation workmanship</p>	
<p><u>Description:</u> Gaskets were found with enough length.</p>	
<p><u>Reminder:</u> Gasket must have extra length, say 20mm, to the relative member.</p>

1) 確保膠條頭尾各有額外 20mm 長

不右候 膠條有額外 20mm 長度

- Midi is reminded to install the gaskets with enough length in accordance with client's comment;
- Weep holes were observed locating at 2 edges of each of the transoms, Midi is reminded not to seal up the weep hole during their site installation work, in order to keep the effectiveness of the weep holes; otherwise, Midi should concern relocating the weep holes to avoid the risks for the weep holes being sealed up by workers during their site installation works.

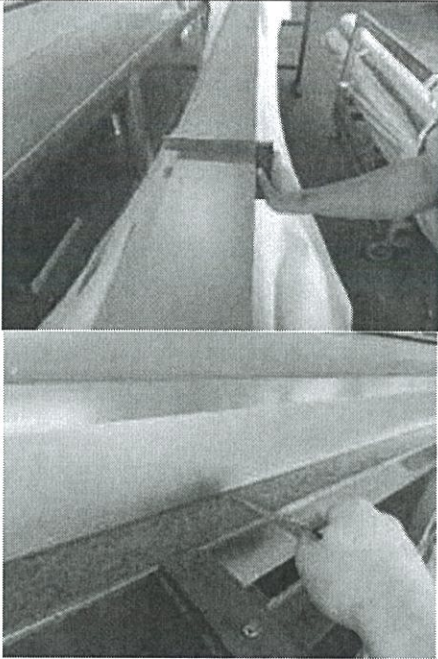
<p>Photo 3</p>

<p><u>Item:</u> Incoming material inspection</p>	
<p><u>Description:</u> Flatness test was conducted to check the aluminium extrusions observed; results satisfactory.</p>	
<p><u>Action:</u> -</p>

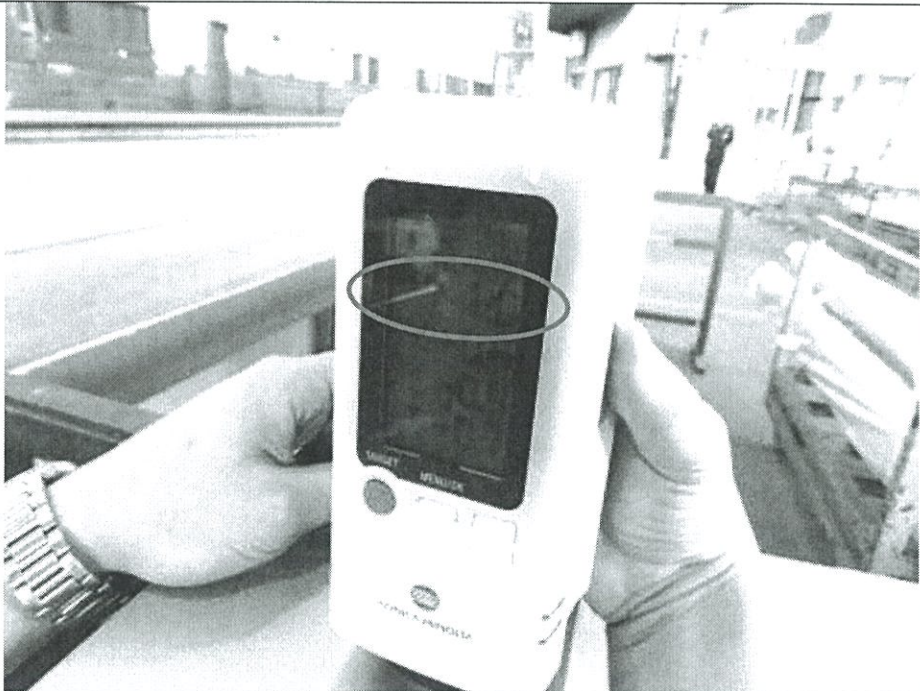
<p>Photo 4</p>

<p><u>Item:</u> Incoming material inspection</p>	
<p><u>Description:</u> Colour checking by calibrated equipment observed, the measured value was within tolerance ($\Delta E < 2$).</p>	
<p><u>Action:</u> -</p>

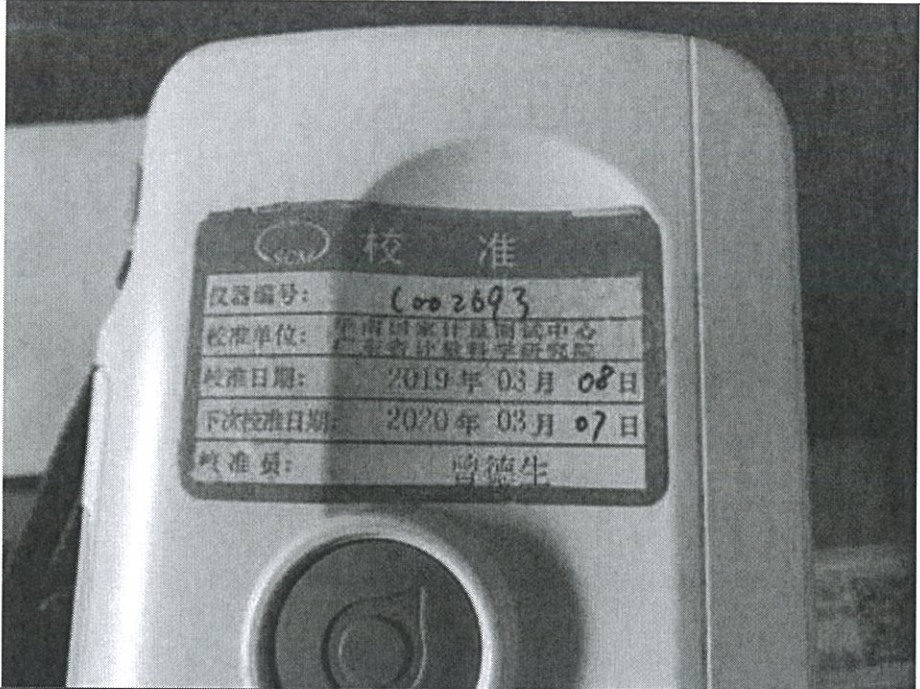
<p>Photo 5</p>

<p><u>Item:</u> Incoming material inspection</p>	
<p><u>Description:</u> Calibration certificate and date of the instrument observed.</p>	
<p><u>Action:</u> -</p>	
<p>Photo 6</p>

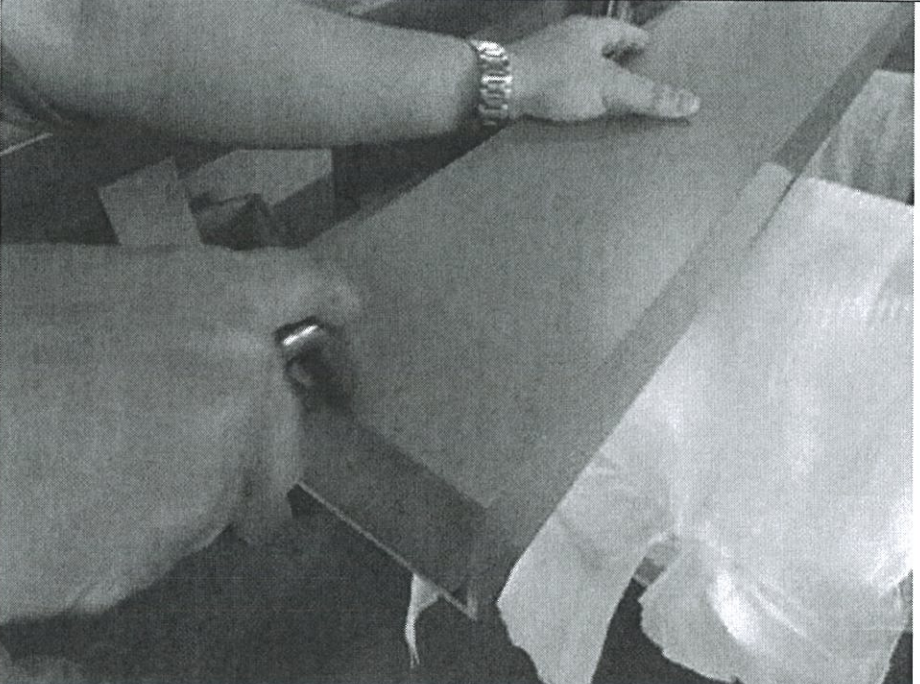
<p><u>Item:</u> Incoming material inspection</p>	
<p><u>Description:</u> Paint adhesion test by cross cutting 1x1mm squares observed.</p>	
<p><u>Action:</u> -</p>

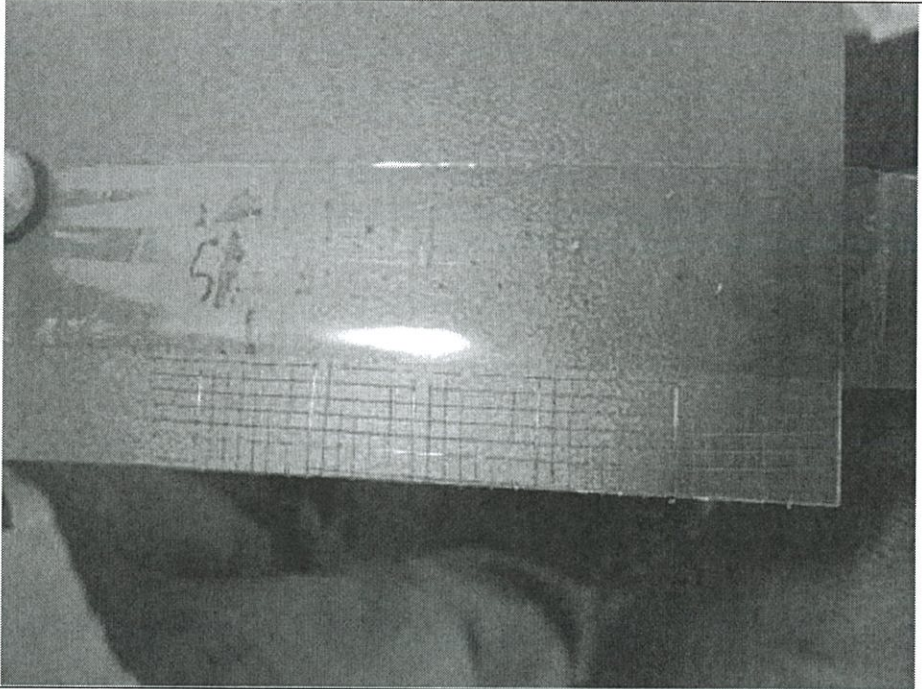
Photo 7

<u>Item:</u> Incoming material inspection	
<u>Description:</u> Test area was pasted and pulled out by the adhesive tape; the result was satisfactory.	
<u>Action:</u> -	
Photo 8

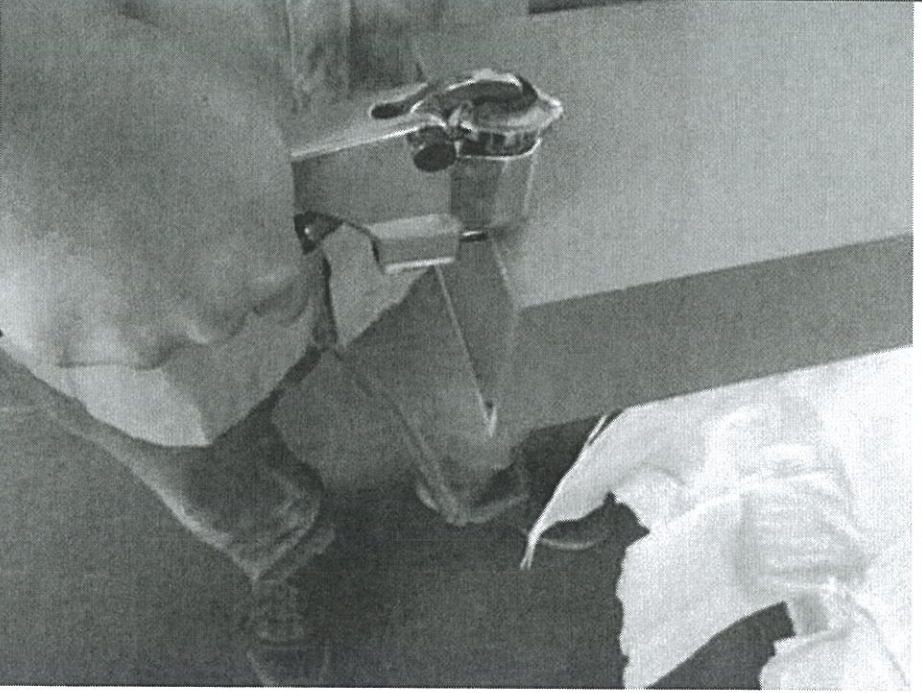
<u>Item:</u> Incoming material inspection	
<u>Description:</u> Extrusion hardness test observed.	
<u>Action:</u> -

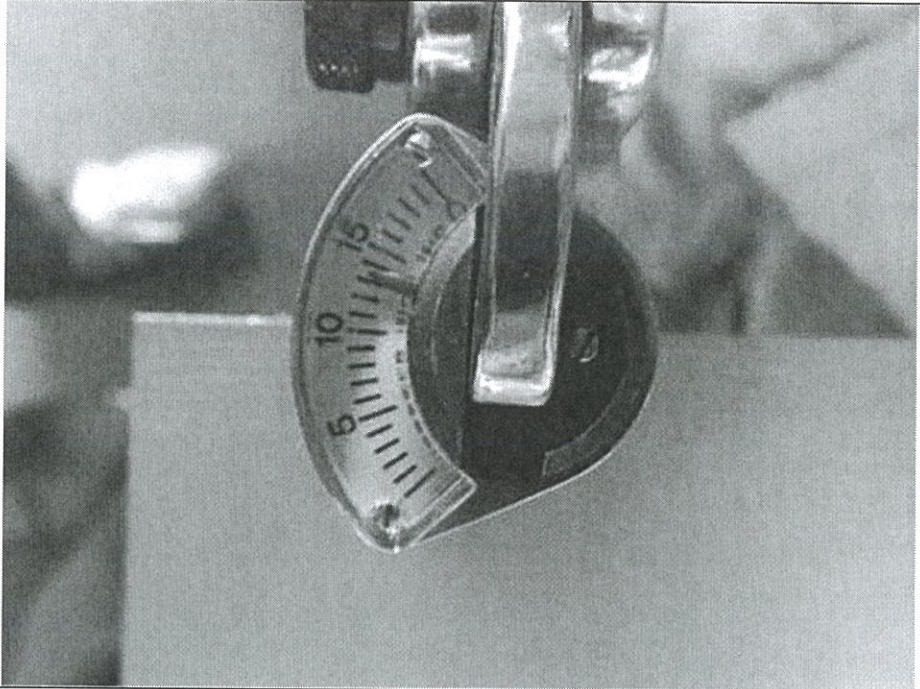
<p>Photo 9</p> <p><u>Item:</u> Incoming material inspection</p> <p><u>Description:</u> The hardness test result was satisfactory (>11).</p> <p><u>Action:</u> -</p>

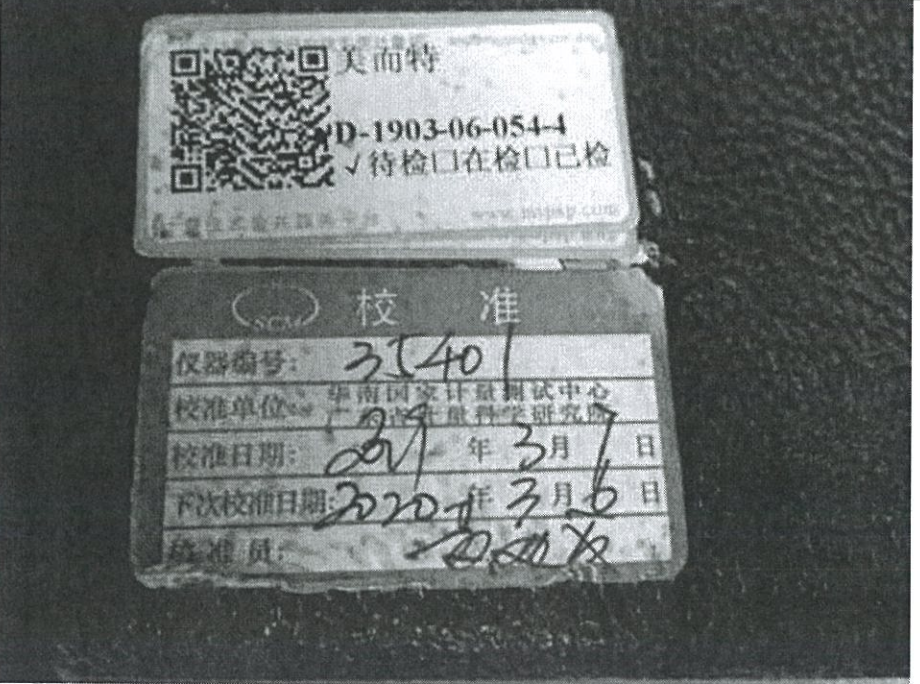
<p>Photo 10</p> <p><u>Item:</u> Incoming material inspection</p> <p><u>Description:</u> Calibration certificate and date of the instrument observed.</p> <p><u>Action:</u> -</p>

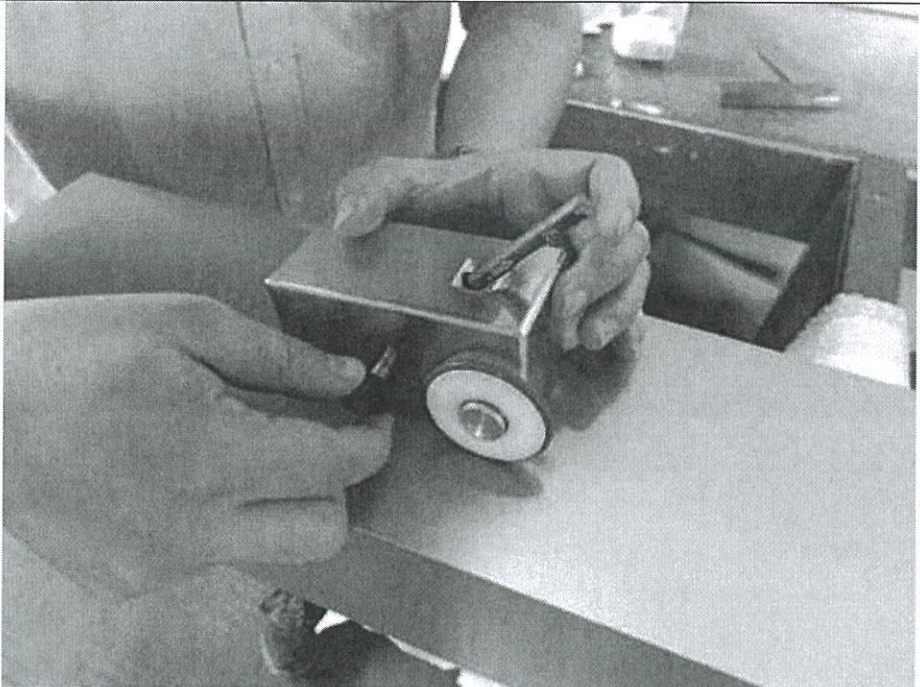
<p>Photo 11</p>

<p><u>Item:</u> Incoming material inspection</p>	
<p><u>Description:</u> Testing on hardness of coating observed; the result was satisfactory.</p>	
<p><u>Action:</u> -</p>

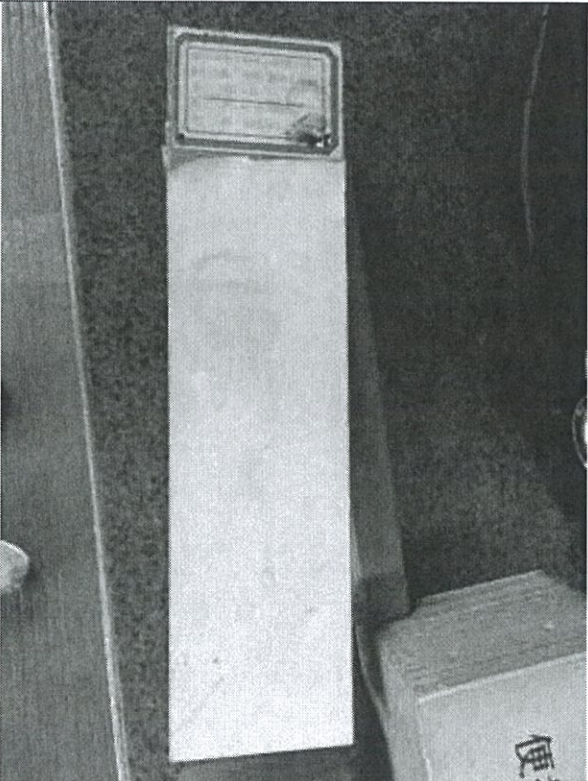
<p>Photo 12</p>

<p><u>Item:</u> Incoming material inspection</p>	
<p><u>Description:</u> Control sample of aluminium extrusions for colour checking observed.</p>	
<p><u>Action:</u> -</p>

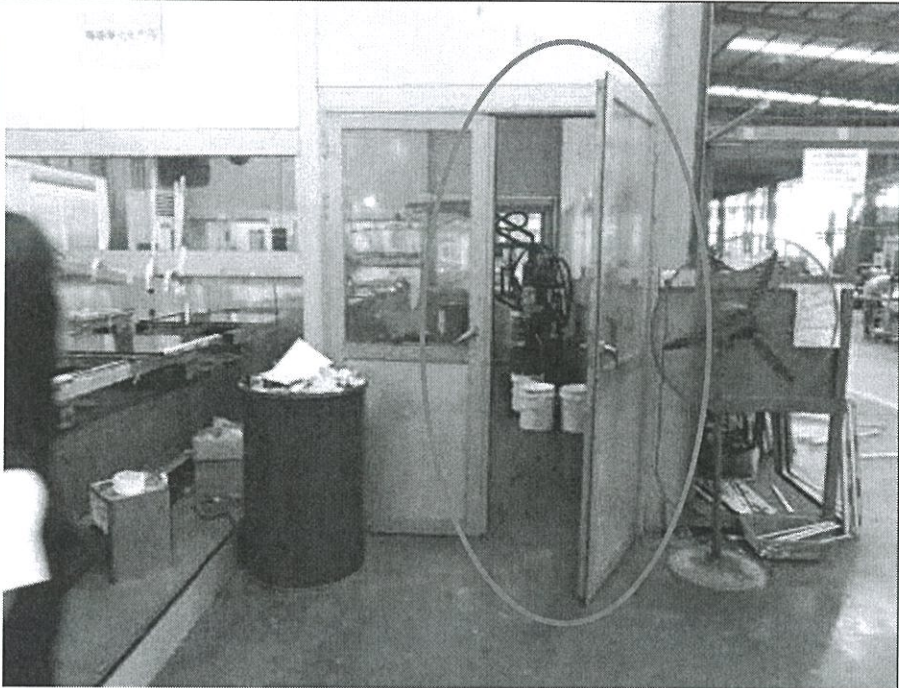
Photo 13

<u>Item:</u> Installation environment	
<u>Description:</u> The doors of SSG room were found always open, possibly affecting the conditions such as temperature, humidity, and cleanliness. Contamination to the glazing process may appear.	
<u>Action:</u> Midi is required to keep the doors closed.

2) 打膠房門必須保持關閉，保持房內溫度、濕度，以及避免有灰塵入房，影響打膠效果
建議增加門鼓，以防忘記關門

打膠房門必須保持關閉，房內溫度及濕度以及避免灰塵進入房內，影響打膠效果
建議增加門鎖，以防忘記關門

- Midi is required to control the conditions of SSG Room under the sealant manufacturer's requirements such as temperature, relative humidity, and keeping doors closed. Contamination to the glazing process may appear with the doors open;
