工程指示編號：EI / 2378 / 20

工程名稱：亞皆老街中電

**J3860 - Proposed Residential Development, At 139 – 147 Argyle Street, Kowloon
Midi's Damage Finding Report of Precast Windows after Concreting (TS026)**

DAMAGE FINDING
FOR
PRECAST WINDOW
AFTER REMOVAL OF PRECAST CONCRETE MOLD
AT
FACADE YARD
AT
139-147 Argyle Street, Kowloon

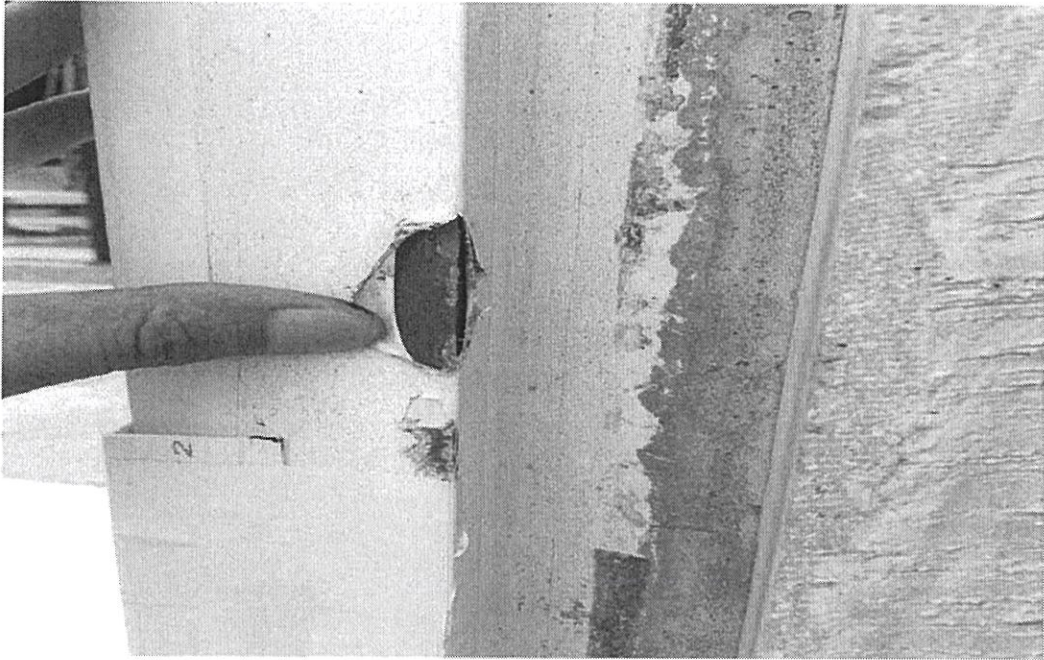
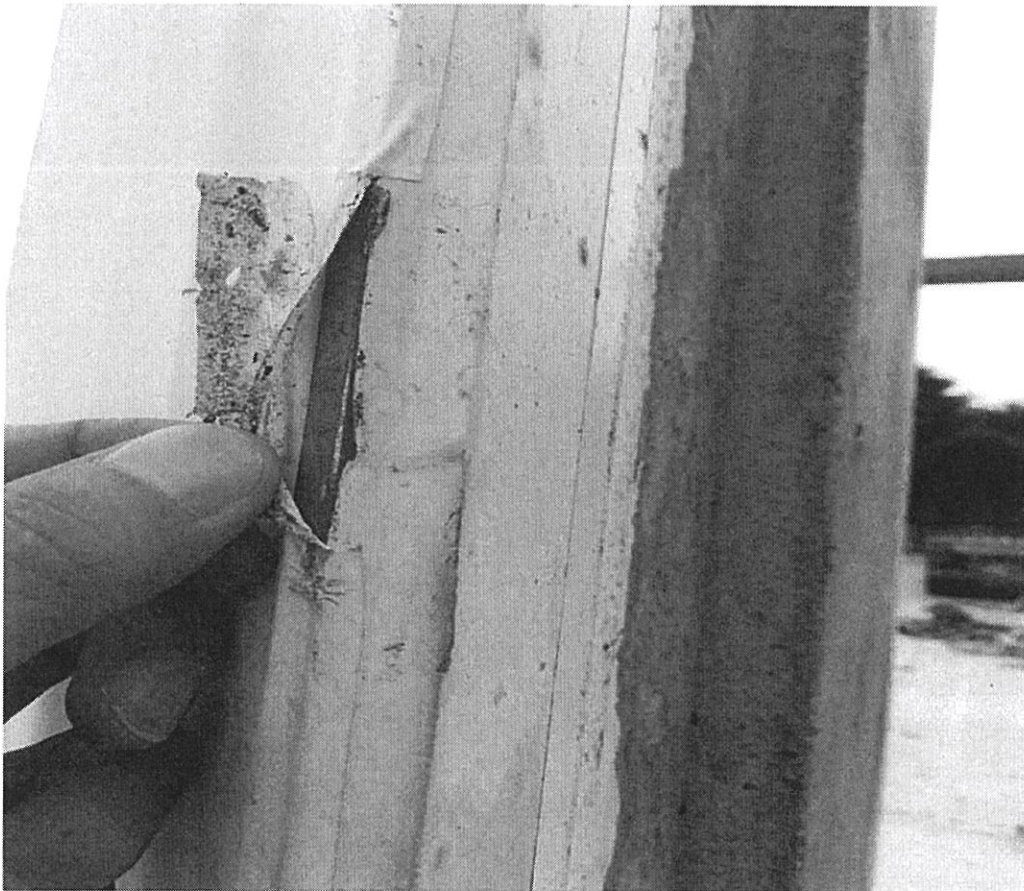
Q.I.REPORT NO. 质量检验报告编号: QRG-852-20-01

INSPECTION 检验工序 编号	SAMPLE SIZE 抽查 数量	DEFECTIVE 次品			DEFECT RAITO 次品率	DESCRIPTION OF DEFECT 次品描述
		CRI 严重	MAI 轻微	MIN		
<u>QRG-852-20-01</u>	<u>1</u>		<u>1</u>		<u>100%</u>	<u>① W4/T3C 在包室内玻璃槽内玻璃破裂 ② W3/T3C 窗在包室内玻璃槽内玻璃破裂 有杂物</u>

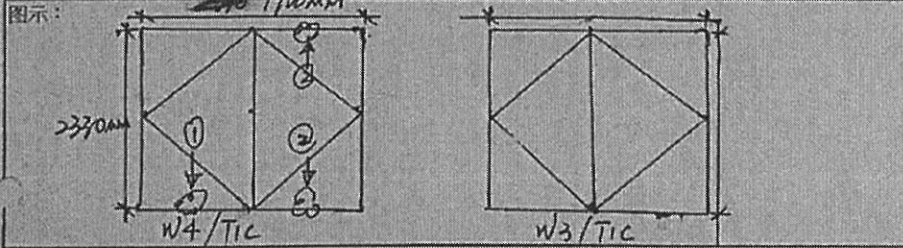
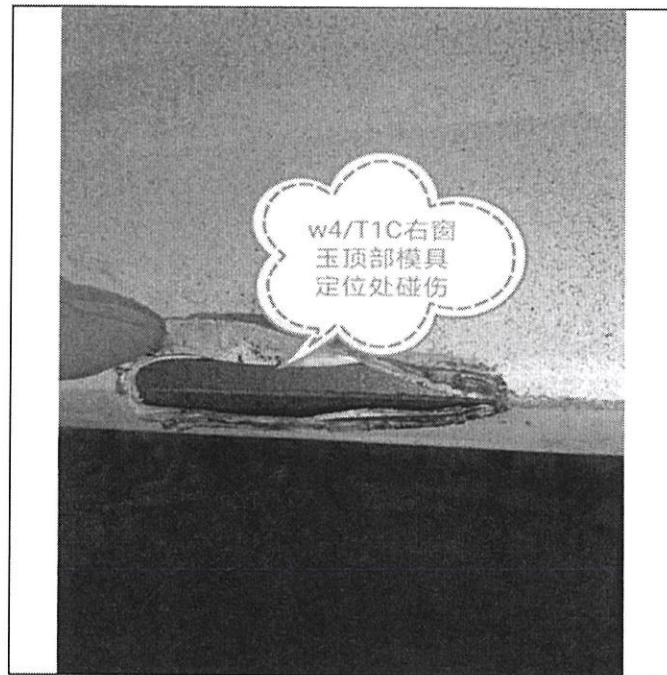
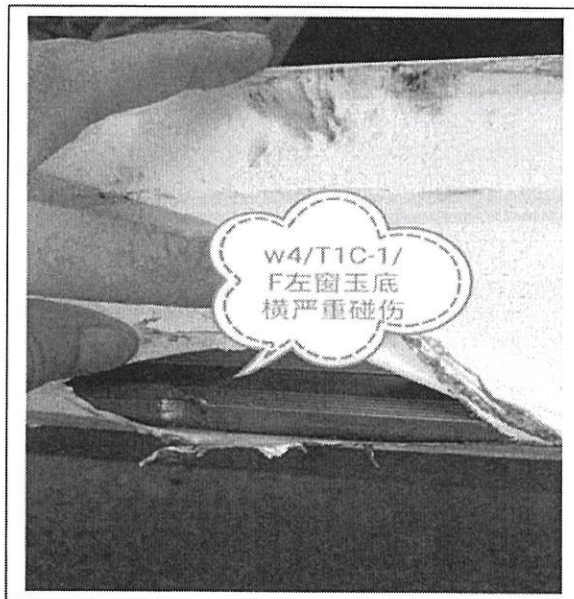
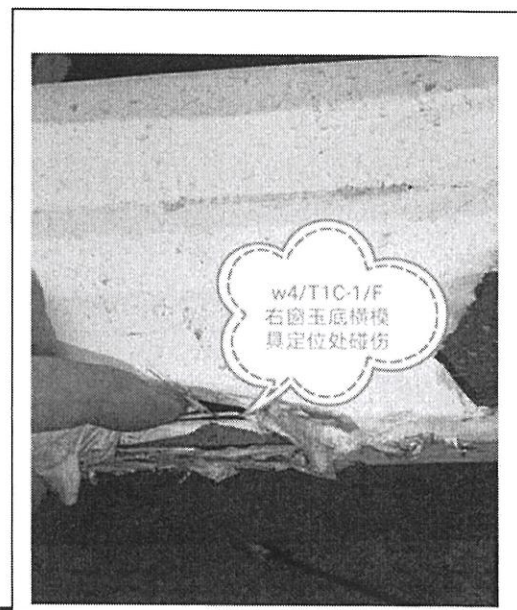
Q.I.REPORT NO. 质量检验报告编号: ARG-852-20-02

INSPECTION 检验工序 编号	SAMPLE SIZE 抽查 数量	DEFECTIVE 次品			DEFECT RAITO 次品率	DESCRIPTION OF DEFECT 次品描述
		CRI 严重	MAJ 轻微	MIN		
	1		1		100%	① W4/TIC 左窗五框横边位外脱模 右严重碰伤。 ② W4/TIC 右窗五框横边位外严重碰伤。

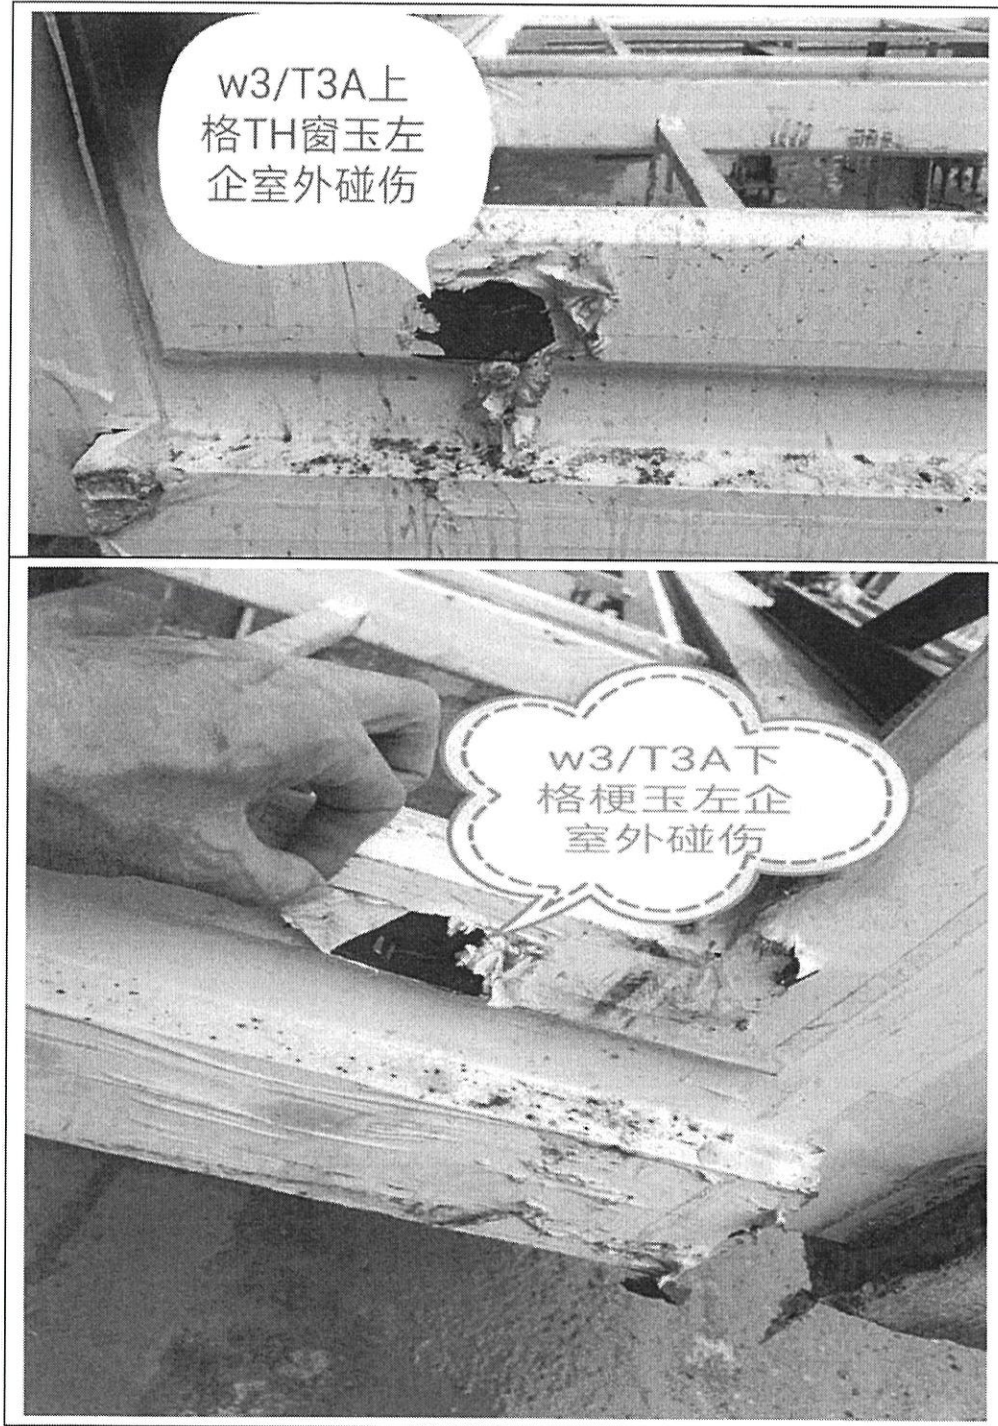
QI.REPORT NO. 质量检验报告编号: AR6-852-20-03

INSPECTION 检验工序 编号	SAMPLE SIZE 抽查 数量	DEFECTIVE 次品			DEFECT RAITO 次品率	DESCRIPTION OF DEFECT 次品描述
		CRI 严重	MAJ 轻微	MIN		
	1		1		100%	①上格T3窗台在企边处碰伤 ②下格窗台在企边处碰伤
