工程指示 / 要求簡箋(E.I.)

工程指示編號：EI / 2921 / 21 修改版次：-
 工程編號 : J - 852 工程名稱 : 亞皆老街中電
 工程項目 : 佛沙窗 師父板 (3rd)
 收件人 : 生統 / 王良 發件人 : Ant Yeung 日期 : 07/01/2021

Site Inspection Report # 06

1980045.1MFHK-SI-RPT-006-00

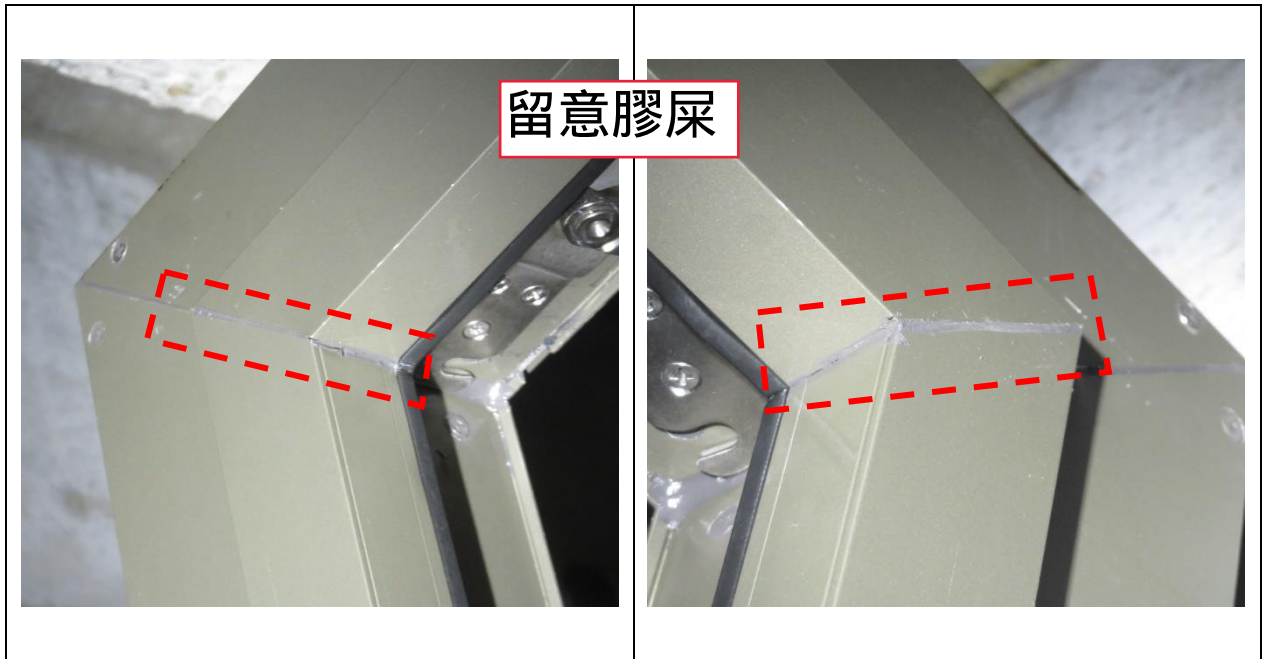
Photo #9

Observation (Window Frame)	Sealant was applied to the tight joints at window frame and sash. However, untidy sealant joints were observed.
Recommendation	Rectification work was carried out with reference to MFT's report 1980045.1MFHK-FI-RPT-002-00 Photo #13. Workmanship for sealant application should be improved.

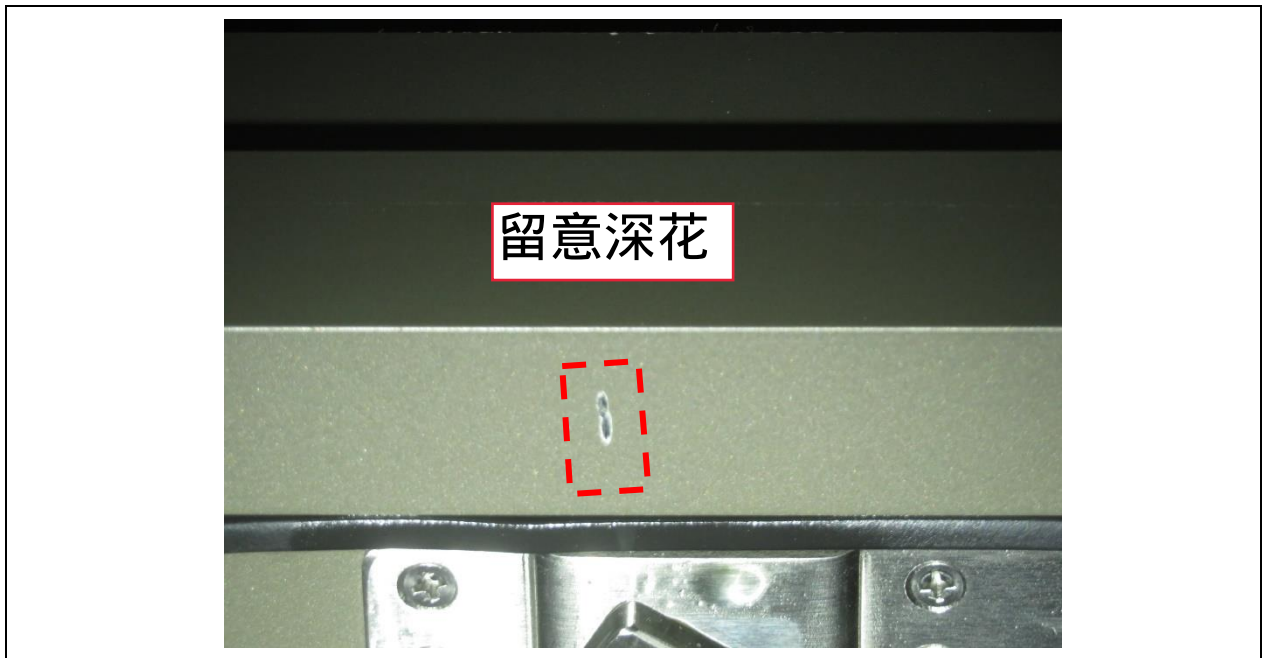
Photo #10

Observation (Window Frame)	A severe damage was noted on the coated surface.
Recommendation	No rectification work was carried out with reference to MFT's report 1980045.1MFHK-FI-RPT-002-00 Photo #14.

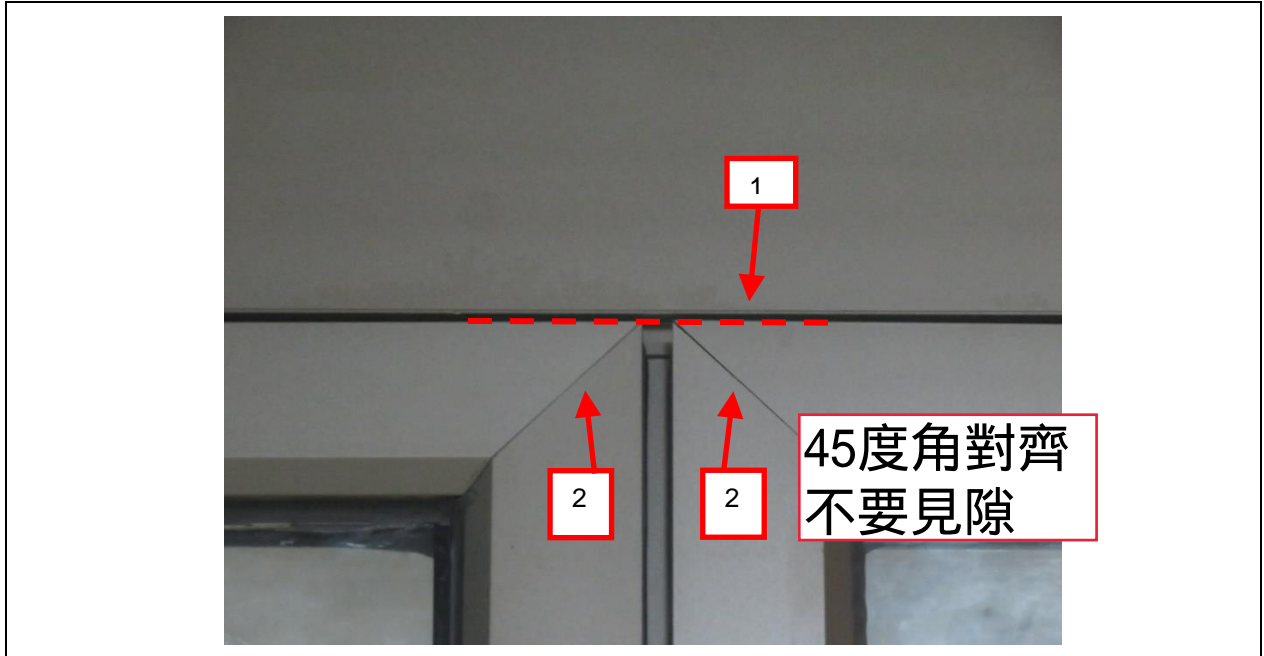
Photo #13

Observation (Window Sash)	1) Alignment between sashes was adjusted. 2) Uneven mitre joints could still be observed.
Recommendation	Rectification work was carried out with reference to MFT's report 1980045.1MFHK-FI-RPT-002-00 Photo #17. It is further reminded to improve the quality of fabrication as well as assembly in factory.

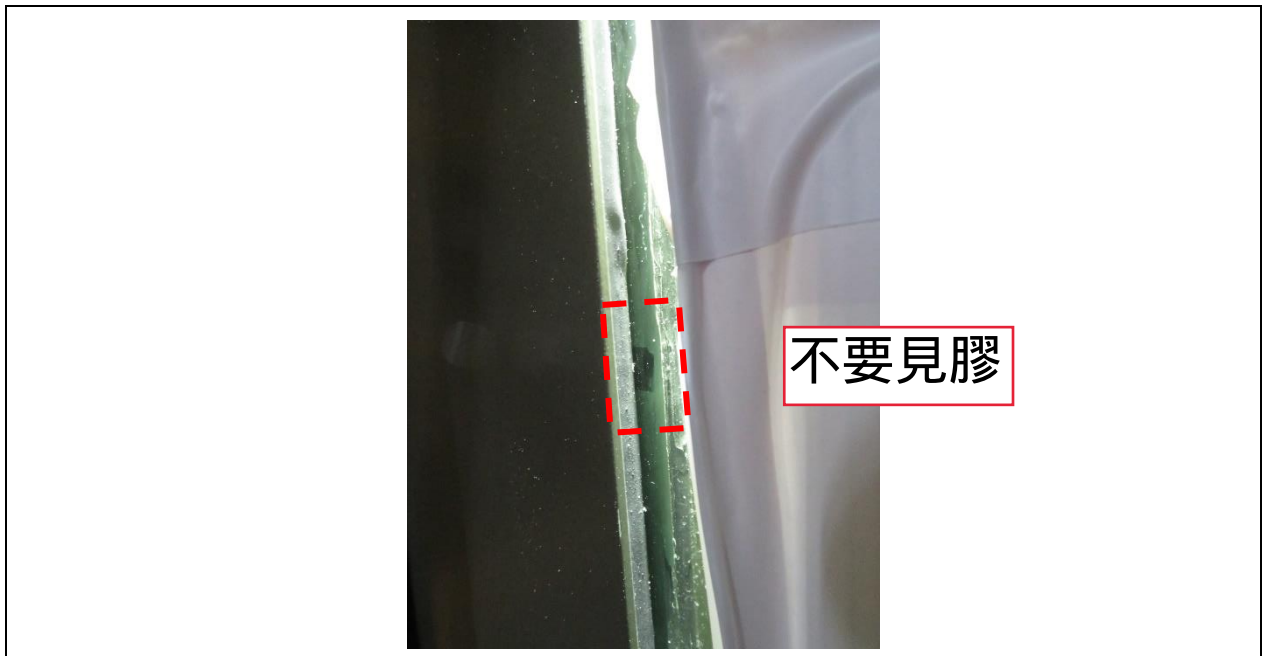
Photo #14

Observation (Glass Barrier)	Some spacers in the sealant joint around barrier glass were noticeable.
Recommendation	No rectification work was carried out with reference to MFT's report 1980045.1MFHK-FI-RPT-002-00 Photo #20.

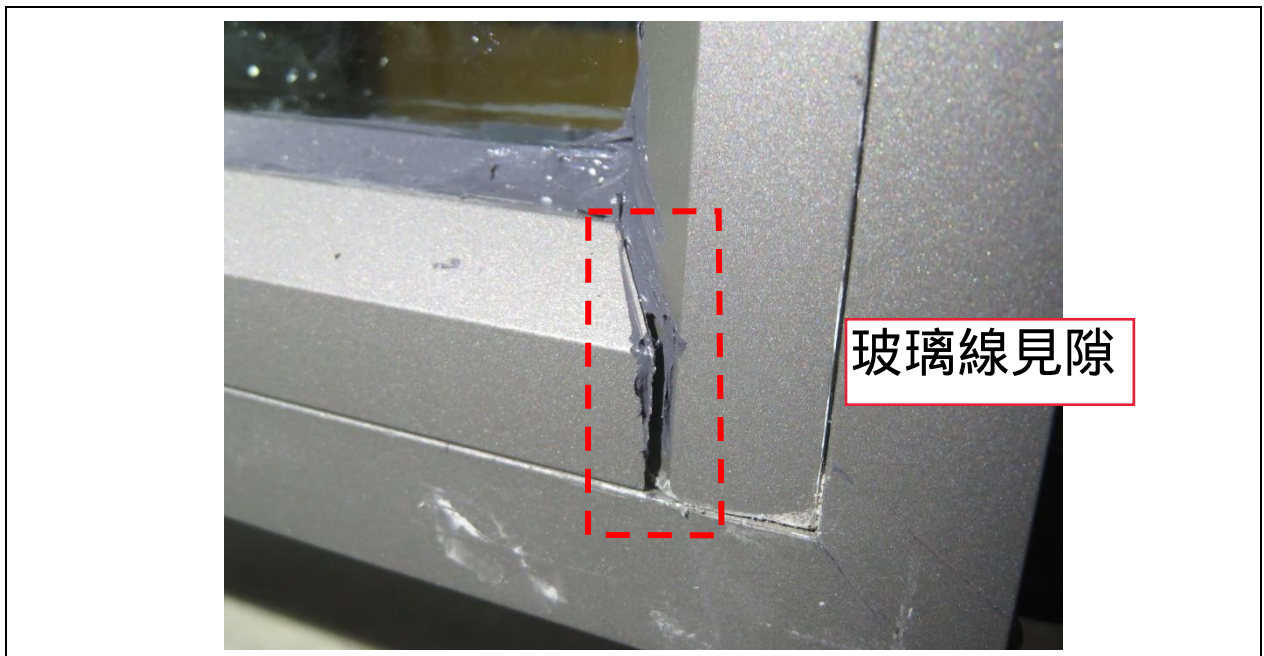
Photo #16

Observation (Window Sash)	Noticeable gap between glazing bead covers of sashes were observed.
Recommendation	Improvement in quality of fabrication as well as assembly is recommended.

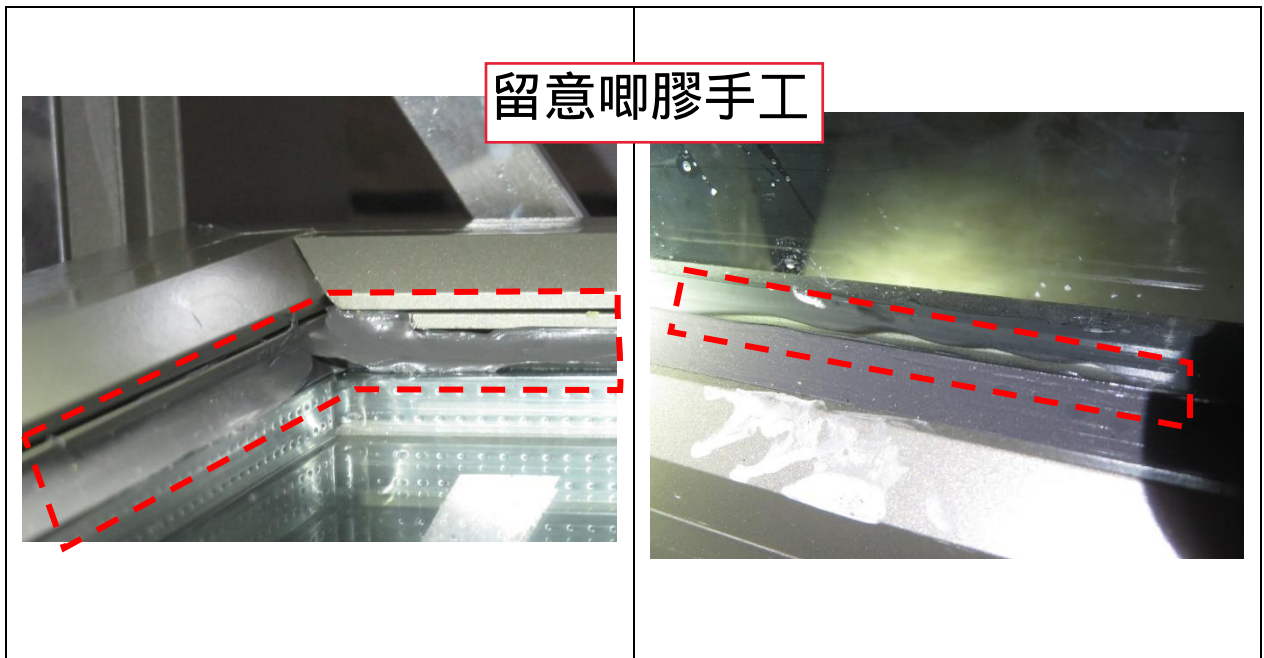
Photo #22

Observation (Window Sash)	Poor workmanship of glazing sealant was generally observed.
Recommendation	Rectification is required. Workmanship for sealant application should be improved.

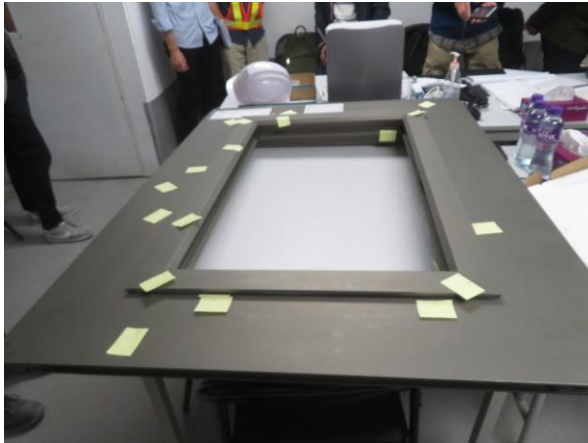
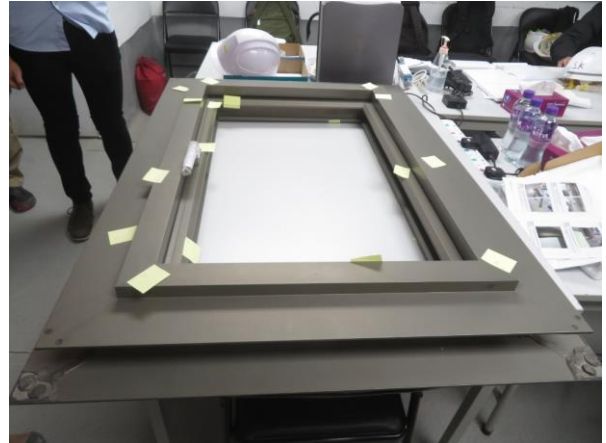
Photo #12

Joint inspection for reviewing the rectification status of alum window sample was carried out with Pacific Shine (Sino), GEC and Midi on 16th Dec 2020. Please refer to Photo #13 – Photo #14 for observations.
