工程指示 / 要求簡箋(E.I.)

工程指示編號：EI / 3187 / 21 修改版次：-
 工程編號：J - 852 工程名稱：亞皆老街中電
 工程項目：佛沙窗 師父板 (4th)
 收件人：生統 / 王良 發件人：Ant Yeung 日期：22/03/2021

Proposed Residential Development at 139-147 Argyle Street, Kowloon

Site Inspection Report # 06

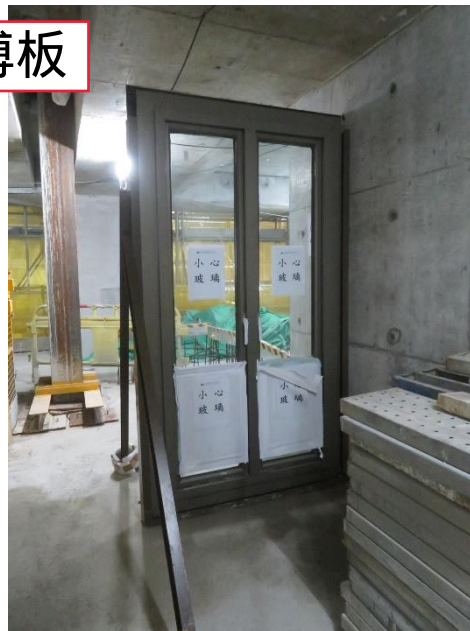
Photo #2

Observation (Alum Window)	Joint inspection for reviewing the rectification status of alum window sample was carried out with Gammon and Midi on 1 st September 2020.
-------------------------------------	---

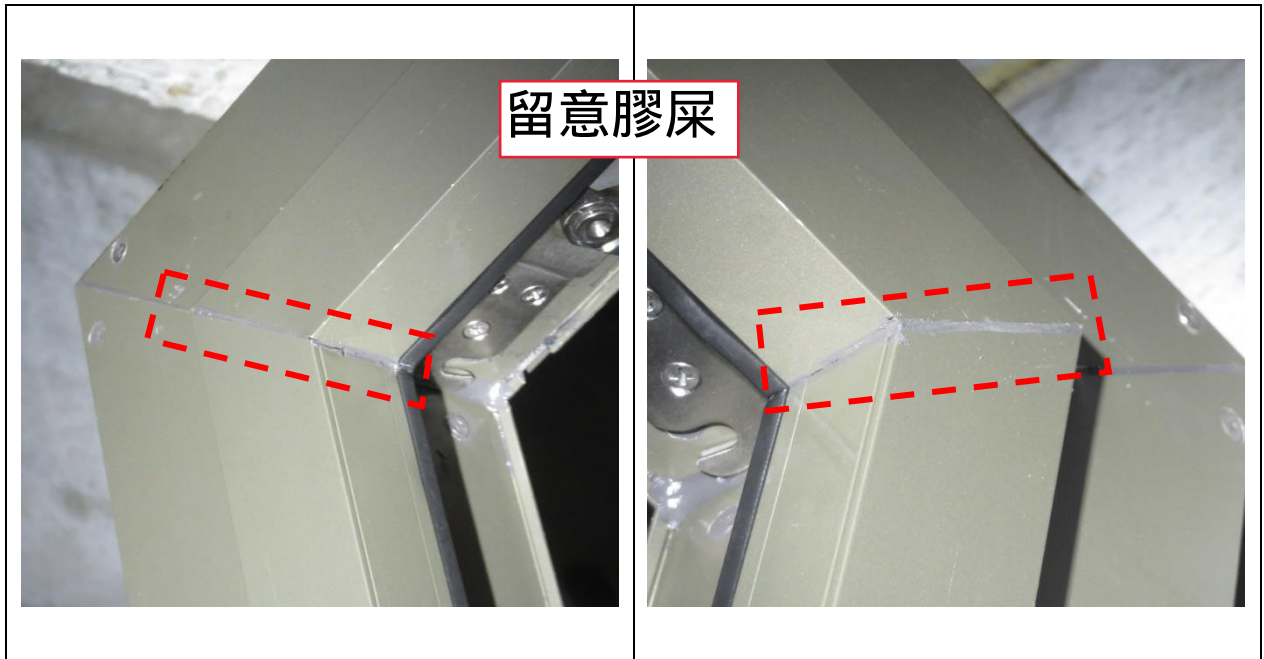
Photo #9

Observation (Window Frame)	Sealant was applied to the tight joints at window frame and sash. However, untidy sealant joints were observed.
Recommendation	Rectification work was carried out with reference to MFT's report 1980045.1MFHK-FI-RPT-002-00 Photo #13. Workmanship for sealant application should be improved.

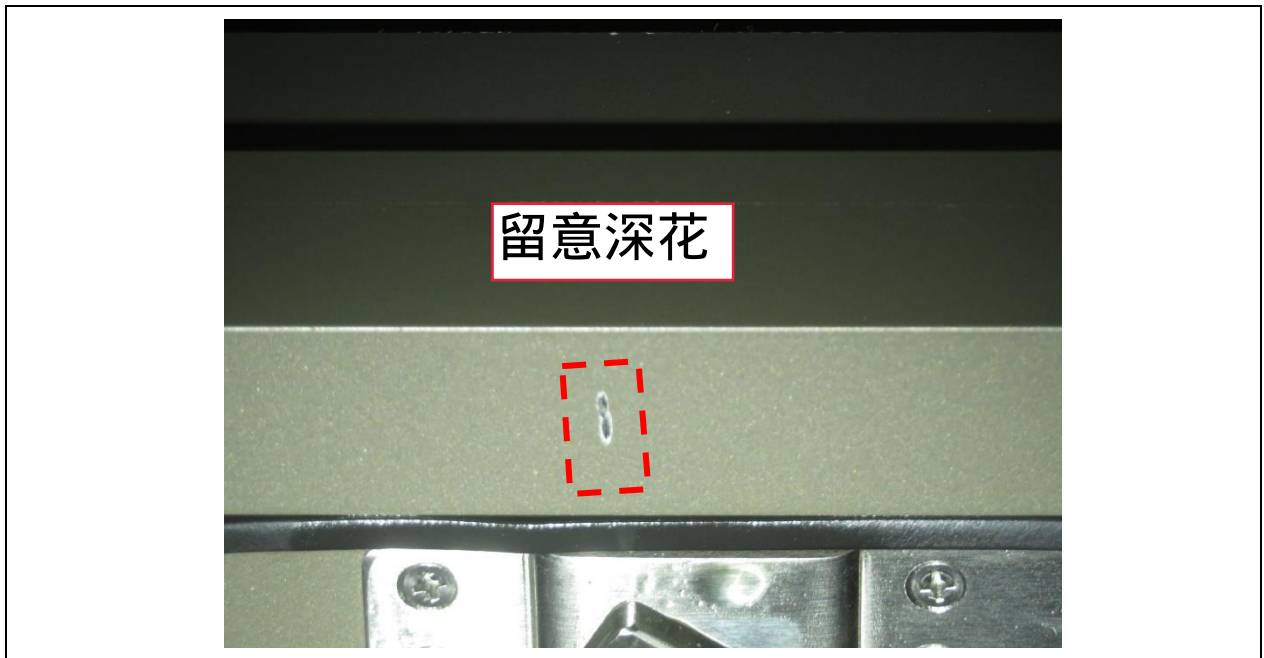
Photo #10

Observation (Window Frame)	A severe damage was noted on the coated surface.
Recommendation	No rectification work was carried out with reference to MFT's report 1980045.1MFHK-FI-RPT-002-00 Photo #14.

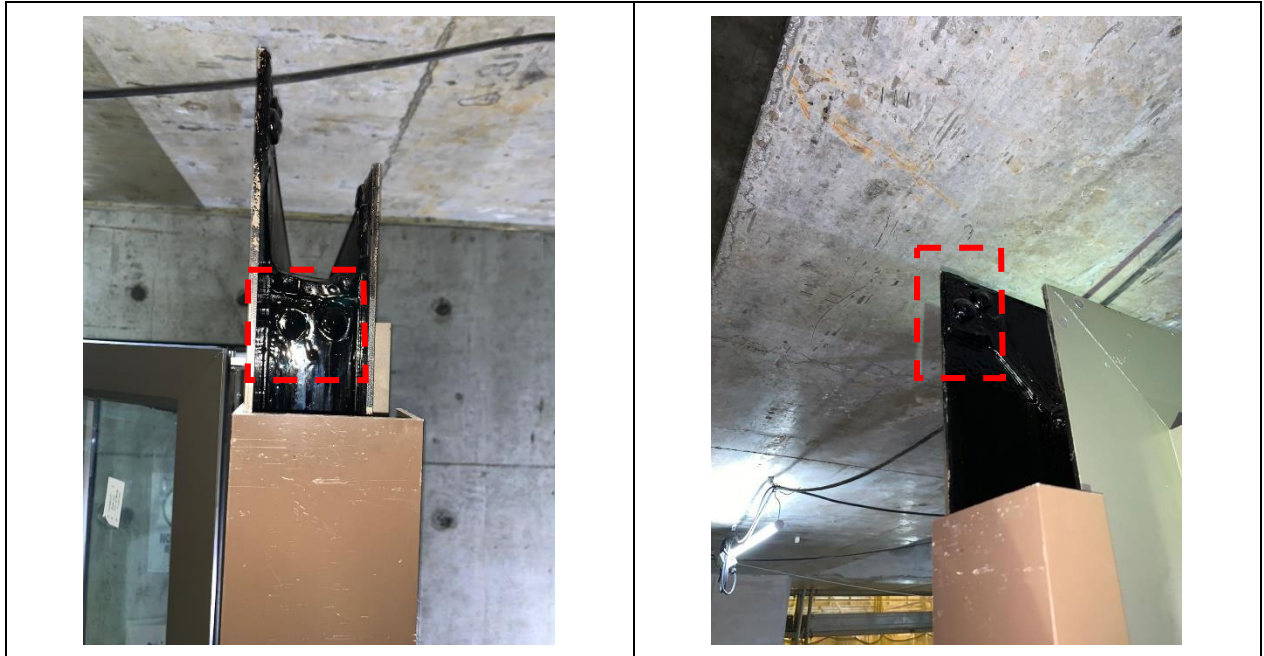
Photo #11

Observation (Window Frame)	Re-application of bitumen paint to the area which to be in contact with precast concrete was noted.
Recommendation	Rectification work was carried out with reference to MFT's report 1980045.1MFHK-FI-RPT-002-00 Photo #15. It is further reminded to improve the workmanship of applying bitumen paint in factory.

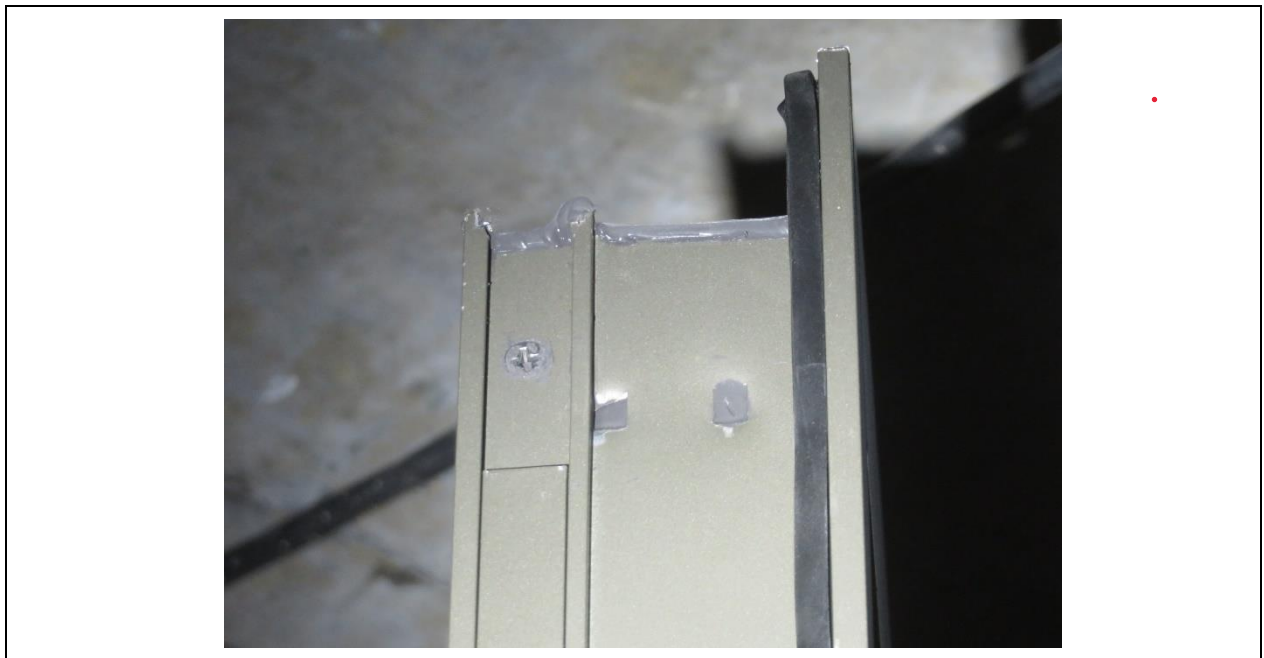
Photo #12

Observation (Window Sash)	Excessive sealant on the corner of a sash was removed.
Recommendation	Rectification work was carried out with reference to MFT's report 1980045.1MFHK-FI-RPT-002-00 Photo #16.

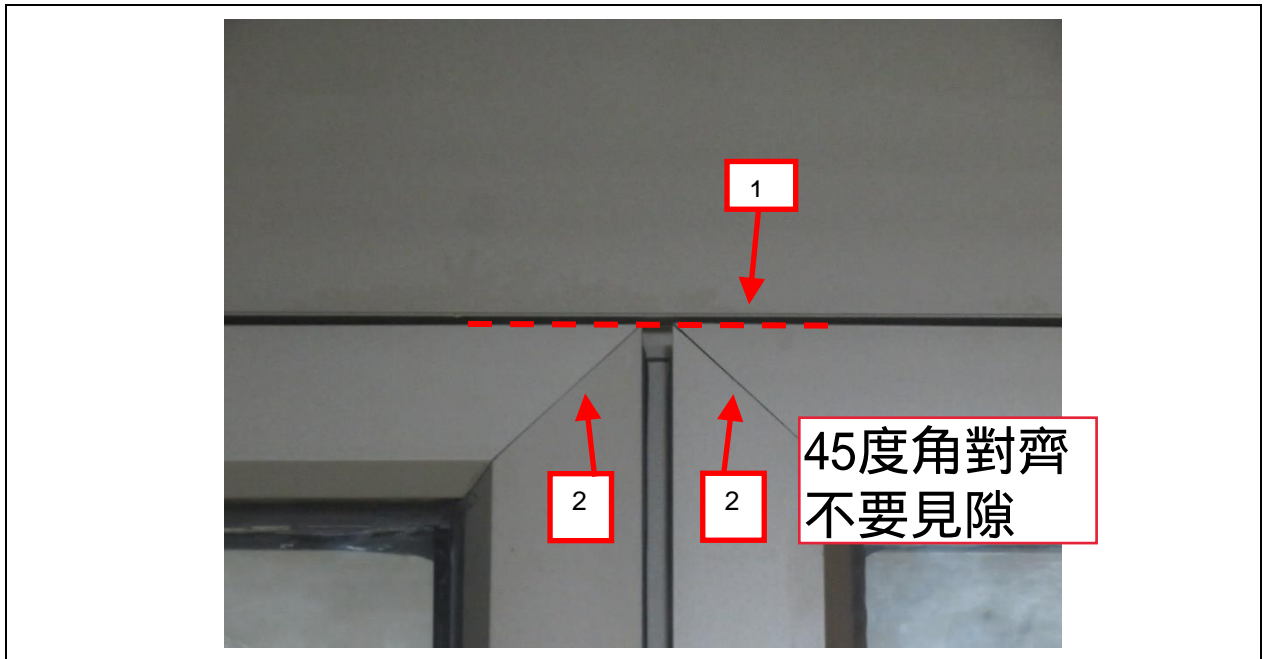
Photo #13

Observation (Window Sash)	1) Alignment between sashes was adjusted. 2) Uneven mitre joints could still be observed.
Recommendation	Rectification work was carried out with reference to MFT's report 1980045.1MFHK-FI-RPT-002-00 Photo #17. It is further reminded to improve the quality of fabrication as well as assembly in factory.

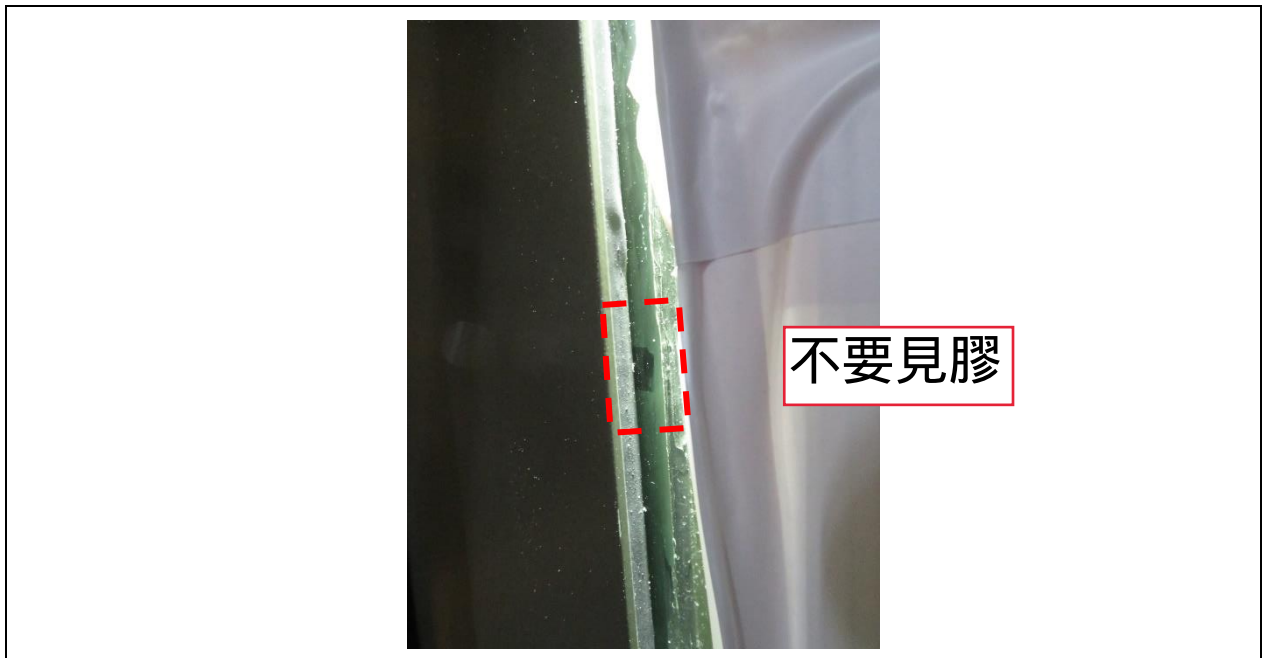
Photo #14

Observation (Glass Barrier)	Some spacers in the sealant joint around barrier glass were noticeable.
Recommendation	No rectification work was carried out with reference to MFT's report 1980045.1MFHK-FI-RPT-002-00 Photo #20.

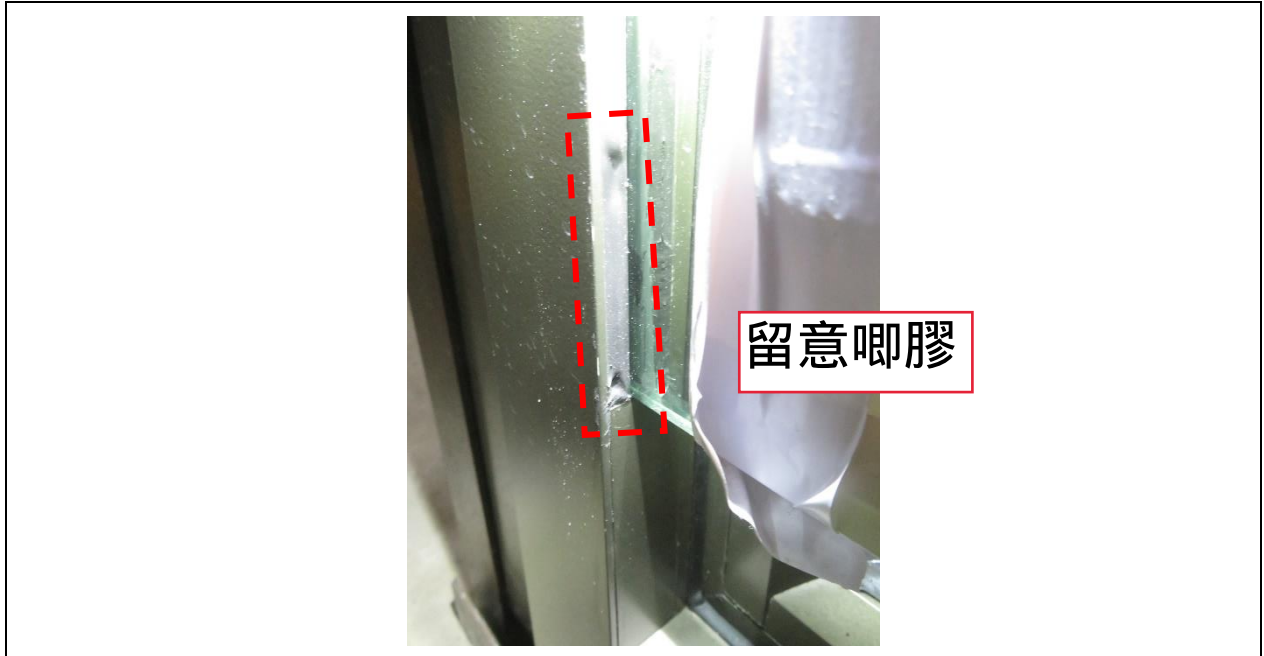
Photo #15

Observation (Glass Barrier)	Poor workmanship was observed at a location of sealant joint.
Recommendation	No rectification work was carried out with reference to MFT's report 1980045.1MFHK-FI-RPT-002-00 Photo #21.

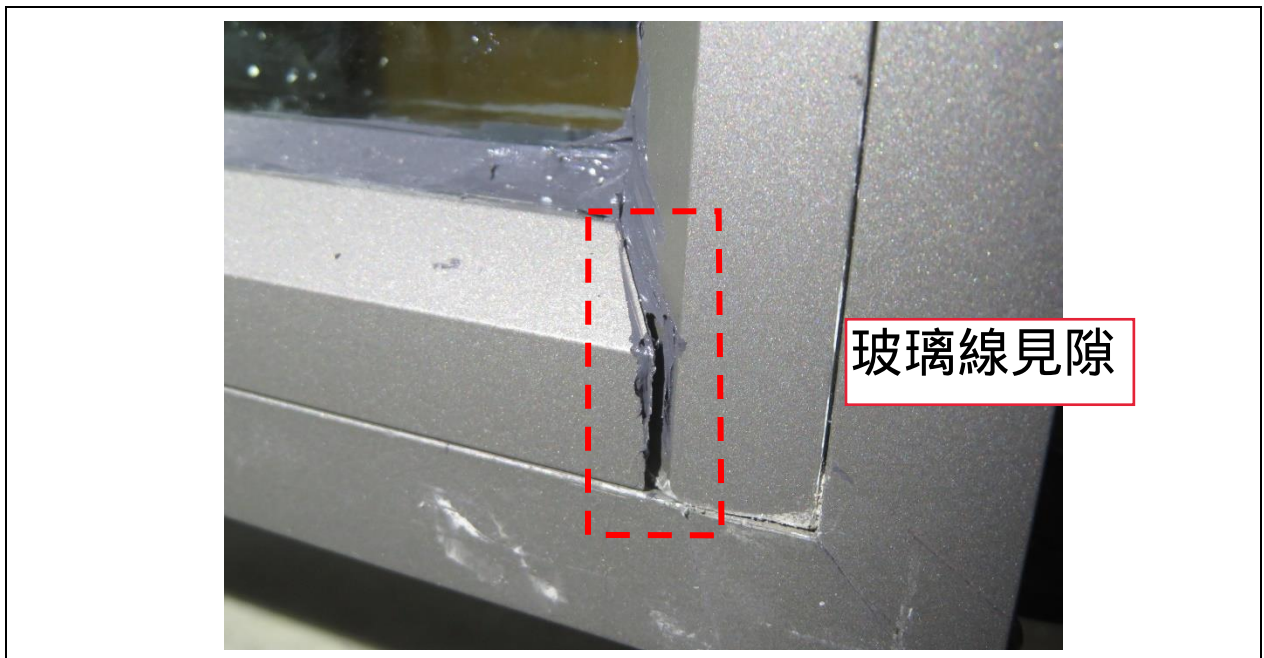
Photo #16

Observation (Window Sash)	Noticeable gap between glazing bead covers of sashes were observed.
Recommendation	Improvement in quality of fabrication as well as assembly is recommended.

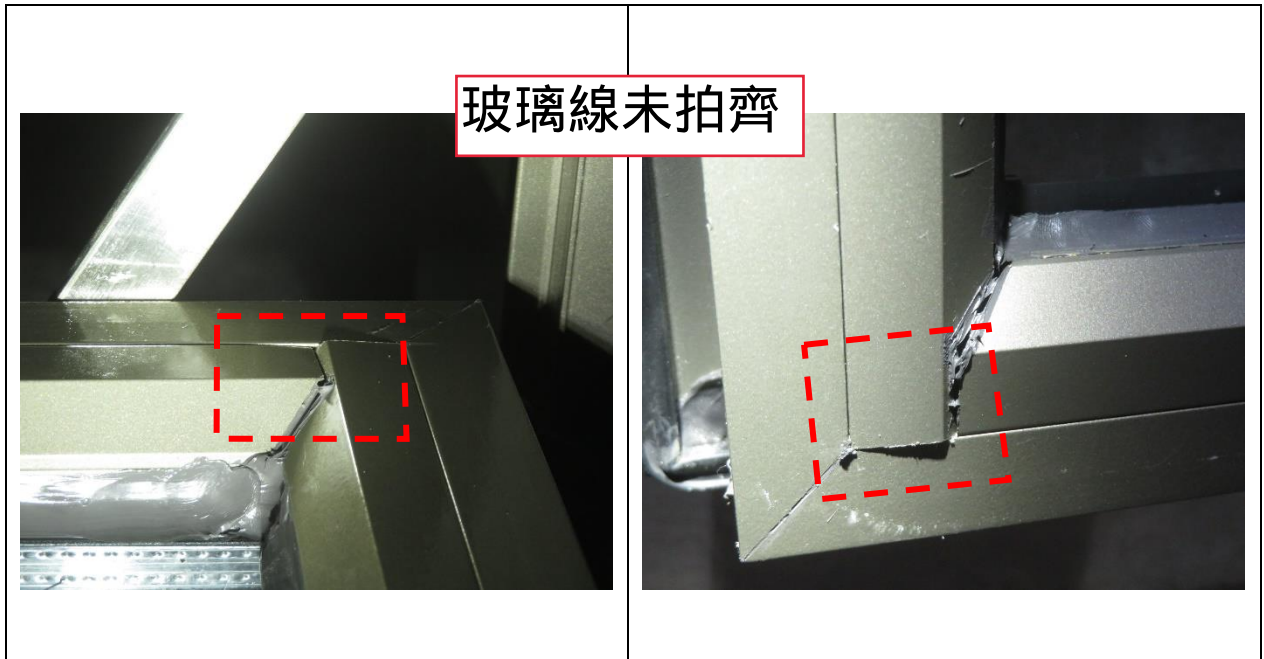
Photo #17

Observation (Window Sash)	Surfaces between glazing bead covers were not flush.
Recommendation	Rectification is required.

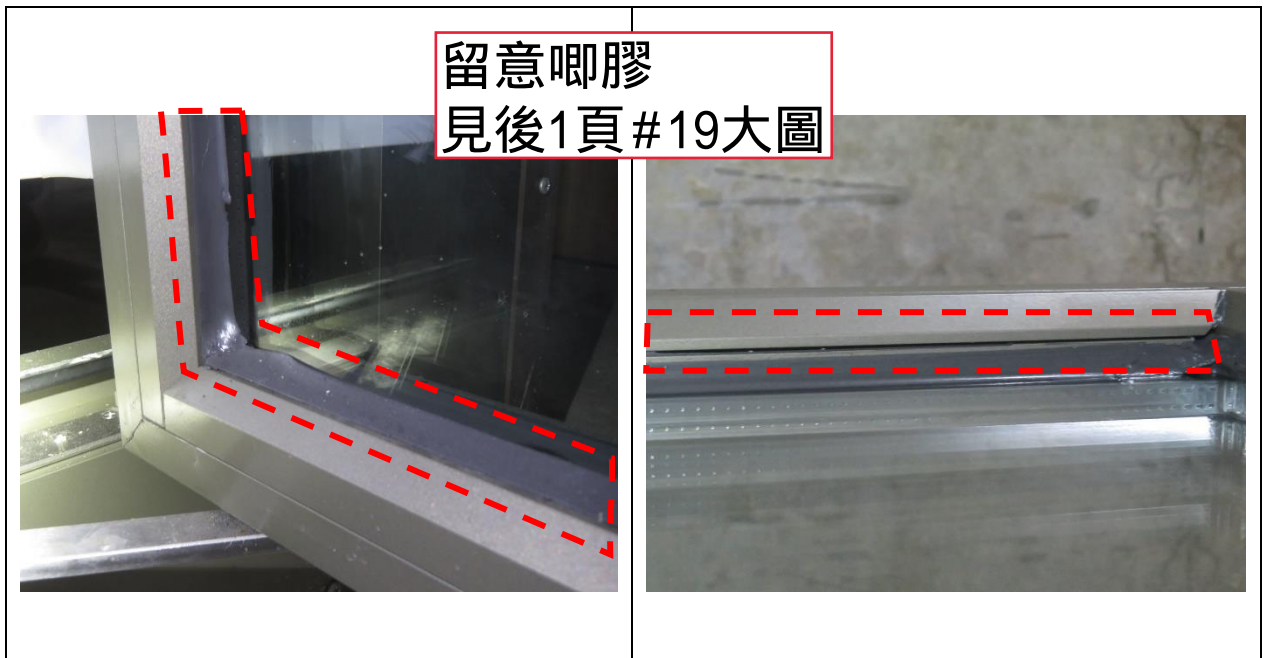
Photo #18

Observation (Window Sash)	Inconsistent glazing sealant of sashes (i.e. gaps between glazing beads and glazing bead covers were filled with sealant (LHS) or without sealant (RHS)). Please refer to Photo #19 for shop drawing detail.
Recommendation	Midi to clarify the inconsistency found. Rectification is required as per latest shop drawing.

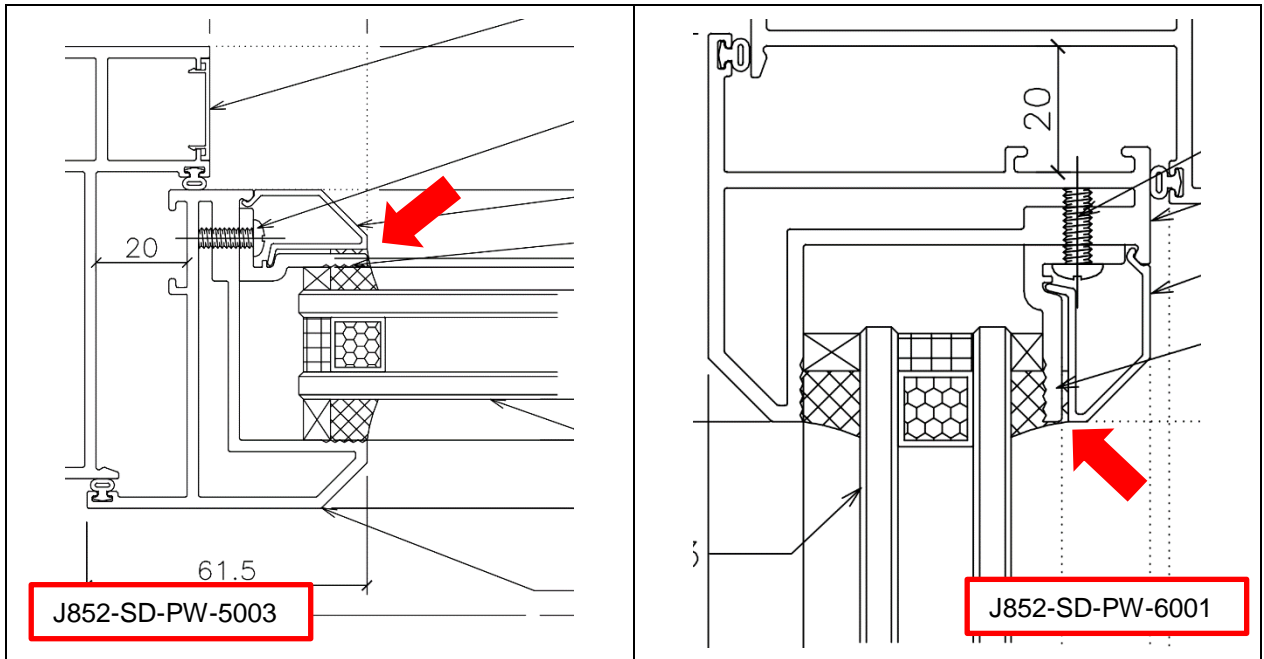
Photo #19

Observation	The above detail is extracted from latest shop drawings no. J852-SD-PW-5003 and J853-SD-PW-6001, sealant should be applied for the gap between glazing bead and its cover.
Recommendation	-

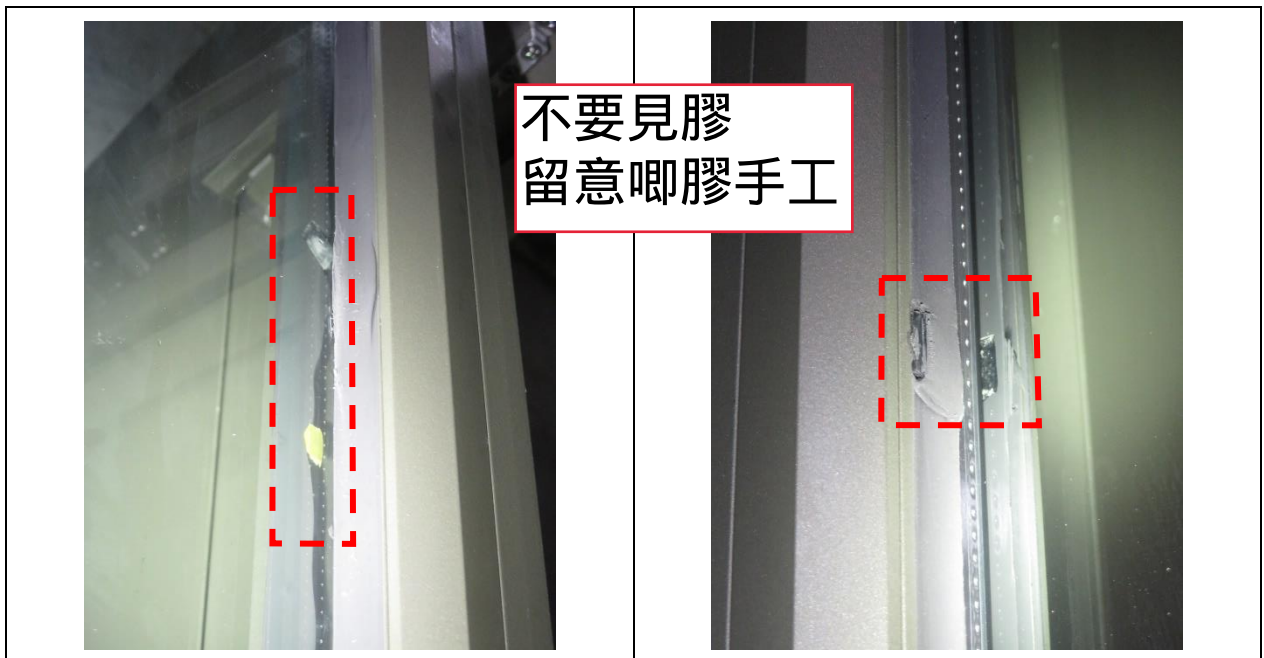
Photo #20

Observation (Window Sash)	Some spacers in the glazing sealant of sashes were noticeable.
Recommendation	Rectification is required.

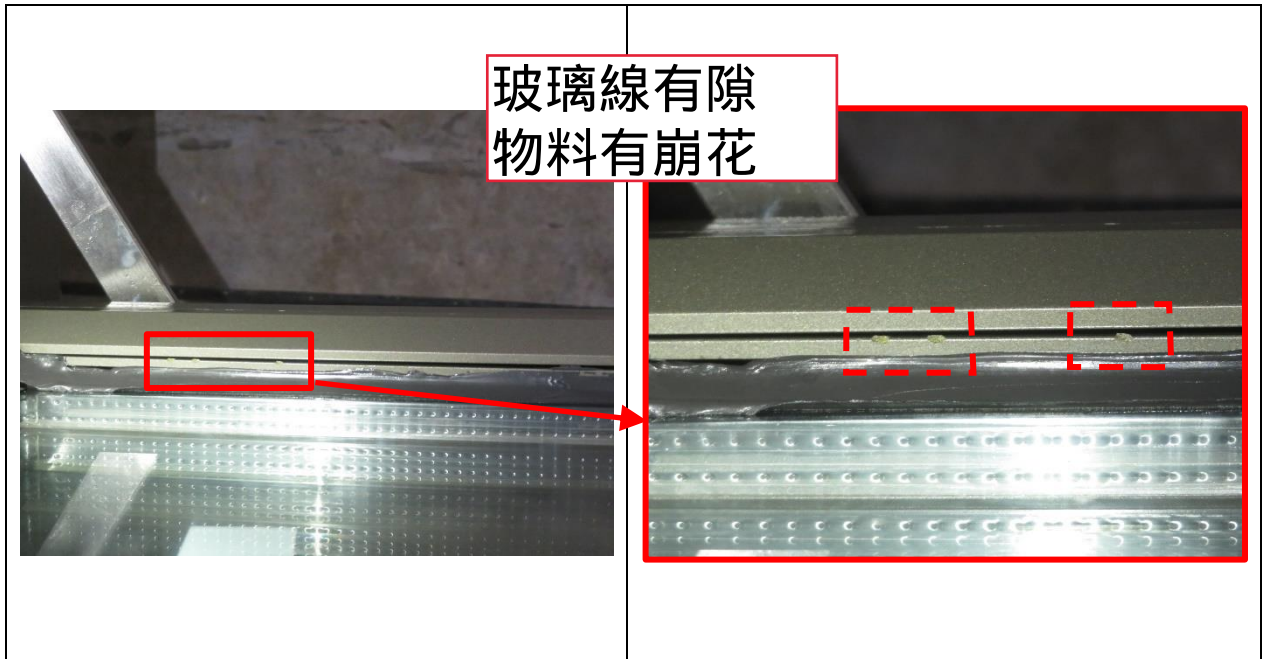
Photo #21

Observation (Window Sash)	LHS: Significant gap between glazing bead and glazing bead cover was noted. RHS: Damages were observed on the edge of glazing bead.
Recommendation	Please refer to Photo #16 for comment. Review of protection and handling of material are recommended.

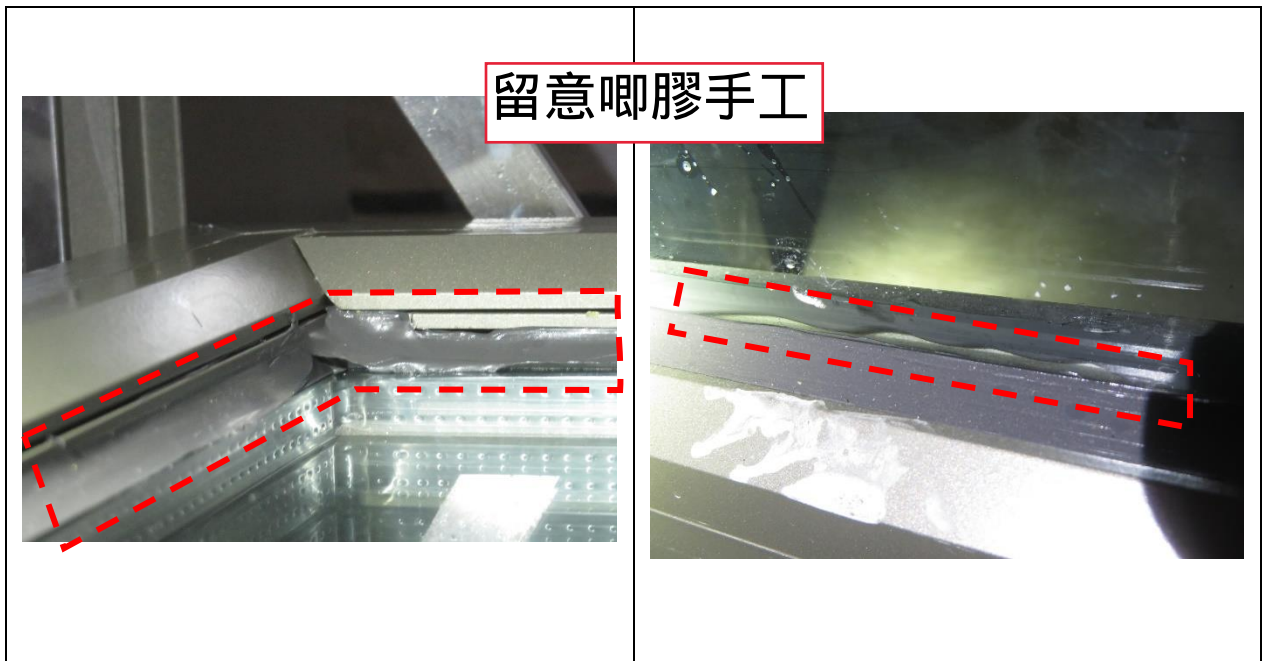
Photo #22

Observation (Window Sash)	Poor workmanship of glazing sealant was generally observed.
Recommendation	Rectification is required. Workmanship for sealant application should be improved.

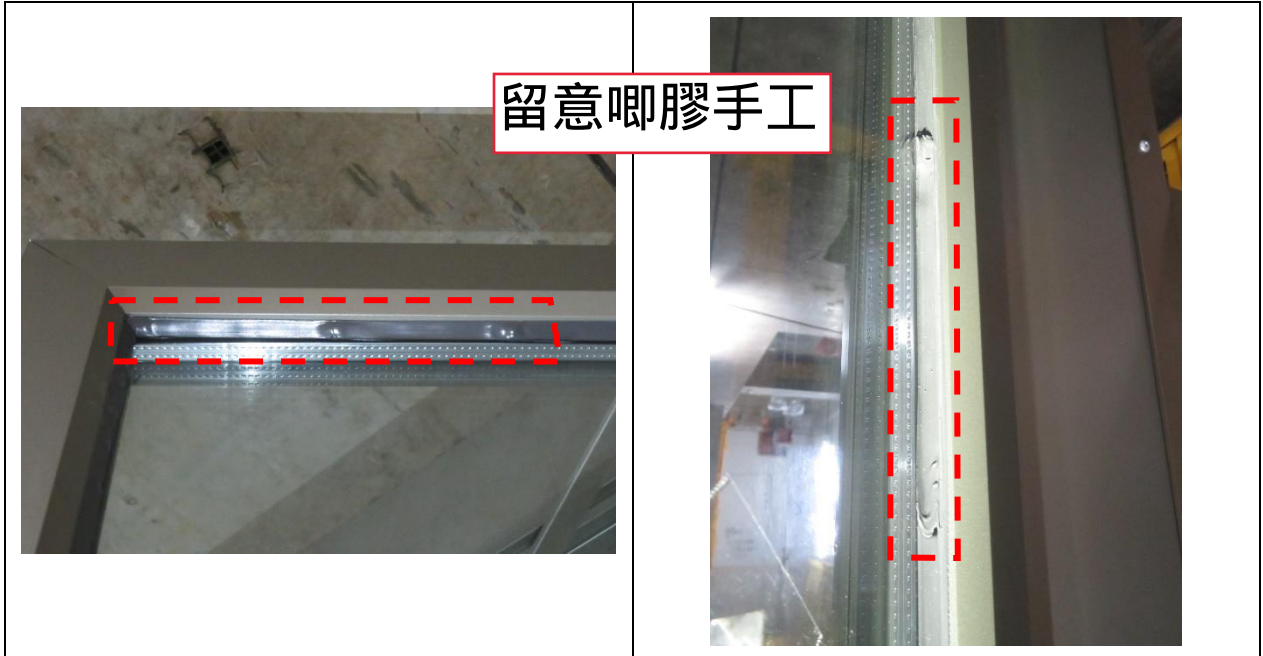
Photo #23

Observation (Window Sash)	Ditto.
Recommendation	Ditto.

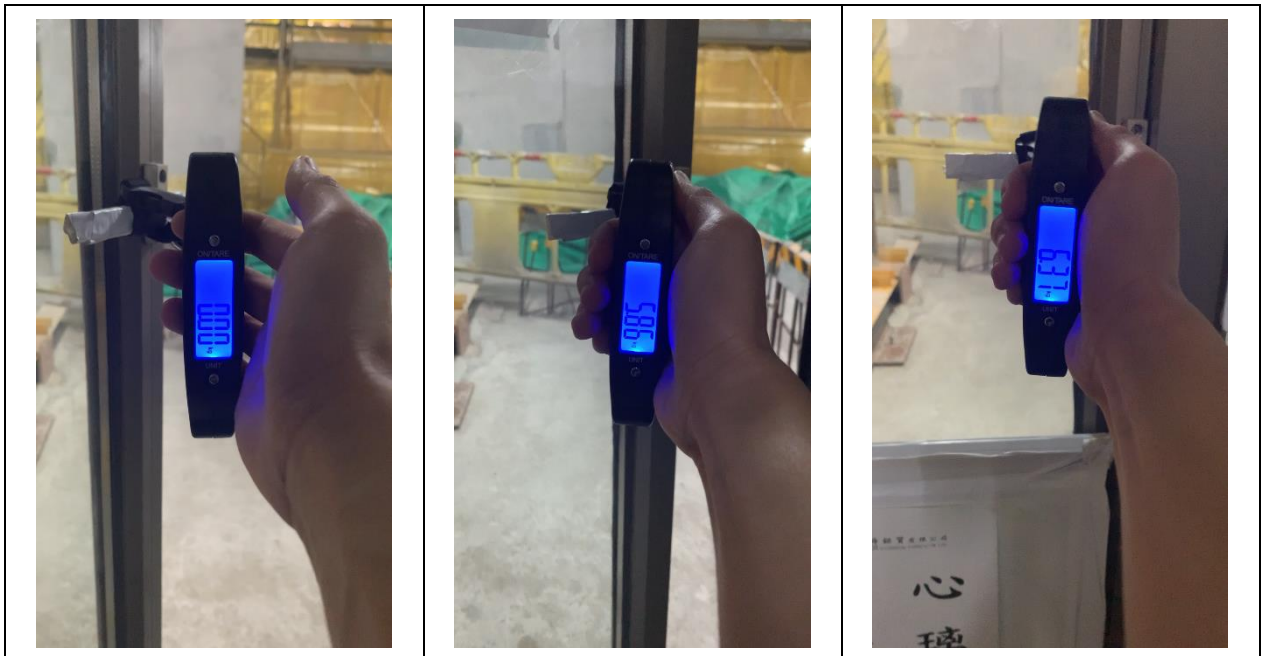
Photo #24

Observation (Window Sash)	Pulling force required to close the window sash was around 5kg – 6.5kg (i.e. around 49N – 64N).
Recommendation	-

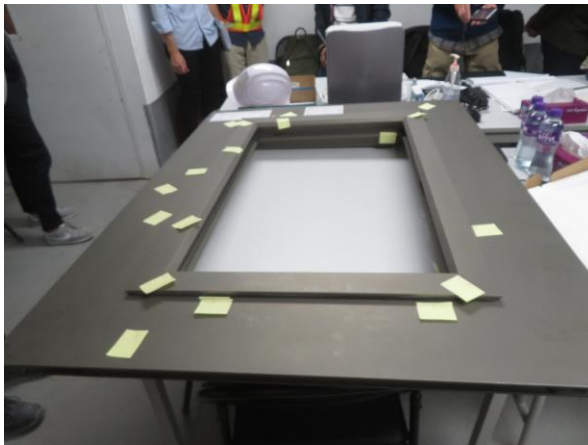
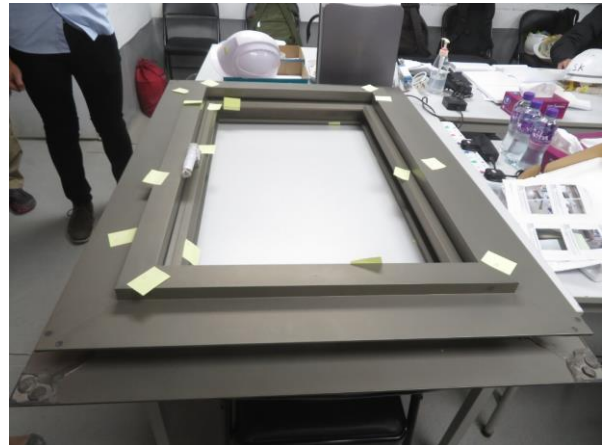
Photo #12

Joint inspection for reviewing the rectification status of alum window sample was carried out with Pacific Shine (Sino), GEC and Midi on 16th Dec 2020. Please refer to Photo #13 – Photo #14 for observations.

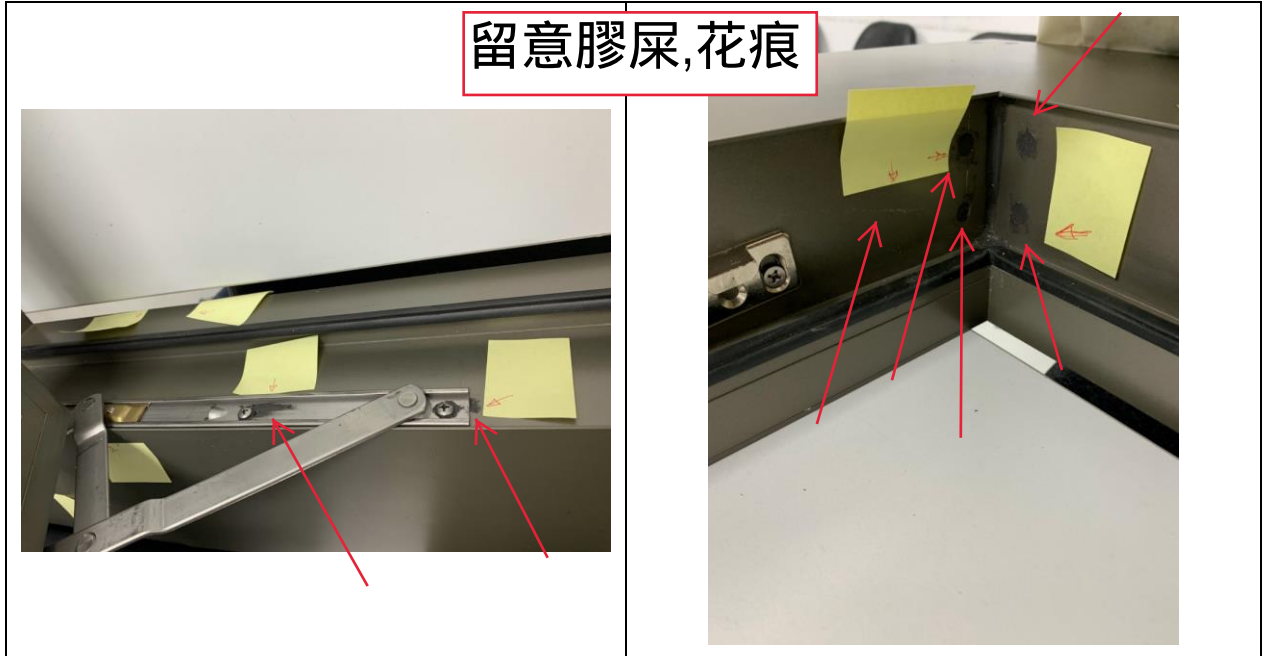
Photo #13

<p>Observation (Alum Window)</p>	<p>In general, no rectification works could be observed to address the observations/comments given by MFT during 1st joint inspection on 7th Aug 2020 (Details refer to report ref. no.: 1980045.1MFHK-SI-PRT-003-00, Photo #14 – Photo #36).</p>
<p>Recommendation</p>	<p>Midi is requested to address the observations/comments mentioned in the above inspection report case by case.</p>

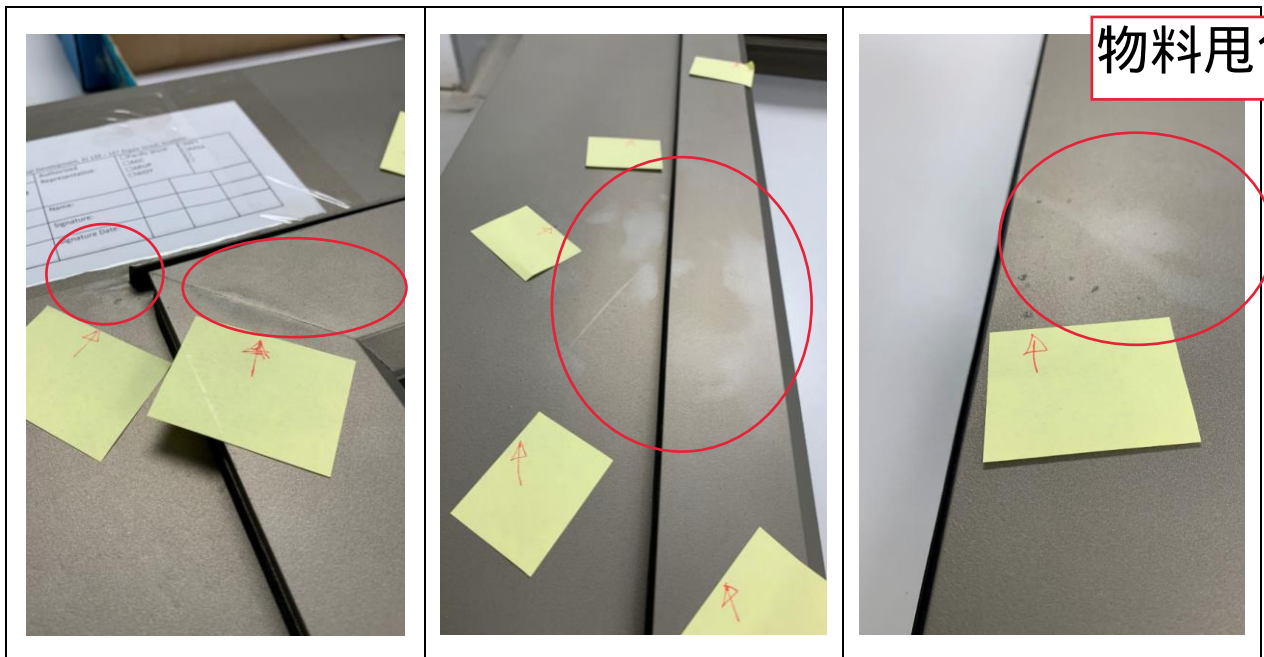
Photo #14

<p>Observation (Alum Window)</p>	<p>Further to Photo #13, noticeable touch-up works were also observed for the whole window sample especially at the locations with mitre joints.</p>
<p>Recommendation</p>	<p>Workmanship for touch-up works should be improved. Midi is required to rectify and resubmit the window sample immediately.</p>

#3) 噴塗脫色，要補油

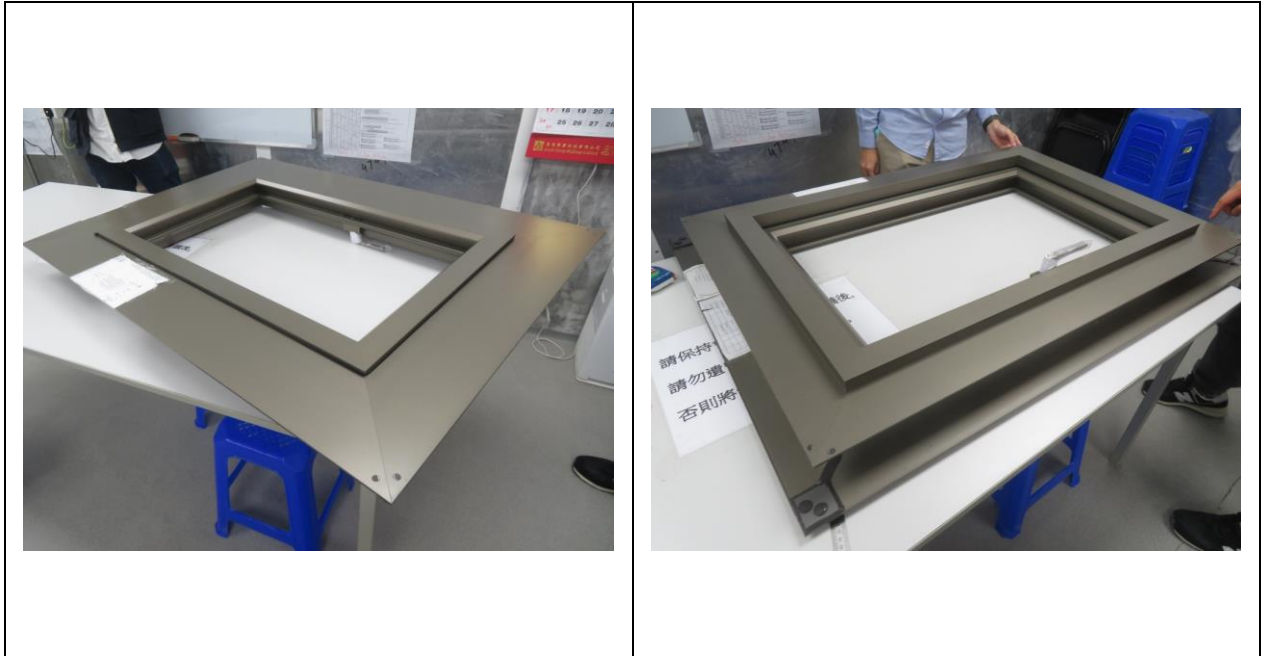
Photo #31

<p>Observation (Alum window sample)</p>	<p>Joint inspection for reviewing the resubmitted control sample of alum window was carried out with Sino OSR and GECCL on 28th January 2021. Please refer to Photo #32 – Photo #50 for observations.</p>
<p>Recommendation</p>	<p>-</p>

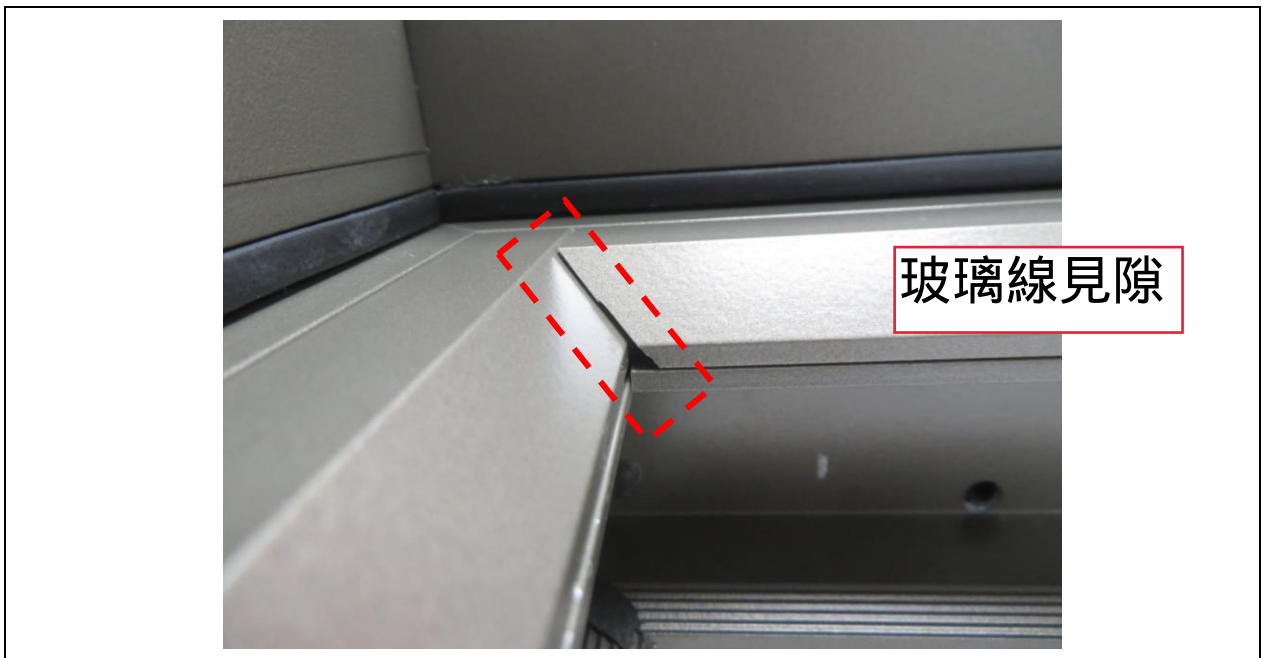
Photo #32

<p>Observation (Window Sash)</p>	<p>Noticeable gap between glazing bead covers of the sash were observed.</p>
<p>Recommendation</p>	<p>Improvement in quality of fabrication as well as assembly is recommended.</p>

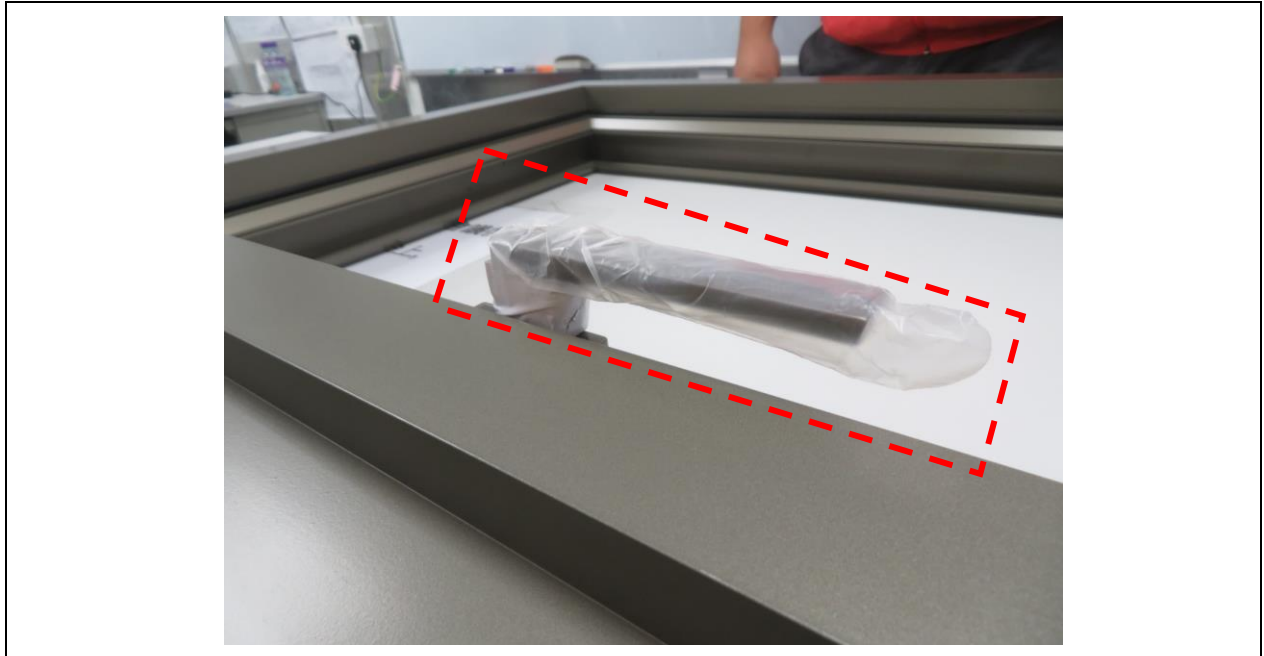
Photo #33

Observation (Window Sash)	Sash handle.
Recommendation	Profile of sash handle to be further reviewed and confirmed by relevant parties.

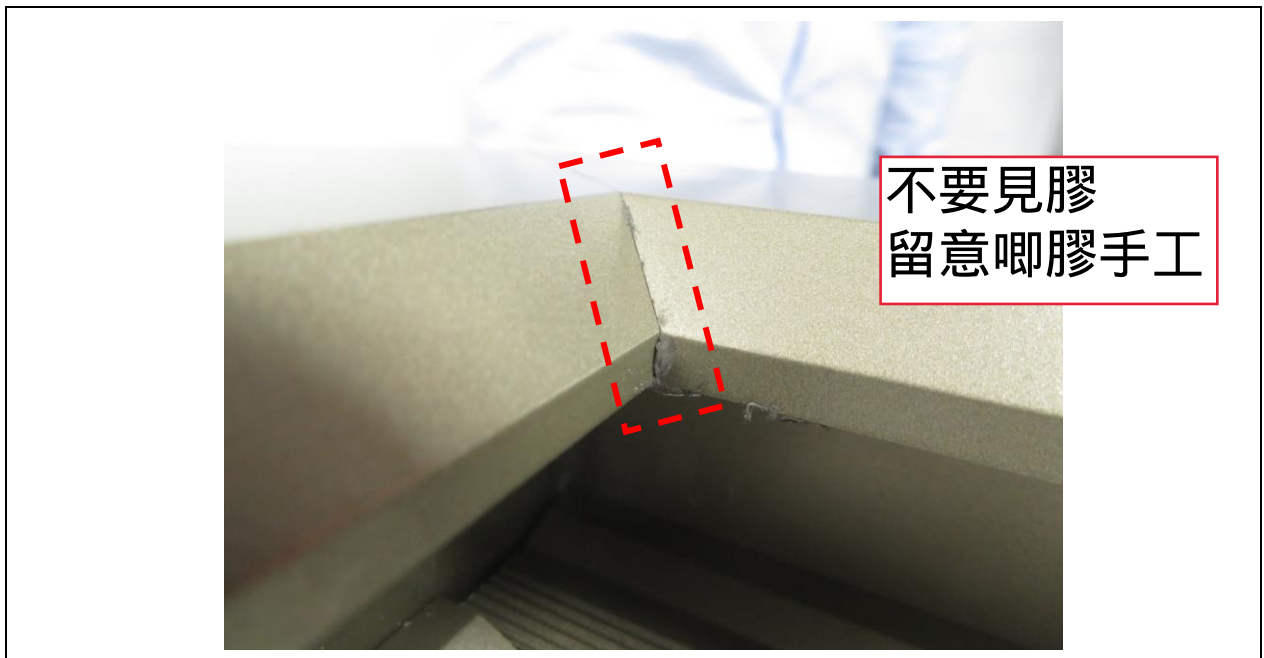
Photo #34

不要見膠
留意啲膠手工

Observation (Window Sash)	Excessive sealant was observed at the mitre joint of sash.
Recommendation	Improvement in the workmanship of applying sealant and cleaning in factory is needed.

#4) 45 度角要多一點點膠，要清理膠漬

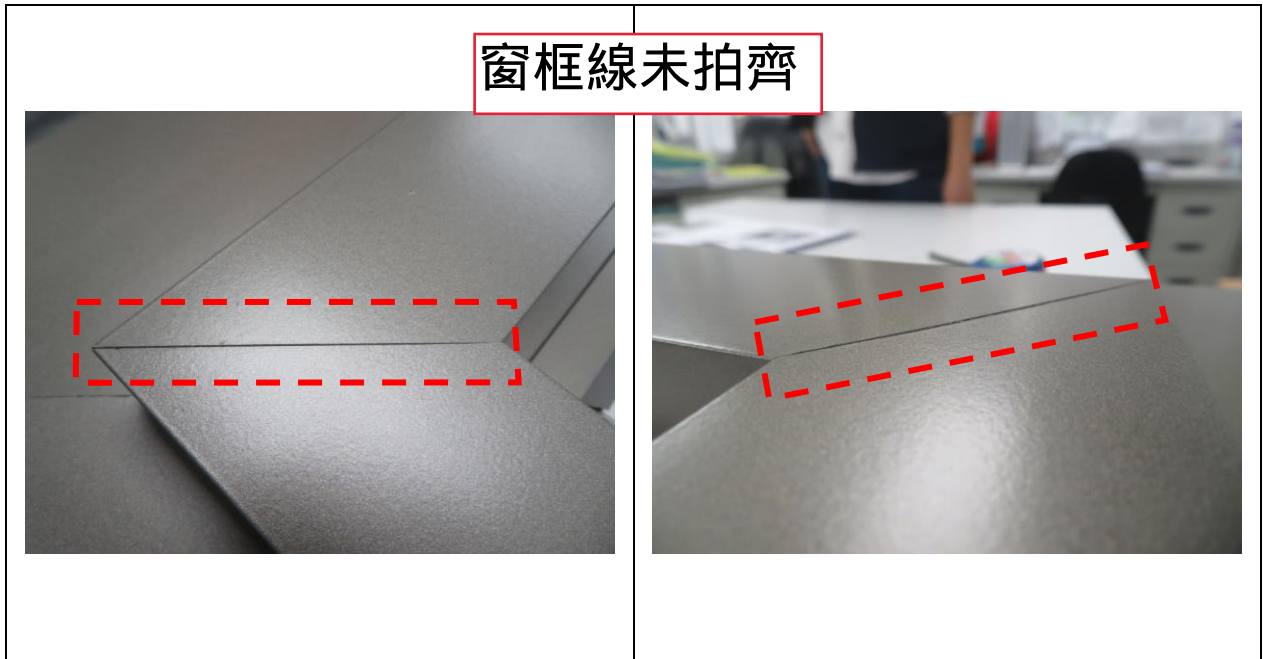
Photo #35

Observation (Window Sash)	A significant and uneven mitre joint for the sash.
Recommendation	Improvement in quality of fabrication as well as assembly is recommended.

#6) 45 度不能起級，不齊

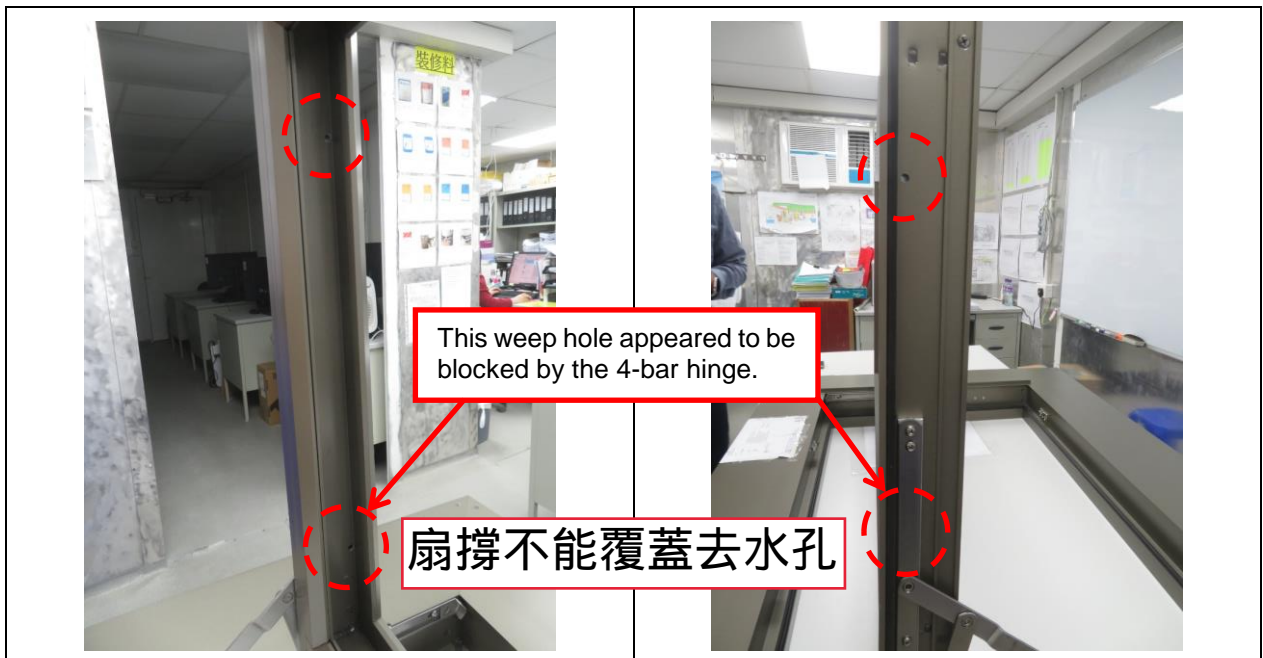
Photo #36

Observation (Window Sash)	Two weep holes were noted at the bottom of sash. One of the weep holes appeared to be blocked by the 4-bar hinge as indicated.
Recommendation	Review on the location of weep hole is recommended. It is also reminded that those weep holes should not be blocked by sealant.

#9) 去水孔要移位，扇撐不能覆蓋去水孔
