工程指示 / 要求簡箋(E.I.)

工程指示編號：EI / 3187 / 21 修改版次：-
 工程編號：J - 852 工程名稱：亞皆老街中電
 工程項目：佛沙窗 師父板 (4th)
 收件人：生統 / 王良 發件人：Ant Yeung 日期：22/03/2021

Proposed Residential Development at 139-147 Argyle Street, Kowloon

Site Inspection Report # 06

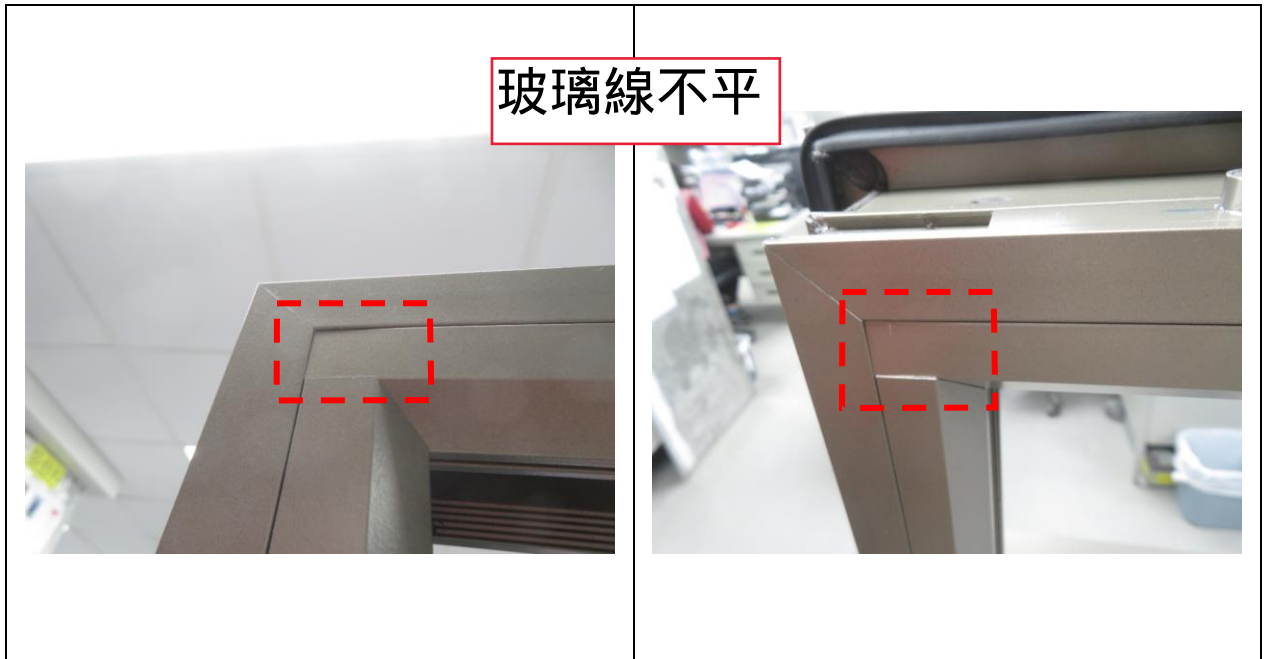
Photo #37

Observation (Window Sash)	Surfaces between glazing bead covers were not flush.
Recommendation	Rectification is required.

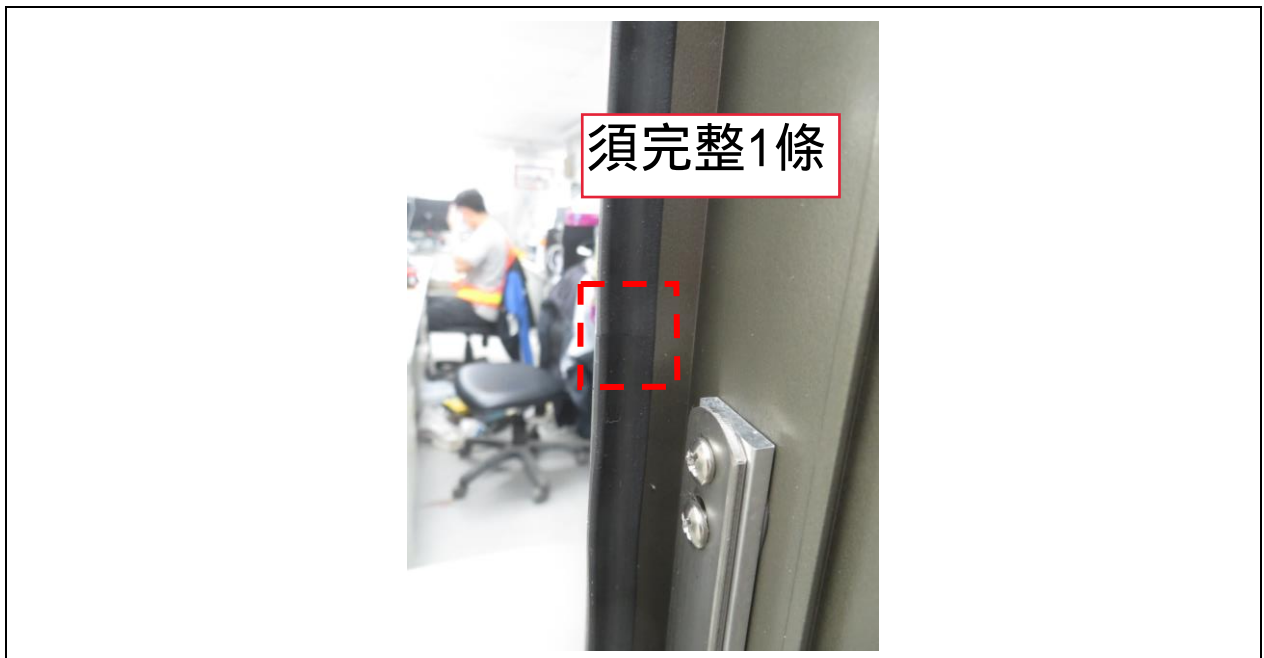
Photo #38

Observation (Window Sash)	Location of cut end of outer gasket around sash was noted.
Recommendation	Any aesthetic issue may defer to relevant parties' comments.

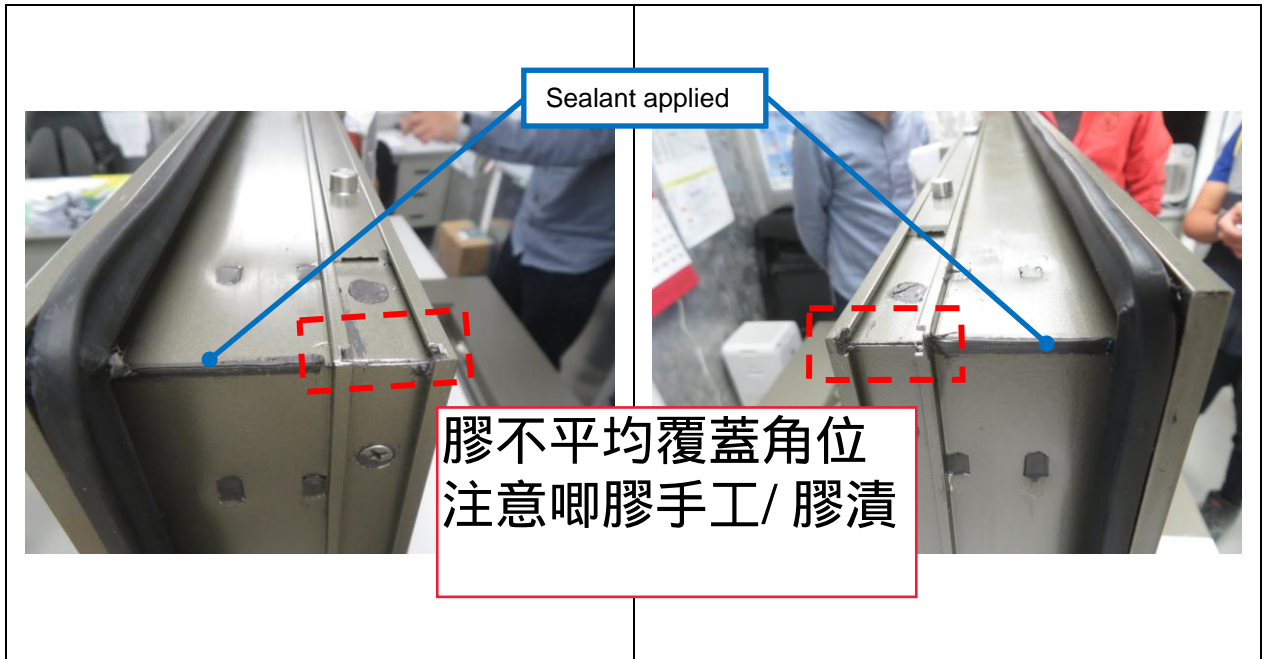
Photo #39

Observation (Window Sash)	Inconsistent sealant application was observed at the corners of sash.
Recommendation	Rectification is required. Sealant application at corners of sash should be standardized.

#2) 轉角位膠條不能鬆脫

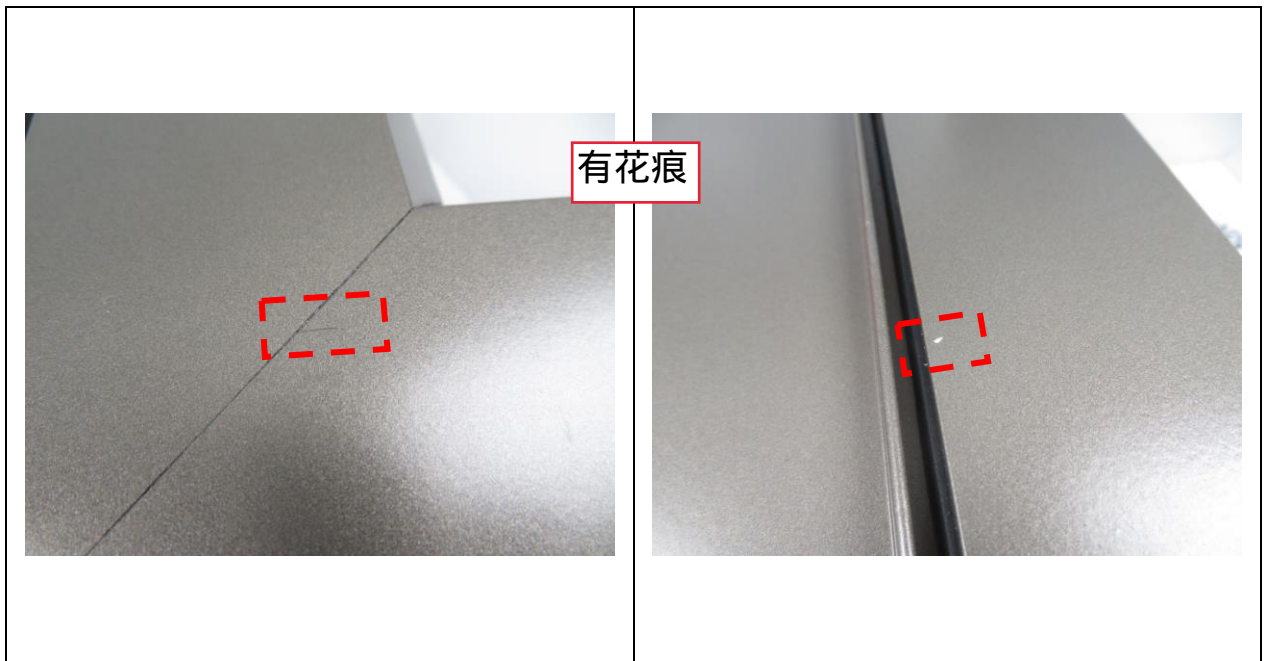
Photo #40

Observation (Window Sash)	Minor scratch and damage were noted on the coated surface of sash.
Recommendation	Review of protection and handling of material is required.

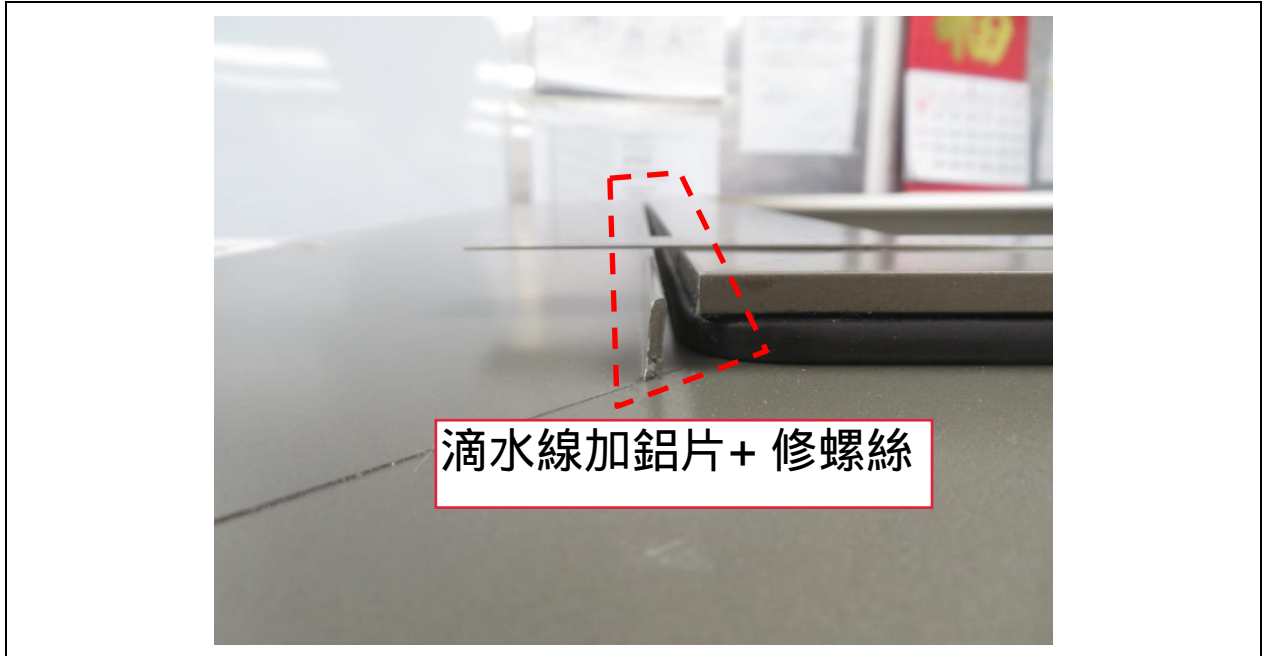
Photo #41

Observation (Window Frame)	Water drip should be projected out from the front surface of sash as per design in shop drawing.
Recommendation	Midi is required to clarify whether further in-out adjustment of sash at its locked position is still a possible way to tackle this quality issue.

#10) 滴水線要加鋁片，要修螺絲

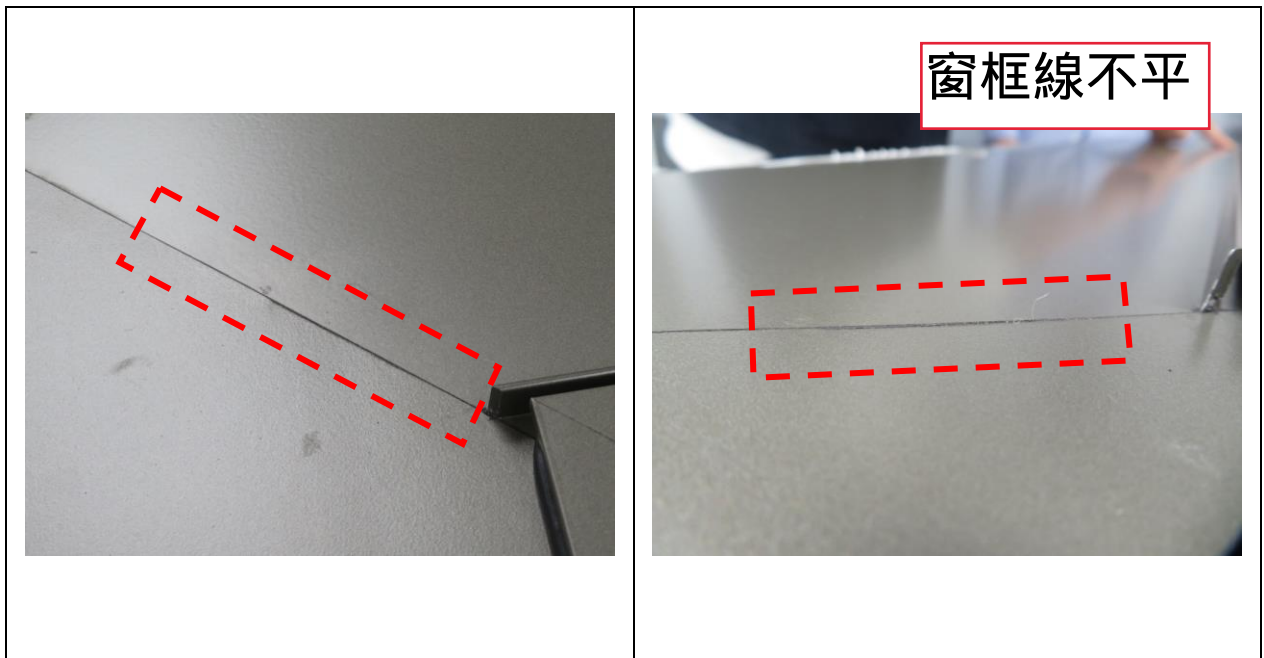
Photo #42

Observation (Window Frame)	A mitre joint for window frame was not flush.
Recommendation	Improvement in quality of fabrication as well as assembly is recommended.

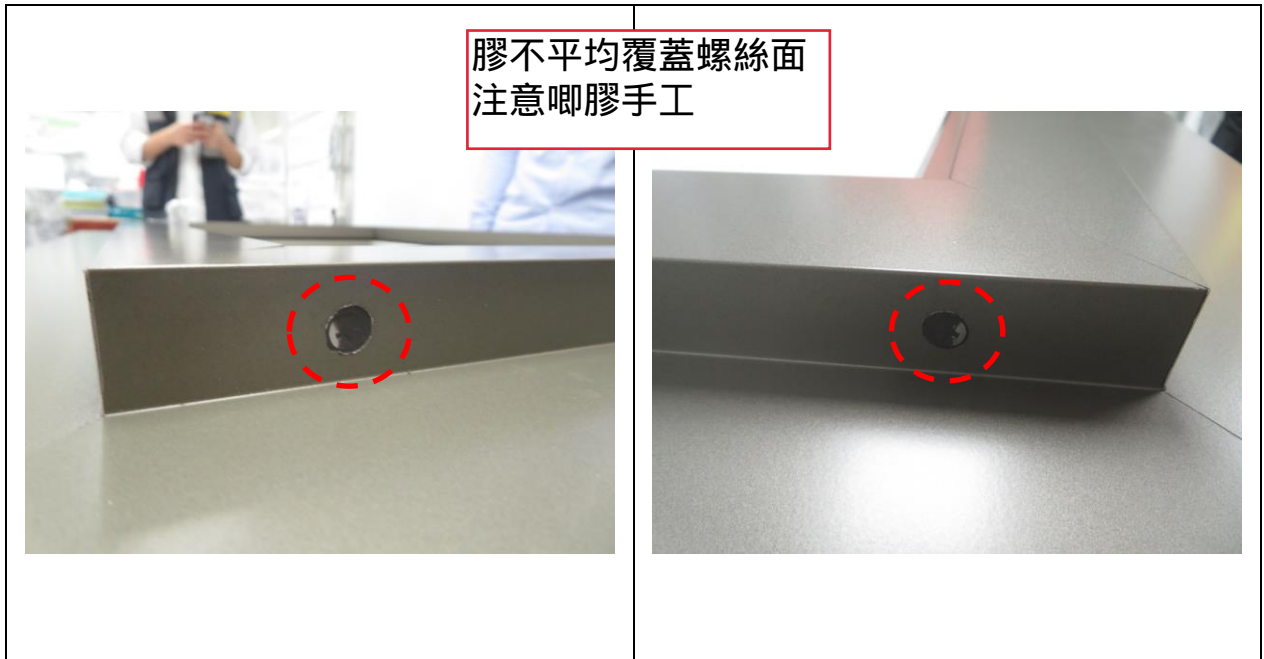
Photo #43

Observation (Window Frame)	Screw heads were partially covered by sealant.
Recommendation	Workmanship of sealant work should be improved.

#1) 所有螺絲孔位置要啣膠，見膠噴，要清理膠漬

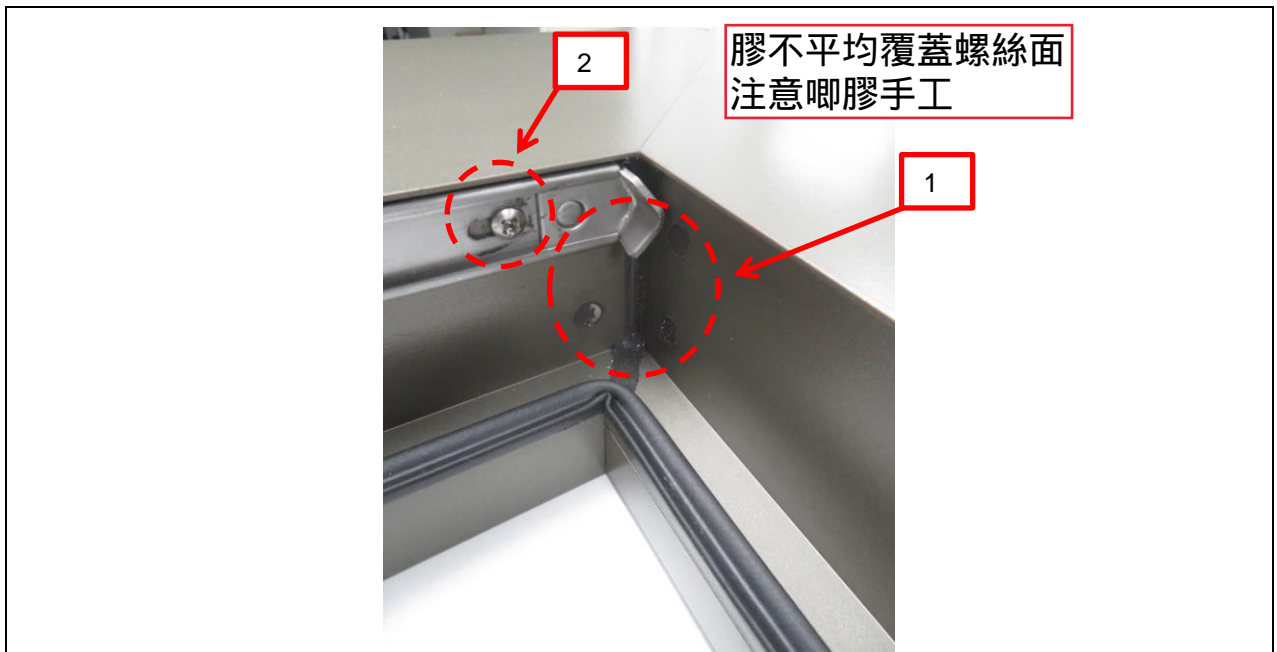
Photo #44

Observation (Window Frame)	1) Inconsistent sealant application on fixing screws (i.e. screw heads partially/fully covered by sealant) at the corner of window frame. 2) Excess sealant was observed on a fixing screw of 4-bar hinge.
Recommendation	Workmanship of sealant work should be improved.

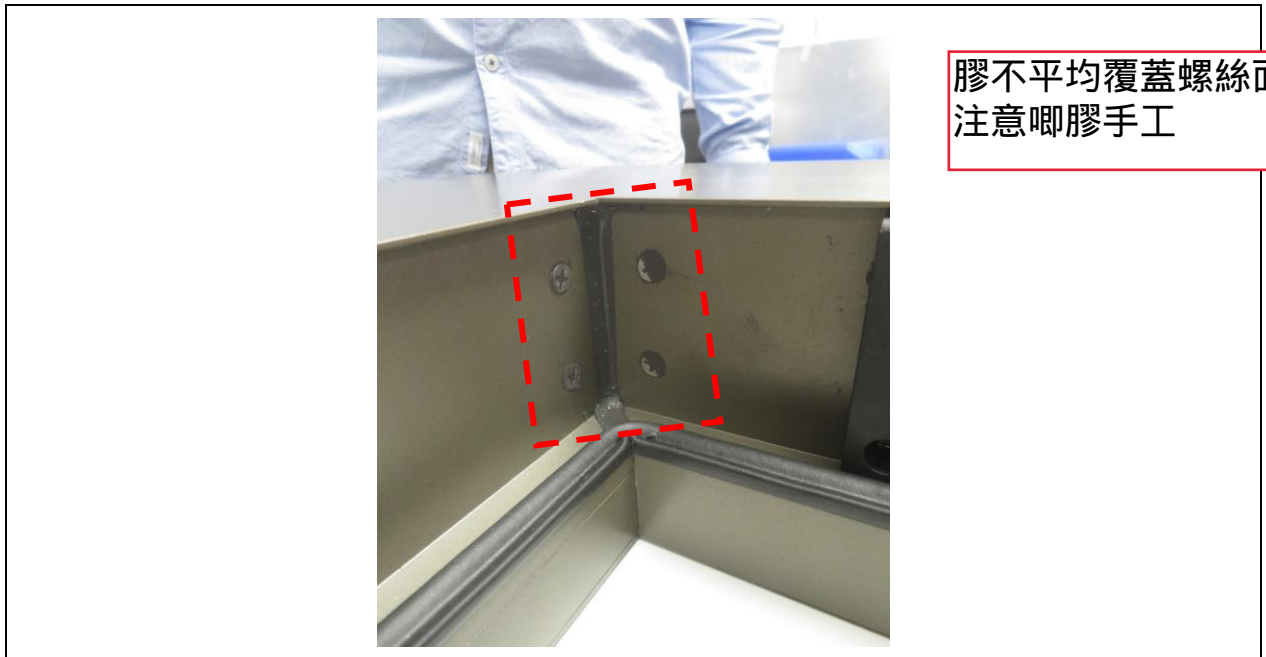
Photo #45

膠不平均覆蓋螺絲面
 注意啱膠手工

Observation (Window Frame)	Inconsistent sealant application on fixing screws (i.e. screw heads with/without sealant) at the corner of window frame.
Recommendation	Ditto.

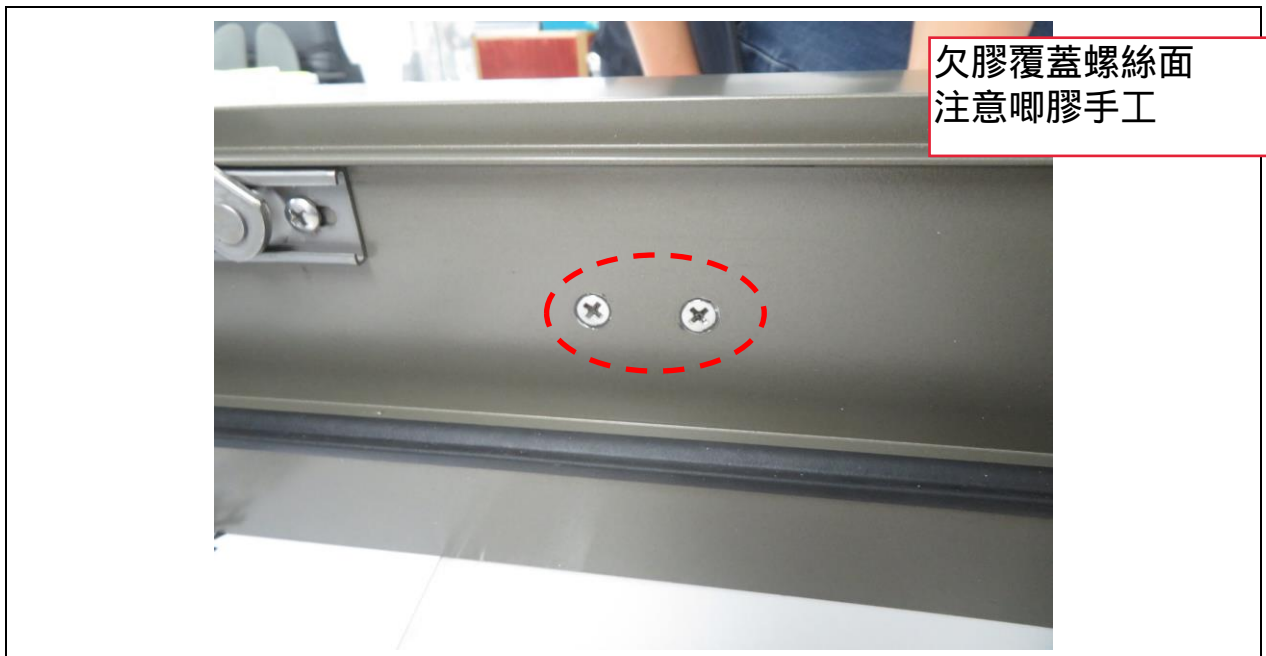
Photo #46

欠膠覆蓋螺絲面
 注意啱膠手工

Observation (Window Frame)	Screw heads without sealant application.
Recommendation	Rectification is required. Sealant application on fixing screw should be standardized.

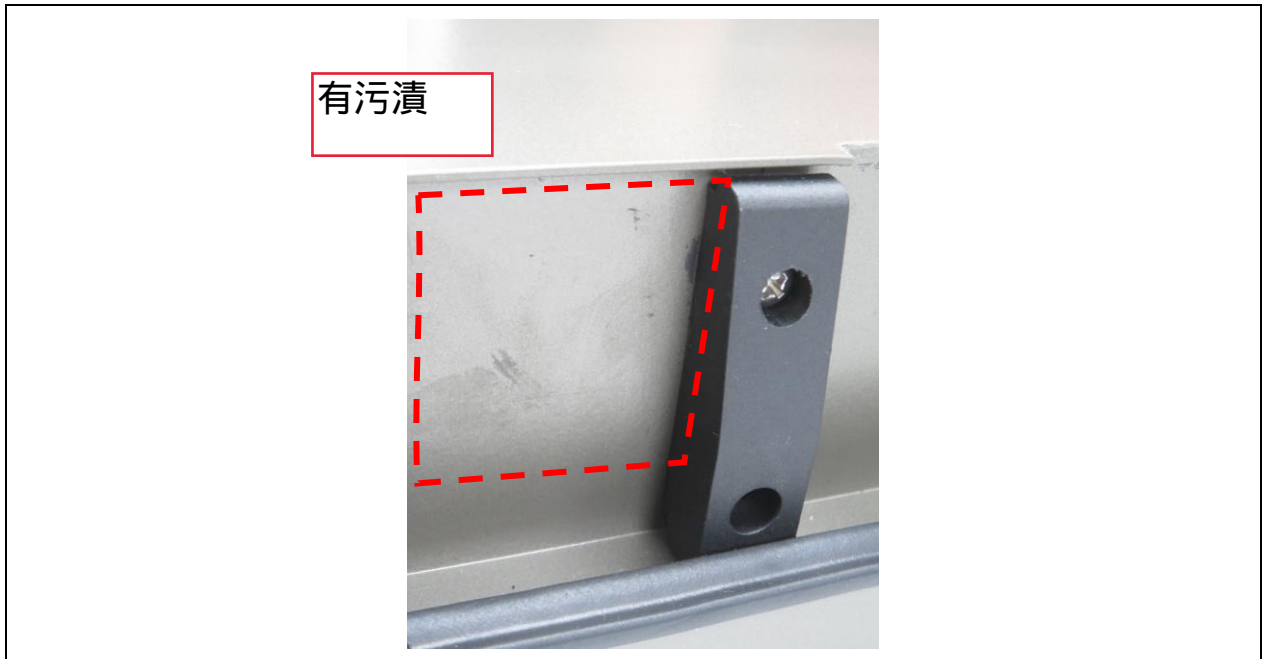
Photo #47

Observation (Window Frame)	Uncleaned surface of the window frame.
Recommendation	Further cleaning is required.

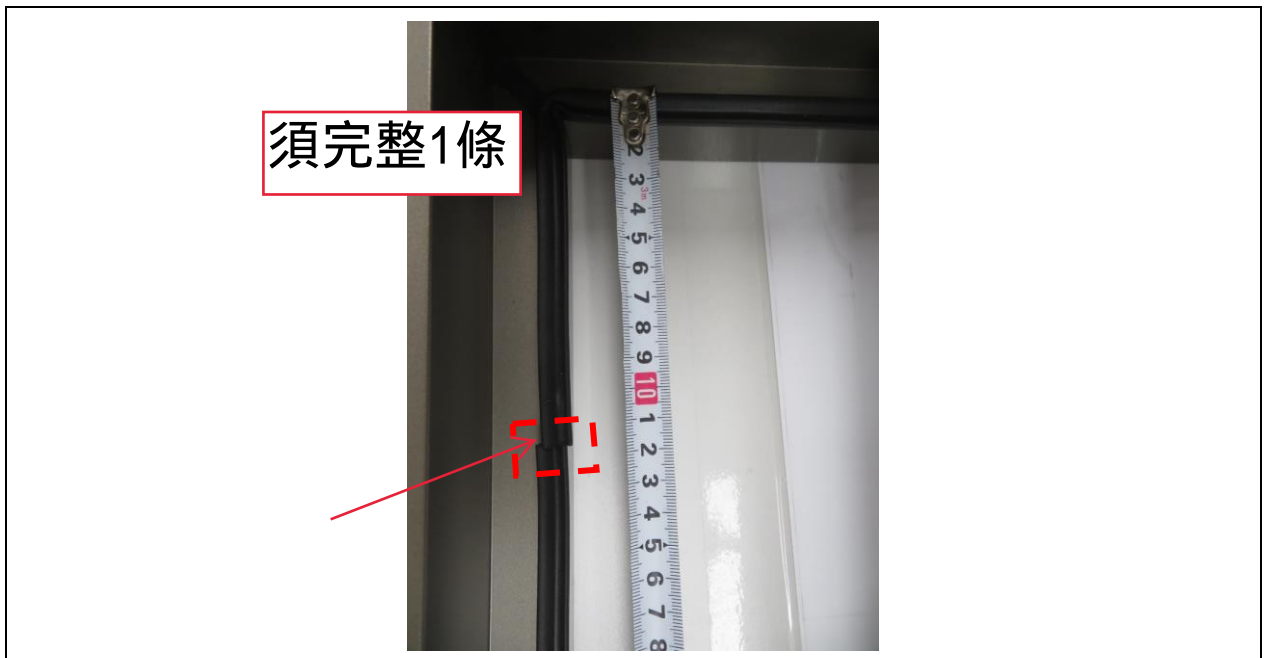
Photo #48

Observation (Window Frame)	Location of cut end of inner gasket around window frame was noted.
Recommendation	As reported by Midi, the location of cut end of inner gasket should be ~100mm below window head for mass production. Midi's further clarification is required. Any aesthetic issue may defer to relevant parties' comments.

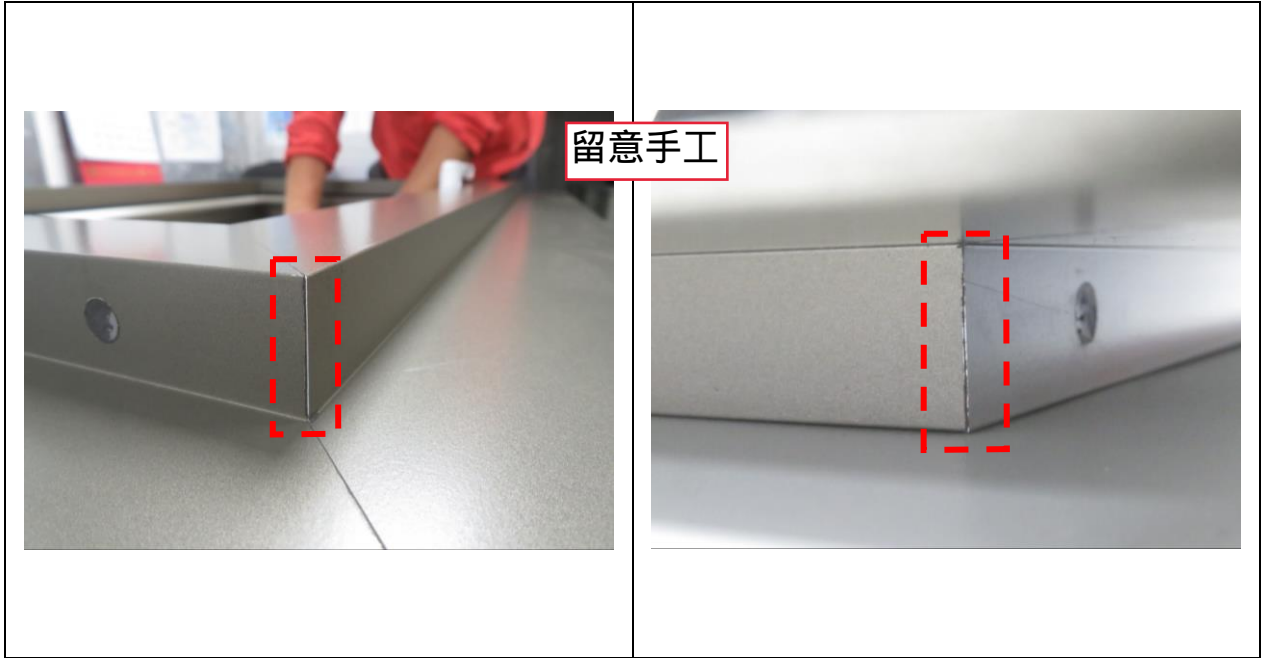
Photo #49

Mitre joints with poor workmanship.

Improvement in quality of fabrication as well as assembly is recommended.

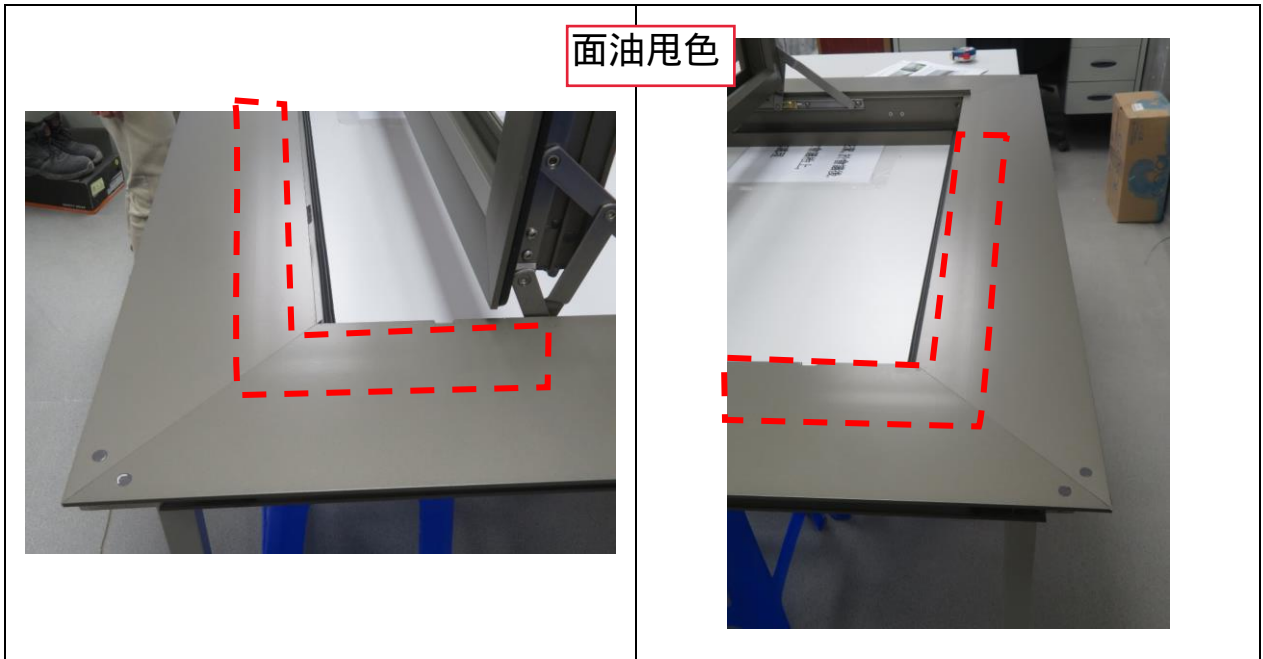
Photo #50

Streaks on coated surface was observed.

Improvement in quality of coating is recommended.
