工程指示編號：EI / 5294 / 22

PROPOSED RESIDENTIAL
DEVELOPMENT AT TKOTL 70RP,
PHASE 11. LOHAS PARK, TSEUNG
KWAN O. N.T.

PMU Inspection Report 01

Inspection Date: 26th October, 2022

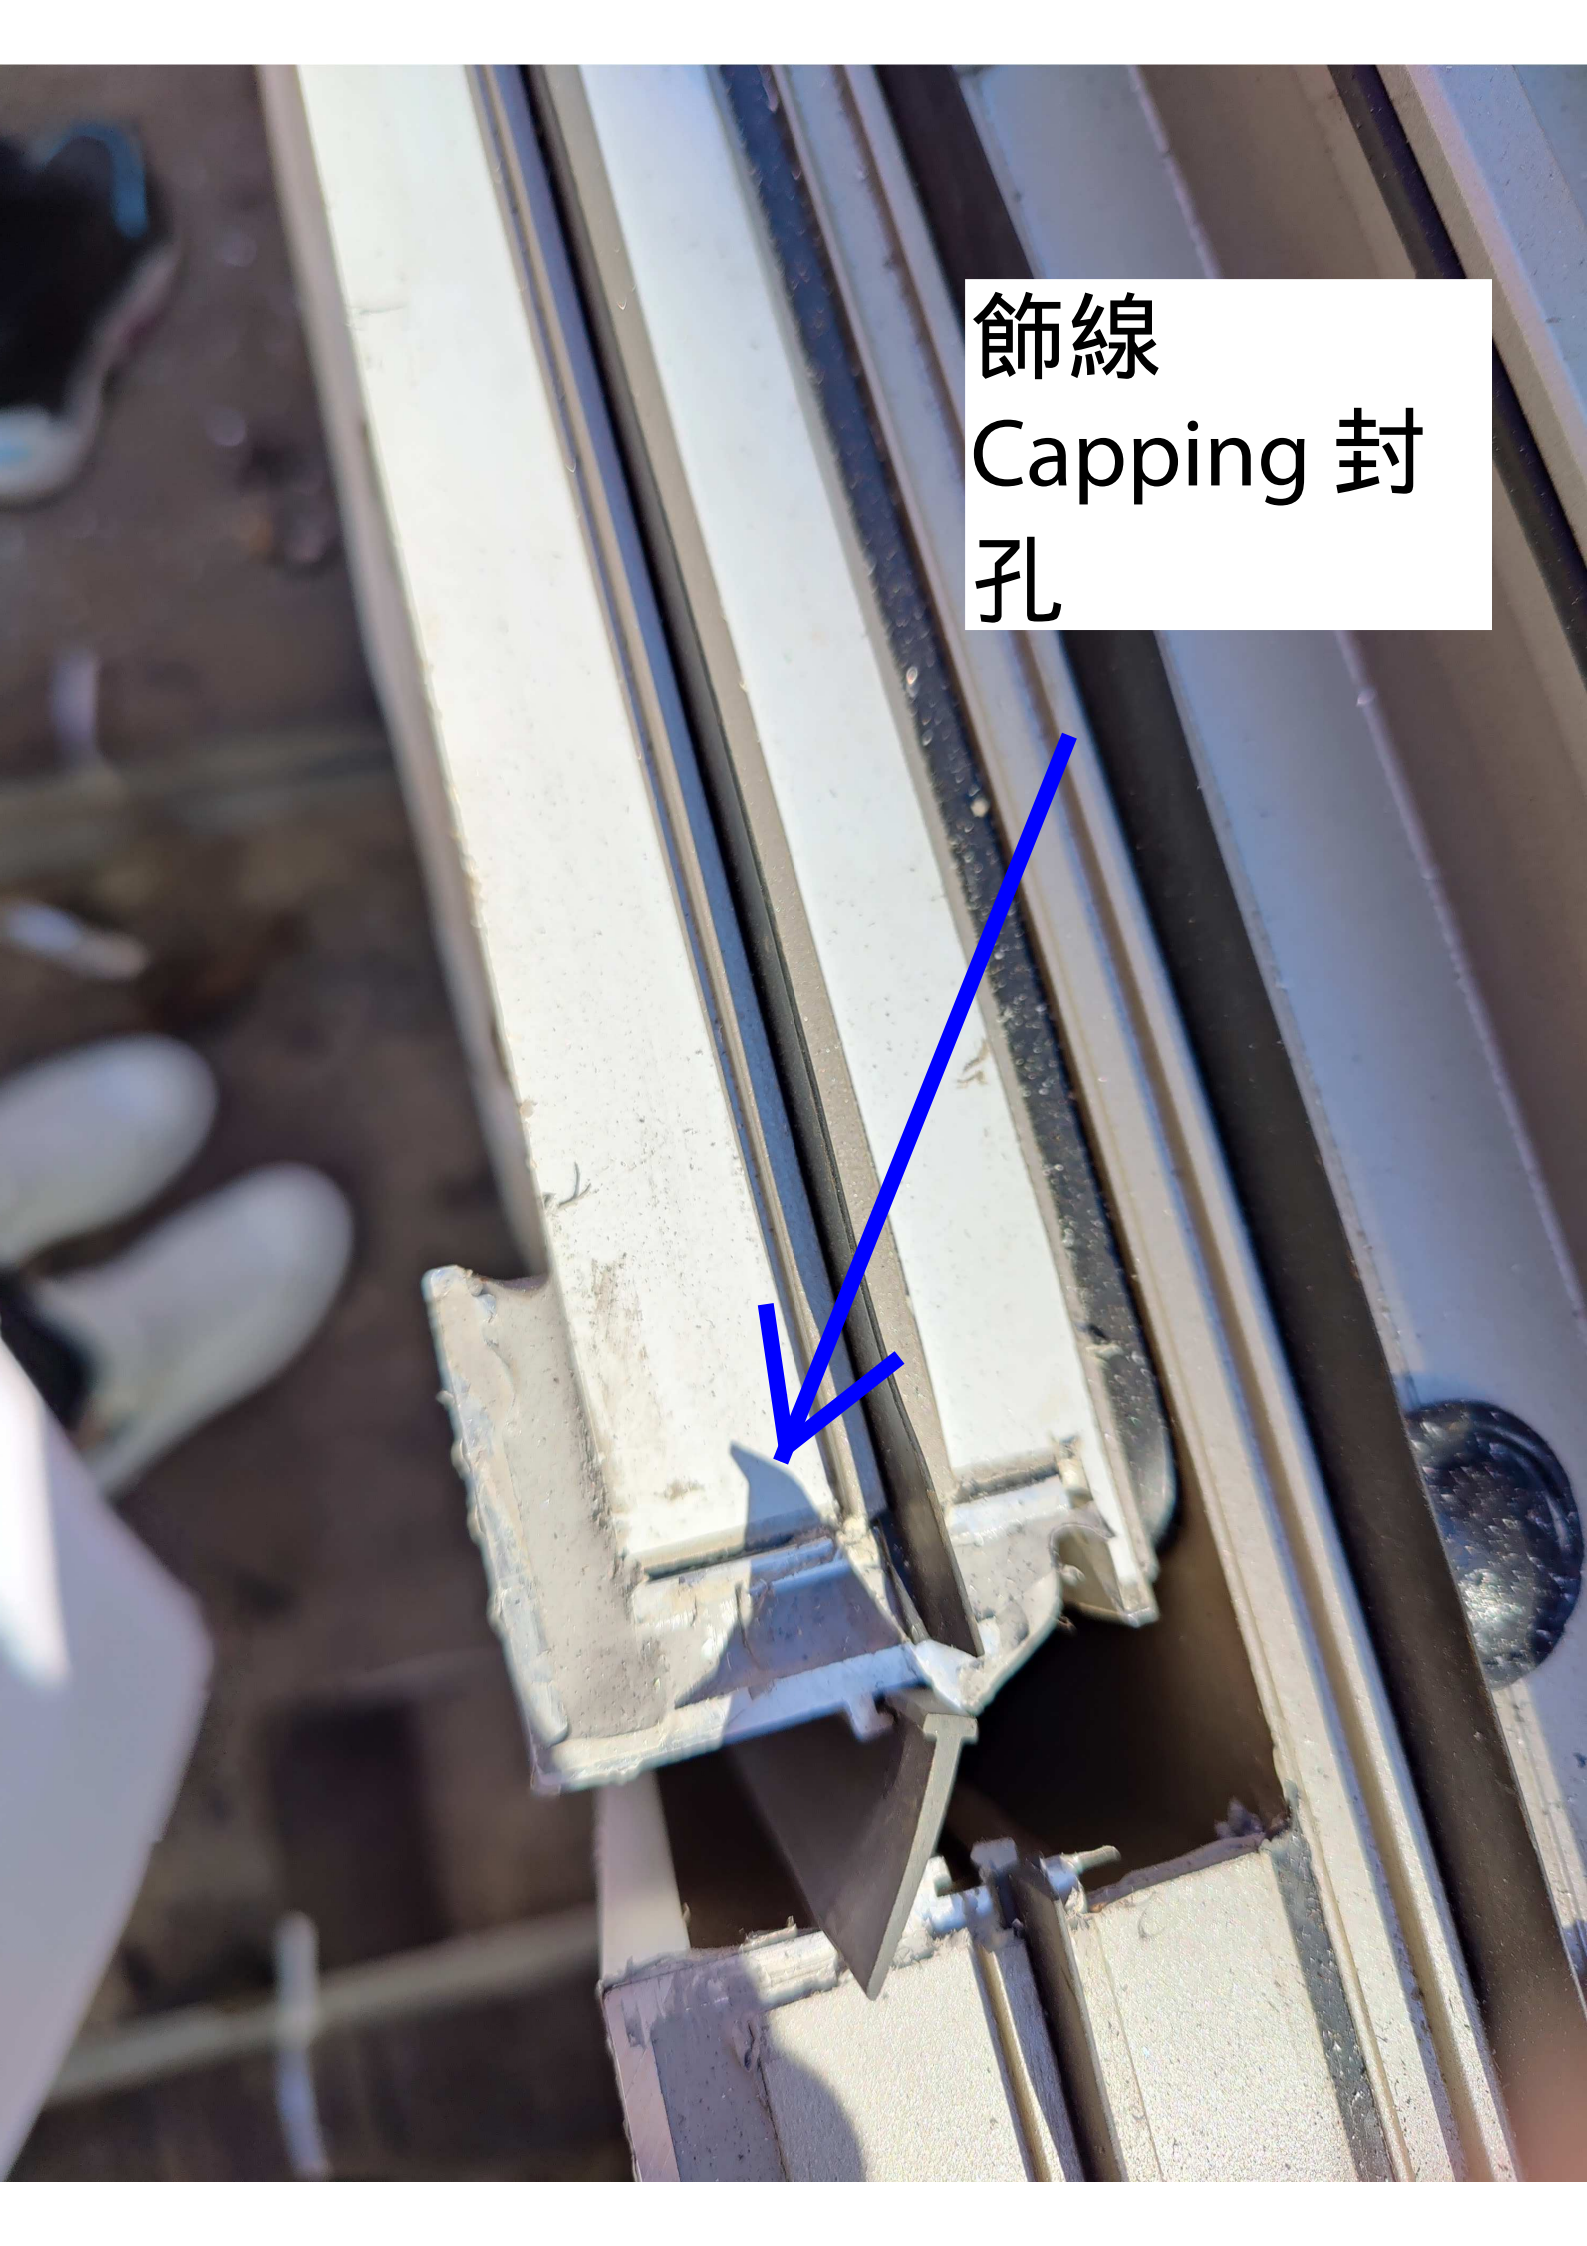
企料企身膠條不
夠高，底不夠長

飾線
Capping 封
孔

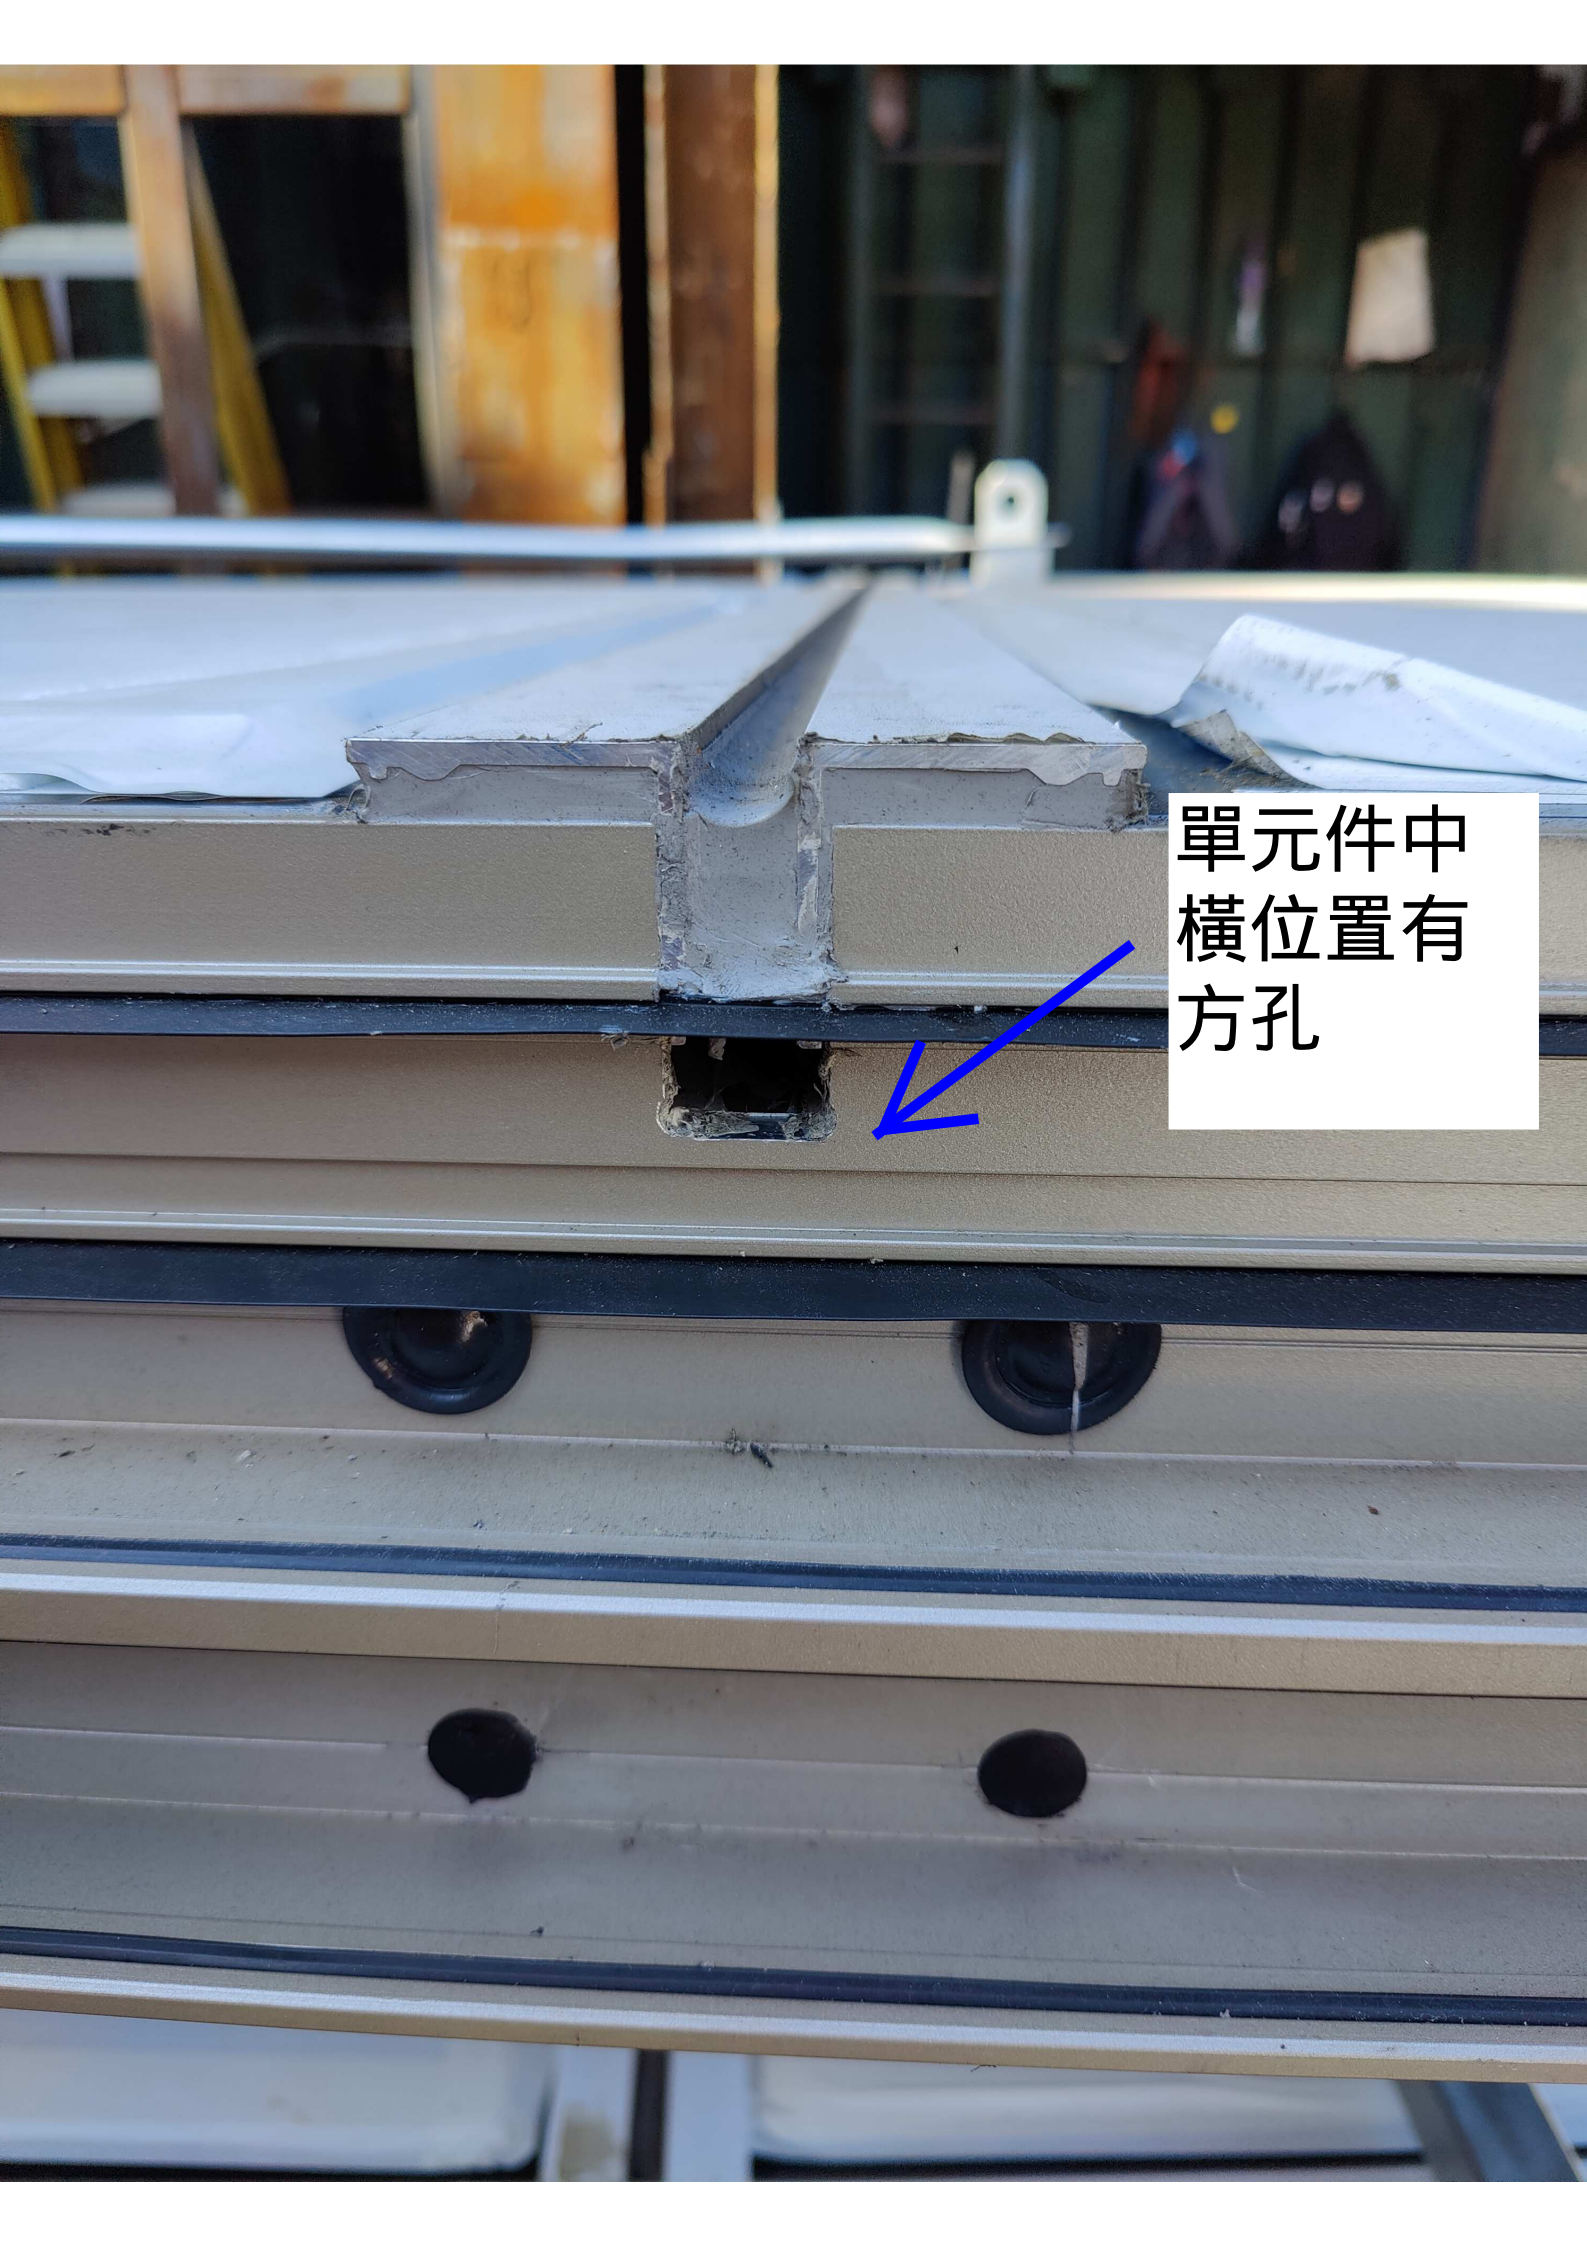
單元件中
橫位置有
方孔

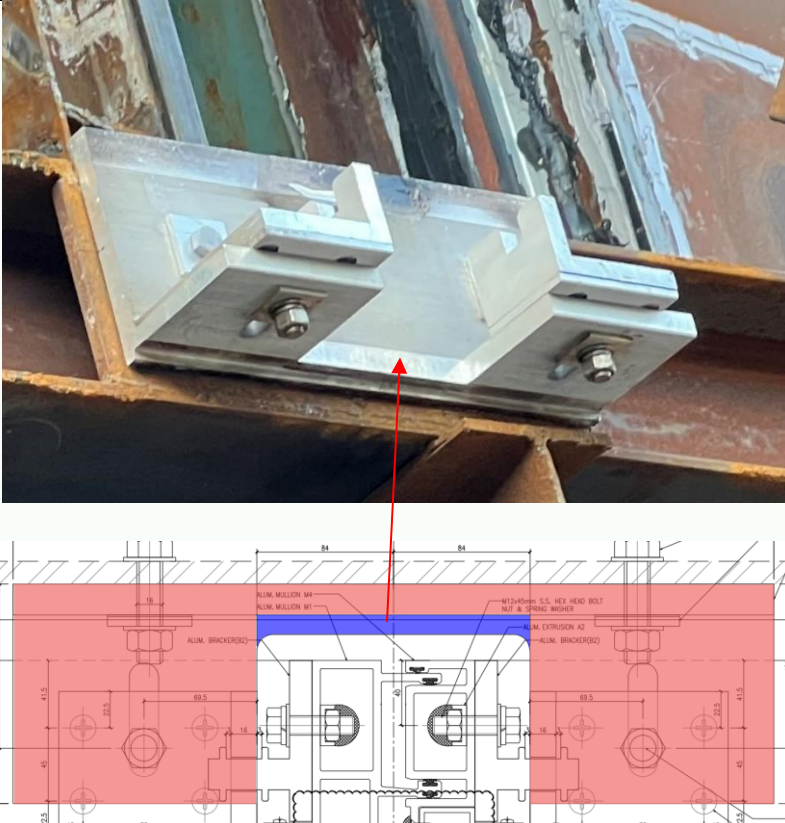
<p>Photo 2</p>

<p><u>Item:</u> Bracket Observation</p>	
<p><u>Description:</u> The installed bracket shape was observed not comply with approved drawing. The blue highlighted part was removed on red highlighted aluminum brackets.</p>	
<p><u>Action:</u> MIDI is required to clarify the discrepancy and carry out QA/QC to guarantee the brackets comply with approved drawings.</p>

Reply: Midi with revise shop drawing and calculation.

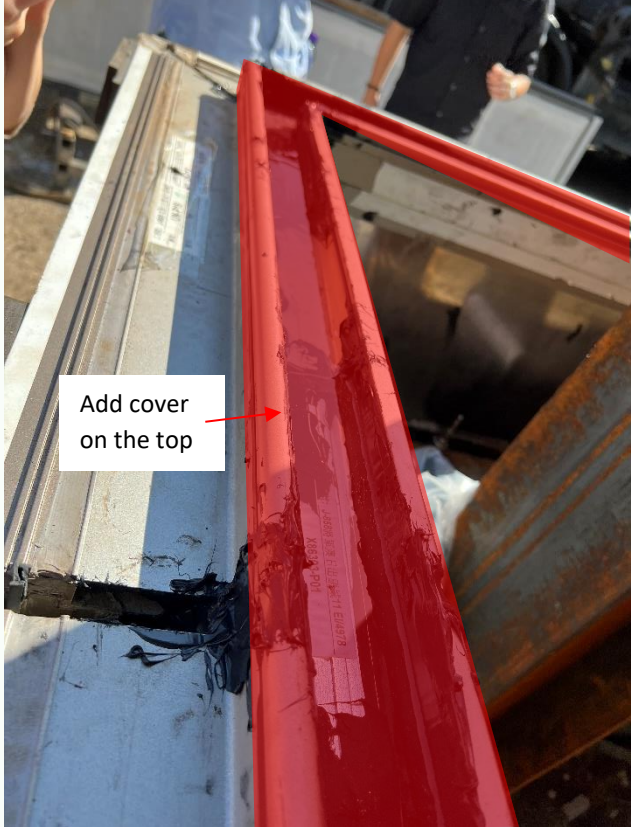
<p>Photo 3</p>

<p><u>Item:</u> Water Gutter Test</p>	
<p><u>Description:</u> The Water gutter test was carried out for the whole gutter with all the water hole sealed with duration for over 2 hours.</p>	
<p><u>Action:</u></p> <ul style="list-style-type: none"> • MIDI is reminded to provide cover /protection on top of the testing gutter, in case of the water evaporation or other unpredictable diminution/augmentation. • MIDI is reminded to provide a control setup beside as water level reference for testing gutter.

Reply: Midi will follow.

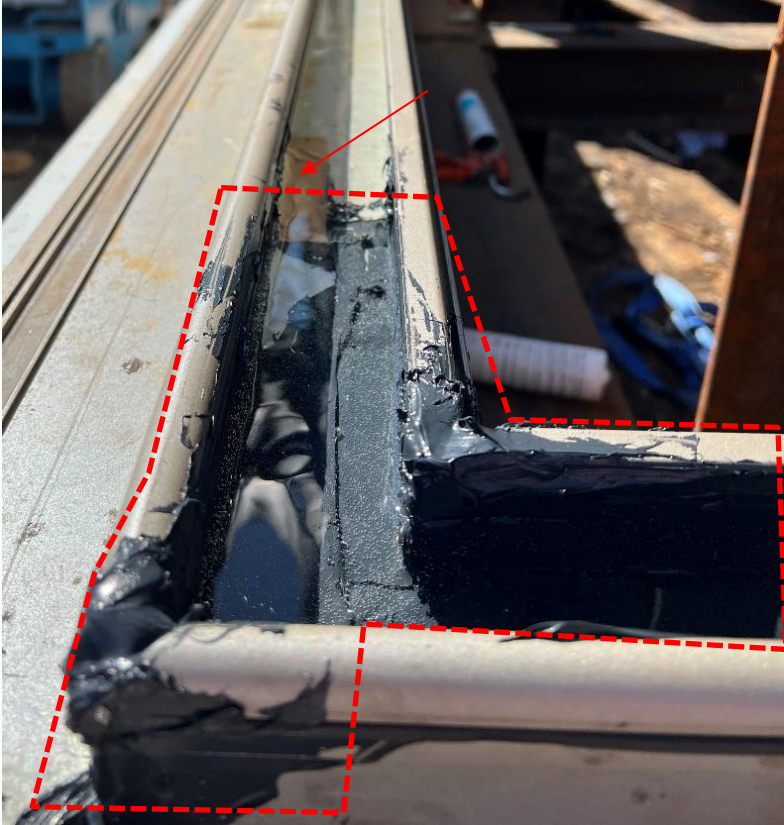
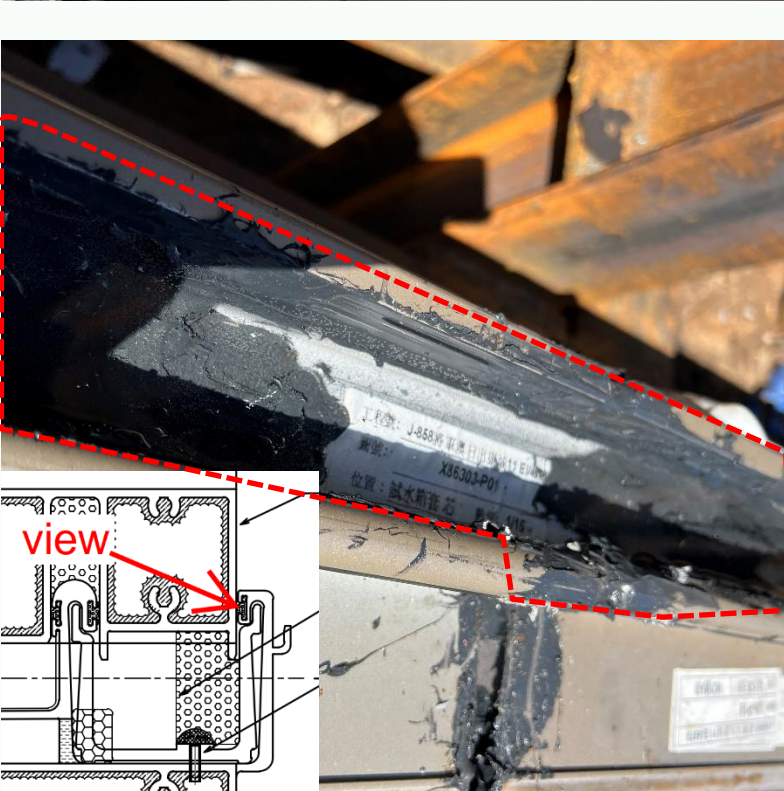
<p>Photo 4</p>

<p><u>Item:</u> Water Gutter Test</p>	
<p><u>Description:</u> Upper photo: The water weep hole was sealed with tape and sealant for water gutter test. Lower photo : The gutter sleeve was sealed with excessive sealant and beyond the scope of gutter.</p>	
<p><u>Action:</u></p> <ul style="list-style-type: none"> MIDI is required to carry out their internal QC/QC method to improve workmanship and avoid excessive sealant to be applied on unnecessary aluminium surface/gasket, which will affect the water tightness and air tightness performance at the gutter zone between transom head and transom sill at stack joint.

Reply: Midi's Director Daniel Woo will provide training for worker to improve workmanship.

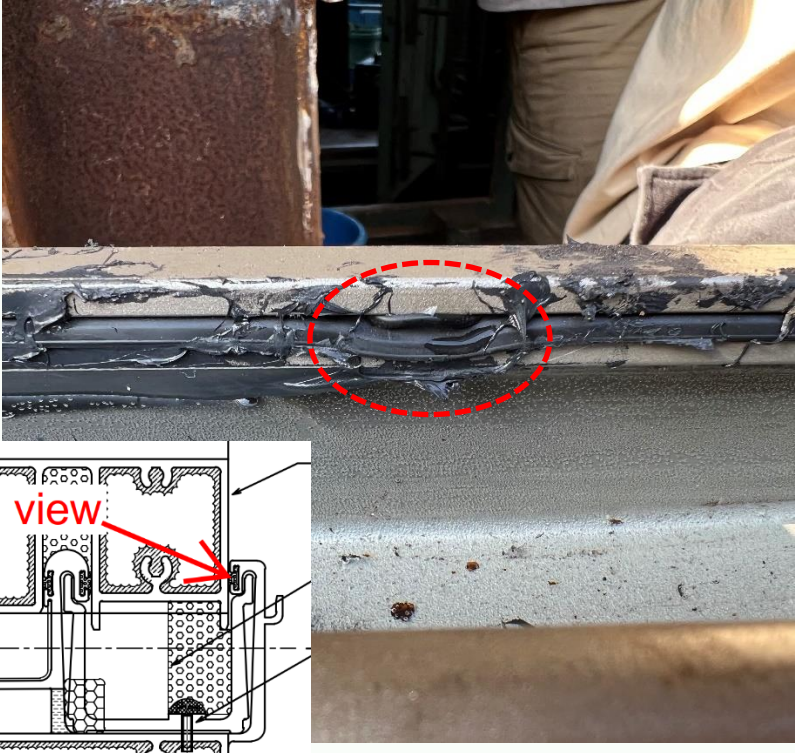
<p>Photo 7</p>

<p><u>Item:</u> Gasket Observation</p>	
<p><u>Description:</u> The gasket was observation deformed and adhered with sealant.</p>	
<p><u>Action:</u></p> <ul style="list-style-type: none"> MIDI is required to revise/ repair the defect and provide method statement to improve internal QA/QC to prevent same issue from happening.

Reply: Midi will replace gasket.

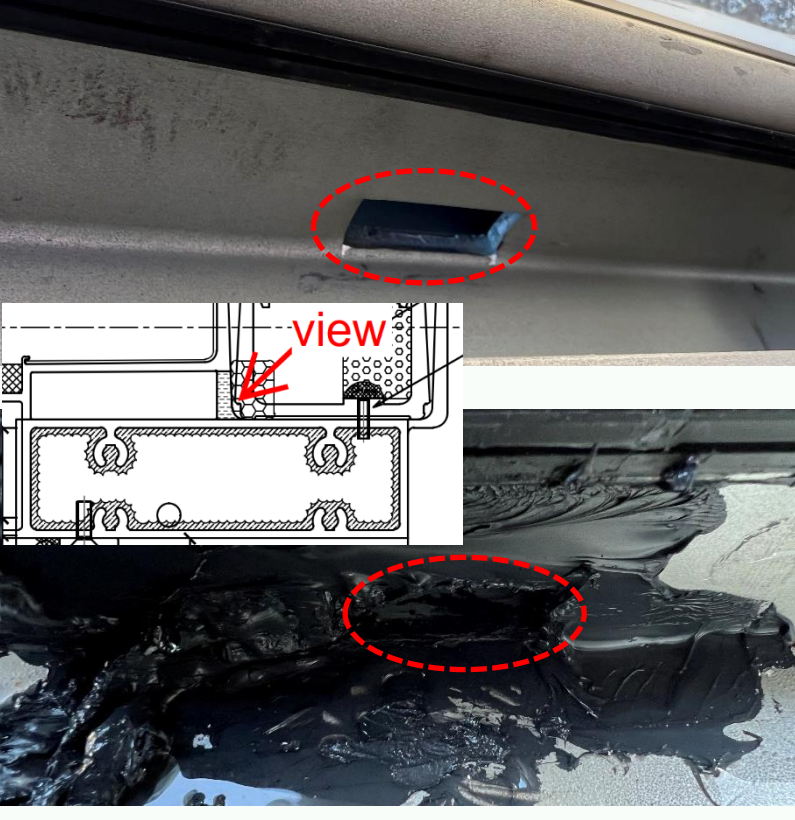
<p>Photo 8</p>

<p><u>Item:</u> Weephole Observation</p>	
<p><u>Description:</u> Upper one for weephole on stored panels. Lower one for weephole after water gutter test with excessive sealant remain which may obstruct weephole.</p>	
<p><u>Action:</u></p> <ul style="list-style-type: none"> MIDI is required to provide method statement on improving internal QA/QC to prevent transom weephole obstruction from happening.

Reply: Reply: Midi will use watertight adhesive.

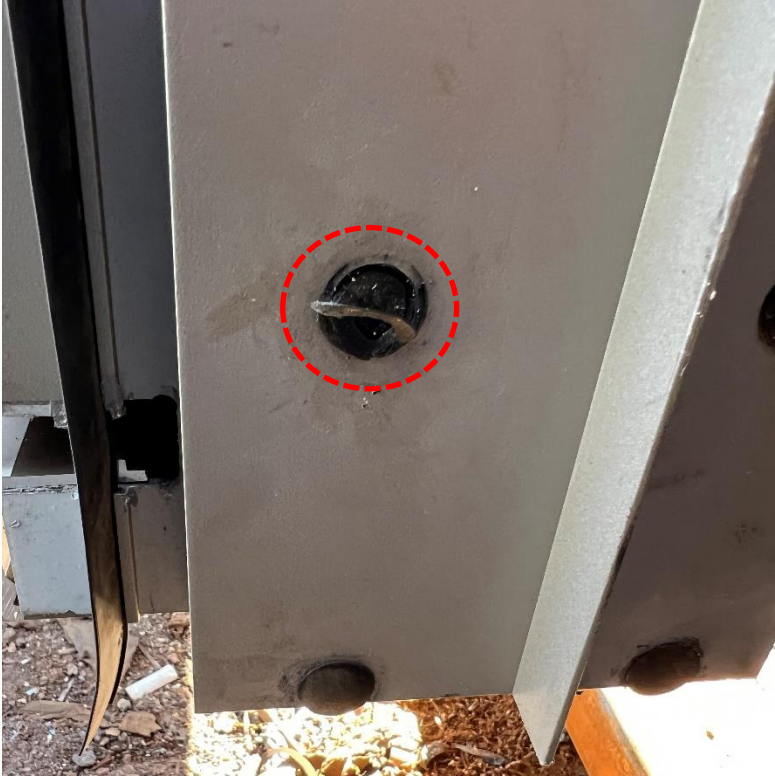
<p>Photo 9</p>

<p><u>Item:</u> Observation</p>	
<p><u>Description:</u> The gasket on mullion bolt hole was observed damaged.</p>	
<p><u>Action:</u></p> <ul style="list-style-type: none"> MIDI is required to carry out their internal QC/QC method to revise/repair the defect and improve their workmanship

Reply: Midi will follow and provide training for worker to improve workmanship.

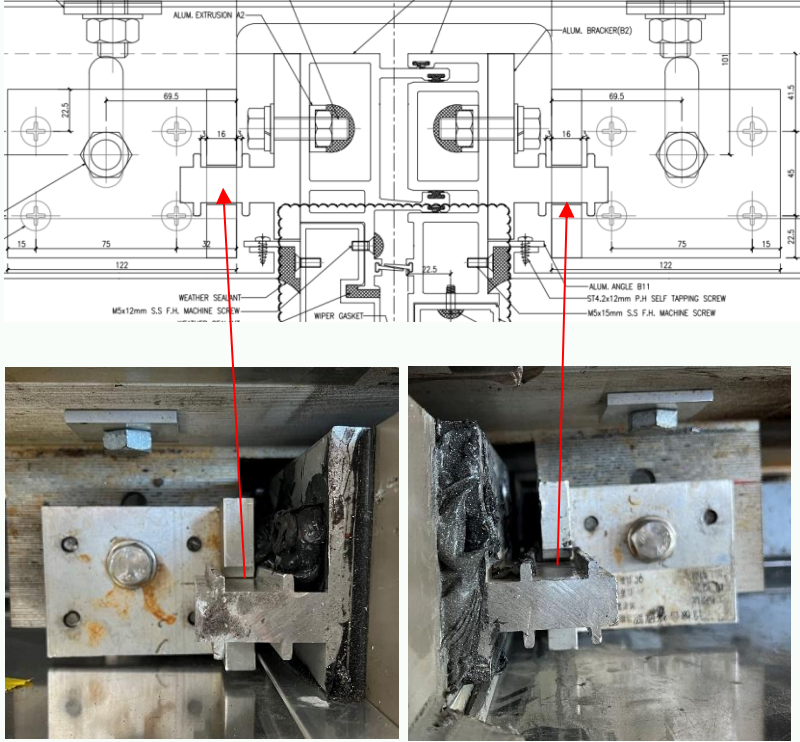
<p>Photo 10</p>

<p><u>Item:</u> Observation</p>	
<p><u>Description:</u> We do not find any restraint on the hanger bracket which had commented on drawing review.</p>	
<p><u>Action:</u></p> <ul style="list-style-type: none"> MIDI is required to clarify the proposal for panel horizontal restraint design.

Reply: The hanger bracket (one side) will be replaced for Movement.

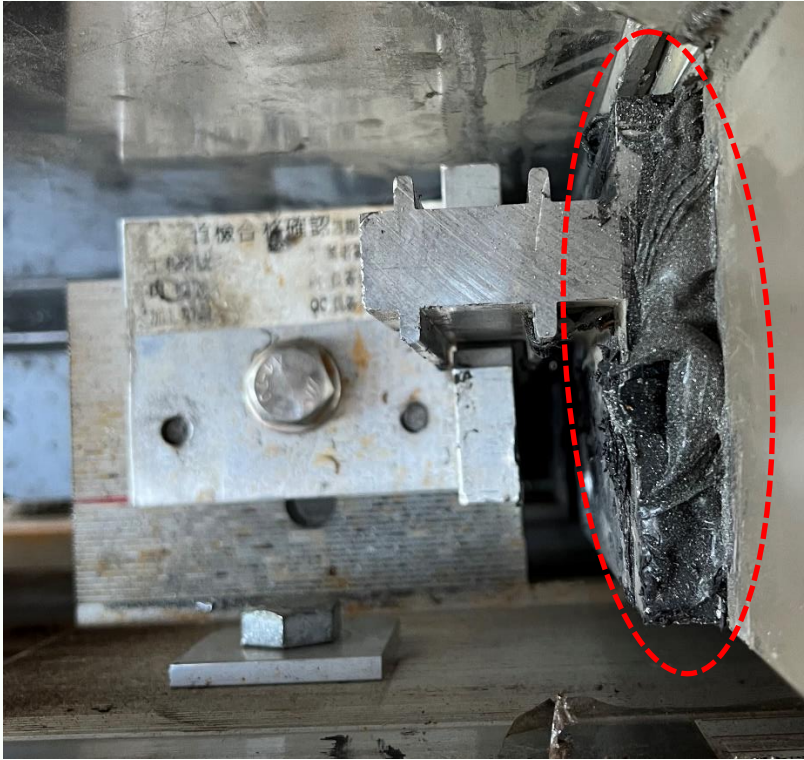
<p>Photo 11</p>

<p><u>Item:</u> Observation</p>	
<p><u>Description:</u> The sealant on bracket was observed untidy and uneven.</p>	
<p><u>Action:</u></p> <ul style="list-style-type: none"> MIDI is required to carry out their internal QC/QC method to improve their workmanship on sealant application work.

Reply: Midi will follow.

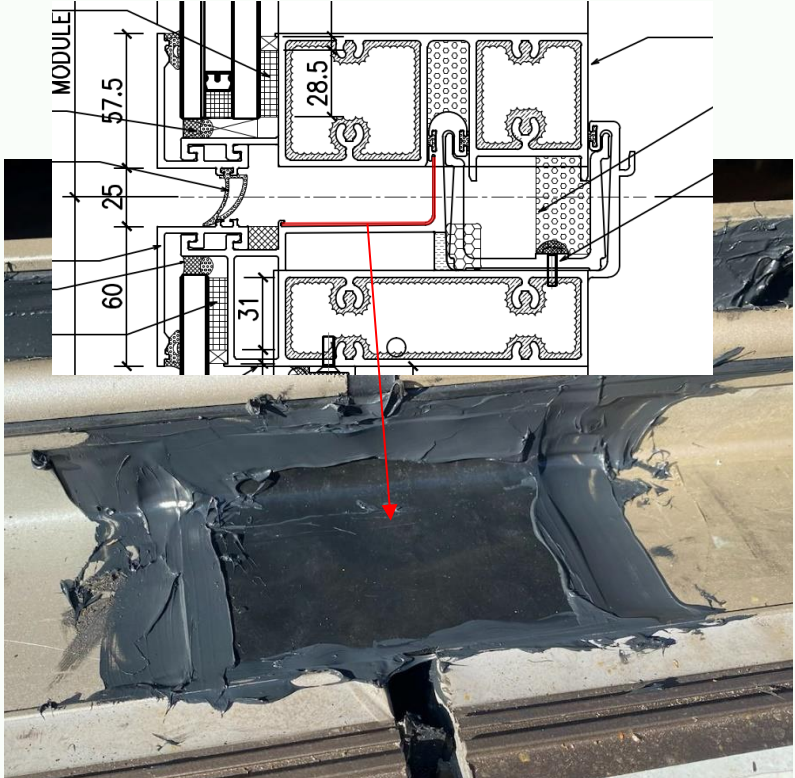
<p>Photo 12</p>

<p><u>Item:</u> Observation</p>	
<p><u>Description:</u> The flashing at joint was observed to use membrane which is not comply with drawing for alum. flashing.</p>	
<p><u>Action:</u></p> <ul style="list-style-type: none"> MIDI is required to revise the flashing material to comply with approved shop drawing detail.

Reply: Midi will use Alum flashing.

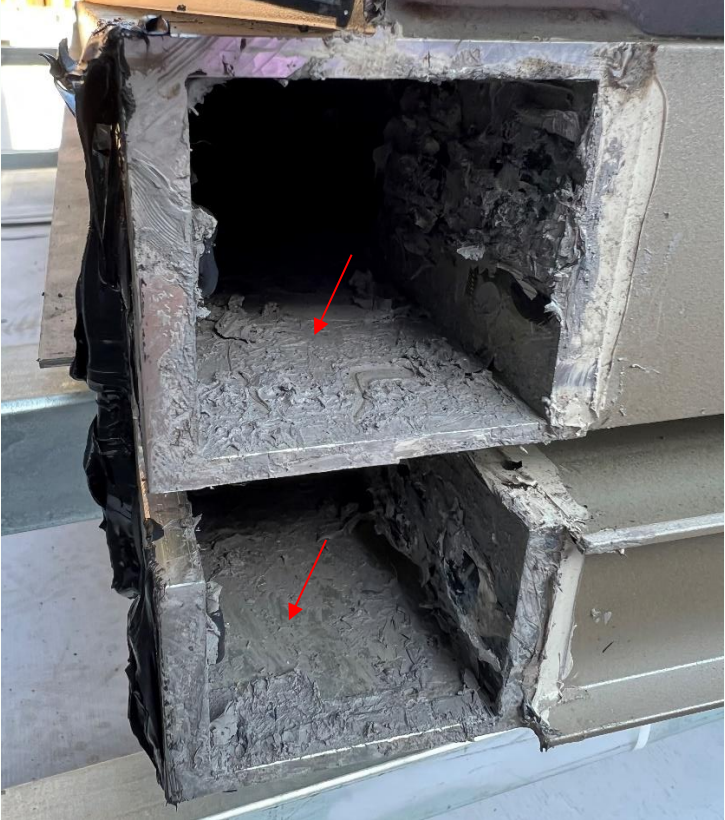
<p>Photo 14</p>

<p><u>Item:</u> Observation</p>	
<p><u>Description:</u> The internal chamber of mullion bottom was observed with excessive sealant remains.</p>	
<p><u>Action:</u></p> <ul style="list-style-type: none"> • MIDI to clarify the use for the sealant here.

Reply: Midi excessive sealant remains due to factory flood test.

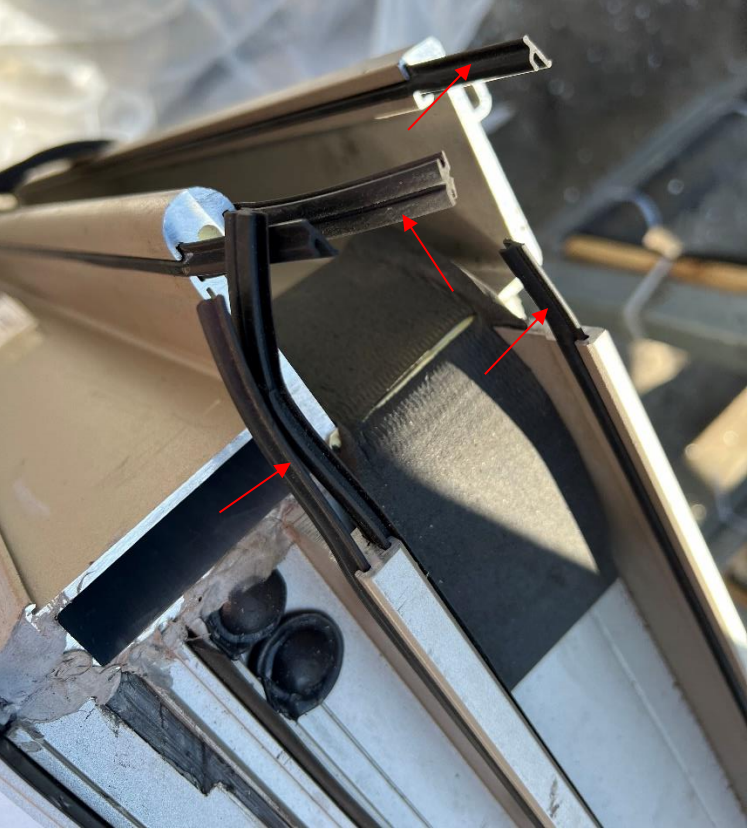
<p>Photo 15</p>

<p><u>Item:</u> Observation</p>	
<p><u>Description:</u> End of gasket on panel mullion and transom.</p>	
<p><u>Action:</u></p> <ul style="list-style-type: none"> • MIDI is required to cut the gasket during the panel installation to avoid defect on water tightness performance.

Reply: Attachment for gasket. Midi will remind the workmanship.

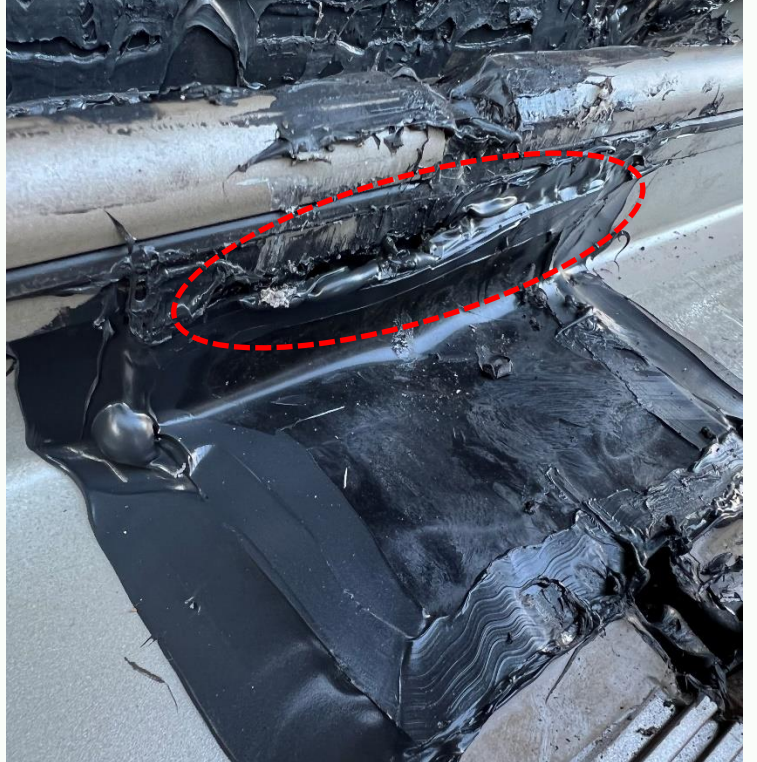
<p>Photo 16</p>

<p><u>Item:</u> Observation</p>	
<p><u>Description:</u> After the panel remove, the front membrane was observed with damage.</p>	
<p><u>Action:</u></p> <ul style="list-style-type: none"> MIDI is required to clarify the discrepancy and carry out QA/QC to guarantee the component comply with approved drawings.

Reply: Midi will remind the workmanship and use L shape Plate.

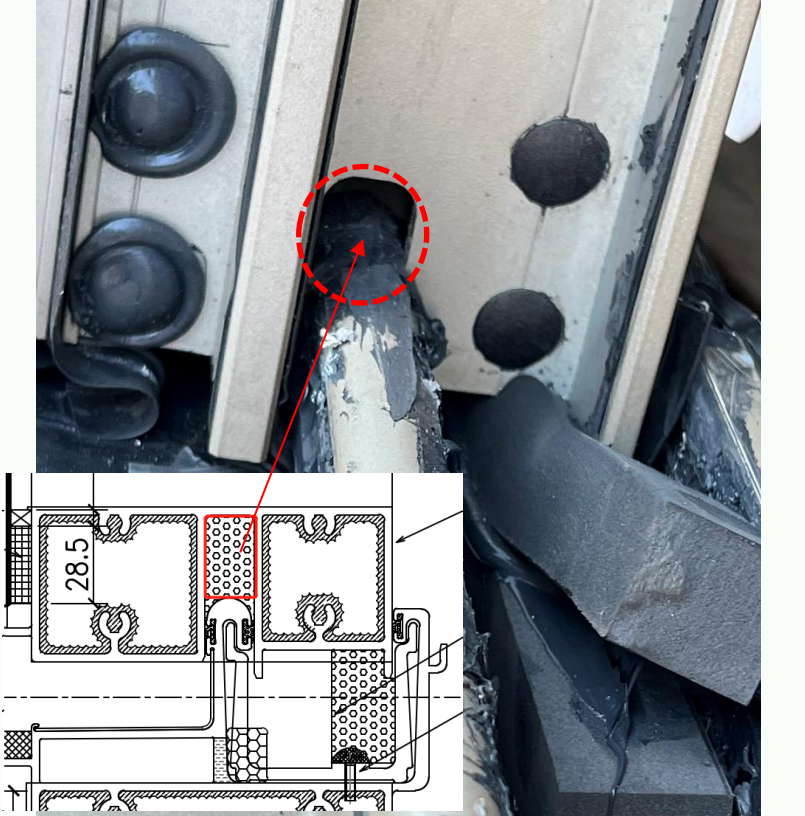
<p>Photo 17</p>

<p><u>Item:</u> Observation</p>	
<p><u>Description:</u> After installation, sponge silicone rubber was observed missed at the joint position.</p>	
<p><u>Action:</u></p> <ul style="list-style-type: none"> MIDI is required to revise/ repair the defect and provide method statement to improve internal QA/QC and prevent this issue from happening.

Reply: Midi will remind the workmanship.

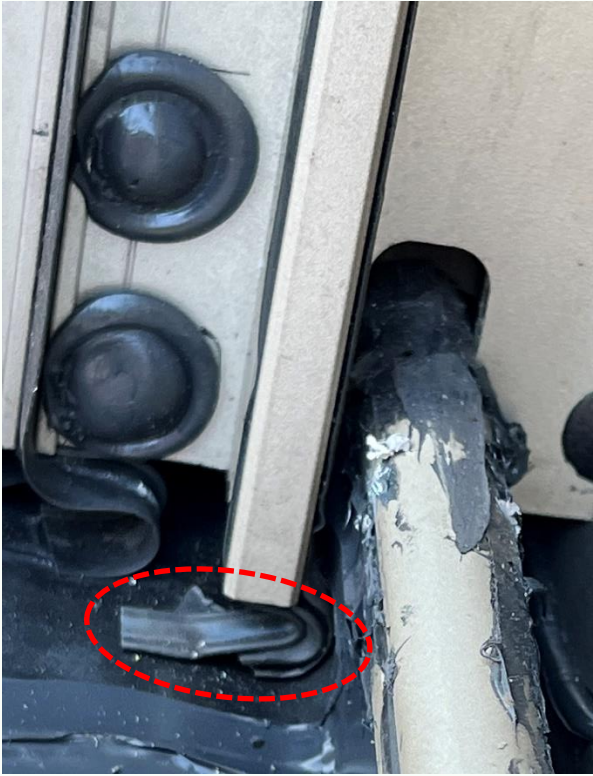
<p>Photo 18</p>

<p><u>Item:</u> Observation</p>	
<p><u>Description:</u> The gaskets of installed panel were observed knotted and warped at the end without any treatment.</p>	
<p><u>Action:</u></p> <ul style="list-style-type: none"> • MIDI is required to carry out their internal QC/QC method to revise/repair the defect and improve construction workmanship

Reply: Midi will follow and remind the workmanship.

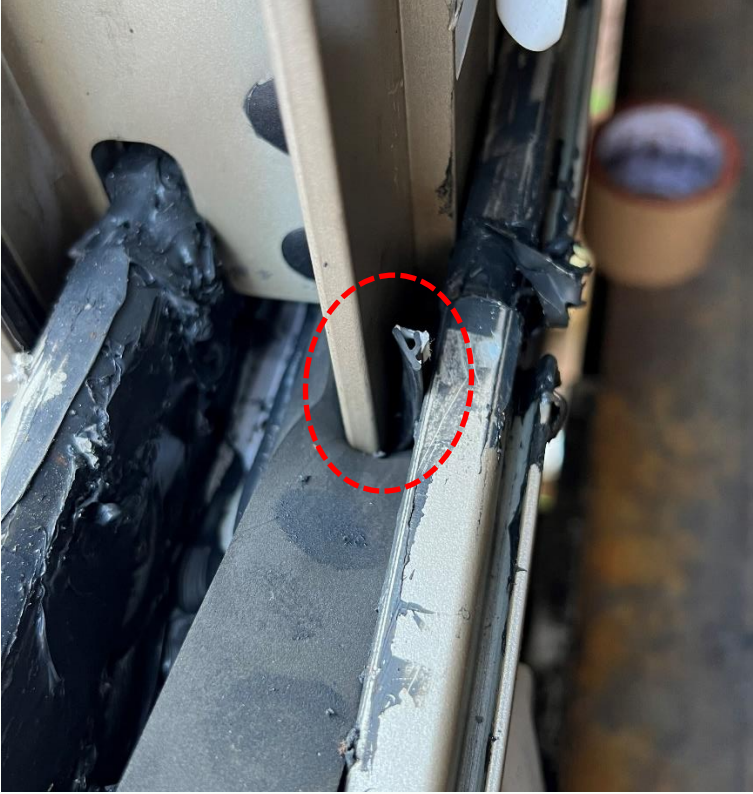
<p>Photo 19</p>

<p><u>Item:</u> Observation</p>	
<p><u>Description:</u> The gaskets of installed panel were observed knotted and warped at the end without any treatment.</p>	
<p><u>Action:</u></p> <ul style="list-style-type: none"> • MIDI is required to carry out their internal QC/QC method to revise/repair the defect and improve construction workmanship

Reply: Midi will follow and remind the workmanship.

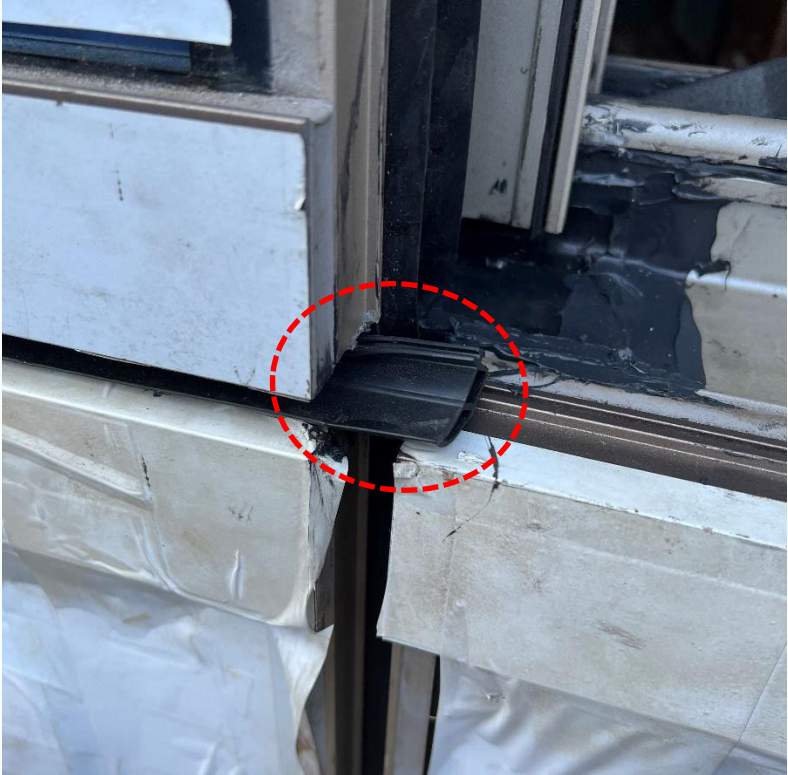
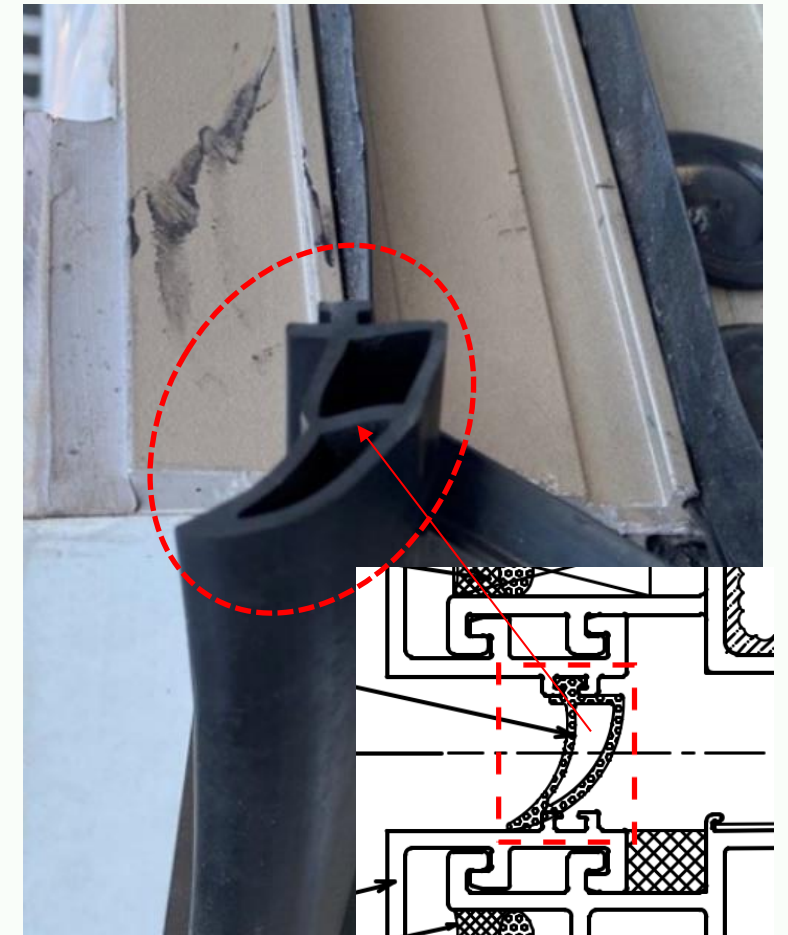
<p>Photo 20</p>

<p><u>Item:</u> Observation</p>	
<p><u>Description:</u> The horizontal gaskets were observed too long without any treatment. And the gasket size does not fit the joint gap.</p> <p>The horizontal gaskets type was observed not comply with approved drawing detail.</p>	
<p><u>Action:</u></p> <ul style="list-style-type: none"> MIDI is required to carry out their internal QC/QC method to revise/replace the gasket component to comply with approved proposal.

<div style="border: 1px solid red; padding: 5px; width: fit-content;"> <p>Reply: Midi will revise shop drawing.</p> </div>

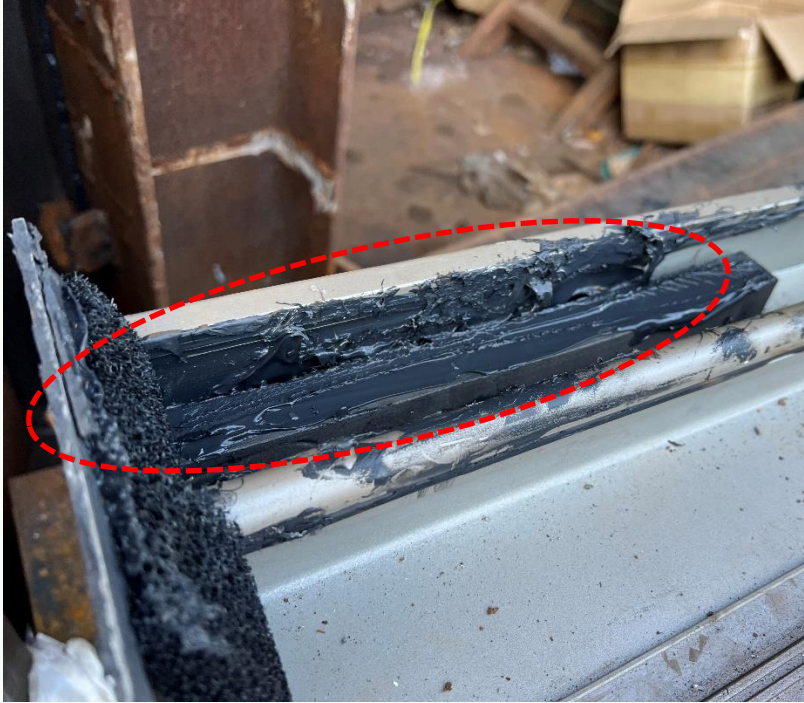
<p>Photo 21</p>

<p><u>Item:</u> Observation</p>	
<p><u>Description:</u> After the panel remove, excessive sealant was observed at the end stack joint position.</p>	
<p><u>Action:</u></p> <ul style="list-style-type: none"> • MIDI is required to carry out their internal QC/QC method to improve workmanship and avoid excessive sealant to be applied on unnecessary aluminium surface/gasket, which will affect the water tightness and air tightness performance at the gutter zone between transom head and transom sill at stack joint.

Reply: Midi will follow and provide workshop training and gasket will use 100 mm length.

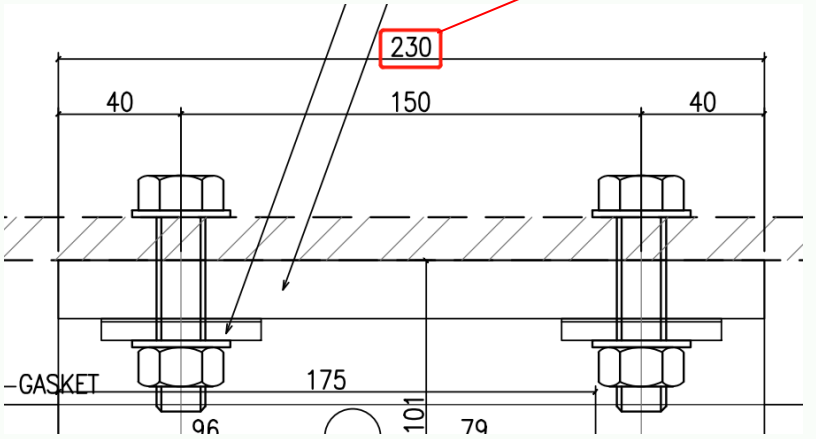
<p><u>Description:</u> The length of one bracket was measured for around 230mm which comply with shop drawing design.</p>

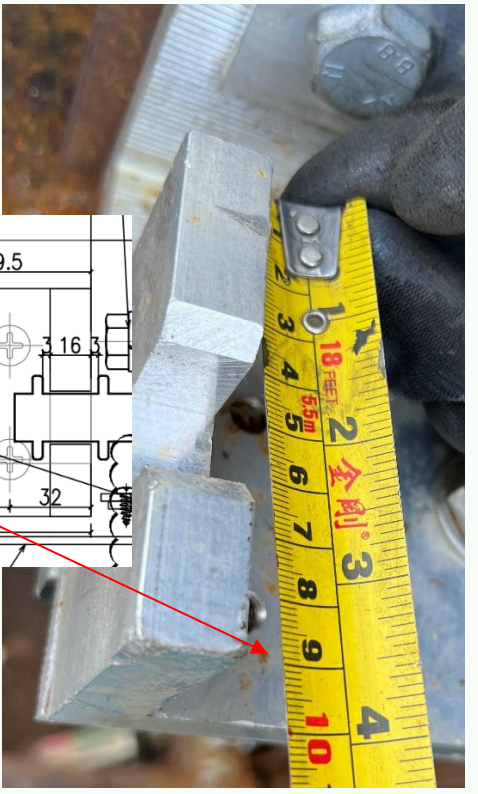
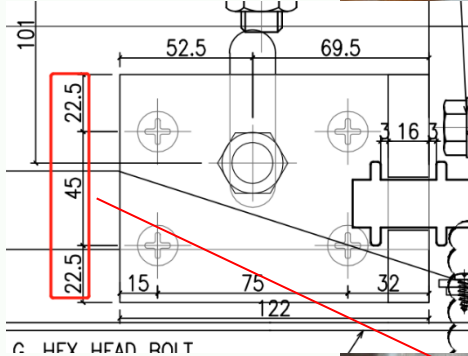
<p><u>Description:</u> The height of support bracket was measured for around 90mm which comply with shop drawing design.</p>

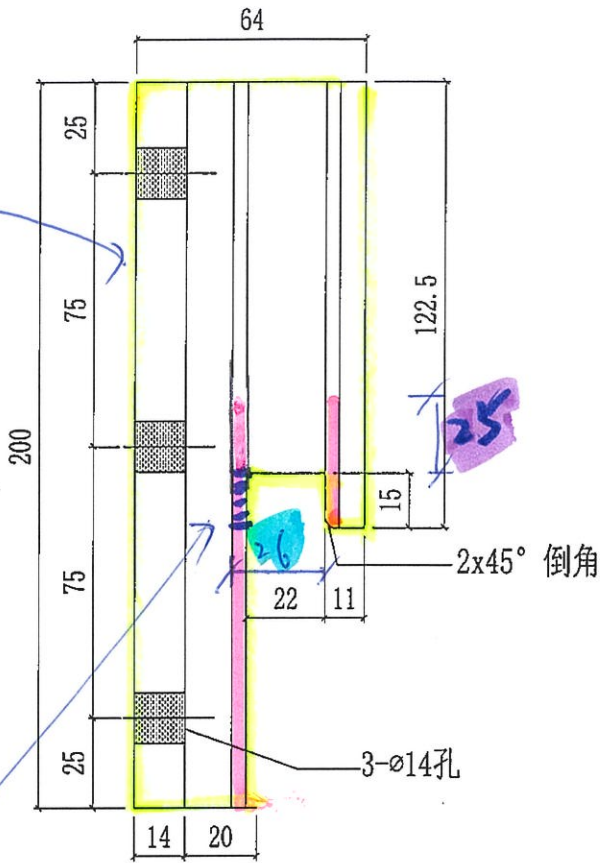
#2 Hatch單元件
掛勾加開
至26mm寬

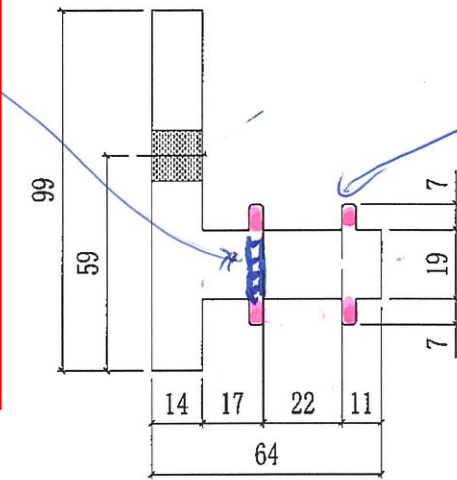
#1 魚骨前去
單元件叉碼的
高度
