工程指示編號：EI / 5294 / 22

PROPOSED RESIDENTIAL
DEVELOPMENT AT TKOTL 70RP,
PHASE 11. LOHAS PARK, TSEUNG
KWAN O. N.T.

PMU Inspection Report 01

Inspection Date: 26th October, 2022

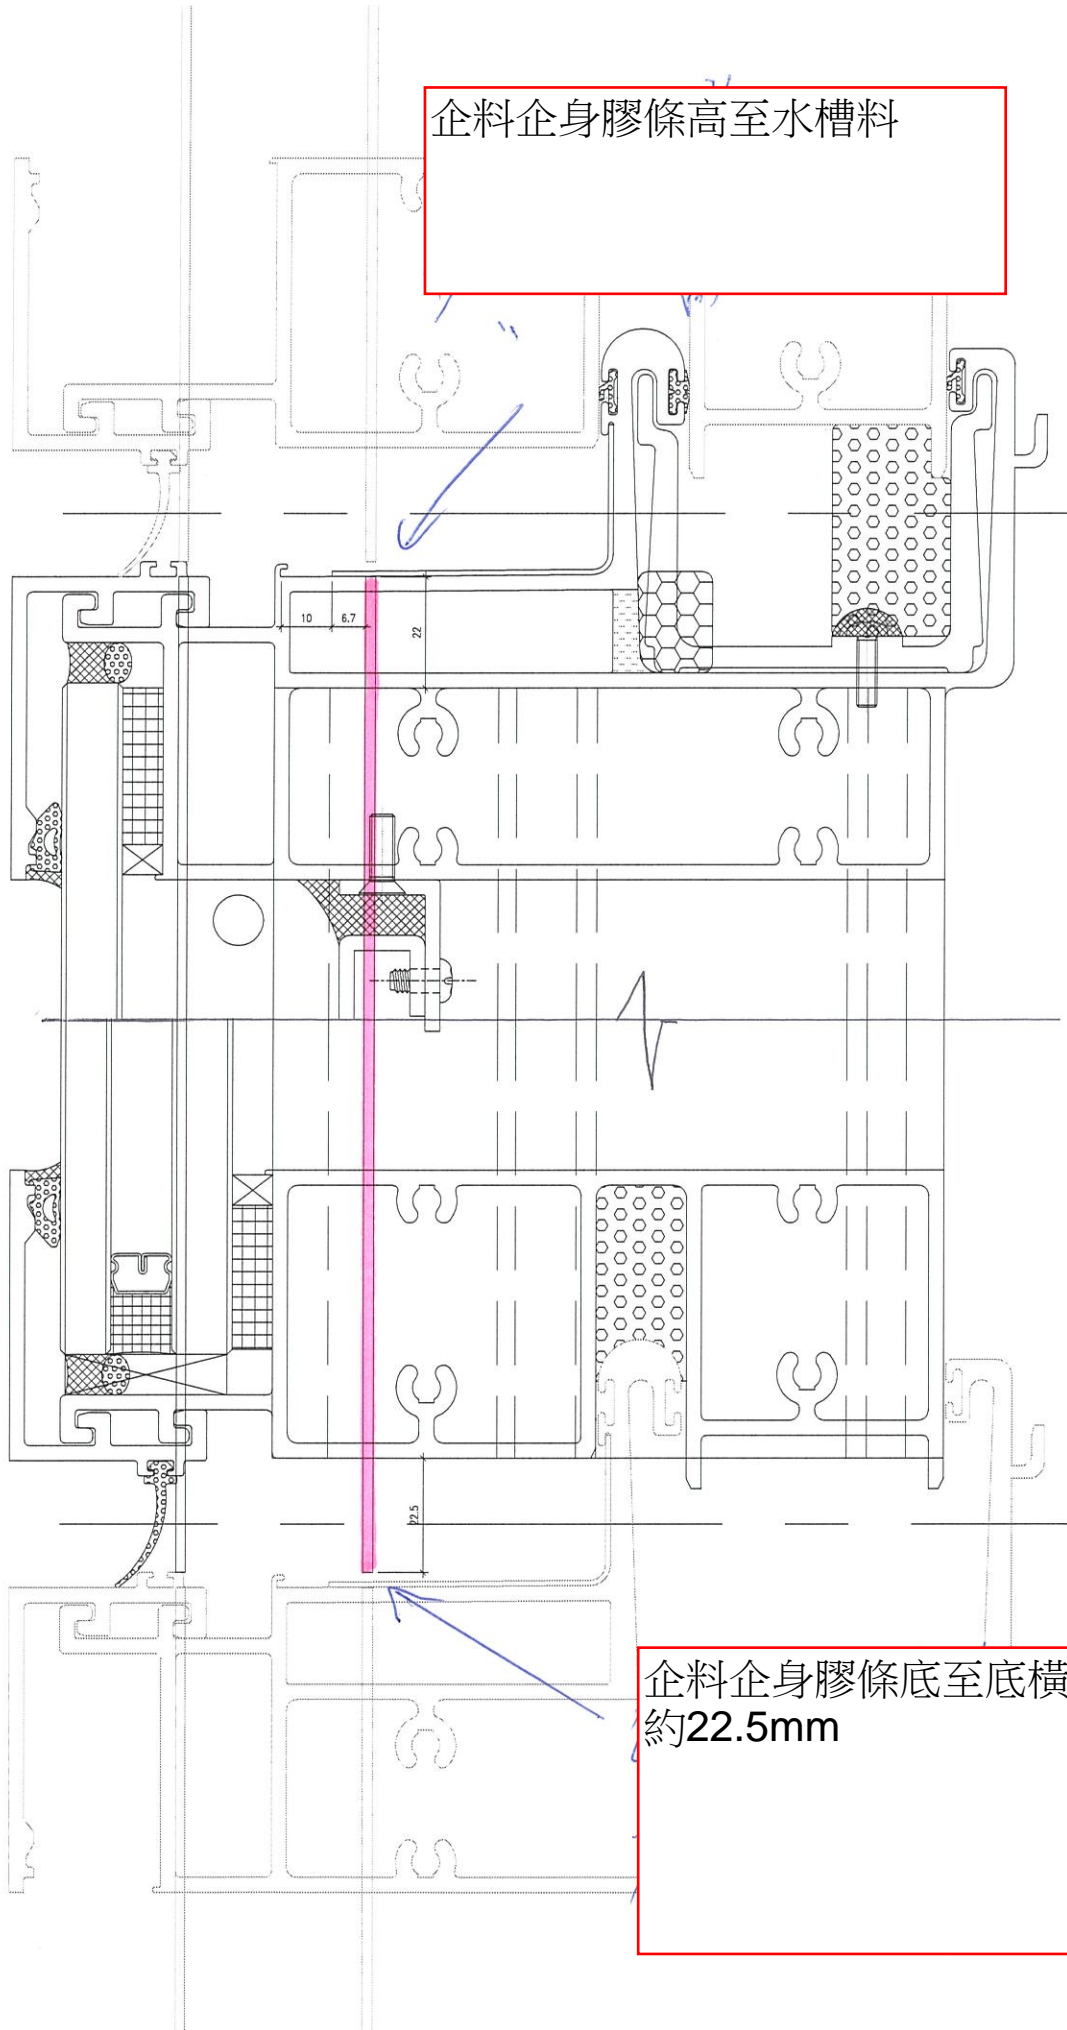
企料企身膠條高至水槽料

企料企身膠條底至底橫
約22.5mm
