工程指示 / 要求簡箋(E.I.)

工程指示編號：EI / 5527 / 22 (原 EI 5272) 修改版次：C

工程名稱：將軍澳日出康城 LP 11

工程項目：幕牆 大貨單元件加工圖

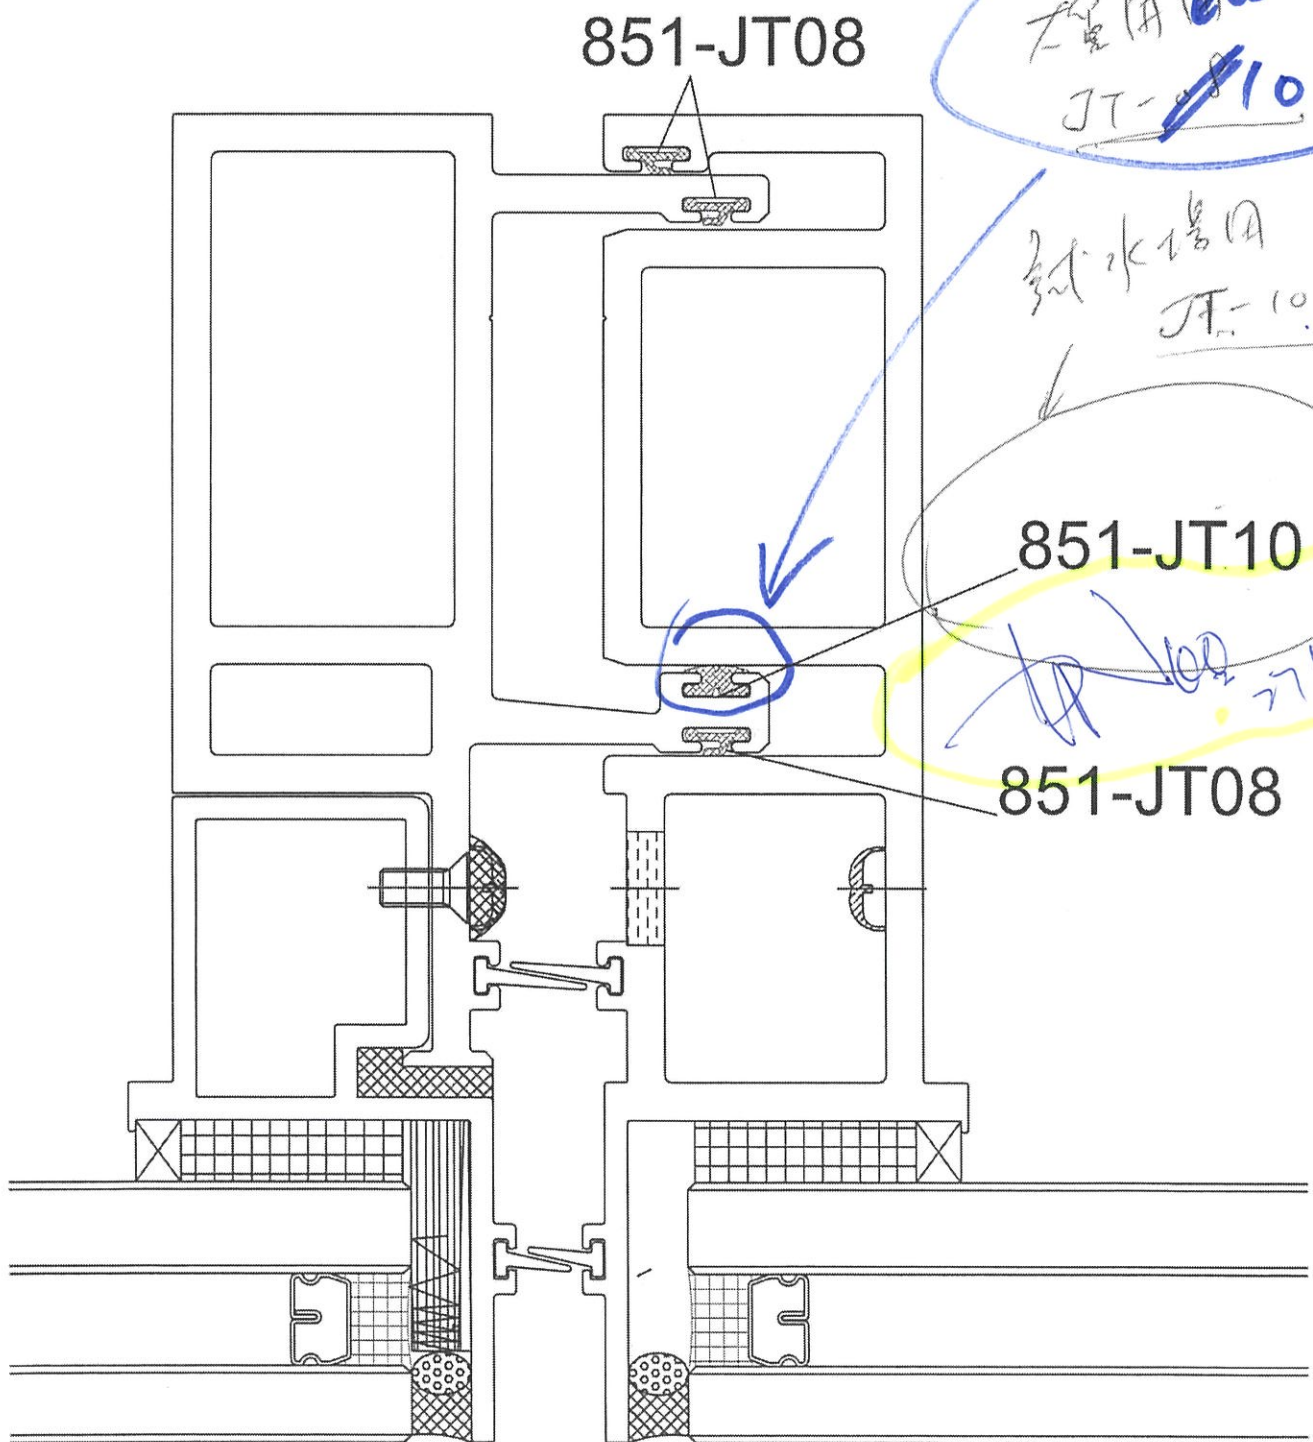
858工程公企、母企胶条配套测试

依拆图全用08，太松

如图示配套，略紧，但可以装。

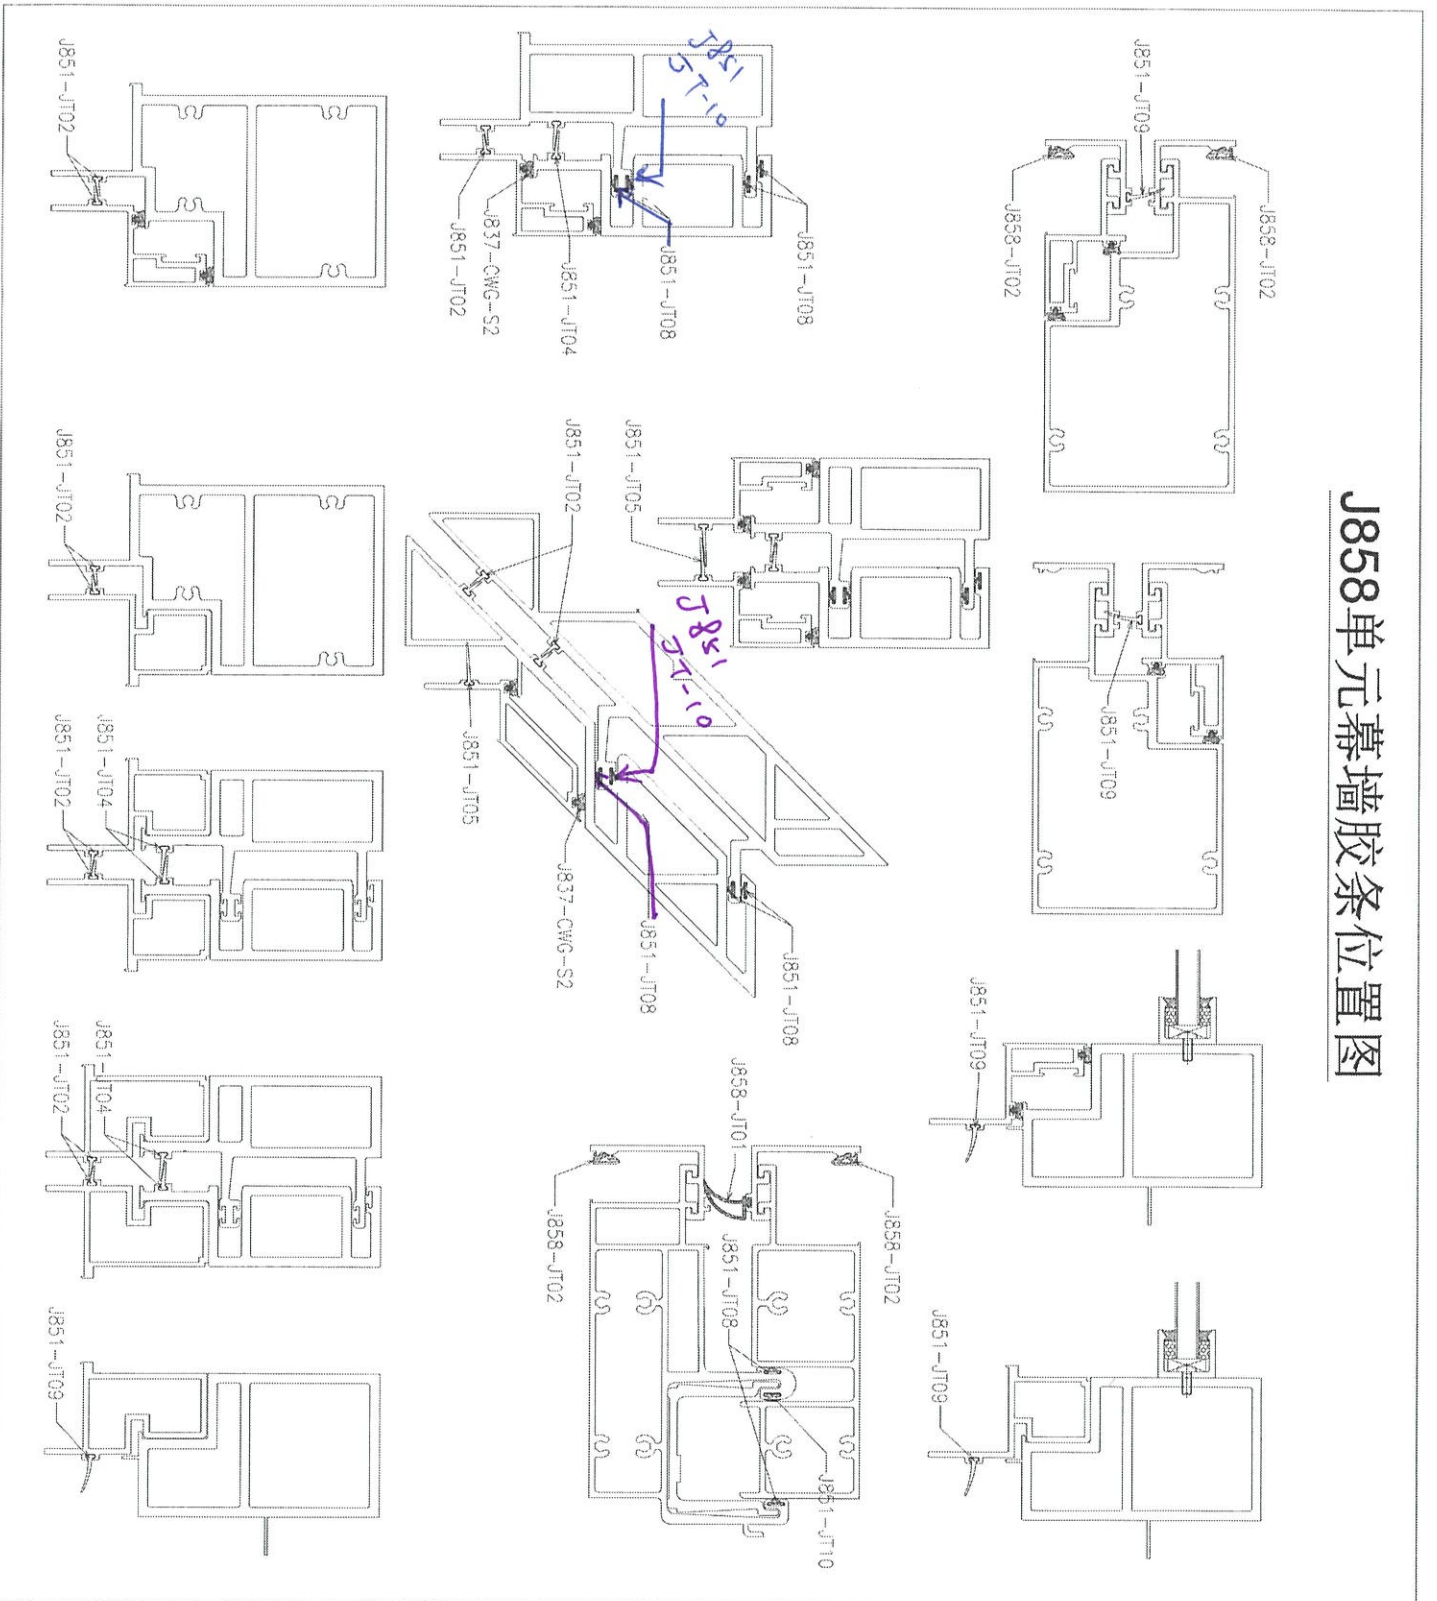
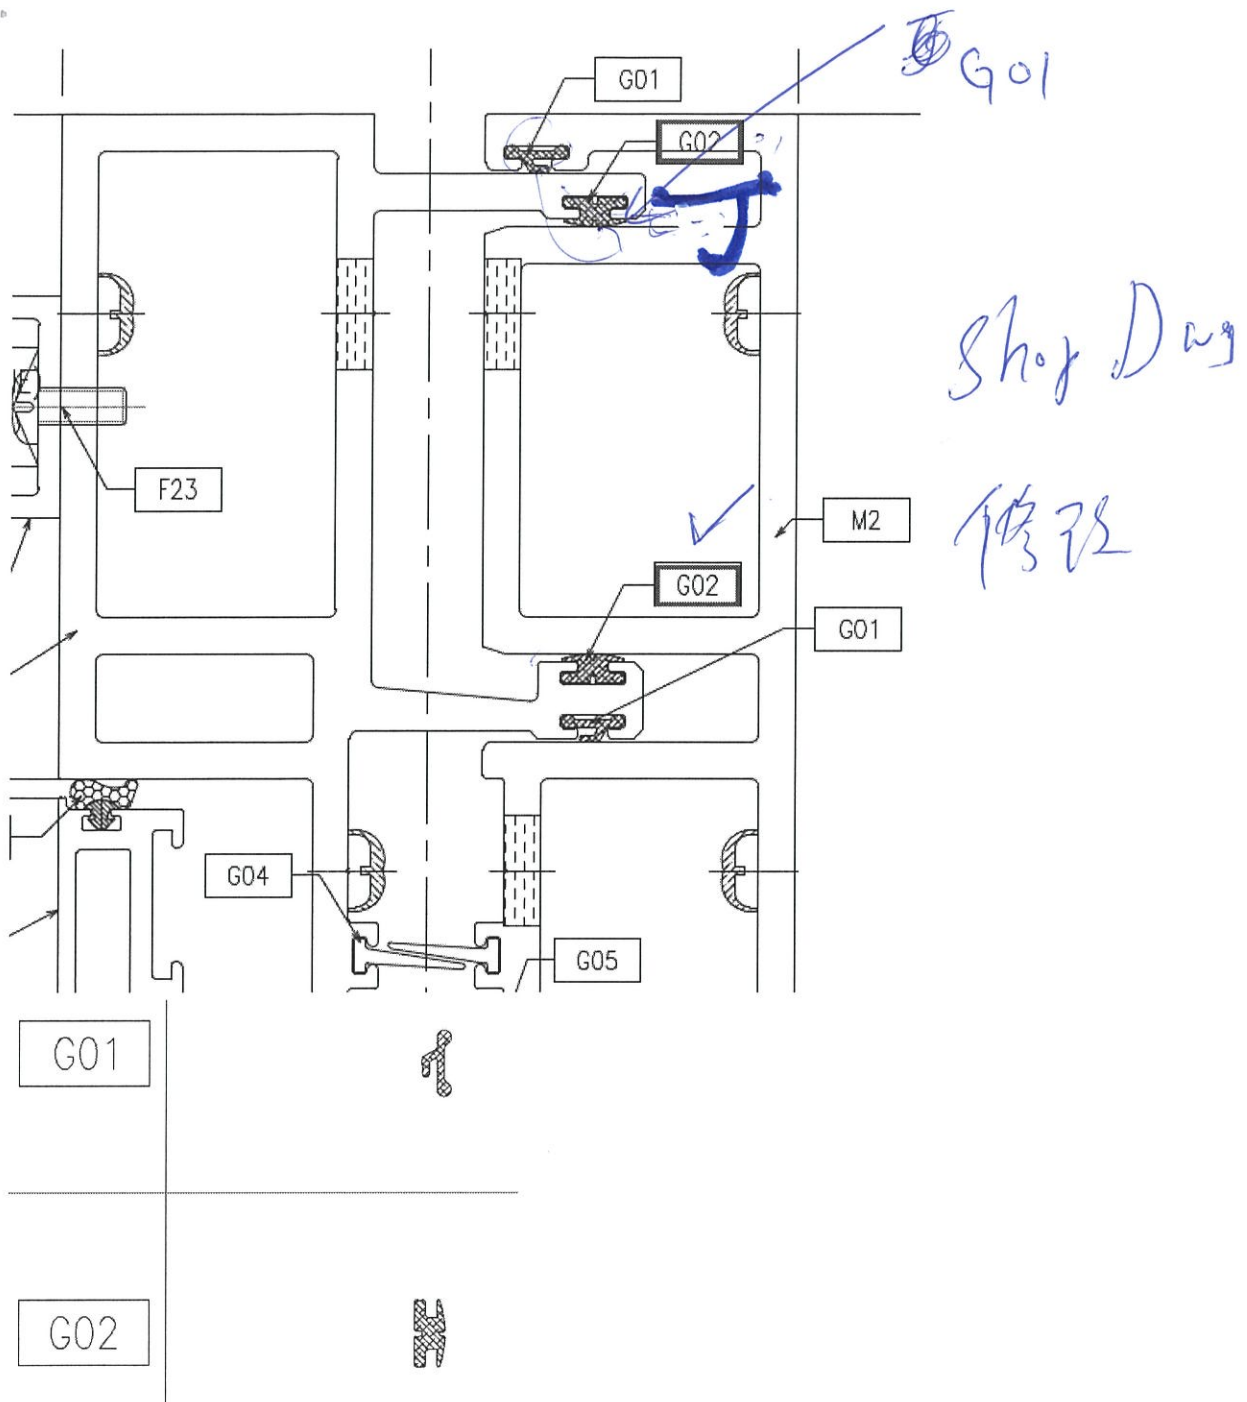
J858单元幕墙胶条位置图

C 版: 顧問質疑公母企防水性能。圖紙, 廠成品, 地盆, -> 需要跟回試水場 (3 條 JT08, 1 條 JT10)。

廠成品-> 需要更換跟回試水場 (3 條 JT08, 1 條 JT10)。

地盆, -> 需要更換跟回試水場 (3 條 JT08, 1 條 JT10)。

另外
企料膠條 有下墮甩出。
請用 502 膠水粘兩頭。
否會保不掉出。

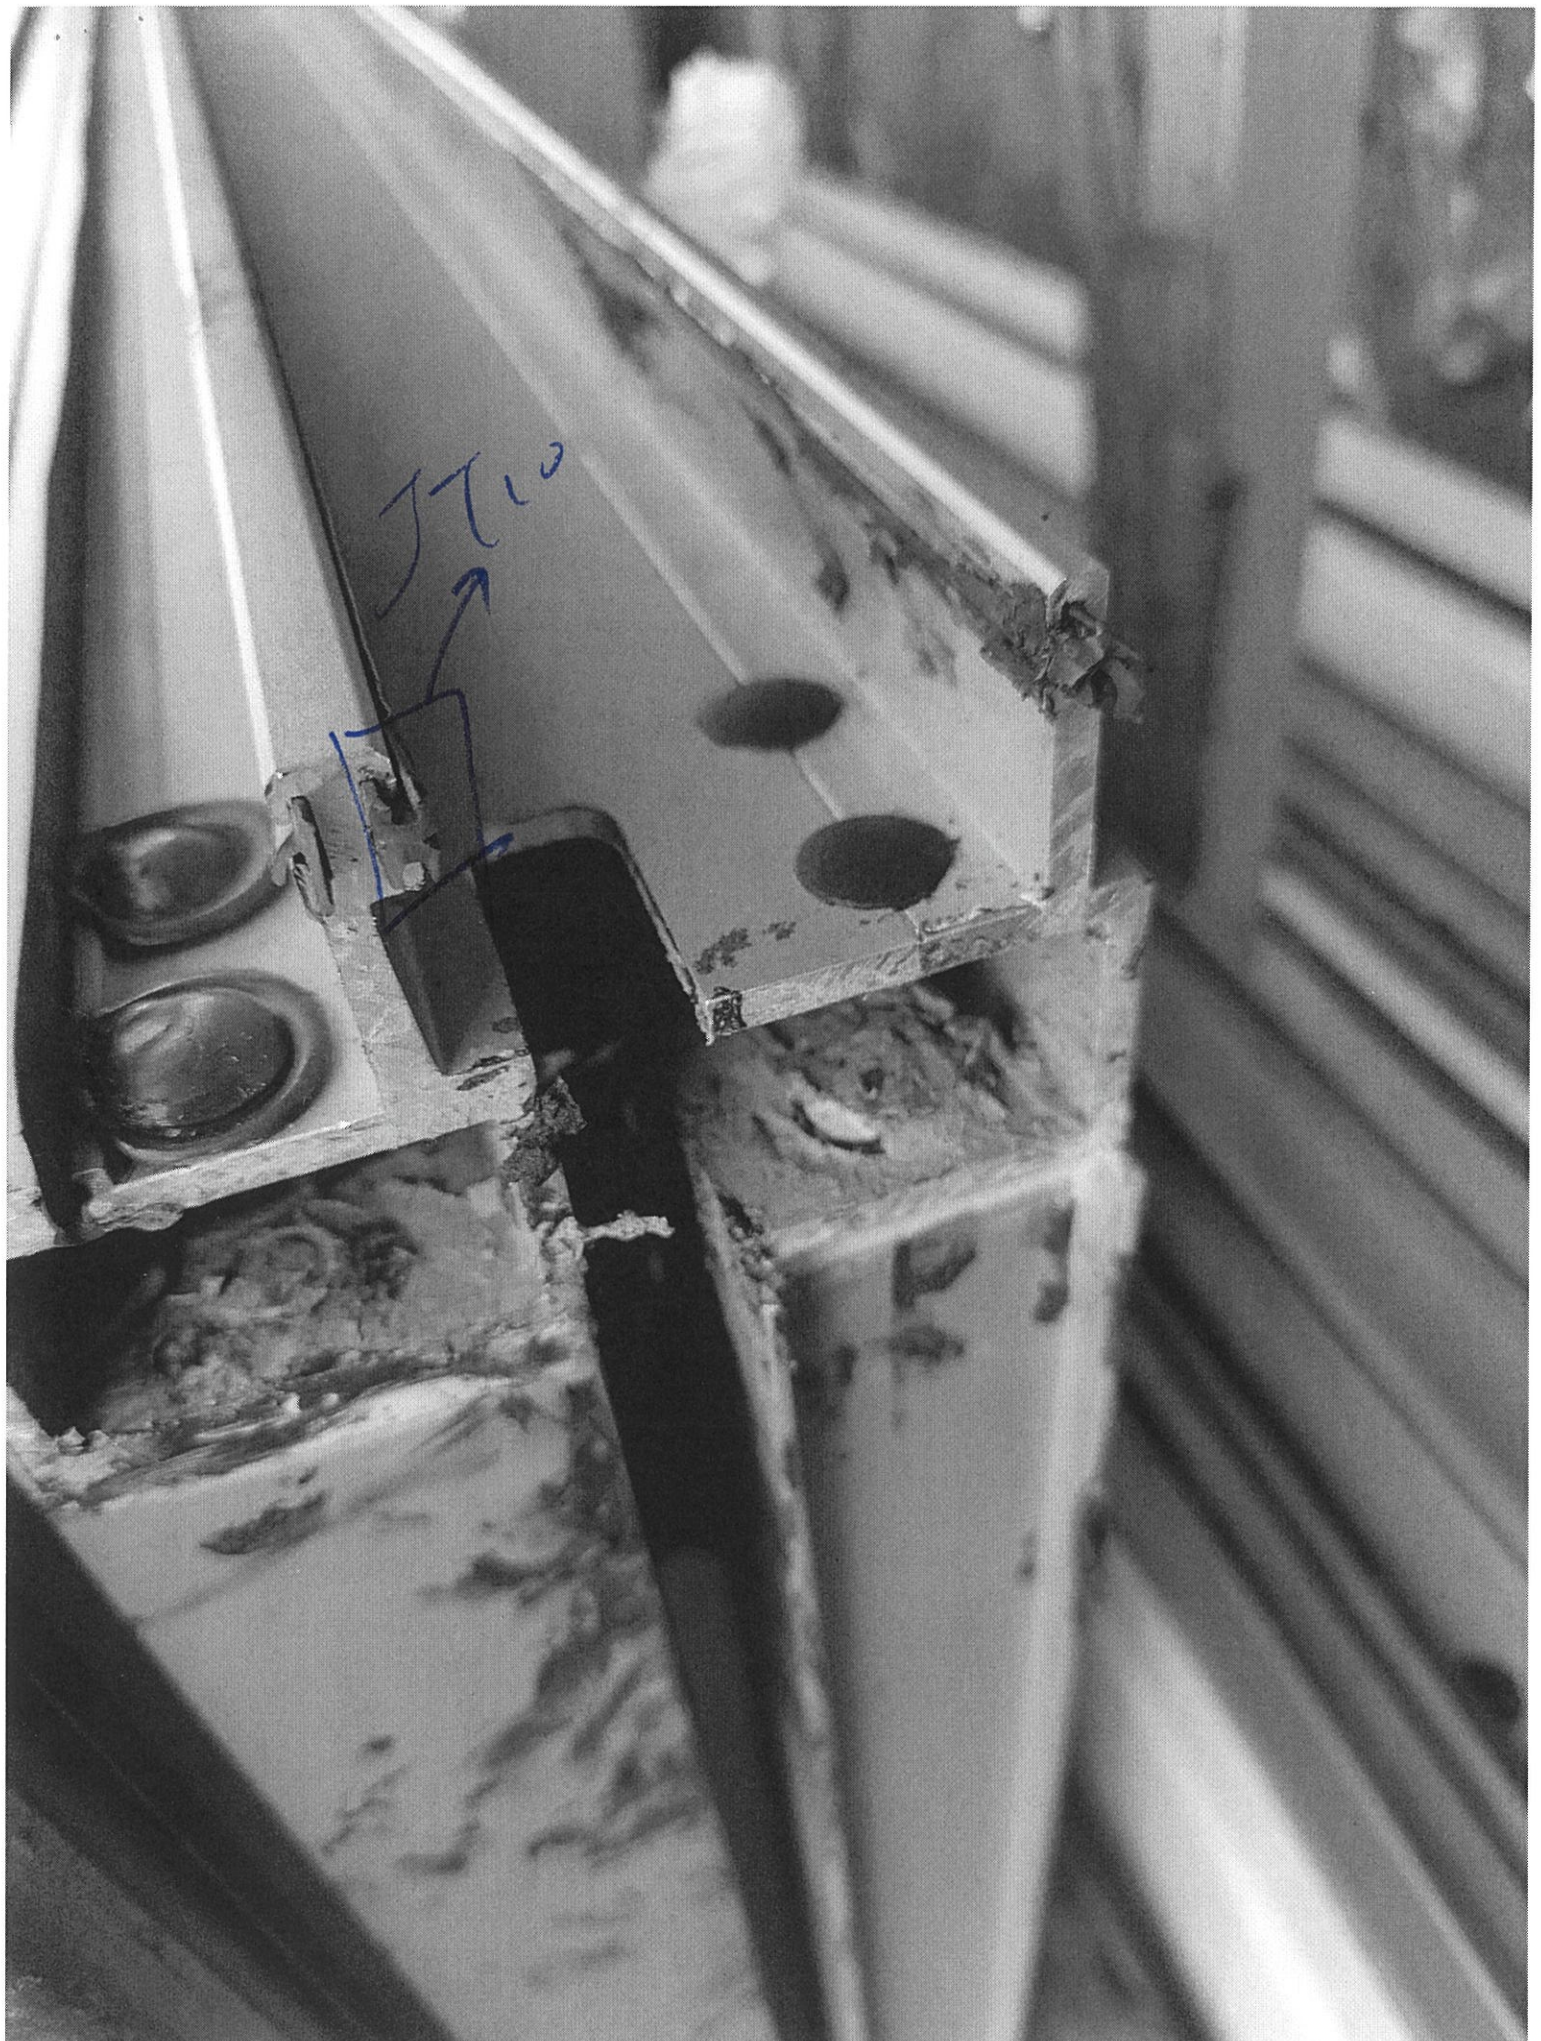
The onsite pre- assembled gasket surface is observed to below the extrusion surface which cannot performance as a reliable water barrier.

The pre-assembled gaskets on male mullion is observed to be not in line with shop drawing design, which may have influence on the whole system water tightness performance.

- a. Replace the gasket on installed panels.
- b. Double check for other onsite stored units and revise is necessary.
- c. Carry out the QA/QC method at factory panel accurate fabrication work to guarantee all works are in line with approved shop drawings.

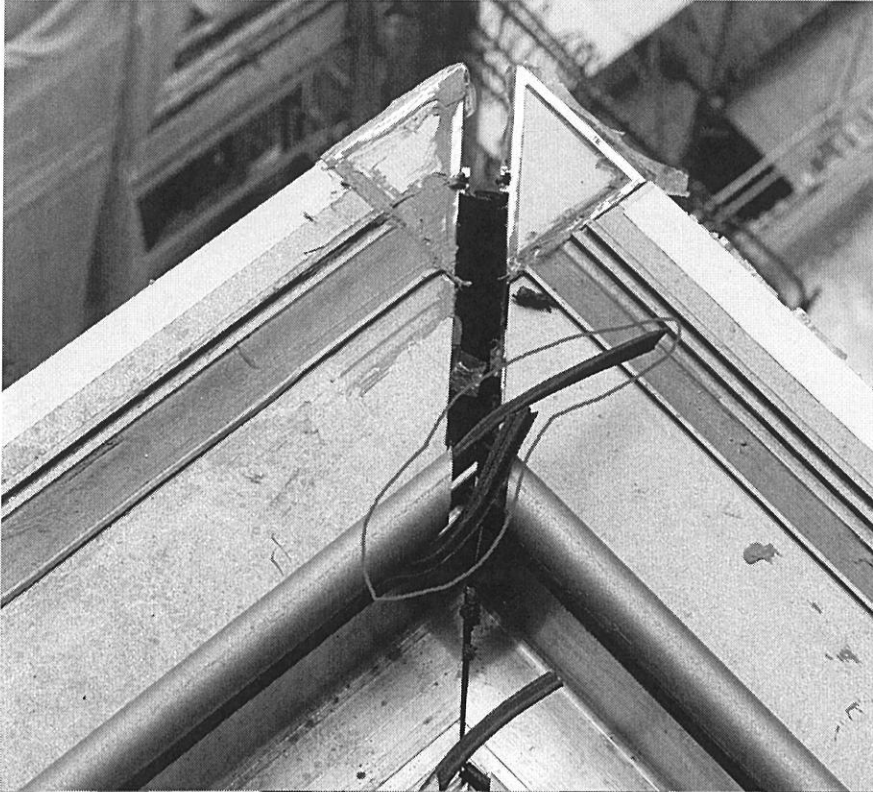
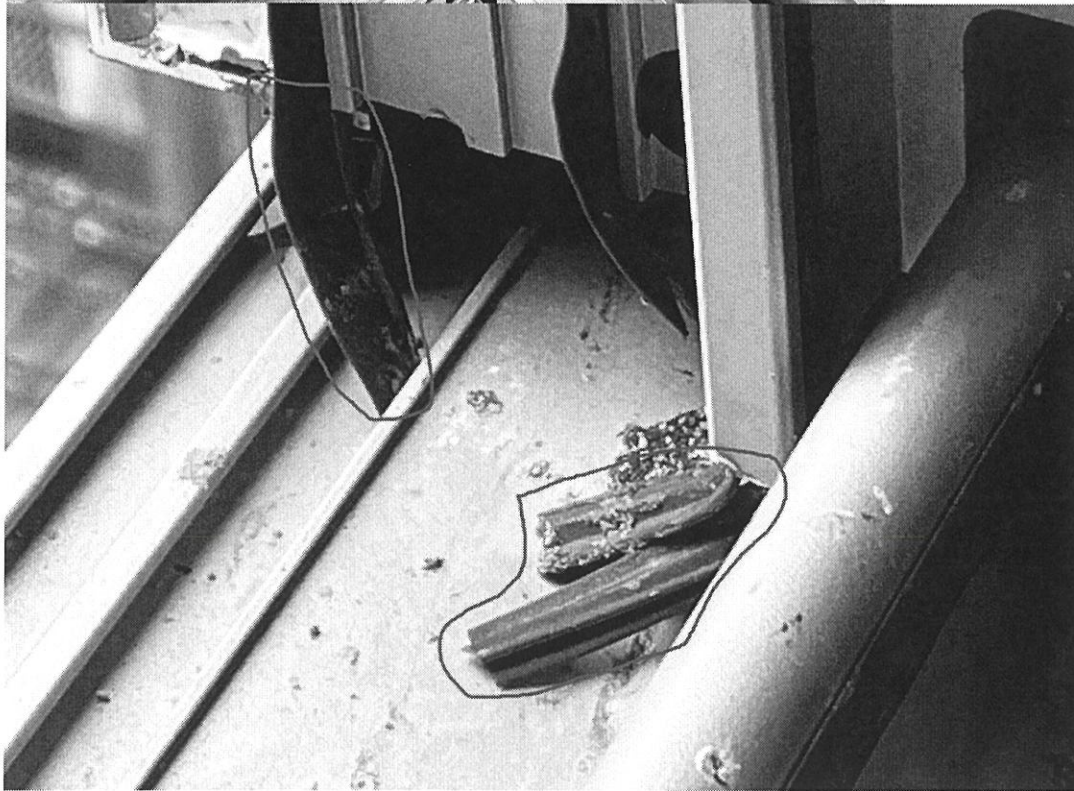
The pre-assembled gaskets on installed units is observed to be with excessive part.

Please cut off the excessive part without causing any defect on its performance before next unit constructions work processes.
