工程指示 / 要求簡箋(E.I.)

工程指示編號：EI / 5527 / 22 (原 EI 5272) 修改版次：C
 工程編號：J - 858 工程名稱：將軍澳日出康城 LP 11
 工程項目：幕牆 大貨單元件加工圖
 收件人：生統 發件人：Ant Yeung 日期：27/01/2023

"ginnychau@rlp.asia"
<ginnychau@rlp.asia>,
"wallaceng@rlp.asia" <wallaceng@rlp.asia>,
"rss19084mw@rlphk.com" <rss19084mw@rlphk.com>,
"andywchan@sino.com"
<andywchan@sino.com>,
"terrywan@sino.com" <terrywan@sino.com>,
"simonspleung@sino.com" <simonspleung@sino.com>,
"kennethleung@sino.com"
<kennethleung@sino.com>,
"stephenchow@sino.com" <stephenchow@sino.com>,
"Ko, Ryan" <Ryan.Ko@aecom.com>, "Lau, Daisy" <Daisy.Lau@aecom.com>,
"Wong,
Crystal" <crystal.wong@aecom.com>,
"Tso, Simon" <Simon.Tso@aecom.com>
Subject: LP11 - CW - onsite inspection issue
Date sent: Thu, 26 Jan 2023 05:28:37 +0000

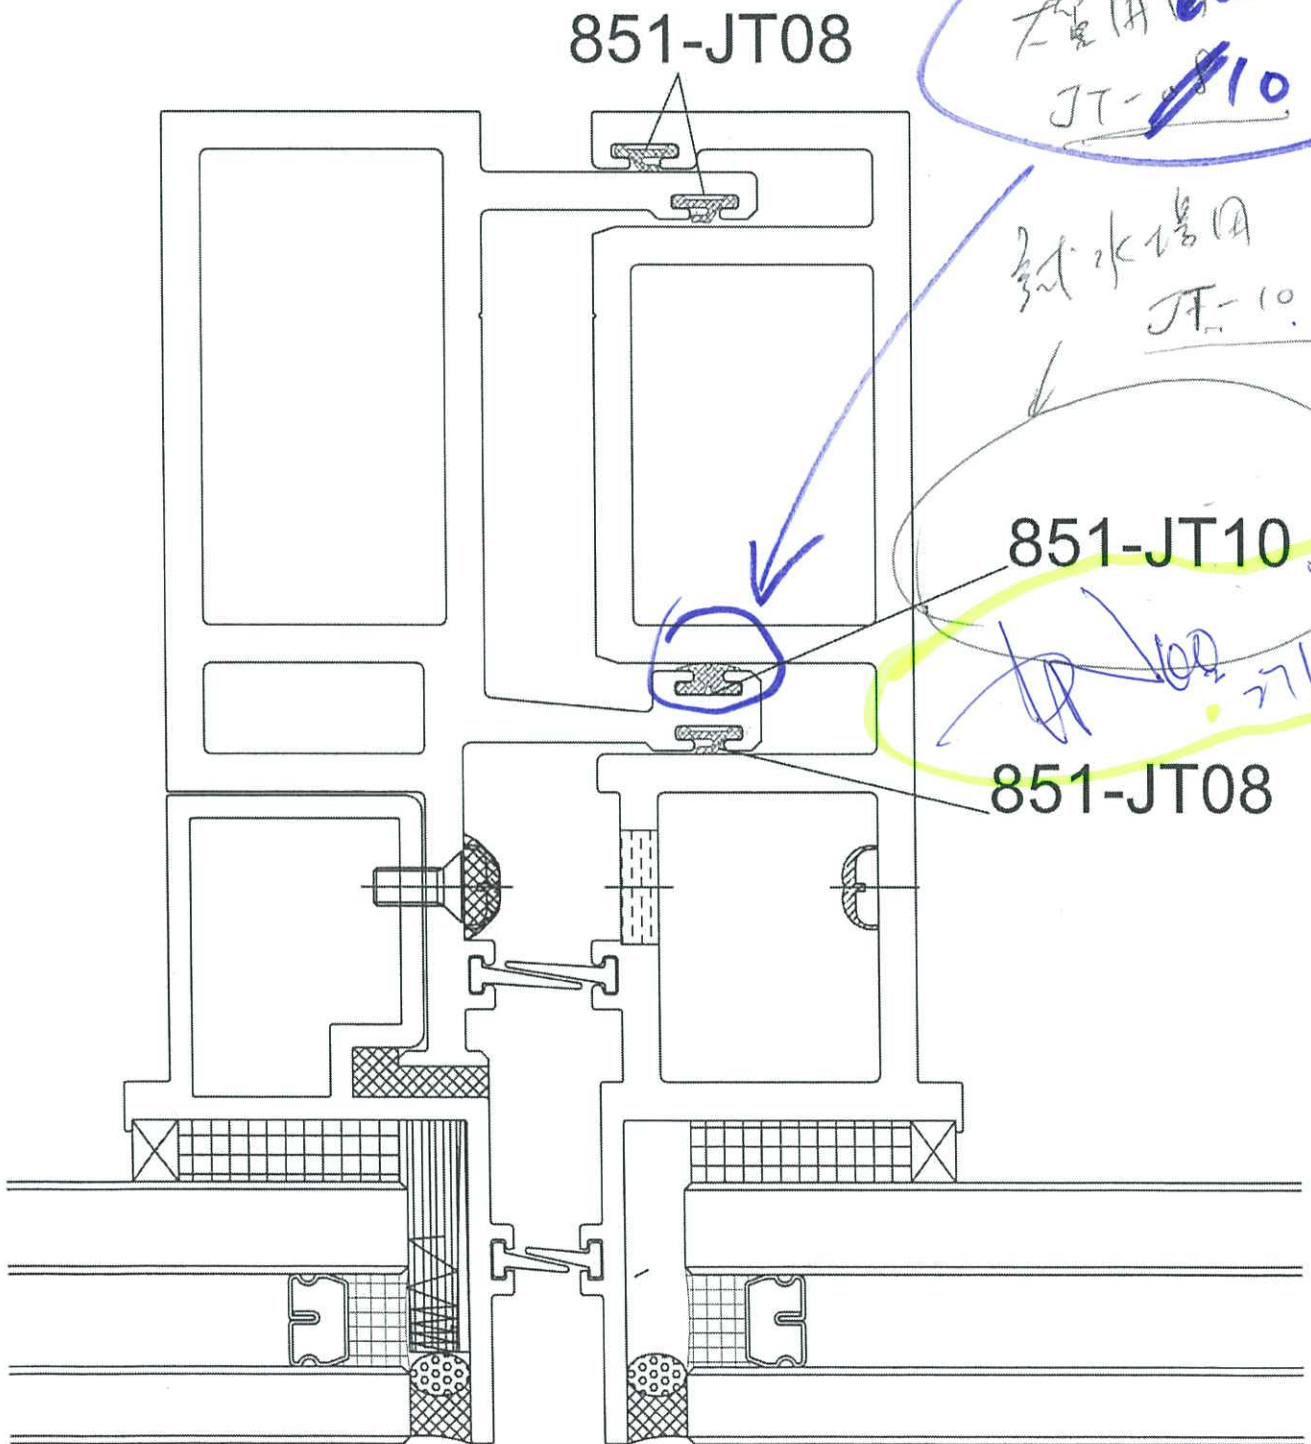
依拆图全用08, 太松

如图示配套, 略紧, 但可以装。

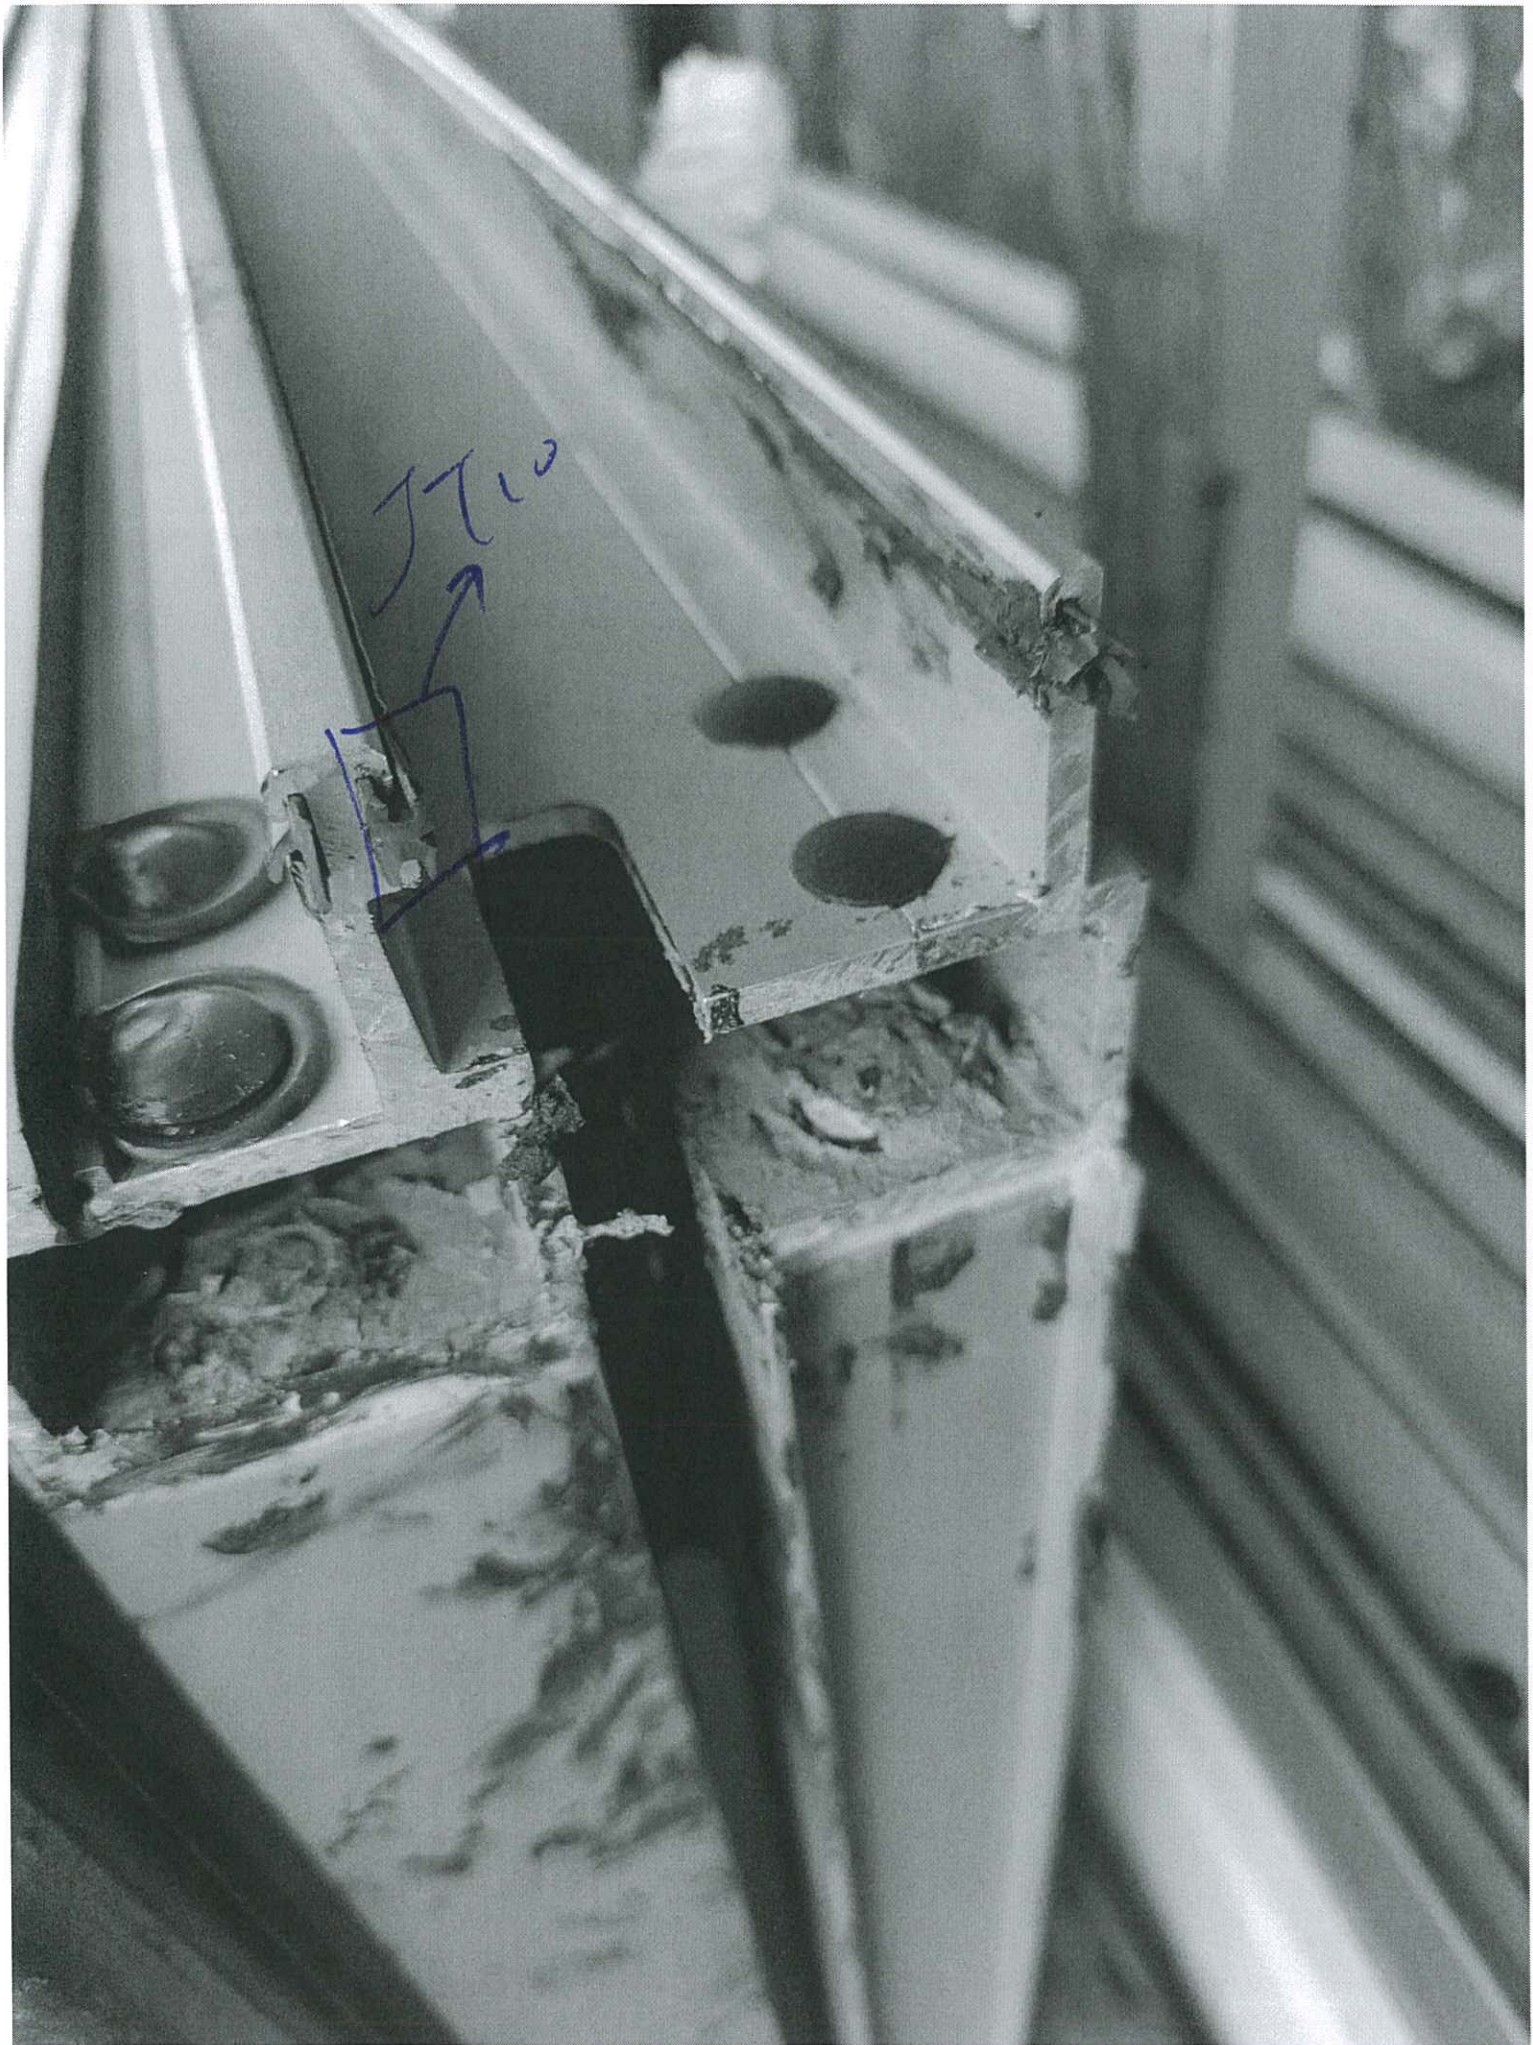
The onsite pre- assembled gasket surface is observed to below the extrusion surface which cannot performance as a reliable water barrier.

The pre-assembled gaskets on male mullion is observed to be not in line with shop drawing design, which may have influence on the whole system water tightness performance.

- a. Replace the gasket on installed panels.
- b. Double check for other onsite stored units and revise is necessary.
- c. Carry out the QA/QC method at factory panel accurate fabrication work to guarantee all works are in line with approved shop drawings.

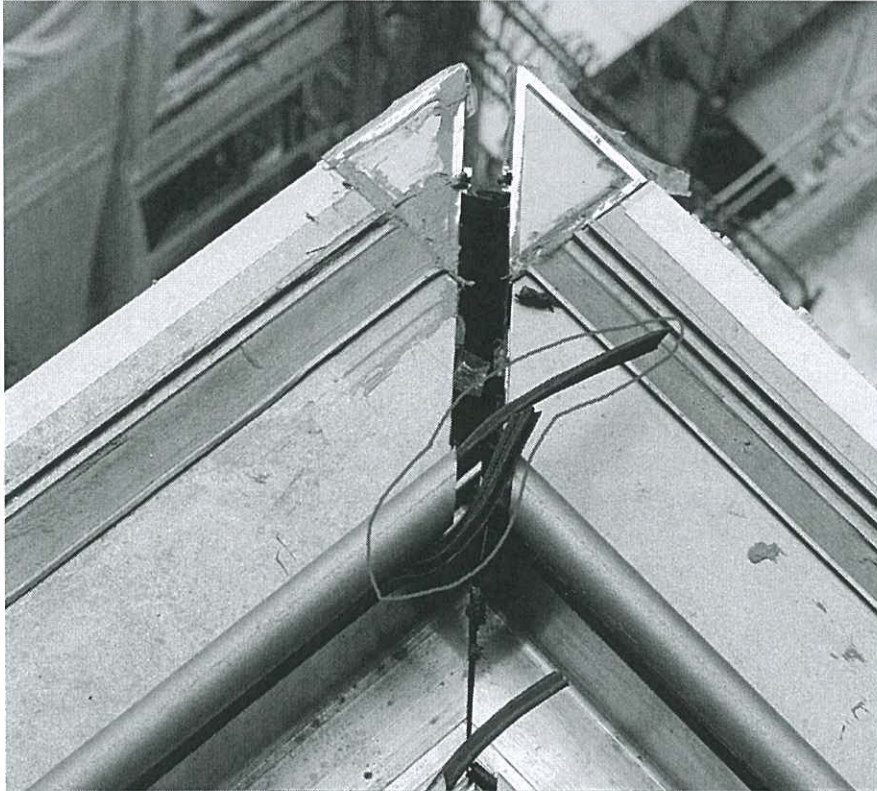
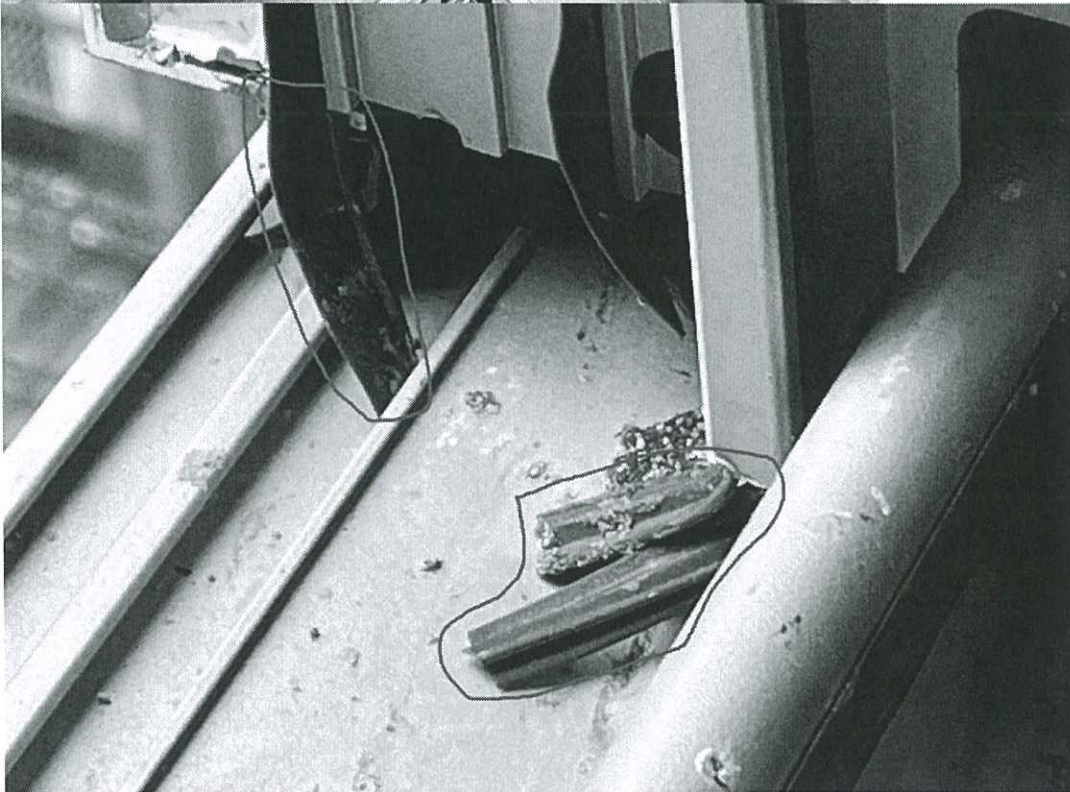
The pre-assembled gaskets on installed units is observed to be with excessive part.

Please cut off the excessive part without causing any defect on its performance before next unit constructions work processes.
