工程指示編號：EI / 5527 / 23 (原 EI 5272) 修改版次：L  
 工程編號：J - 858 工程名稱：將軍澳日出康城 LP 11  
 工程項目：幕牆 大貨單元件加工圖 **防火棉** 以此為準  
 收件人：生統 / 王良 / 水洪 發件人：Ant Yeung 日期：20/02/2023

**Proposed Residential Development at TKOTL 70RP, Phase 11, Lohas Park,  
Tseung Kwan O, N.T., Site C2**

**Site Memorandum**

Subject: **Site Observation for Matter on Fire Isolation Installation and Other Issues at 12/F BD of T1**

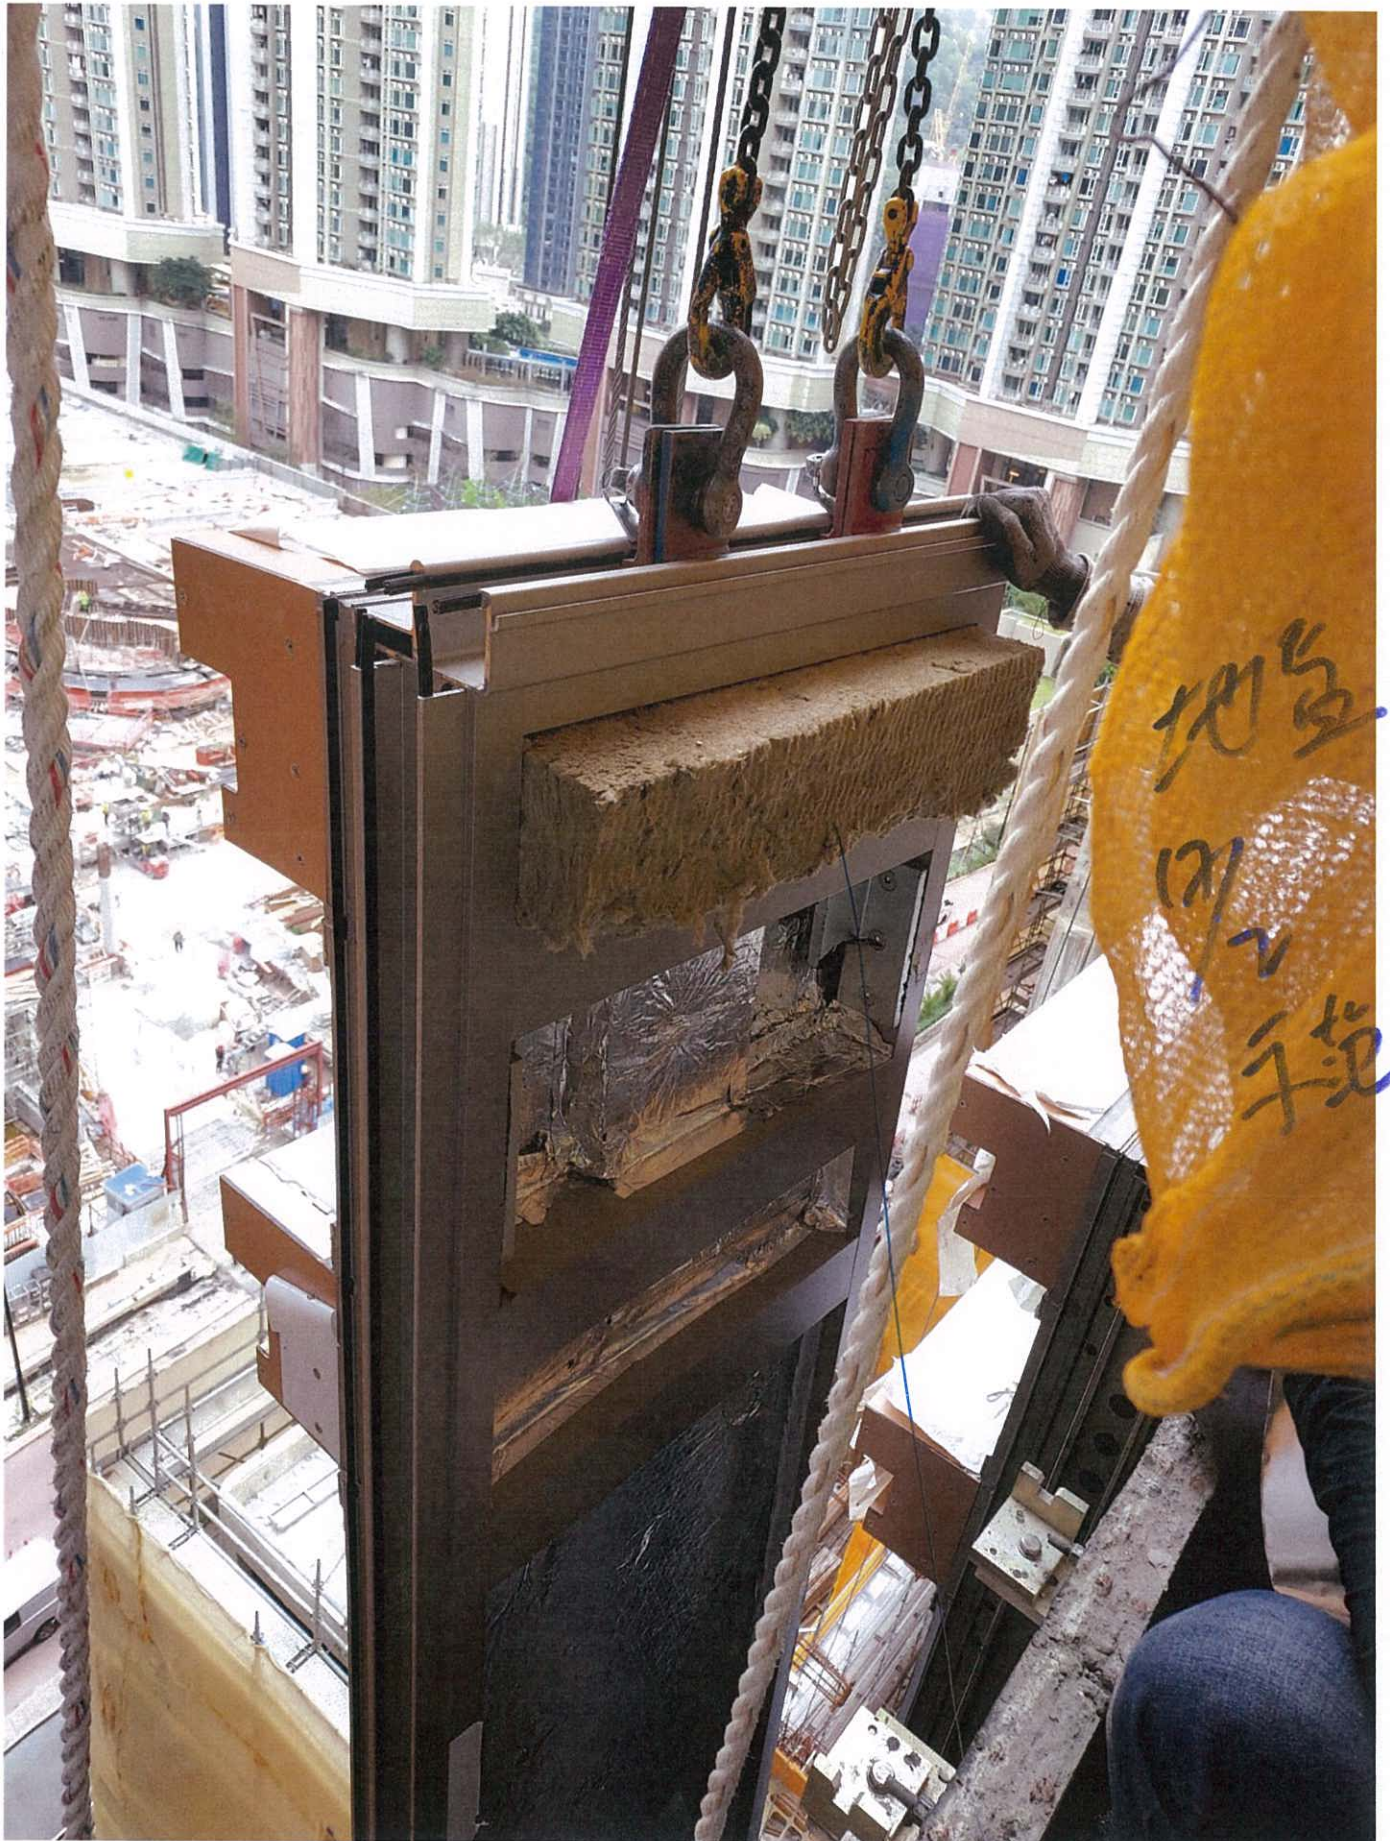
↓ 需用錫紙包好  
完整

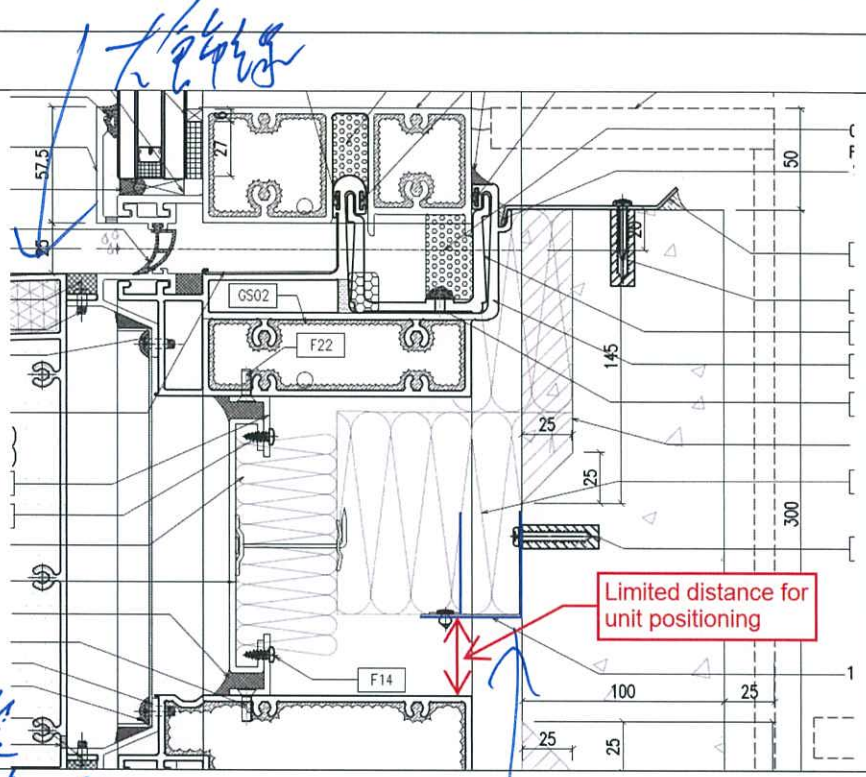
**Photo 3**

The retainer plate will clash with unit due to it limits unit movement for positioning.

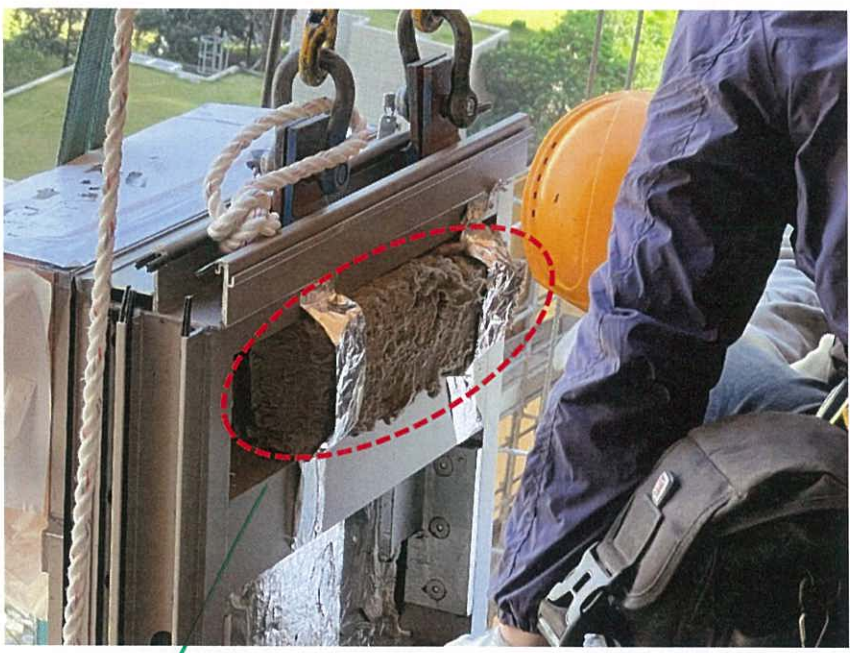
**Photo 4**

It was coordinated and agreed that the fire insulation was pre-mounted onto spandrel position for formal installation.

需用錫紙包好 (7/2 示範)  
(完裝包好, 不裝時拆)

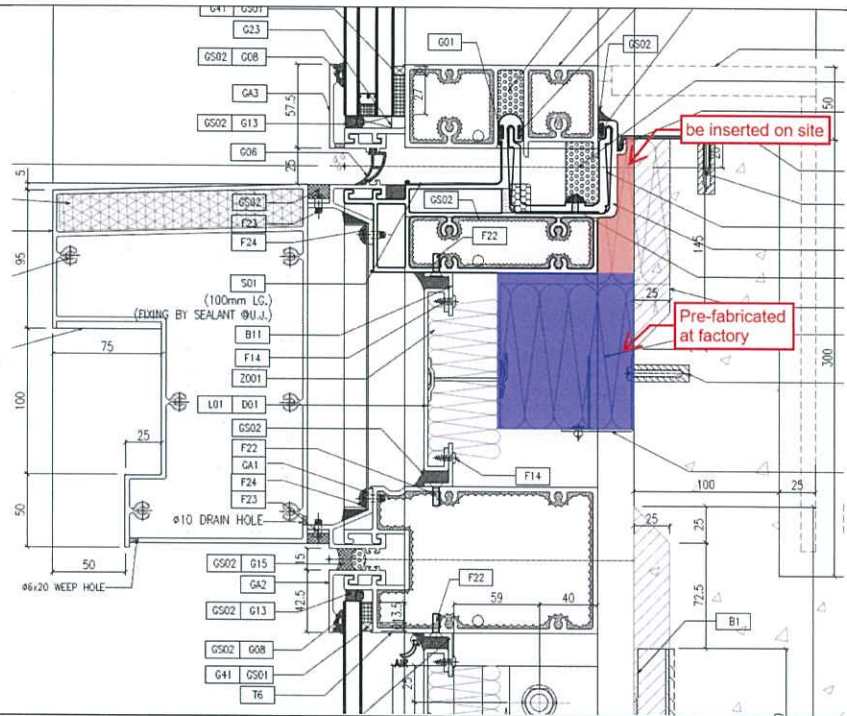
**Photo 5**

As per feedback from site, we recommend to pre-fabricate the fire insulation on to units at factory. And other parts of insulation can be inserted on site.

凡有能預製等元件  
在廠安裝更穩

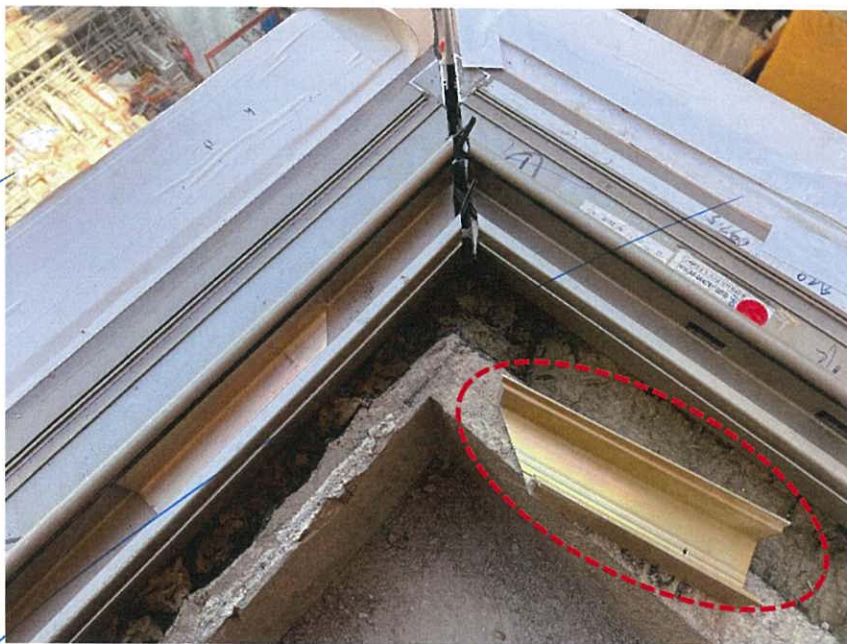
**Photo 6**

The gutter sleeve was observed to be missed for 1<sup>st</sup> installed corner panel top. Please revise and improve the QA/QC on construction sequence.
