工程指示編號：EI / 5527 / 23 (原 EI 5272) 修改版次：L  
 工程編號：J - 858 工程名稱：將軍澳日出康城 LP 11  
 工程項目：幕牆 大貨單元件加工圖 **防火棉** 以此為準  
 收件人：生統 / 王良 / 水洪 發件人：Ant Yeung 日期：20/02/2023

**Proposed Residential Development at TKOTL 70RP, Phase 11, Lohas Park,  
Tseung Kwan O, N.T., Site C2**

**Site Memorandum**

**Subject: Site Observation for Matter on Fire Isolation Installation and Other Issues at 12/F BD of T1**

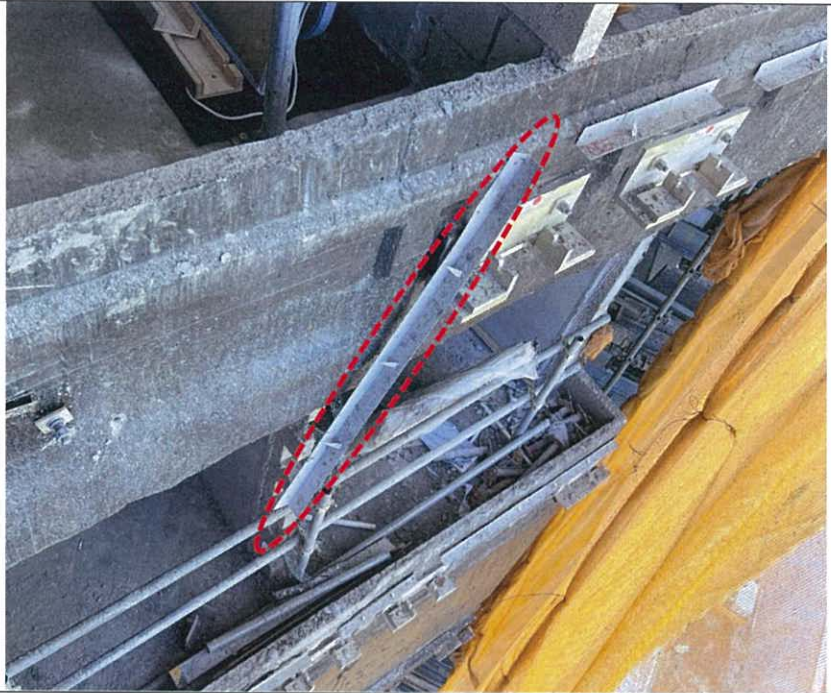
**Photo 1**

The retainer plate for fire insulation was observed to be damaged on the 12/F slab. It was removed after informed of MIDI.

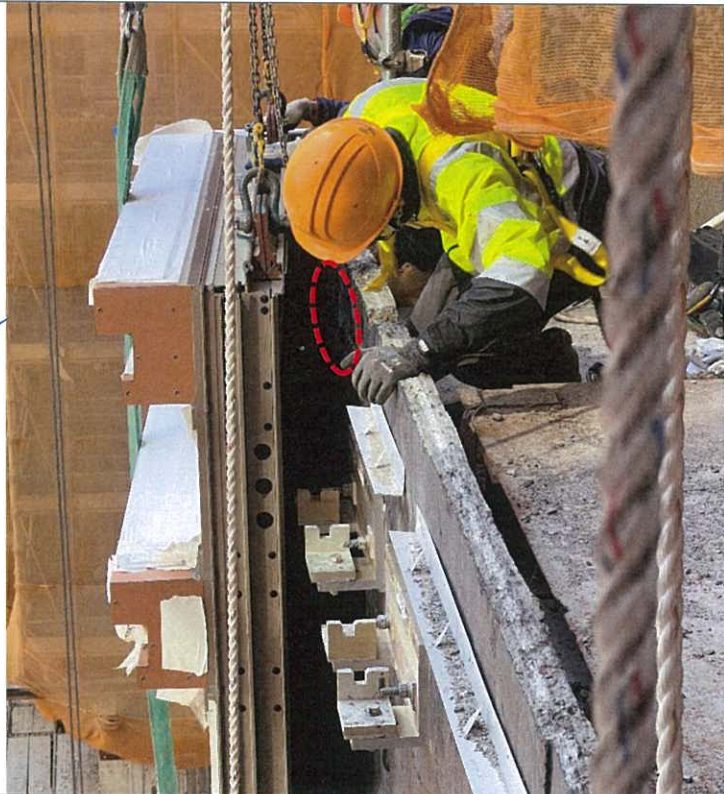
**Photo 2**

The retainer plate was observed to be removed due to the it will clash with unit during installation.

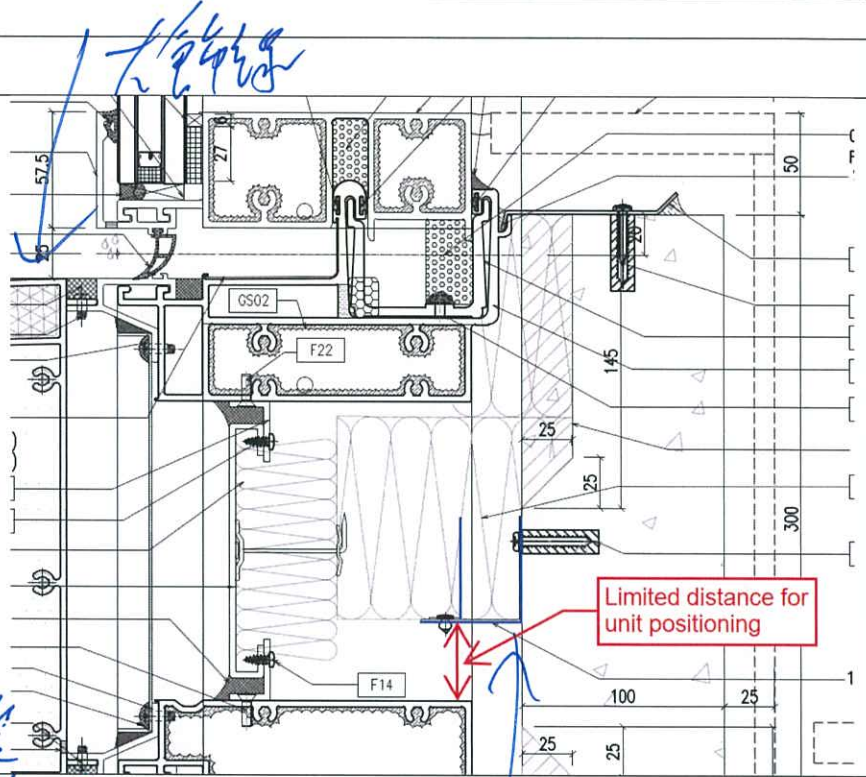
Photo 3

The retainer plate will clash with unit due to it limits unit movement for positioning.

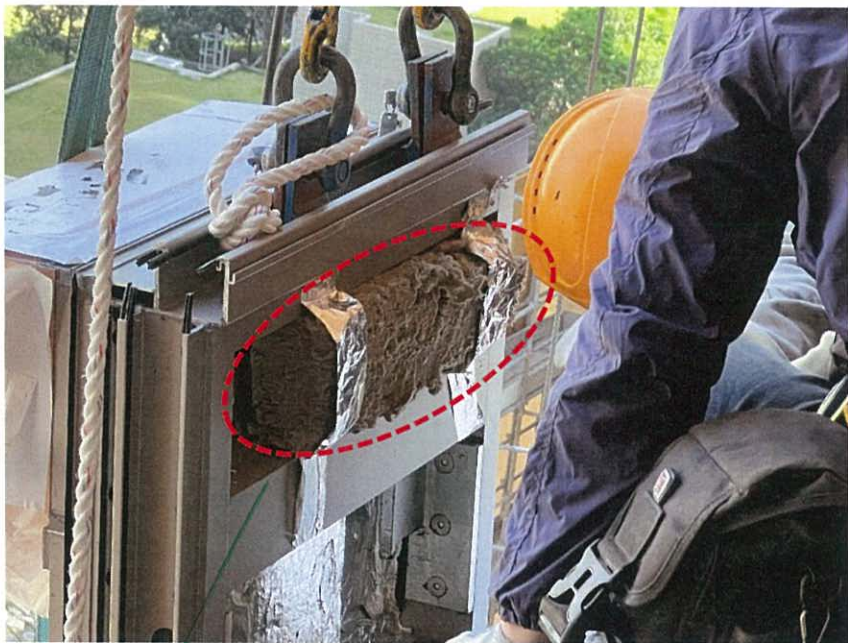
Photo 4

It was coordinated and agreed that the fire insulation was pre-mounted onto spandrel position for formal installation.

需用錫紙包好 (7/2 示範)  
(空包好, 不要跨士特)

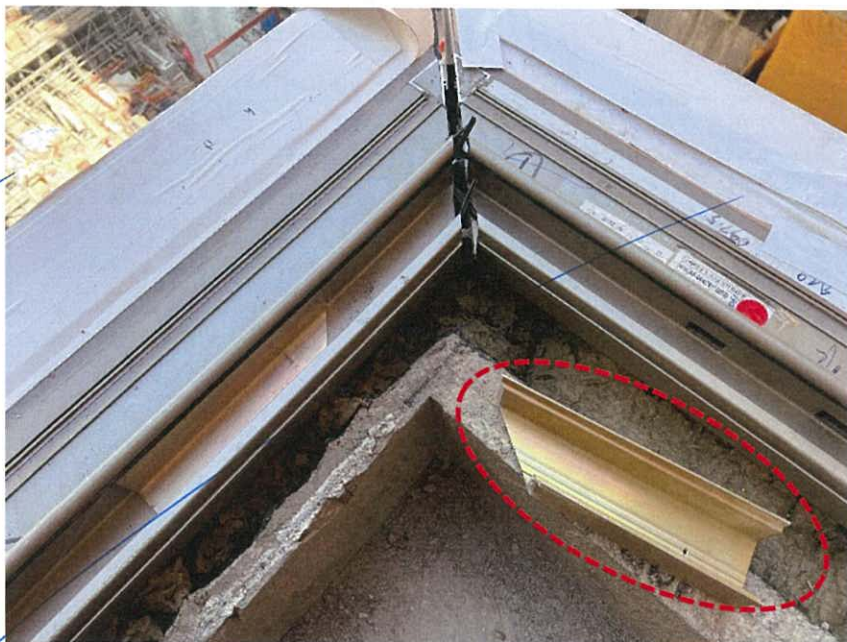
**Photo 6**

The gutter sleeve was observed to be missed for 1<sup>st</sup> installed corner panel top. Please revise and improve the QA/QC on construction sequence.

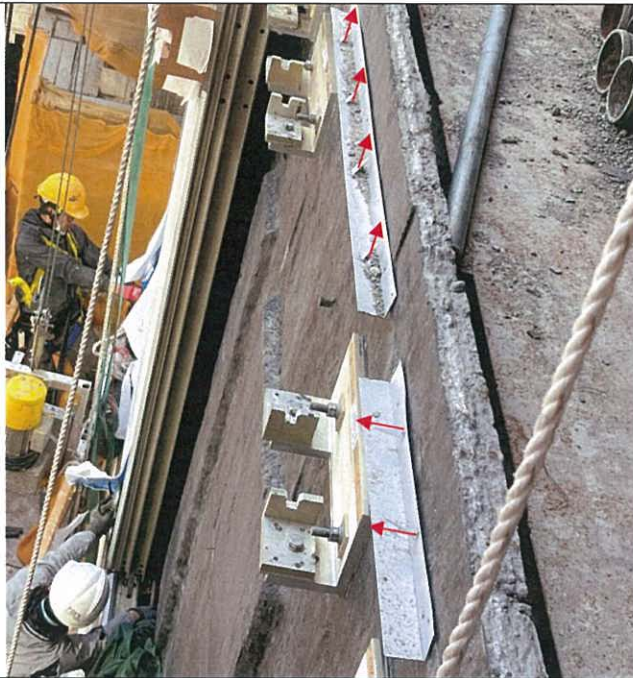
**Photo 7**

The installed retainer plate was observed to be with different orientation.

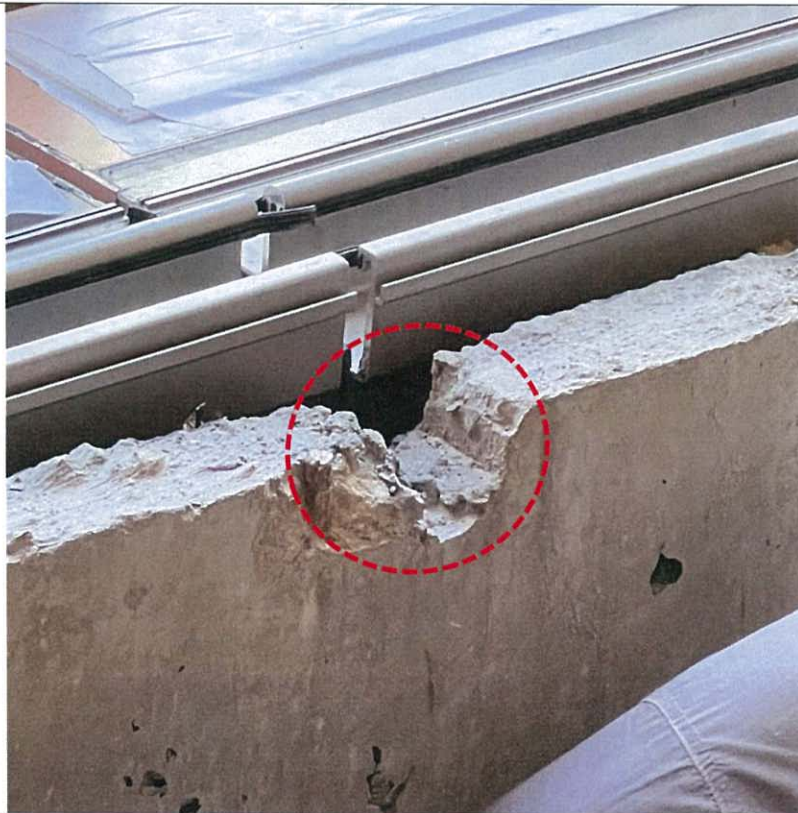
**Photo 8**

The RC curb was observed with damaged notch, please provide remedial for proposal its water proofing and fire rated performance.

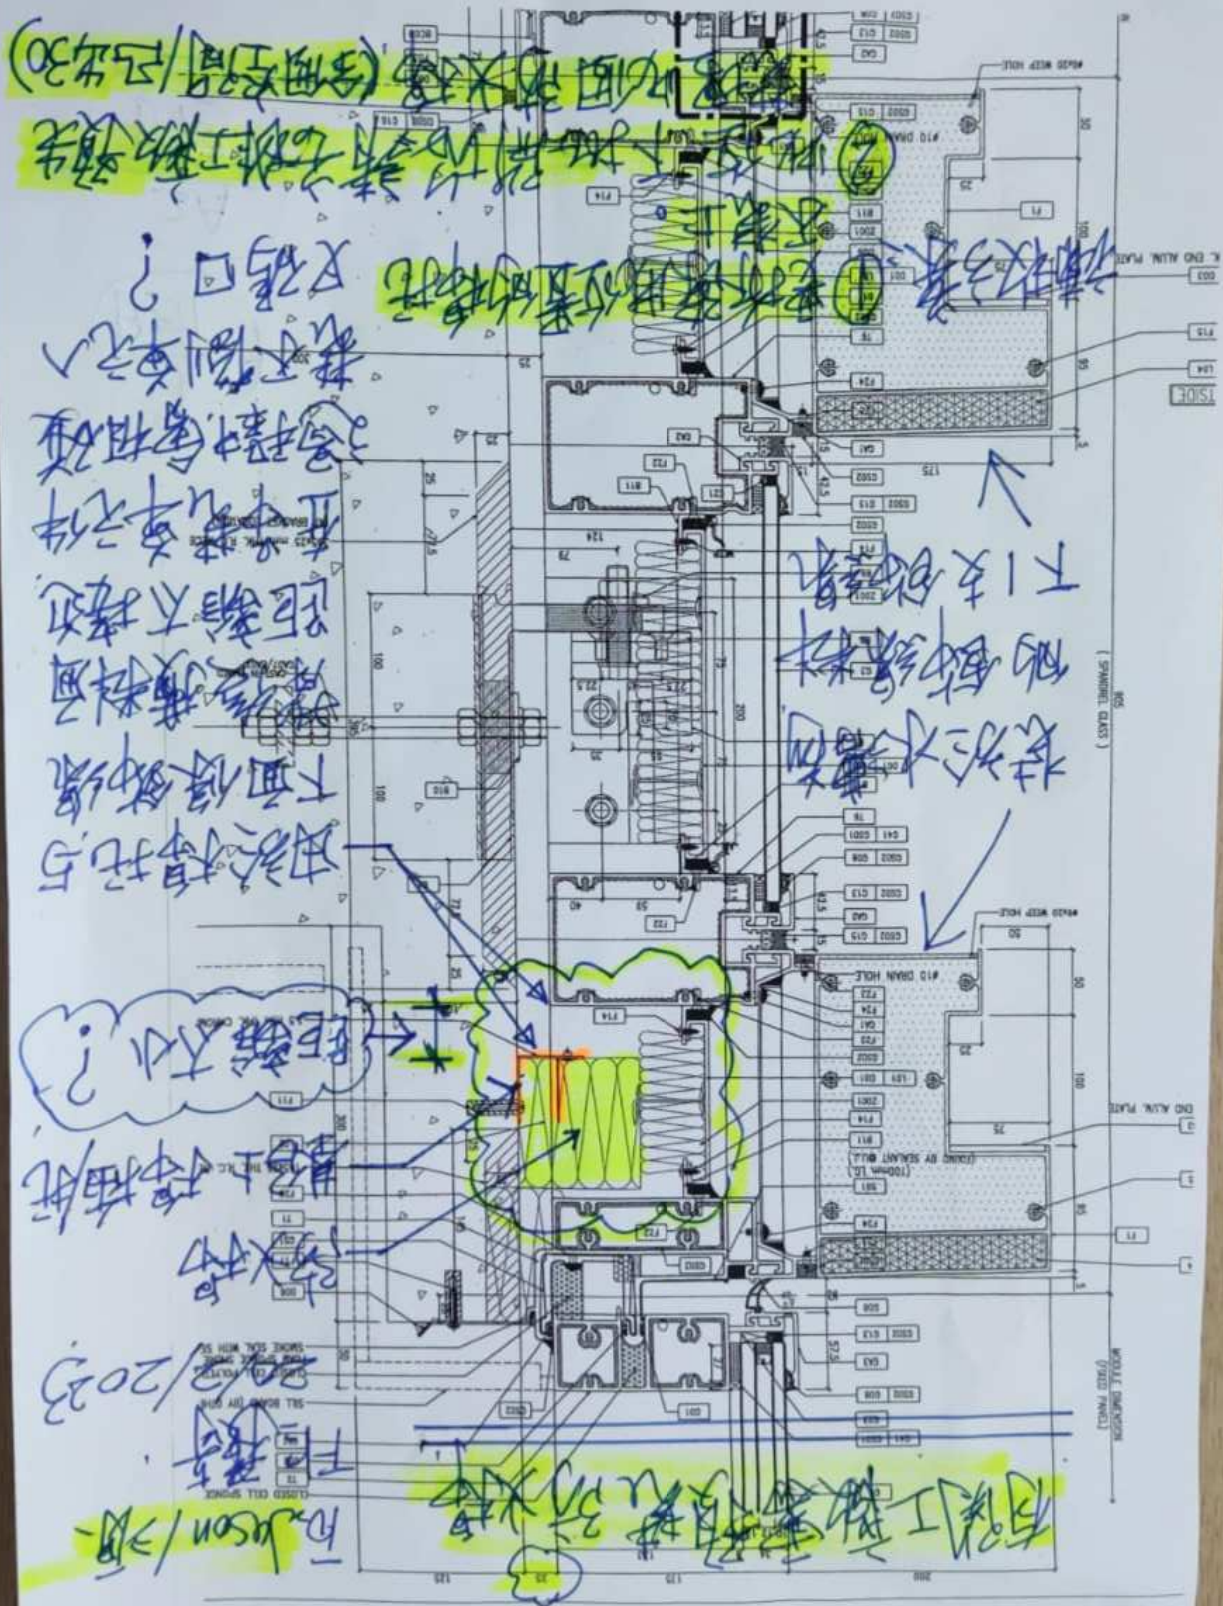
由於棉托與  
下面保飾線  
距離太接近  
導致橫料面  
距離不接近  
在裝車元件  
過程中會相碰  
甚至劇烈入

此零件請工程師先  
確認此圖的結構 (參閱圖/24.30)
