工程指示 / 要求簡箋(E.I.)

工程指示編號：EI / 5781 / 23

工程名稱：將軍澳日出康城 11

工程項目：幕牆 單元件 地盆顧問報告

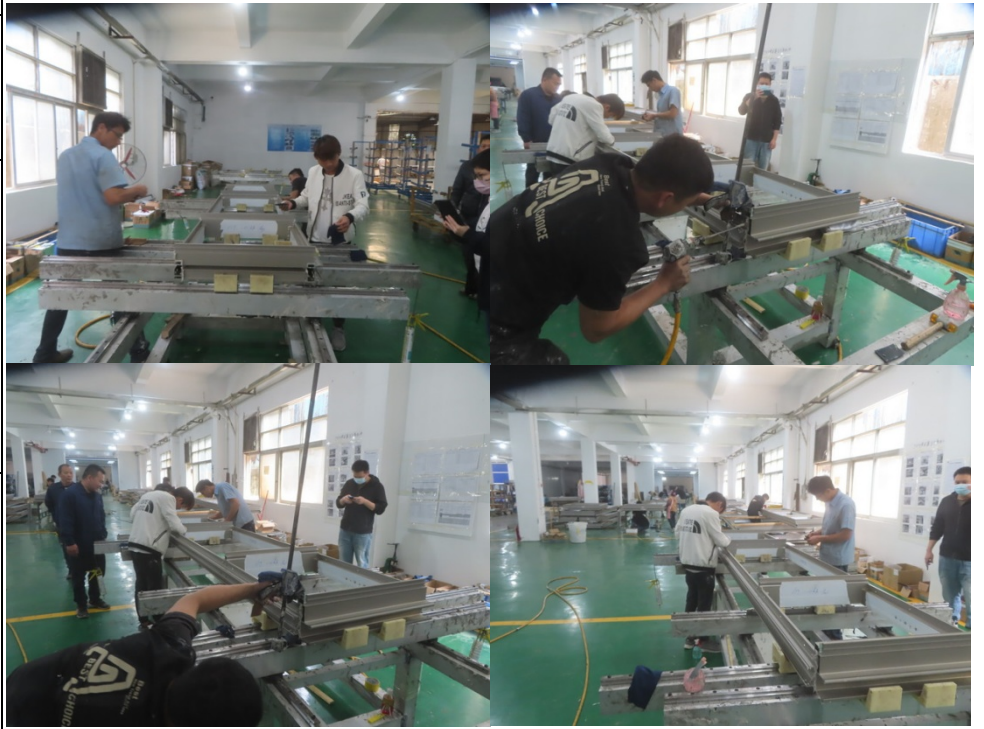
Photo 5

Description:
Fit-up assembly of Mullion and Transom for Zone M3 & 4 (3rd log unitized panels)

廠方注意: 鉻化部分有損毀，不建議用此鋁料

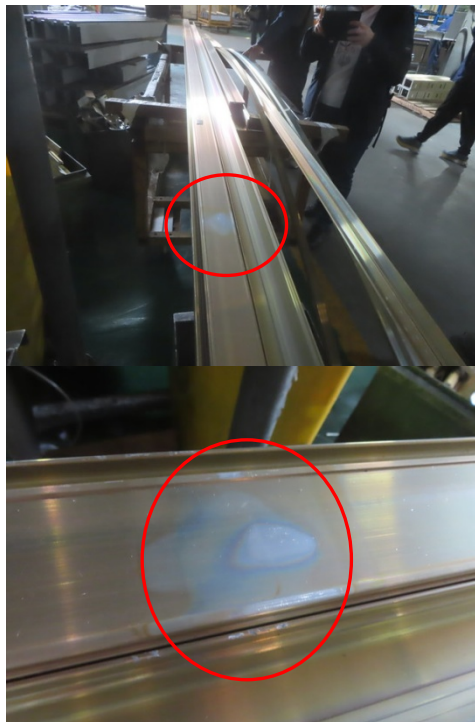
Photo 6

Description:
Defective chrome plated finishing for gutter sleeve was found during factory inspection

Action:
- MIDI is required to carry out their internal QA/QC method to repair the defective chrome plate finishing and improve workmanship for future works

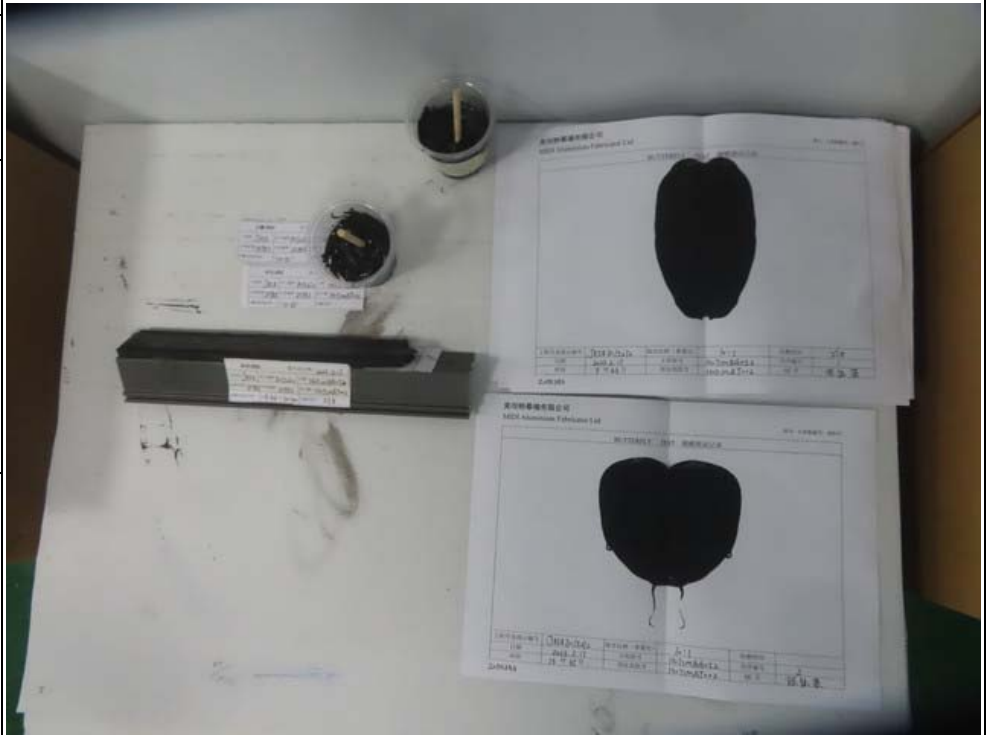
Photo 9

Description:
Samples for peel adhesion test and butterfly test

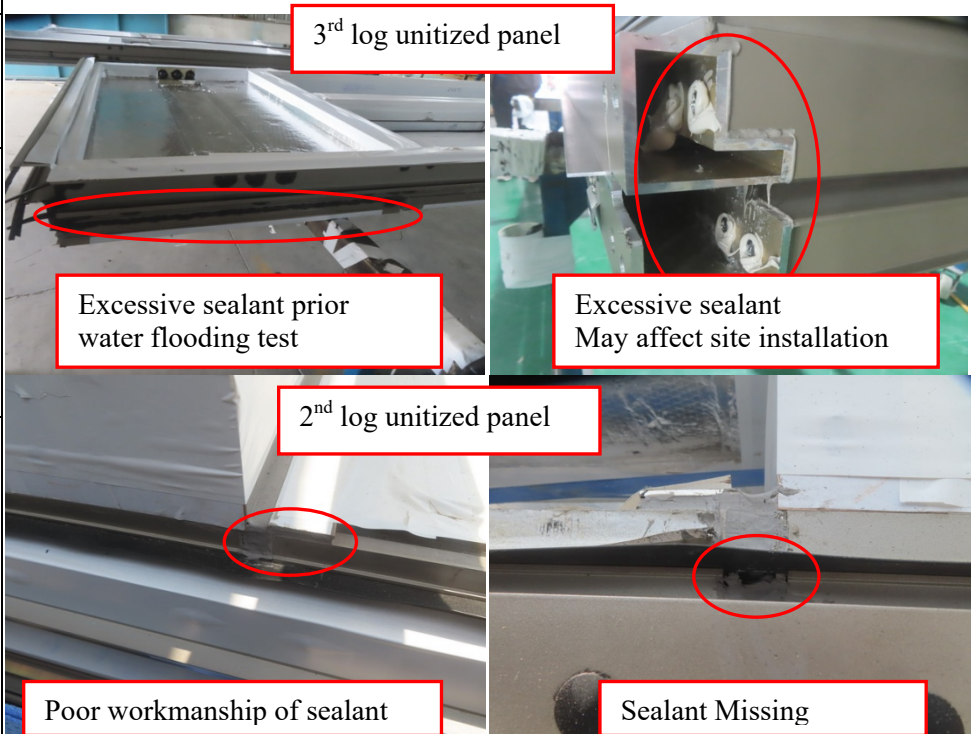
Photo 10

Description:
Defective sealant for 2nd & 3rd log unitized panels were found during final inspection and packing

廠方注意：
提升打膠
質量

Action:
- MIDI is reminded to carry out the remedial works prior products delivery and to improve workmanship for future works

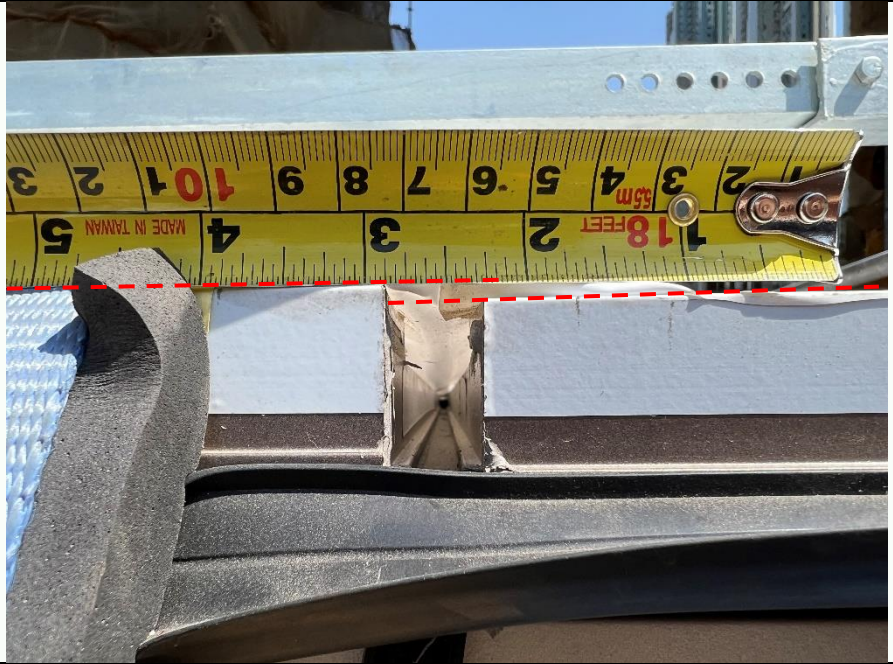
Photo 2

The transoms on new delivered unit were observed to be not aligned (plan view). Technically this would be impossible be revised at site, MIDI is required to improve their QA/QC for factory fabrication.

廠方注意:左右
收口不對稱

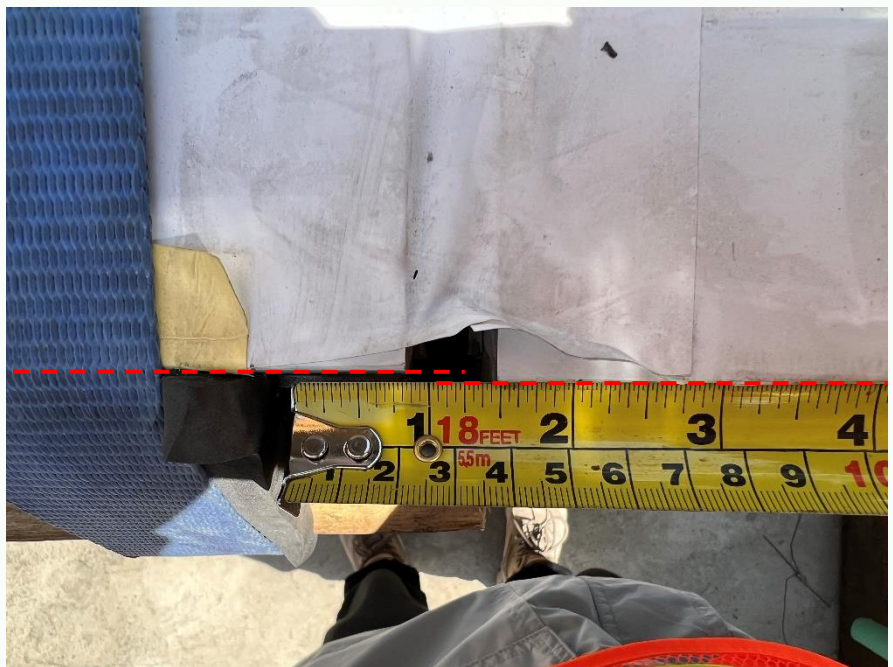
Photo 3

The transoms on new delivered unit were observed to be not aligned (plan view). Technically this would be impossible be revised at site, MIDI is required to improve their QA/QC for factory fabrication.

廠方注意:左右
收口不對稱

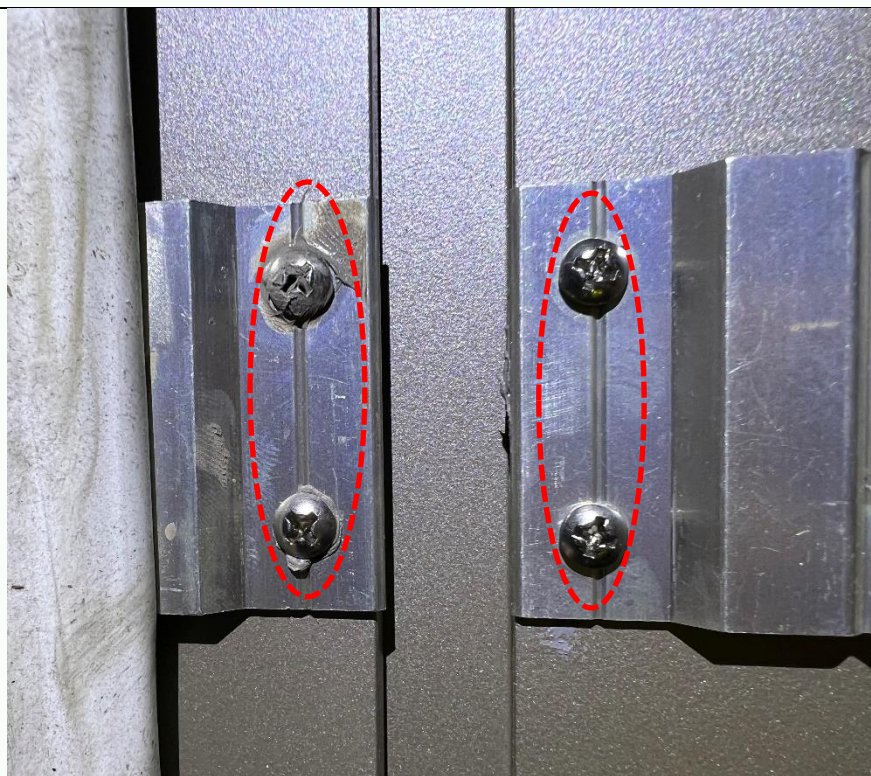
Photo 5

The bracket screw fixing was observed to be different among different units. The left one with sealant for screw-in and the right one without. Please clarify for this issue.

廠方注意: 要先打膠, 才安裝螺絲。

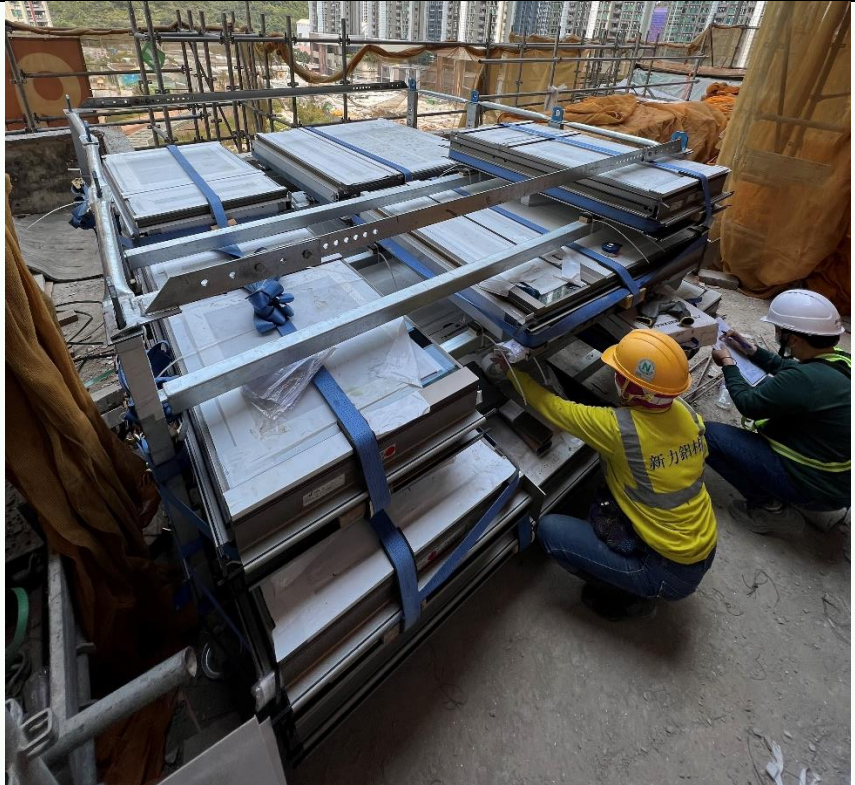
Photo 1

Units are delivered on 9/F for 12/F AG of T1 curtain wall system installation.

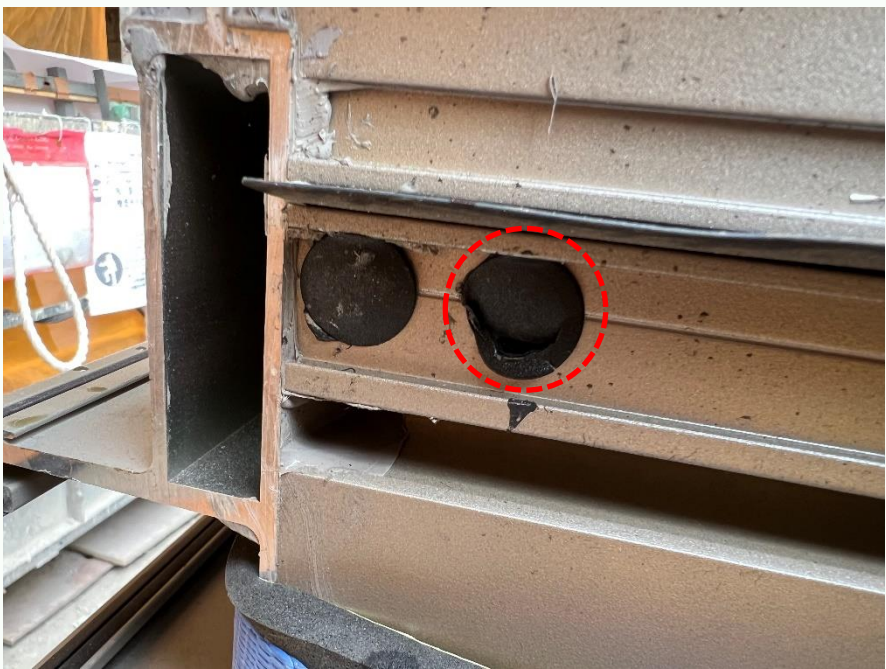
Photo 2

The plastic cover on fabrication hole of unit was observed to be damaged. MIDI is required to replace.

廠方注意:注意
膠蓋質量。

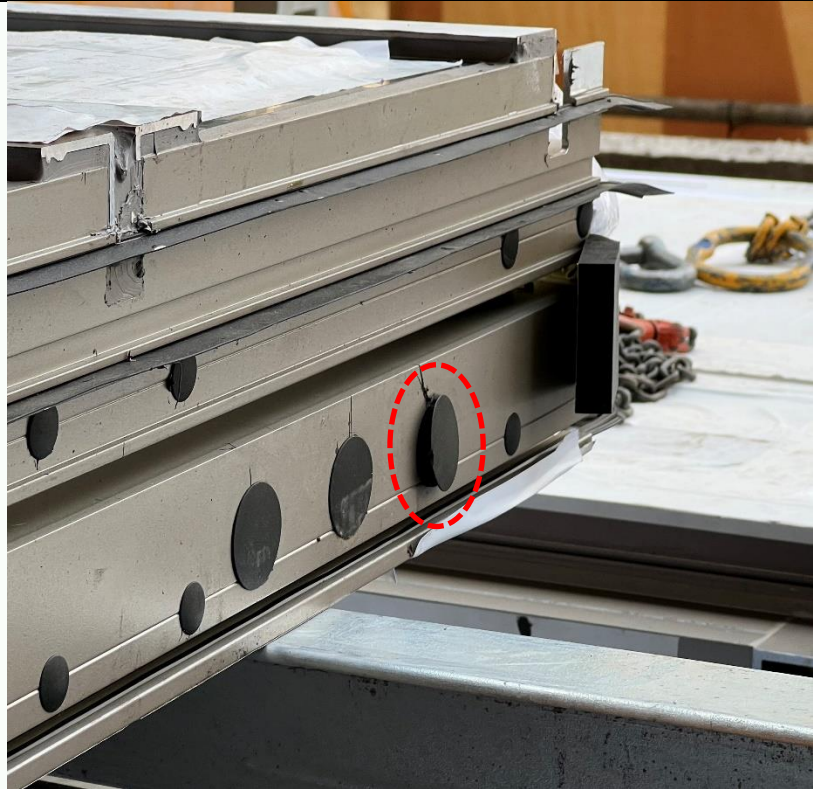
Photo 3

The plastic cover on fabrication hole of unit was observed to be damaged. MIDI is required to replace.

廠方注意：
注意膠蓋質量。

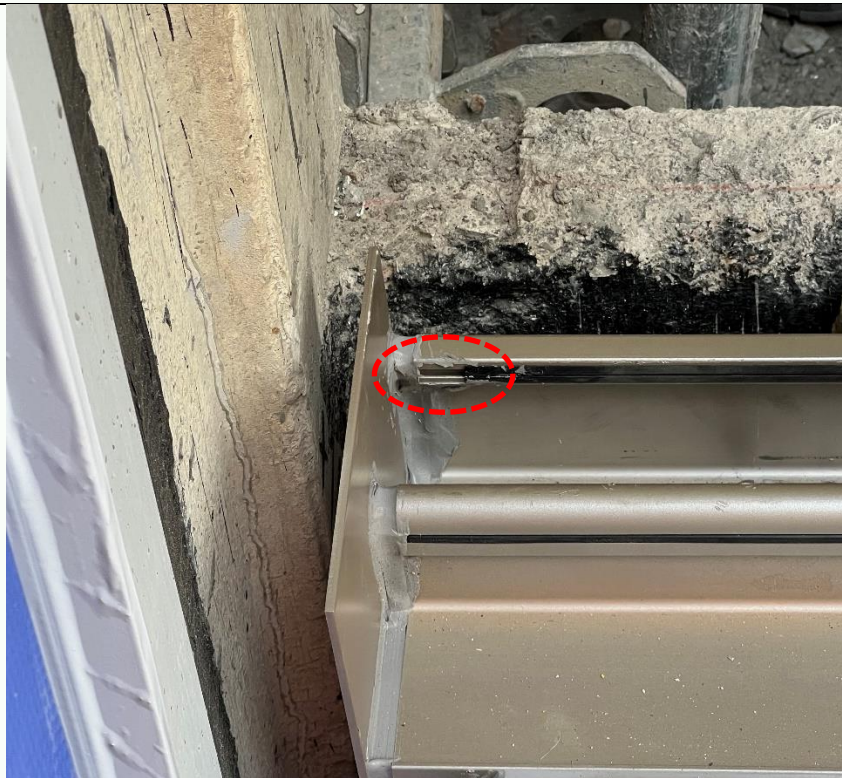
Photo 4

The gasket was observed to be noted connected to the end plate, this needs to be revised before the gutter test here.
