工程指示 / 要求簡箋(E.I.)

工程名稱：將軍澳日出康城 11

工程項目：幕牆 單元件 地盆顧問報告 3/2 ~ 22/2

**Proposed Residential Development at TKOTL 70RP, Phase 11, Lohas Park,
Tseung Kwan O, N.T., Site C2**

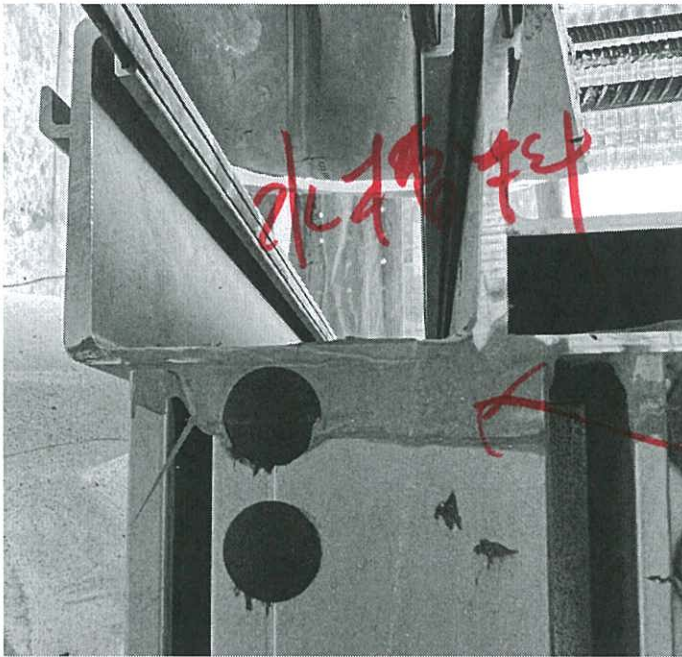
1. It was observed that the backpan fixing angle will block the unit installation work, please refer to attachment and provide the modification method at factory for it.
2. It was observed the transom with mullion joint was applied with excessive sealant, it will lead to new installed pane cannot descend due to these sealant. Please coordinate with factory assemble work to avoid/remove excessive sealant.

① (已通知廠, 本地區前, 廠改好擋板)

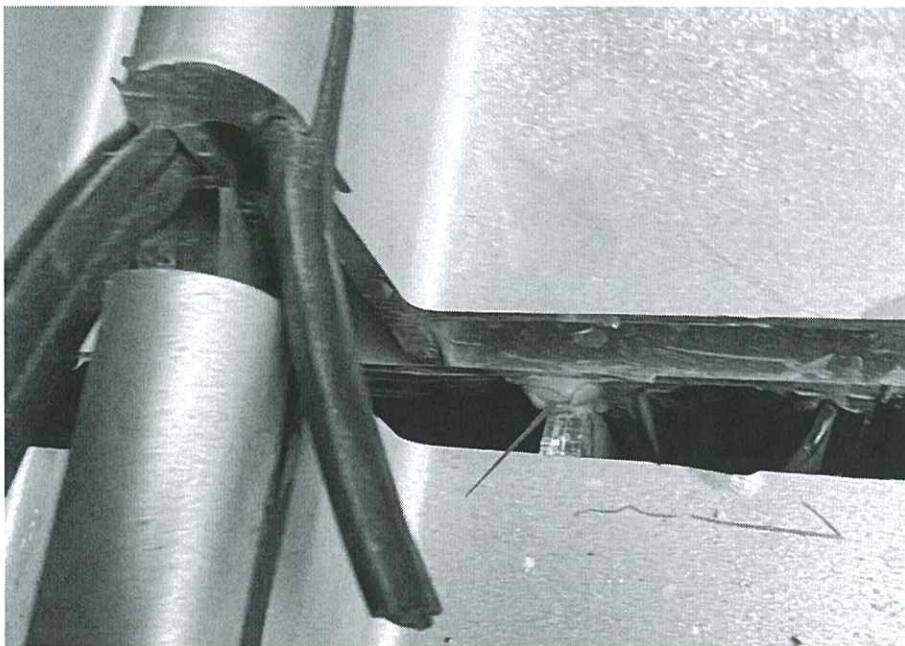
✘ *
做
膠不用太多

② 已通知廠作改善

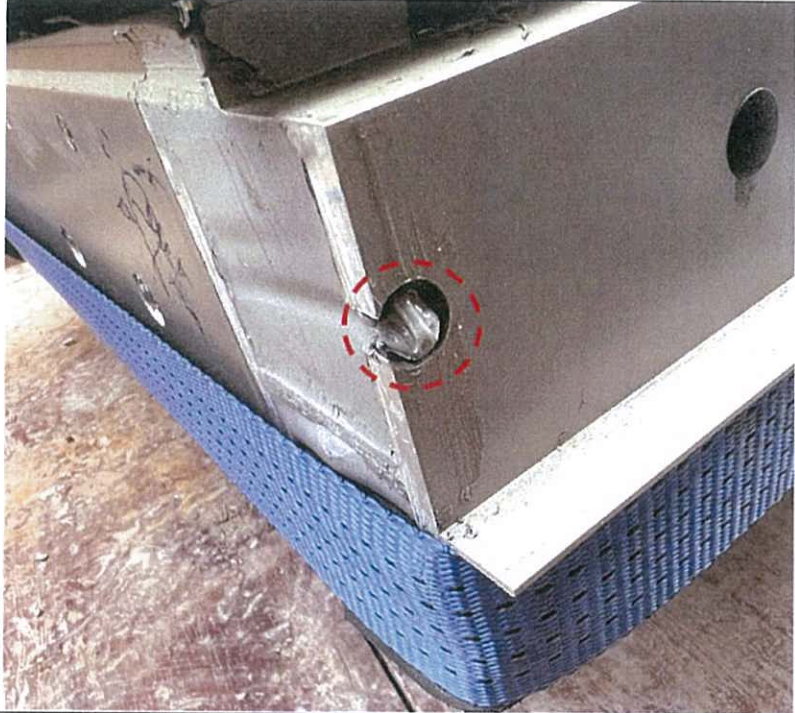
Photo 1

Description:
The gasket cover for this construction hole was observed to be missed.

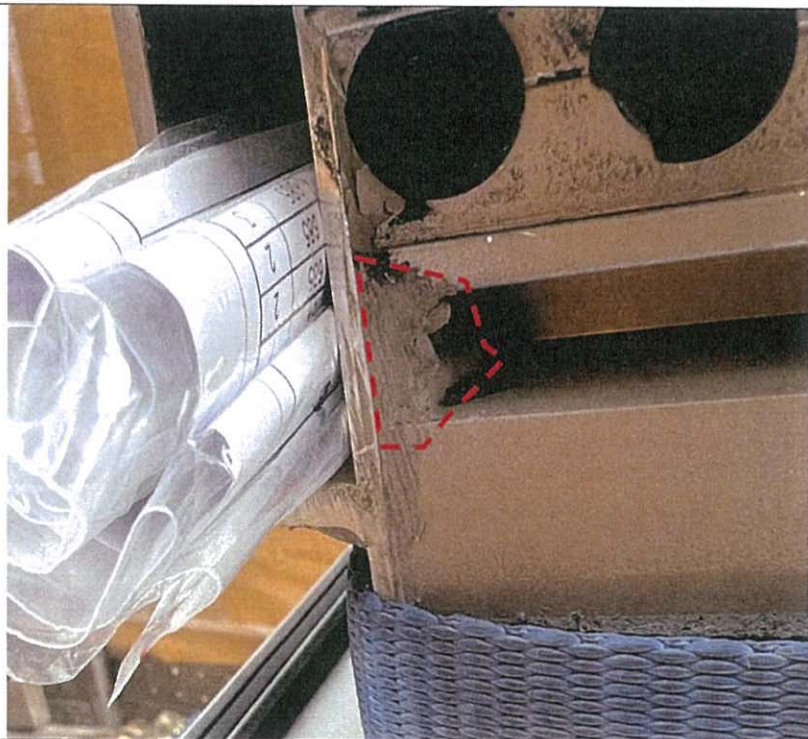
Photo 2

Description:
This transom joint head was observed to be applied with excessive sealant which may affect the unit installation.

Midi: 廠唧膠量減少，避免有機會影響安裝。

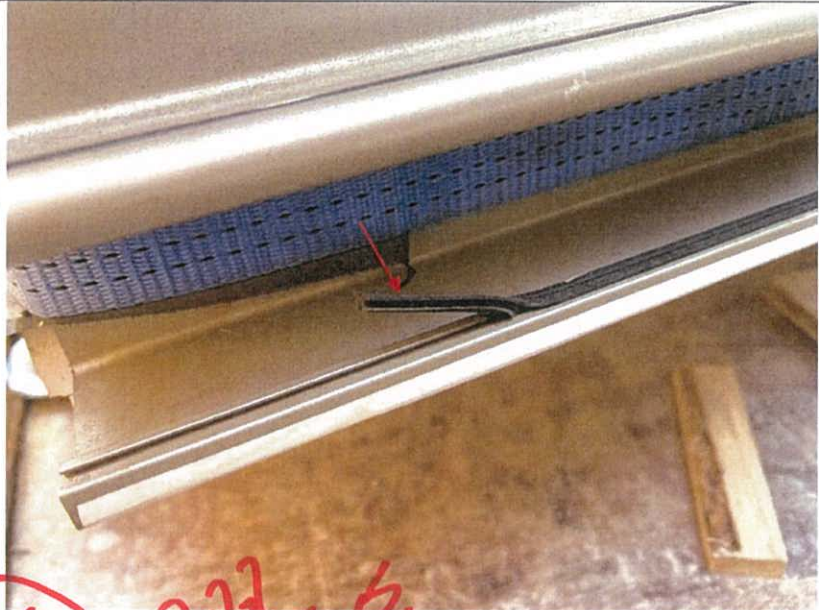
Photo 3

One gasket on transom was observed to be short and needs to be replaced.

Midi: 膠條受損，更換膠條。

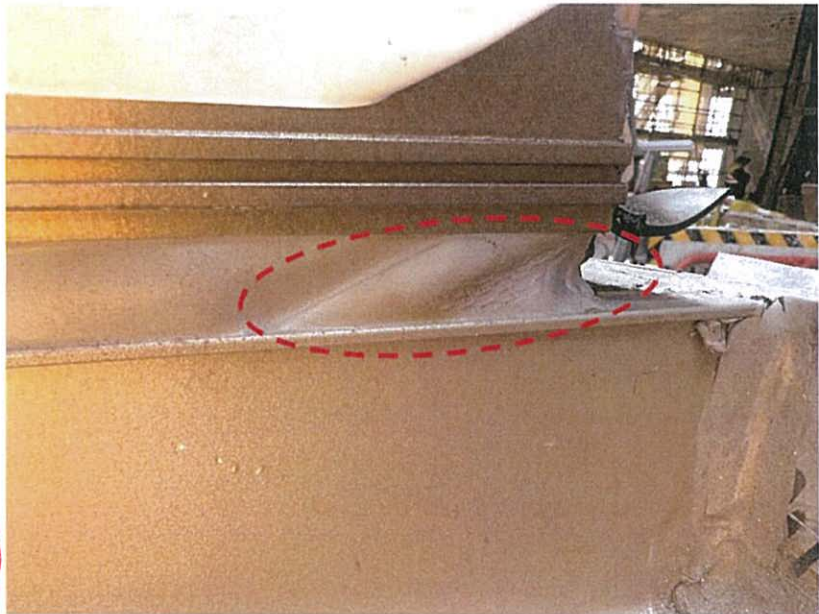
Photo 4

Poor applied sealant was observed at the joint position between transom and alum. cladding.

Midi: 已通知廠改善手工。

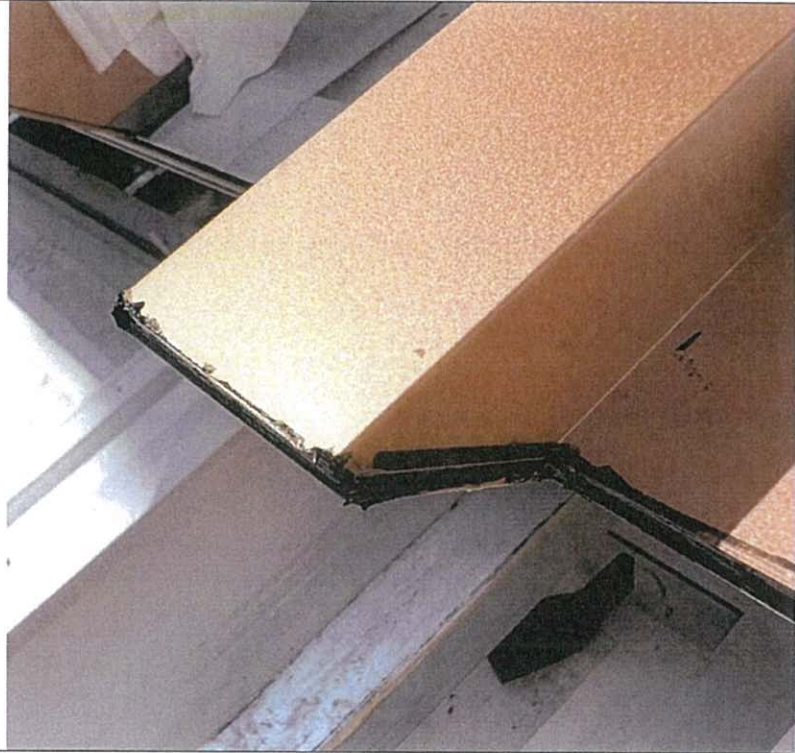
Photo 5

The end plate for cladding feature was observed with poor workmanship.

Midi:通知廠改善飾線封口片手工。

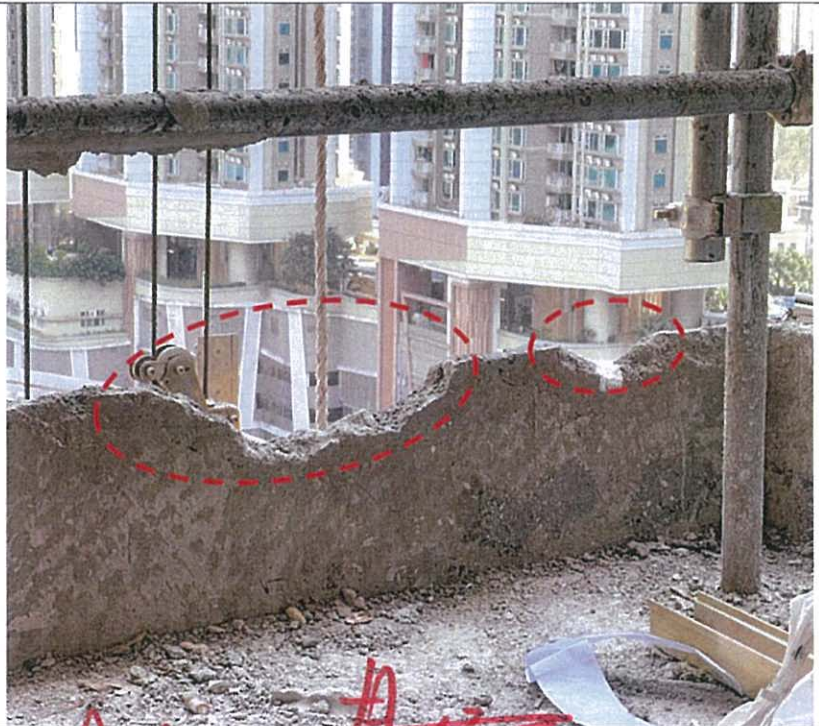
Photo 1

The RC curb at BD 12/F of T1 was observed to be cracked with notches which will affect the construction of waterproofing, please provide rectification for this defect.

Midi: 已通知大判處理。

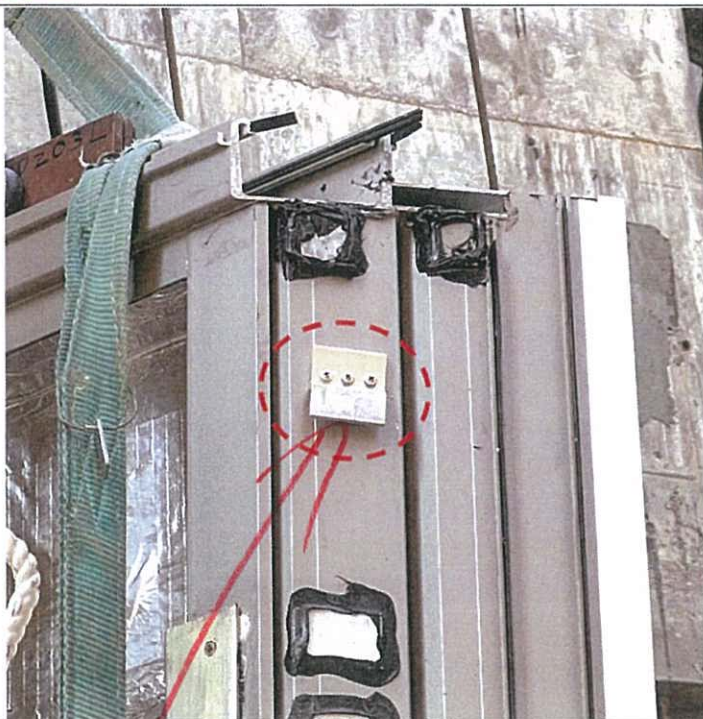
Photo 2

The anti-torsion bracket at corner mullion was observed to be not properly installed (tilted), which will affect the installation work. Please factory carry out QA/QC to improve the precision of fabrication.

Midi: 已通知廠對準。

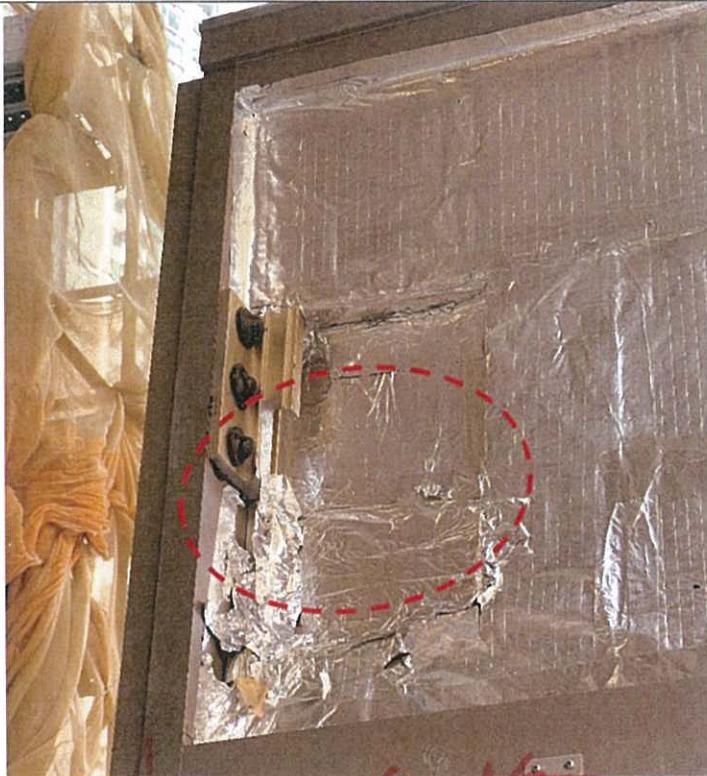
Photo 3

Part of the thermal insulation was observed to be cut off due to room limited during installation. This happened several times and please MIDI coordinates with factory for optimization of unit material fabrication size.

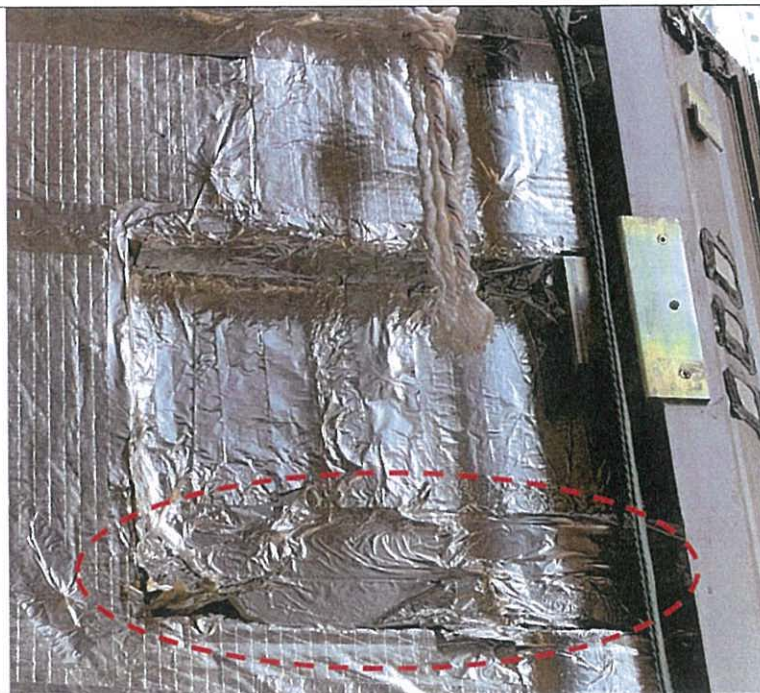
Photo 4

Part of the thermal insulation was observed to be cut off due to room limited during installation. This happened several times and please MIDI coordinates with factory for optimization of unit material fabrication size.

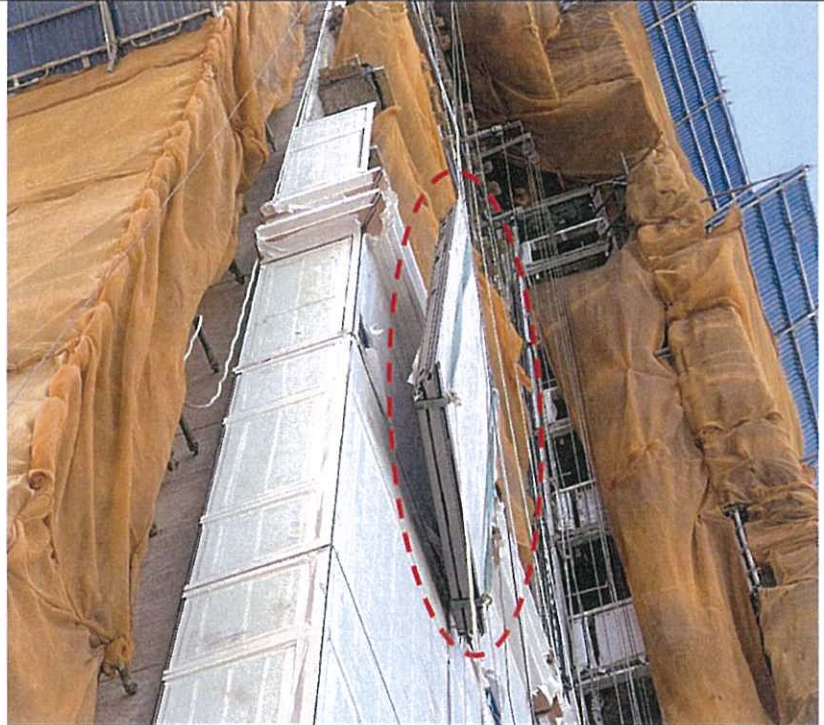
Photo 5

The unit panel was observed to be without any tie back protection during lifting, this is not safety and please coordinate with onsite fitters for improvement.

Midi: 已通知安全代表注意。

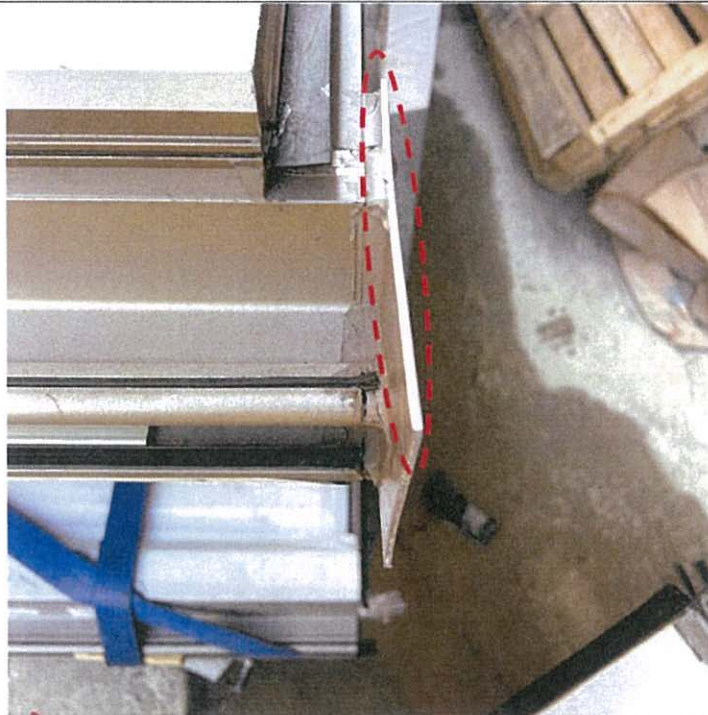
Photo 6

The end plate on the unit panel was observed to be deformed. Please revise this and improve the protection during delivery.

Midi: 已通知執修 end dam。

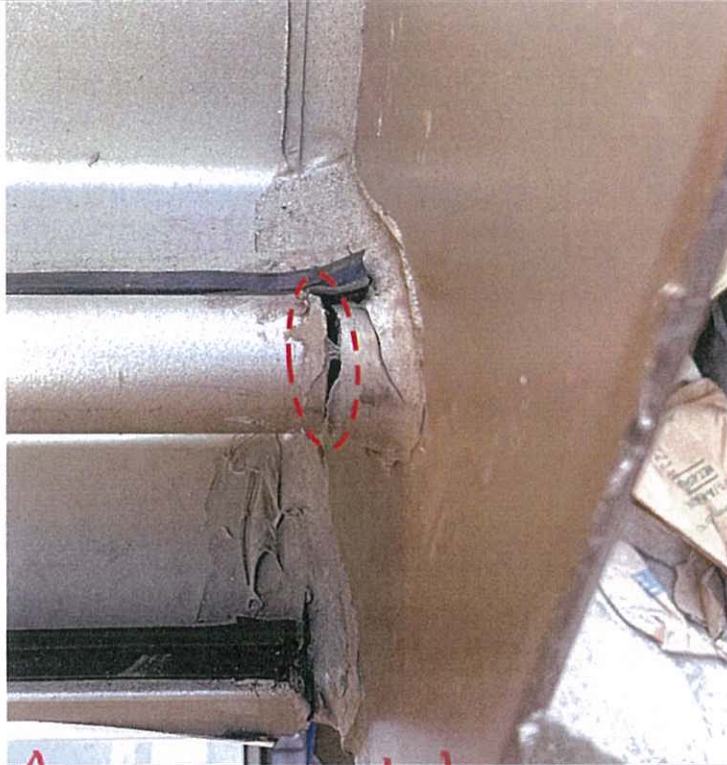
Photo 7

Sealant crack was observed due to end plate deformed. Please revise this and improve the protection during delivery.

Midi: 已補膠。

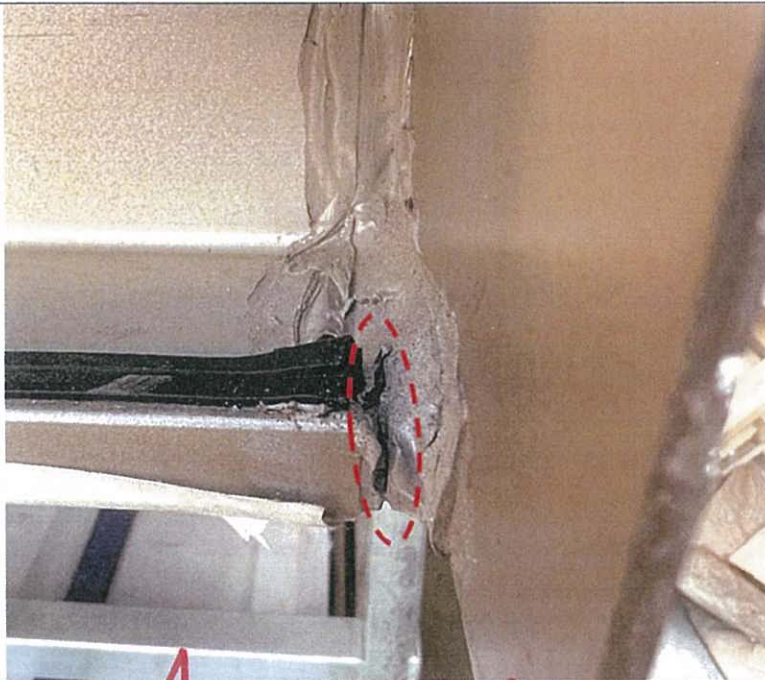
Photo 8

Sealant crack was observed due to end plate deformed. Please revise this and improve the protection during delivery.

Midi: 已補膠。
