工程指示 / 要求簡箋(E.I.)

工程名稱：將軍澳日出康城 11

工程項目：幕牆單元件 水槽料保護鋁蓋 (鋁摺件不用鉻化) 樣板 *地盤用*

Site Memorandum

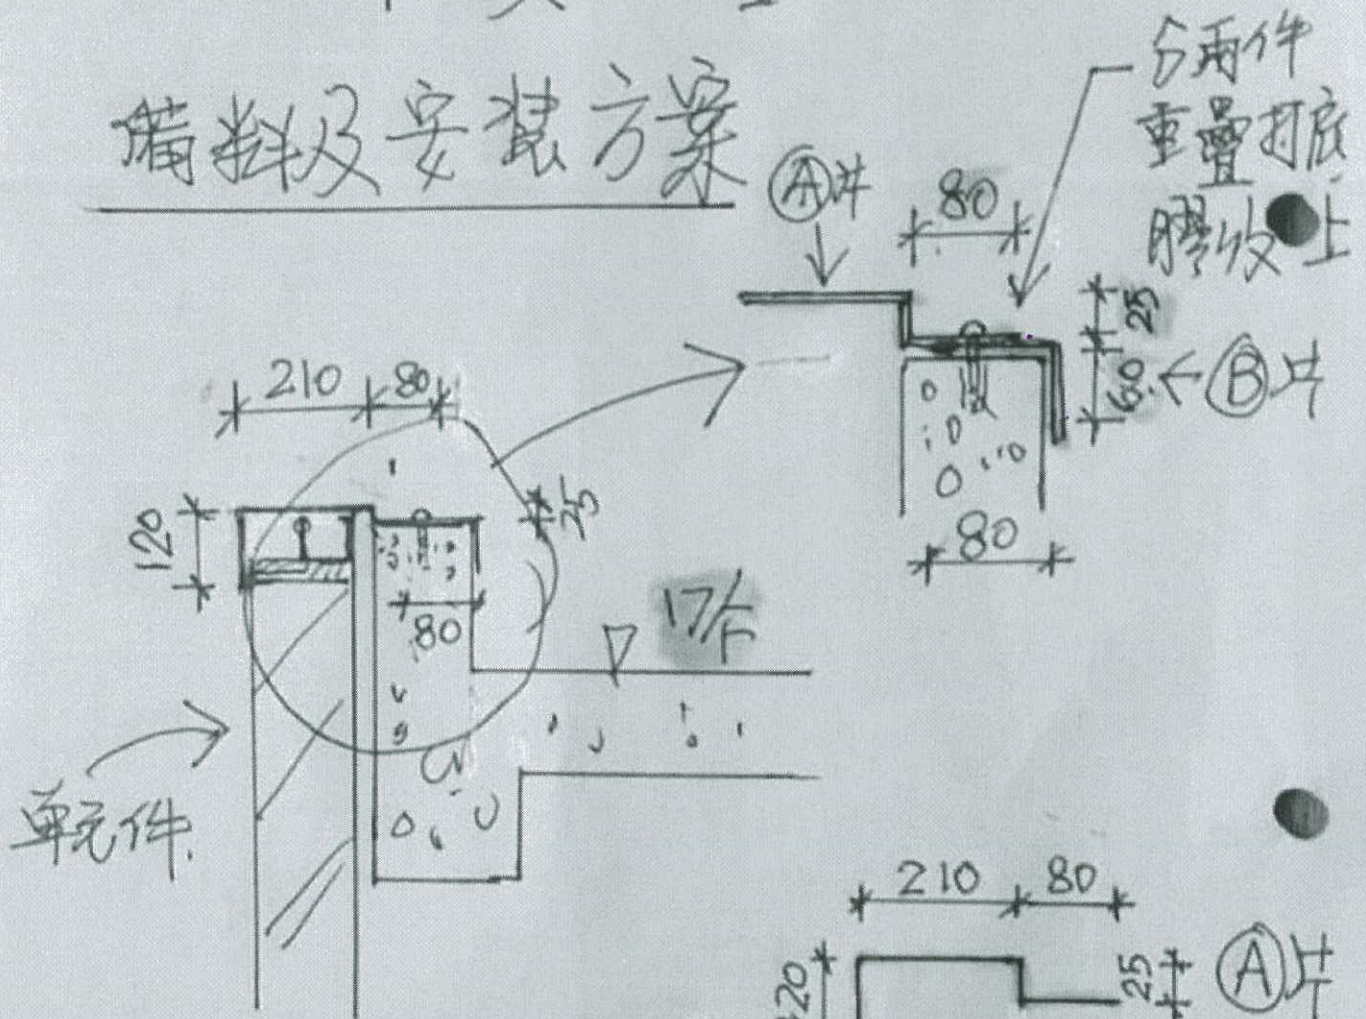
備料及安裝方案

鋁片封蓋、溝水漕面，

於16年頂一層。

(要調節出入)

- 1) 用 1.2 厚Mall鋁片
- 2) 長度約 2000 至 2400 1 件
- 3) 擢成呔吋(看圖示)

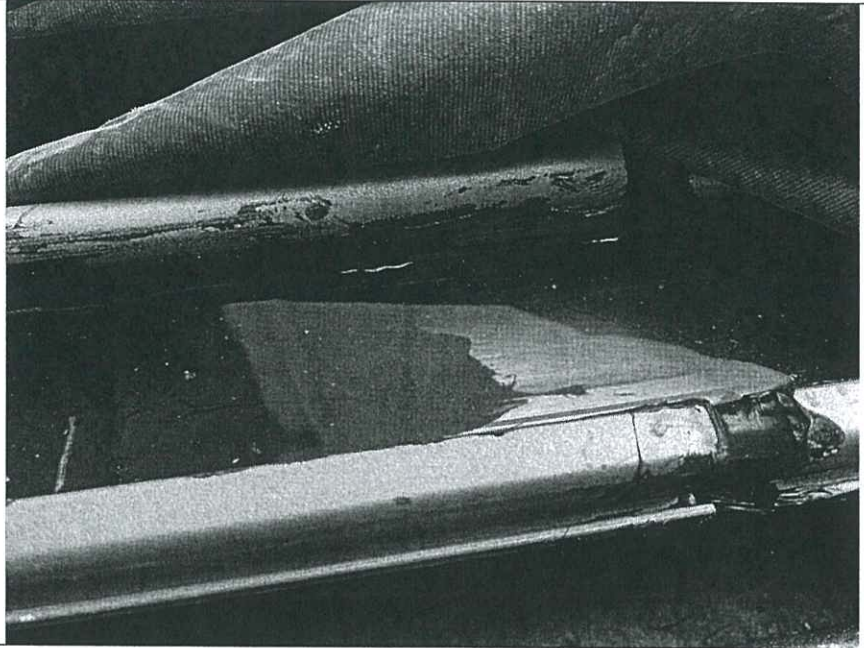
Photo 1

Gutter water test at 12/F BD of T1 was processed and no leakage was observed.

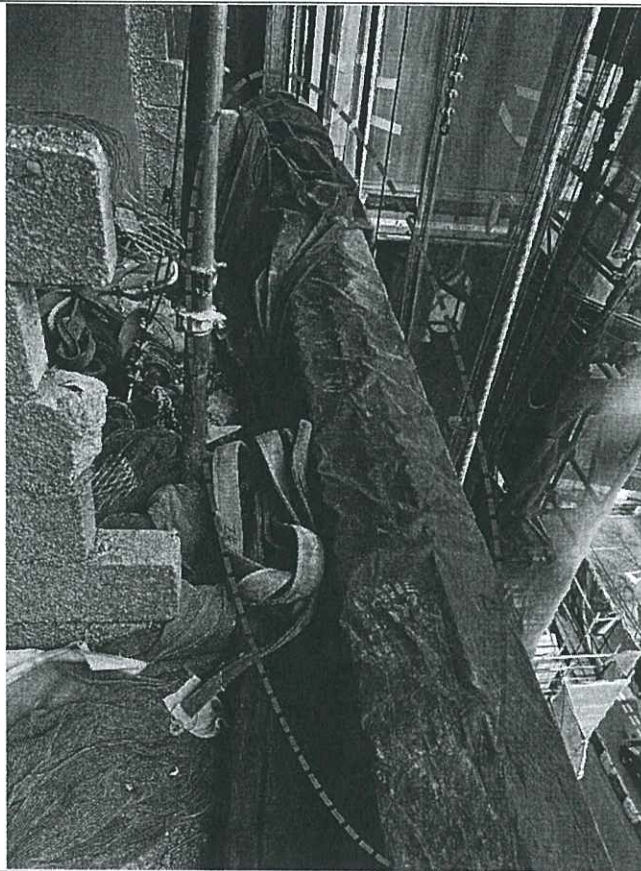
Photo 2

The canvas was observed to be used during units gutter water test, we recommend using wooden or plastic cover as tidy method for elimination of ambience influence.

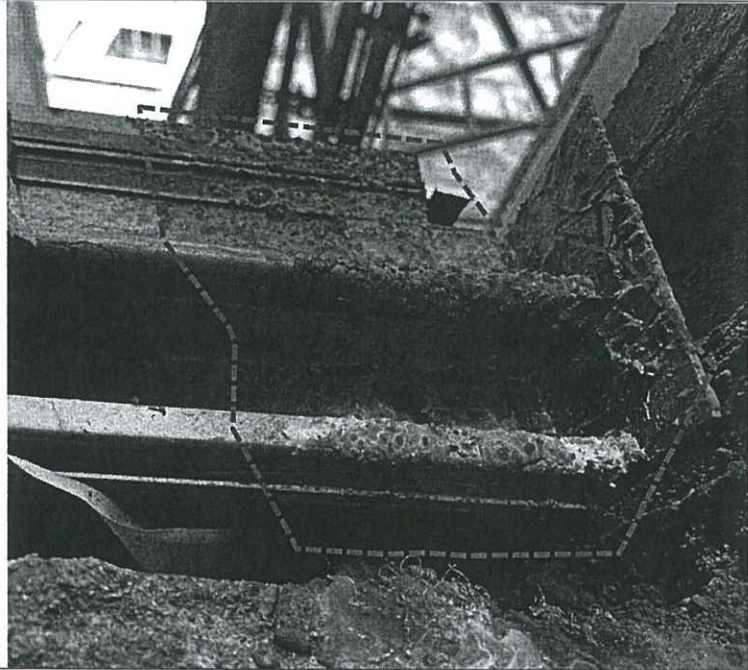
Photo 1

A mount of slurry was observed to exist on the transom gutter of T1 16/F installed unit.

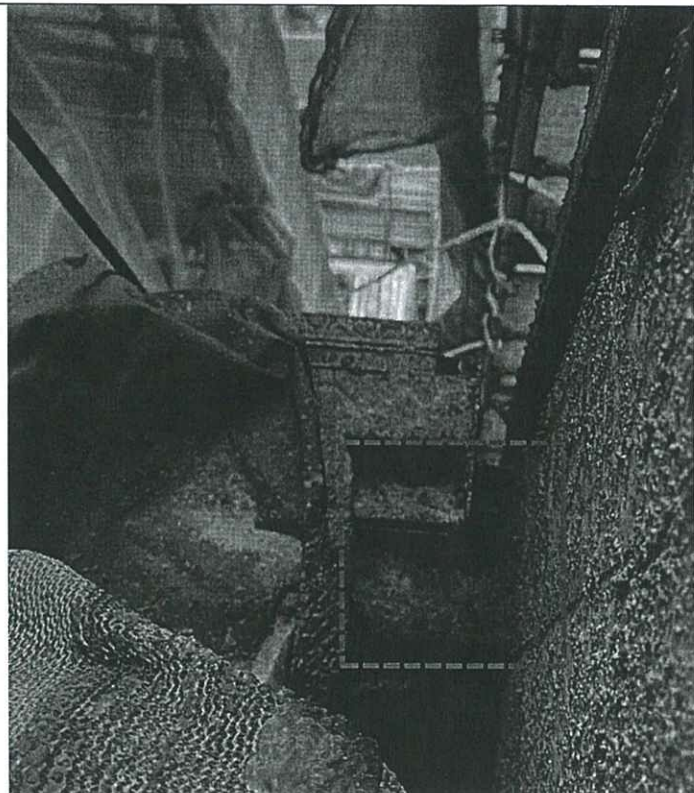
Photo 2

A mount of slurry was observed to exist also on the water flashing at gap between RC wall.

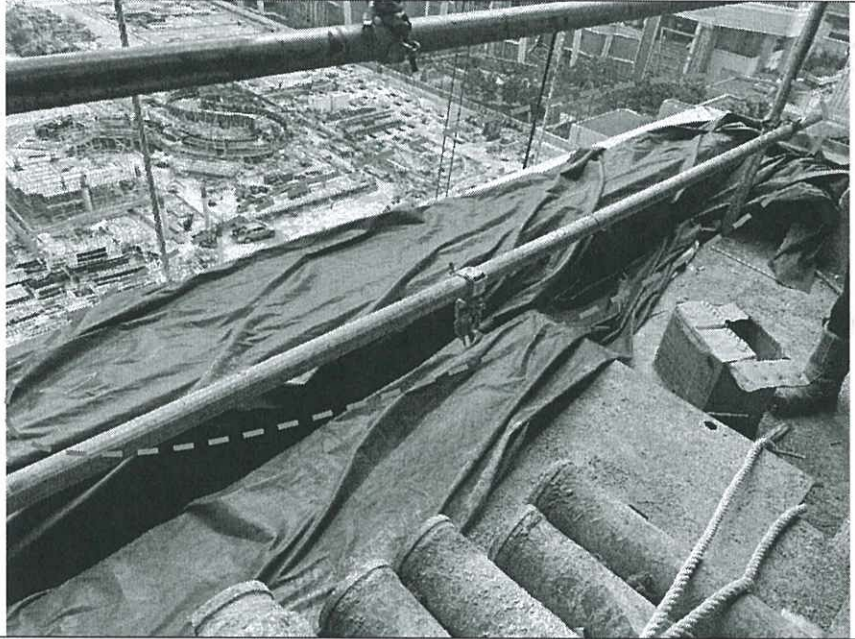
Photo 3

The canvas was observed to be used during units gutter water test, we recommend using wooden or plastic cover as tidy method for elimination of ambiance influence.

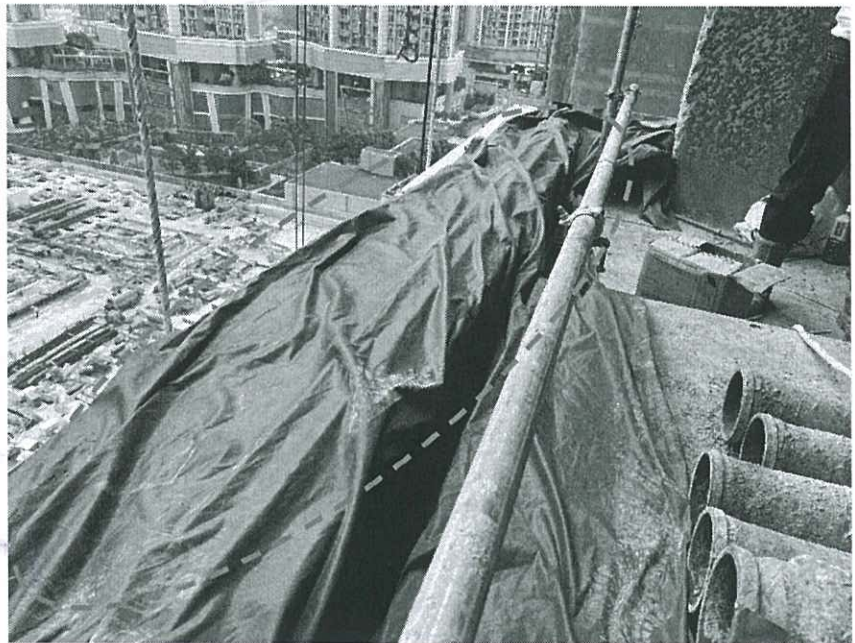
Photo 4

The canvas was observed to be used during units gutter water test, we recommend using wooden or plastic cover as tidy method for elimination of ambiance influence.
