工程指示 / 要求簡箋(E.I.)

工程名稱：將軍澳日出康城 11

**Proposed Residential Development at TKOTL 70RP, Phase 11, Lohas Park,
Tseung Kwan O, N.T., Site C2**

Subject: **Site Observation for Make Use of Wooden or Plastic Cover for Gutter Water Test (2nd Reminder)**

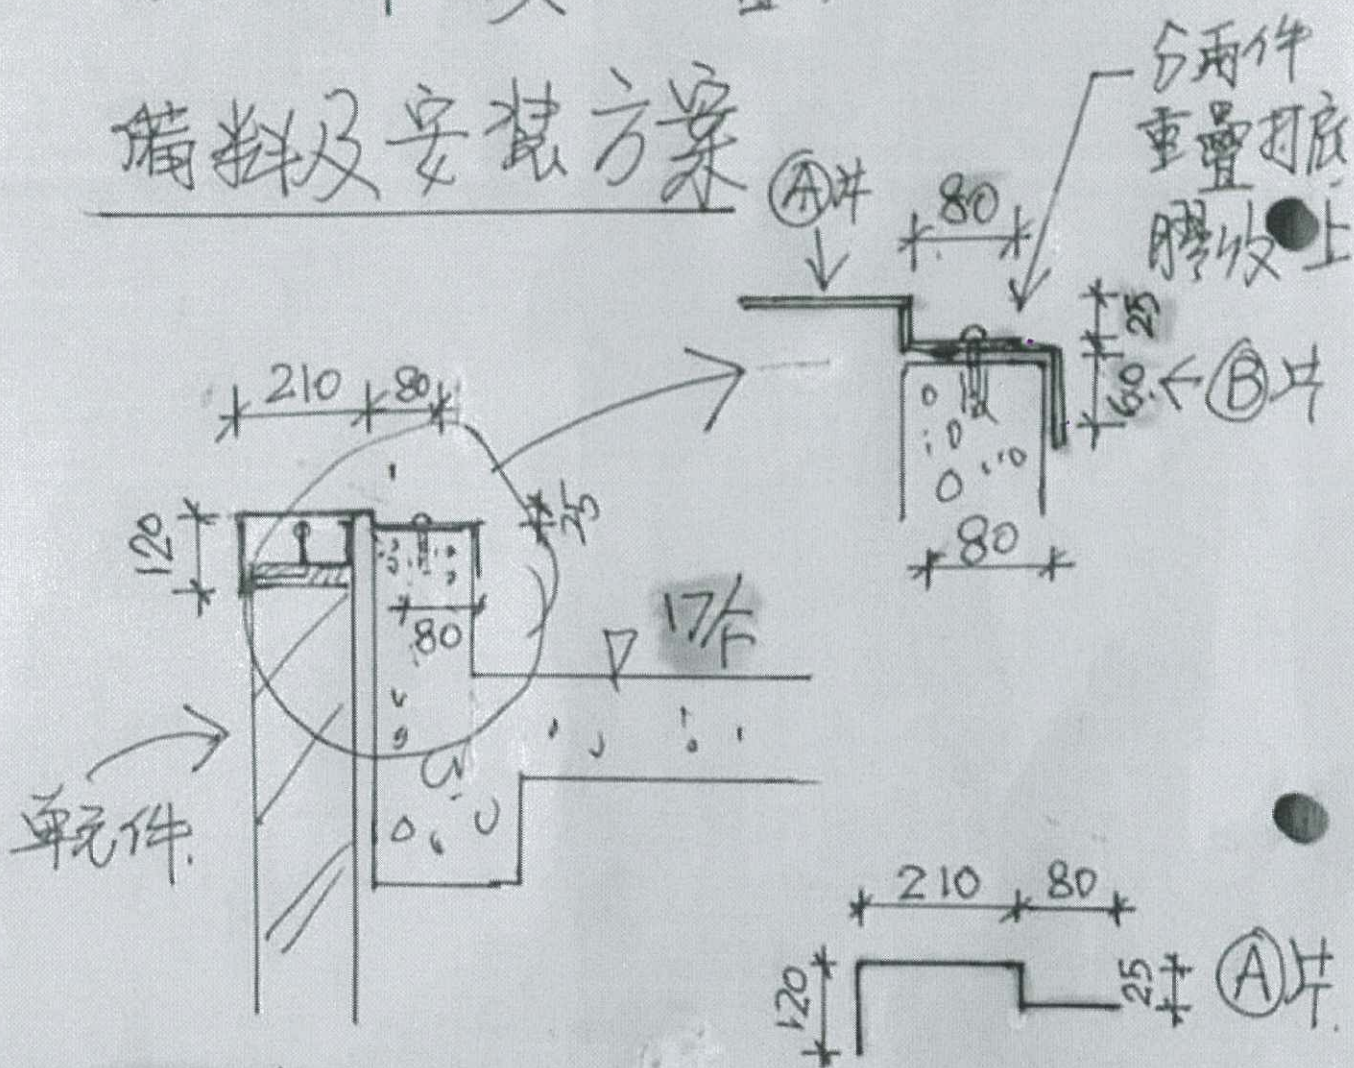
簡料及安裝方案

裂片封蓋、基橋水漕面。

於16年頂一層。

- 1) 用 1.2 厚 304 鋁片
- 2) 長度約 2000 至 2400 1 件
- 3) 擰成呔吋 (看圖示)

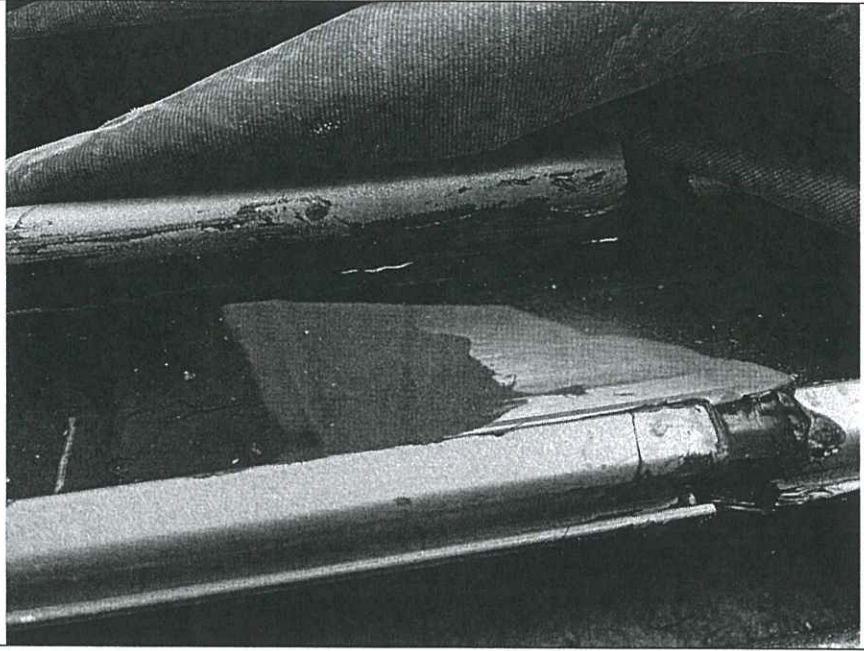
Photo 1

Gutter water test at 12/F BD of T1 was processed and no leakage was observed.

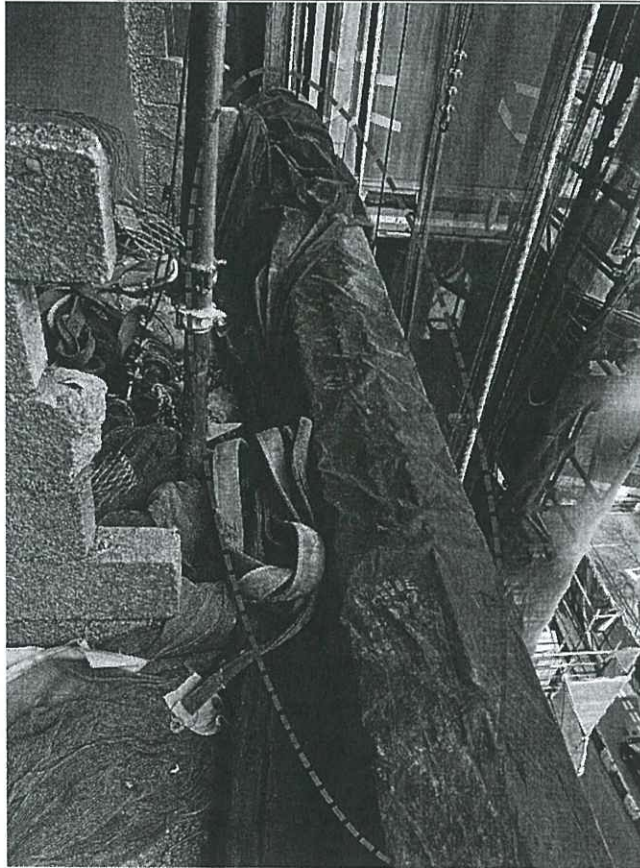
Photo 2

The canvas was observed to be used during units gutter water test, we recommend using wooden or plastic cover as tidy method for elimination of ambience influence.

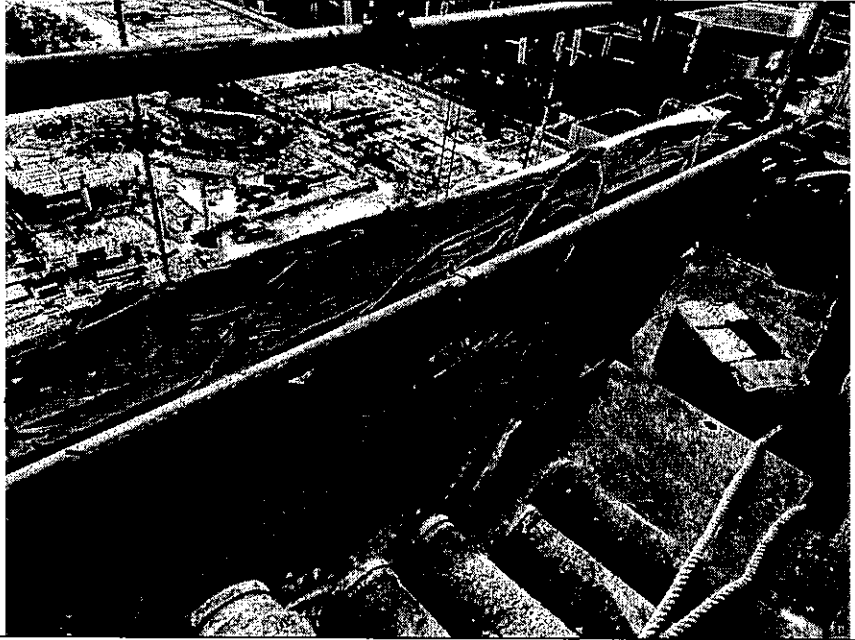
Photo 3

The canvas was observed to be used during units gutter water test, we recommend using wooden or plastic cover as tidy method for elimination of ambient influence.

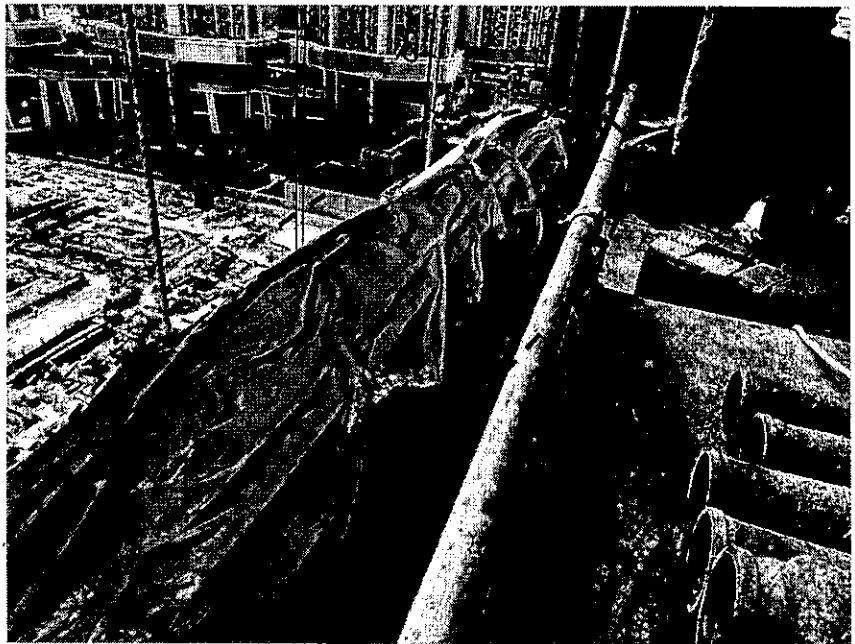
Photo 4

The canvas was observed to be used during units gutter water test, we recommend using wooden or plastic cover as tidy method for elimination of ambient influence.
