PROPOSED RESIDENTIAL
DEVELOPMENT AT TKOTL 70RP,
PHASE 11. LOHAS PARK, TSEUNG
KWAN O. N.T.

Factory Inspection Report 01

Inspection Date: 18th November 2022
Issue Date: 05th December 2022

Report Reference: 60646872-FI-R-01

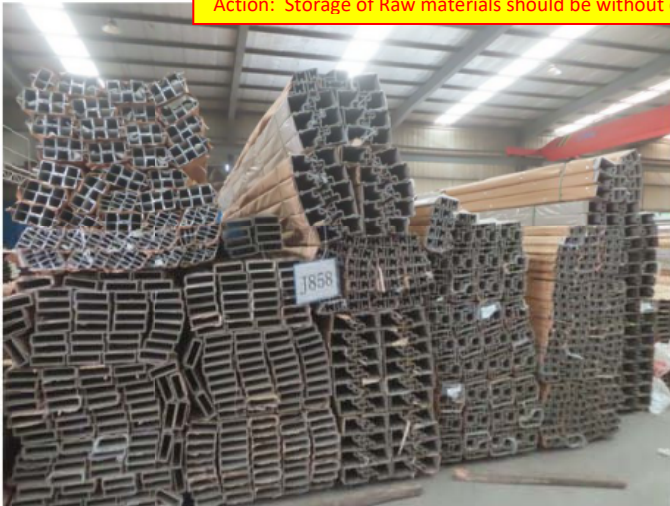
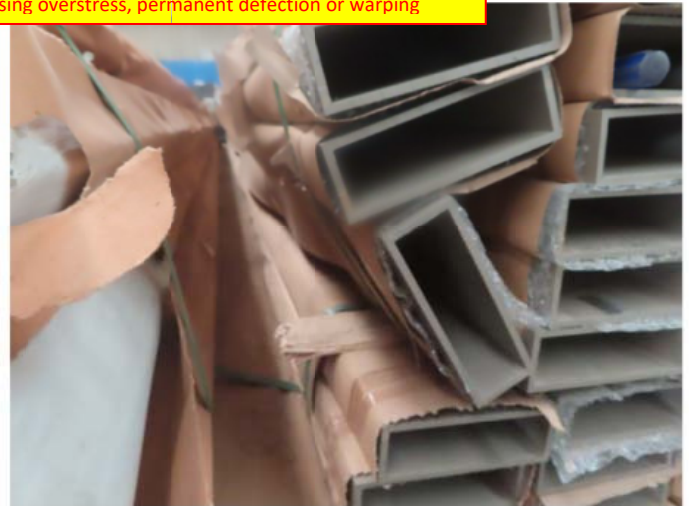
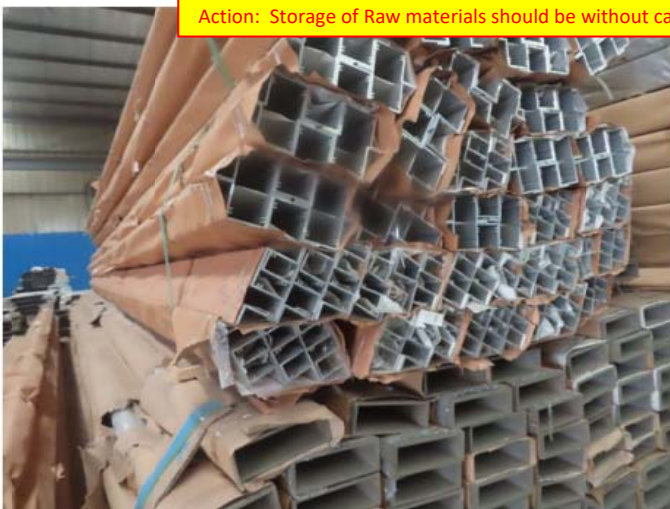
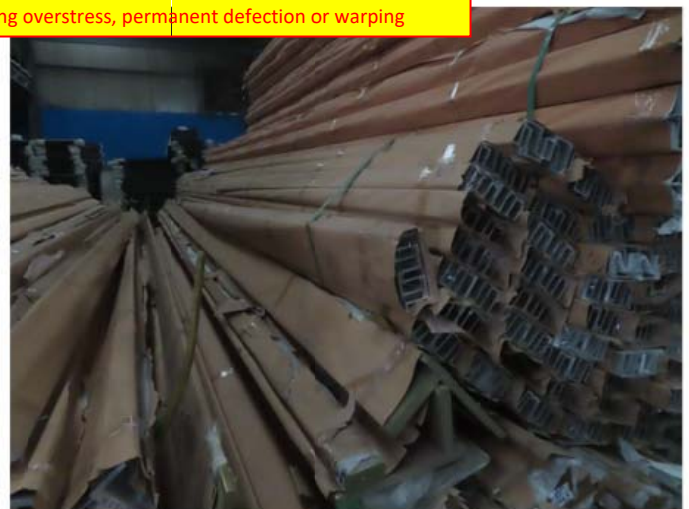
3_Raw materials are in messy and heavy loading condition

4_Raw materials are in messy and heavy loading condition

5_Raw materials are in messy and heavy loading condition

6_Raw materials are in messy and heavy loading condition

- Raw materials of extrusion were found messy and heavy loading condition, MIDI is required to ensure storage of materials without causing overstress, permanent defection or warping.

Action: Storage of Raw materials should be without causing overstress, permanent defection or warping

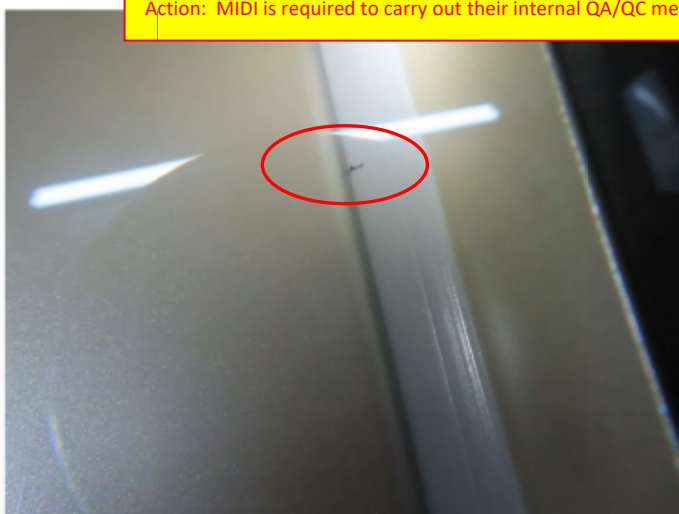
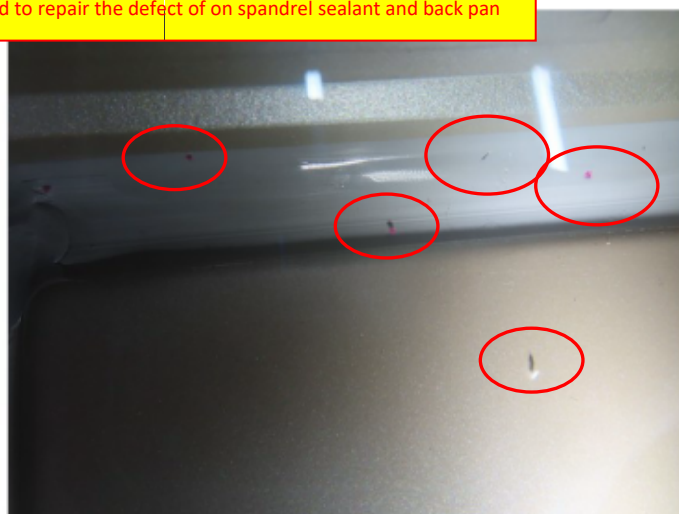
23_Blemish was observed to be existed at spandrel sealant

24_Blemish was observed to be existed at spandrel sealant

Action: MIDI is required to carry out their internal QA/QC method to repair the defect of on spandrel sealant and back pan

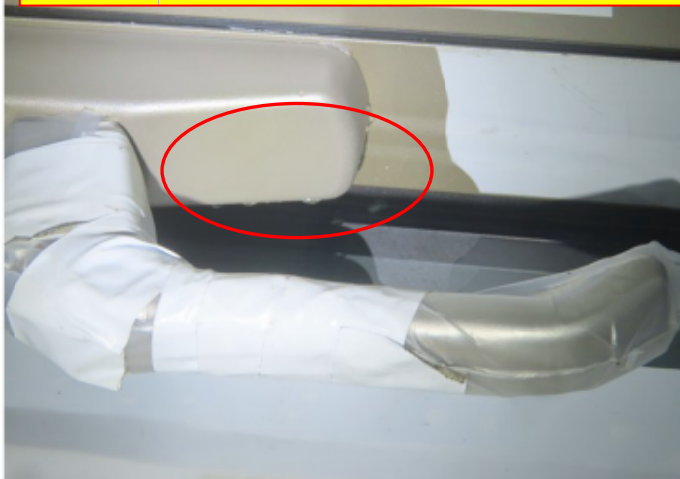
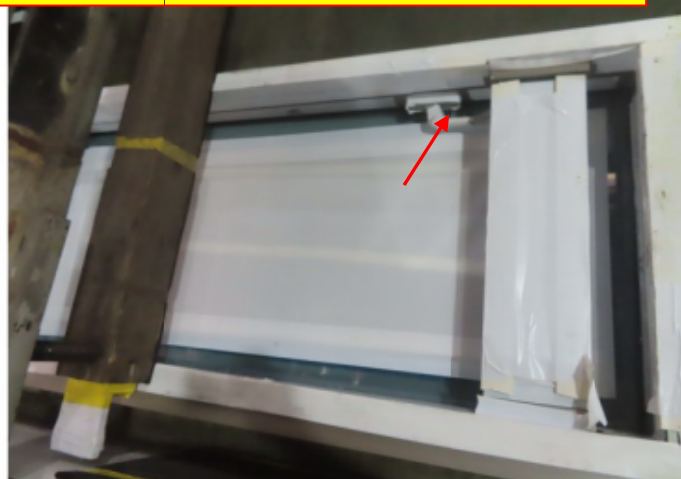
25_15F-T1BCW4 AS-01 water leakage

26_15F-T1BCW4 AS-01 water leakage

- Water leakage was found during flooding test for Panel number 15F-T1B-CW4_AS-01. MIDI is required to carry out their internal QA/QC method to repair the leakage unitized panel, MIDI needs to improve workmanship for future works.

Action: MIDI is required to carry out their internal QA/QC method to repair the leakage unitized panel, MIDI needs to improve workmanship for

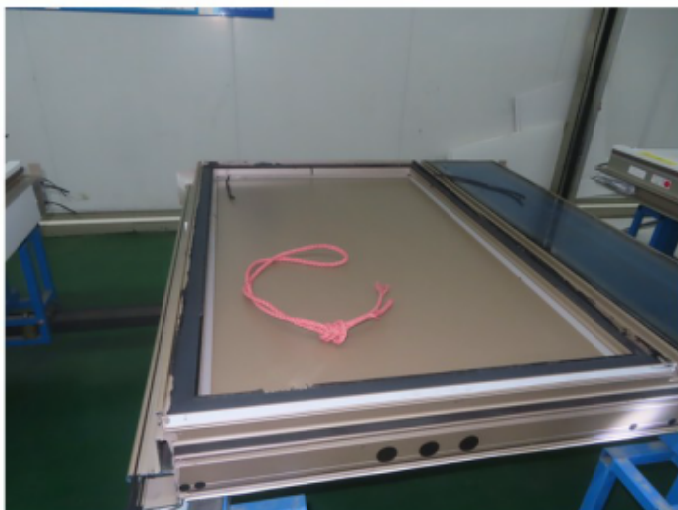
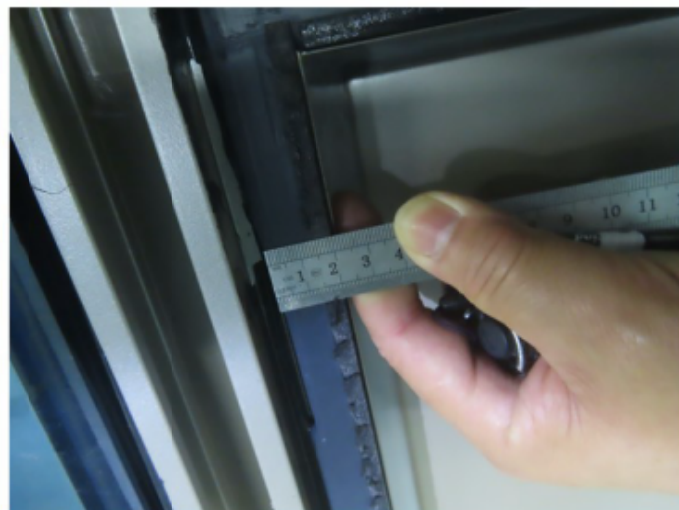
29_ Repair the defect of on spandrel sealant and back pan

30_ Repair the defect of on spandrel sealant and back pan

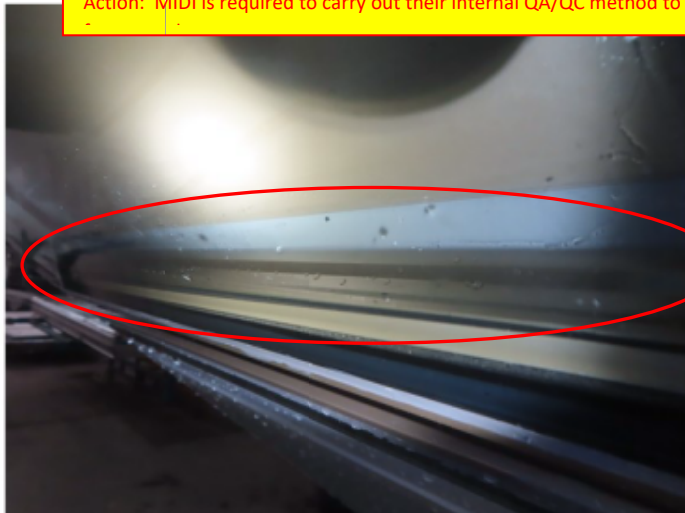
19_Water leakage was found inside spandrew backpan

- Water leakage was found during flooding test for Panel number 9F-T1B-CW4_AS-03. MIDI is required to carry out their internal QA/QC method to improve workmanship for future works.

Action: MIDI is required to carry out their internal QA/QC method to repair the leakage unitized panel, MIDI needs to improve workmanship for

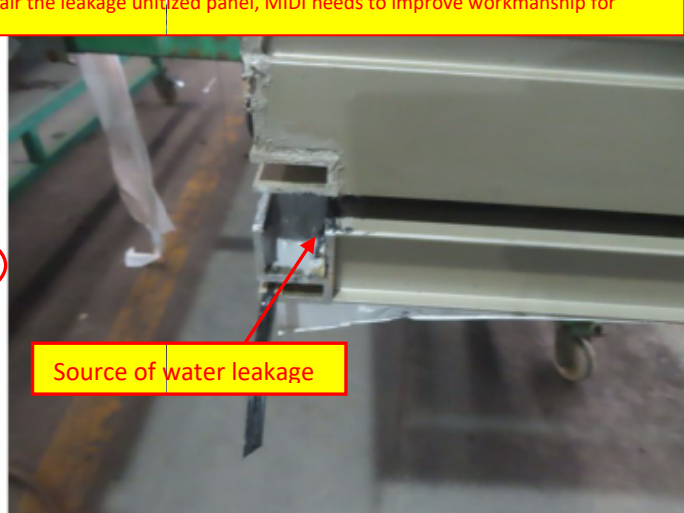
20_Damage sealant was found at end position of mullion

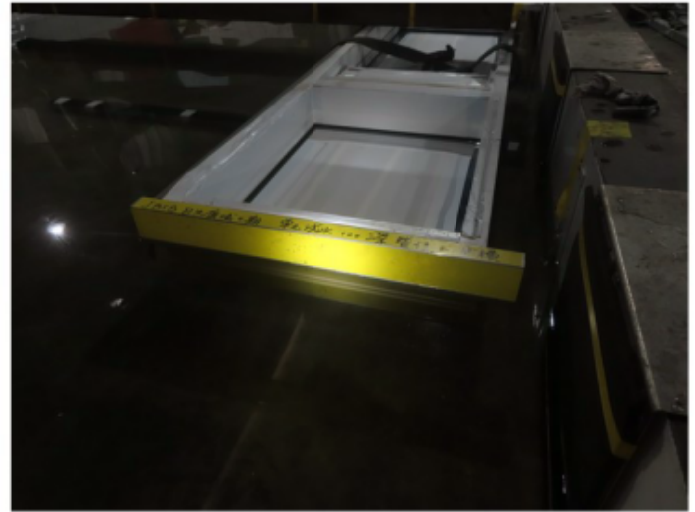
26_9F_T1BCW4_AS0_Retest after make-good defective sealant

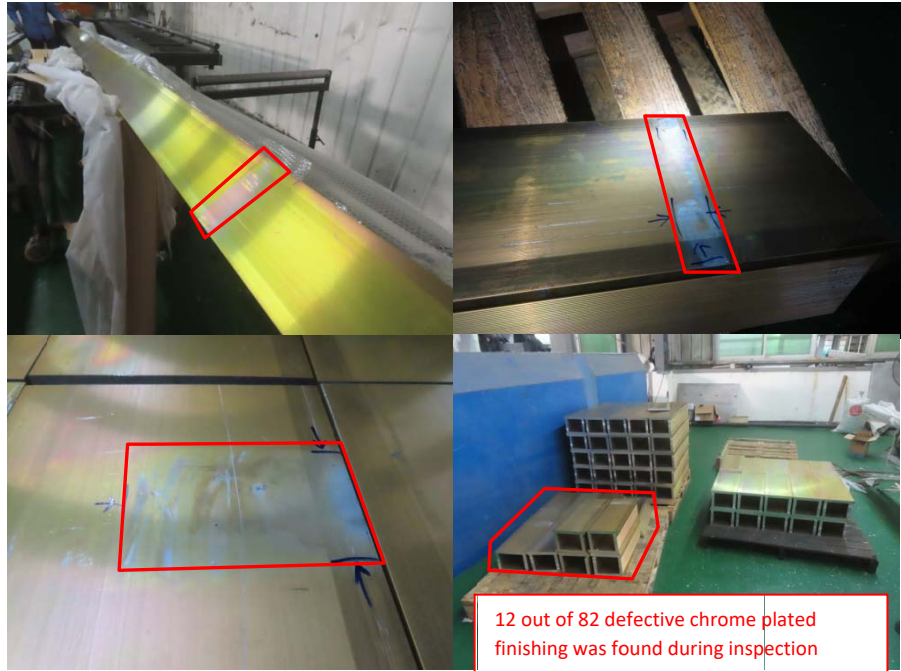
Description:
12 out of 82 defective chrome plated finishing was found during factory inspection

Action:
- MIDI is required to carry out their internal QA/QC method to repair the defective chrome plated finishing and improve workmanship for future works.

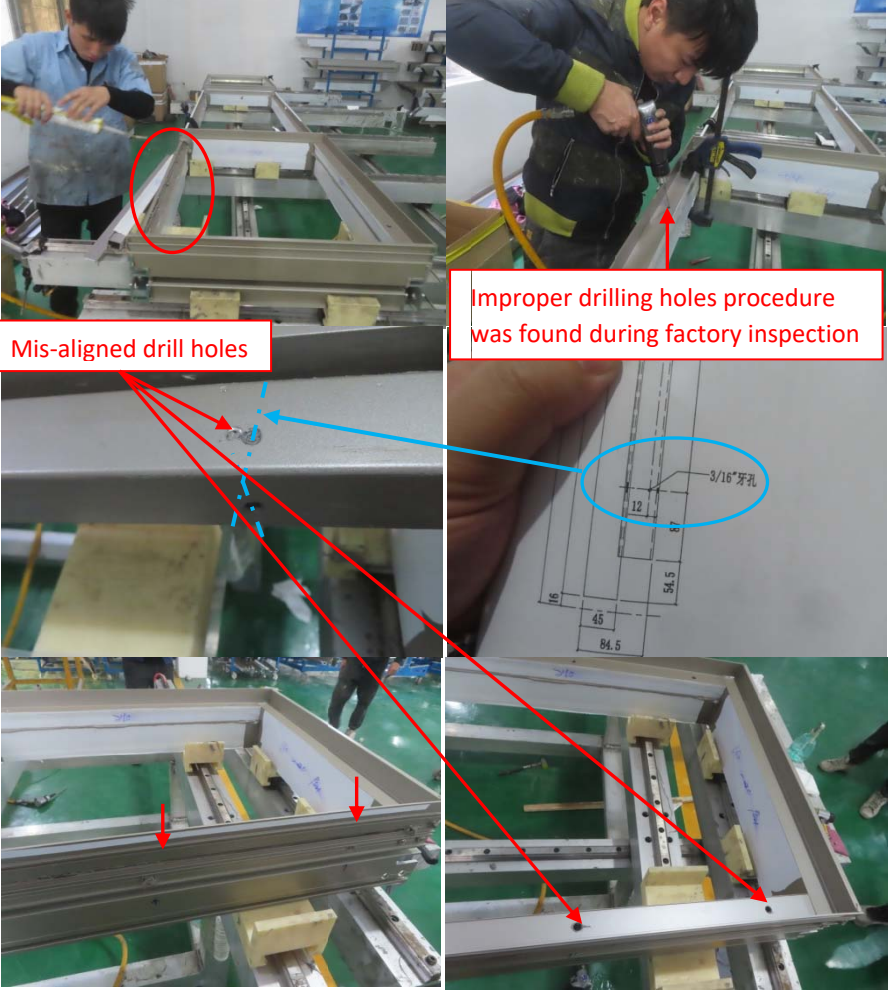
<p><u>Item:</u> Observation</p>		
<p><u>Description:</u> Improper holes drilling procedure was found during factory inspection</p>		
<p><u>Action:</u> - MIDI is required to carry out their internal QA/QC method to improve workmanship for future works.</p>

8	Improper holes drilling procedure was found during factory inspection  	MIDI is required to carry out their internal QA/QC method to improve workmanship for future works	Report-R-05 Photo 16

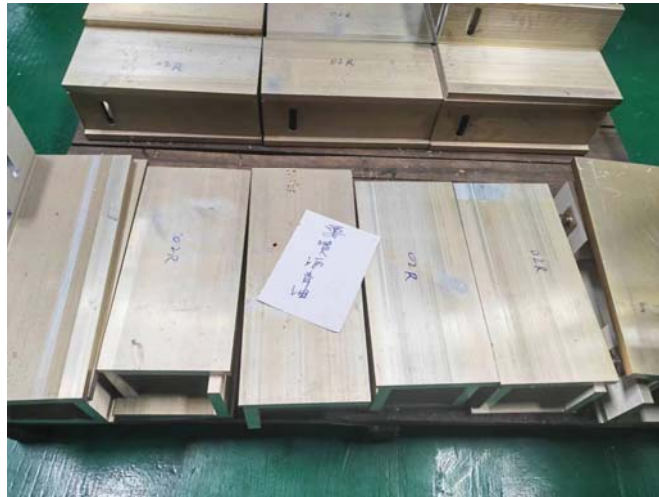
缺陷鉻化料

回覆：工廠會將有缺陷的鉻化鋁碼挑選出來，在完成配合組裝后再在缺陷位塗瀝清油處理；（詳見圖片）

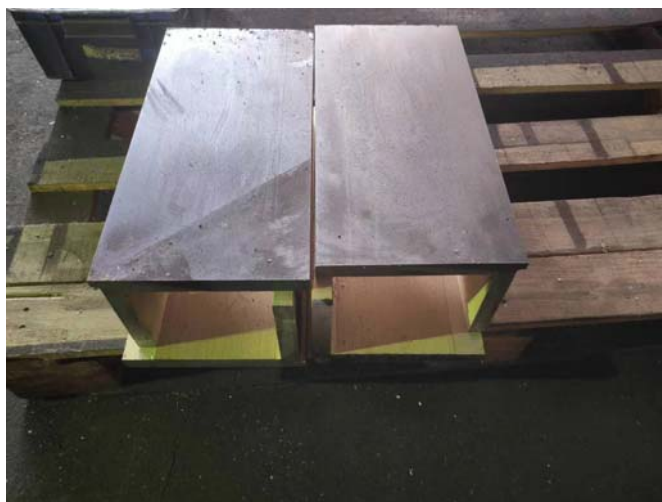
缺陷鉻化料表面塗瀝清油后的效果

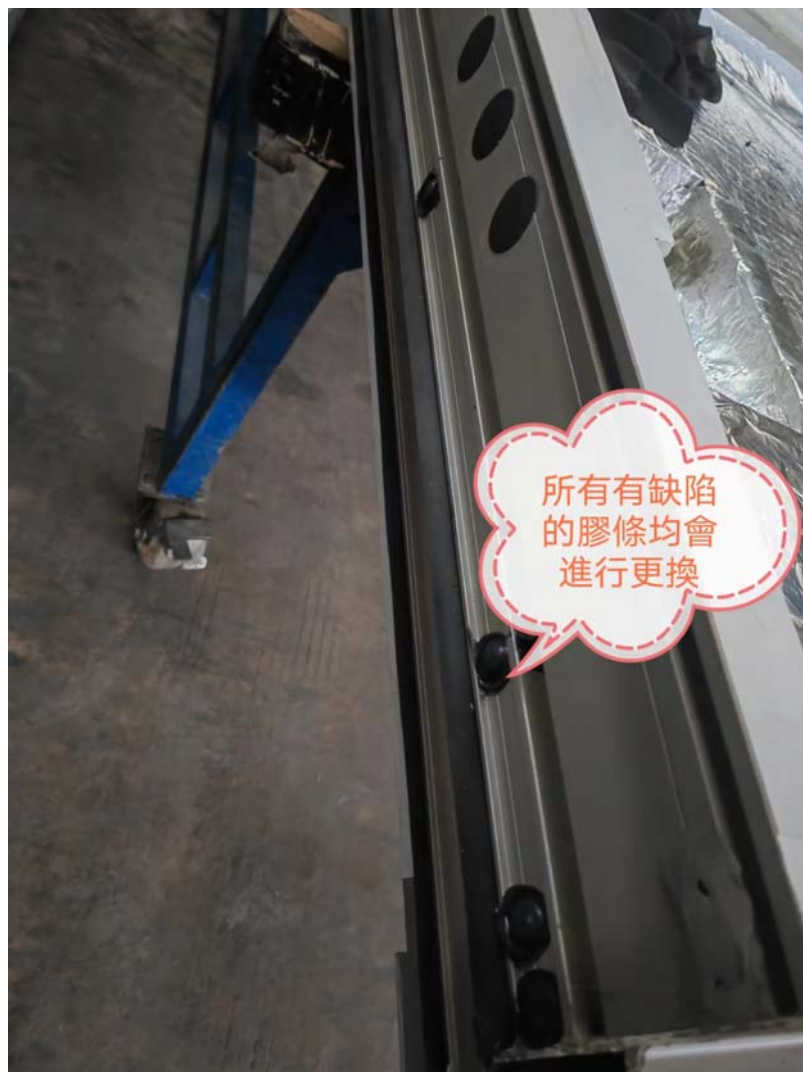
會安排將有缺陷膠條進行更換

回覆：工廠會要求車間人員將有缺陷的膠條進行更換（詳見圖片）

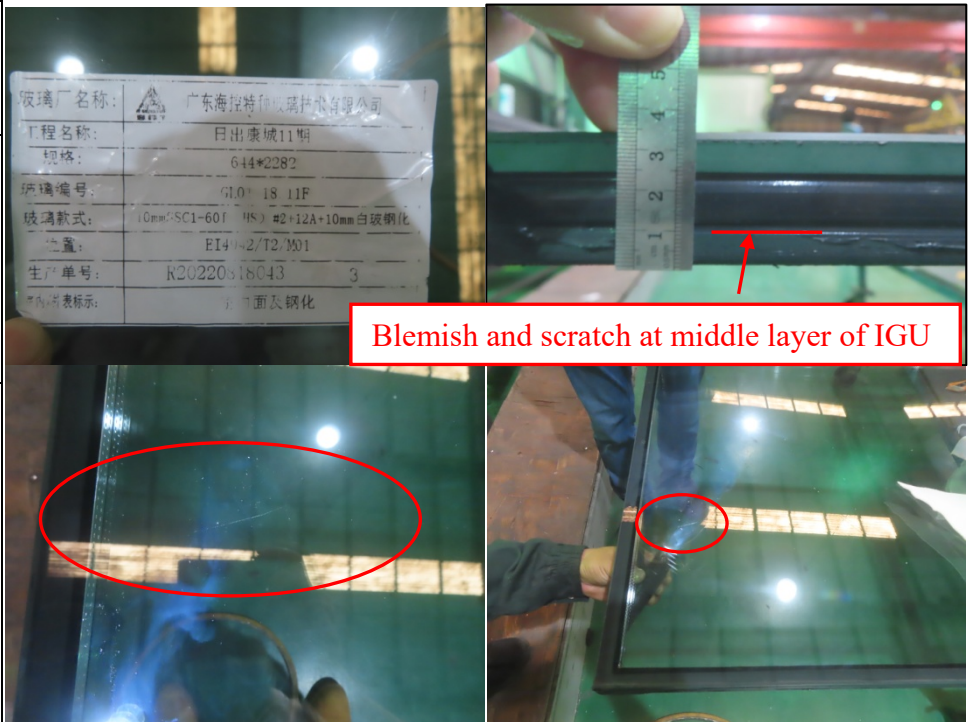
Blemish and scratch at middle layer of IGU

Action:
- MIDI is required to improve workmanship for further works
