Midi Factory Inspection on 18-Nov-2022 - Report No. R01

Midi Factory Inspection on 21-Nov-2022 - Report No. R02

Midi Factory Inspection on 25-Nov-2022 - Report No. R03

Midi Factory Inspection on 30-Nov-2022 - Report No. R04

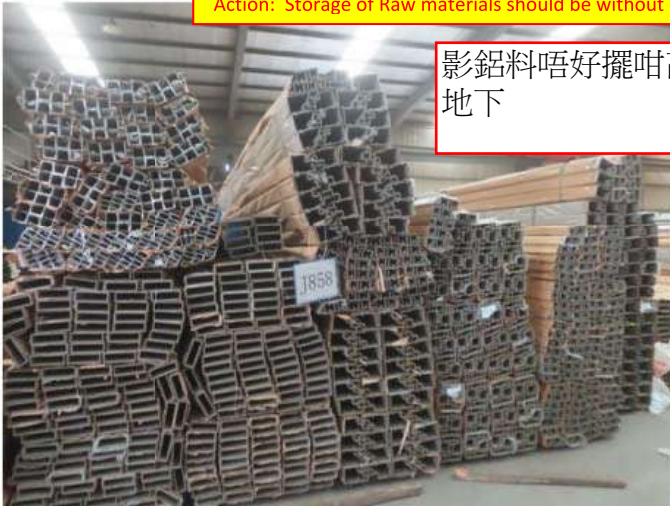
3_Raw materials are in messy and heavy loading condition

Action: Storage of Raw materials should be without causing overstress, permanent defection or warping

影鋁料唔好擺咁高，影一兩扎擺係地下

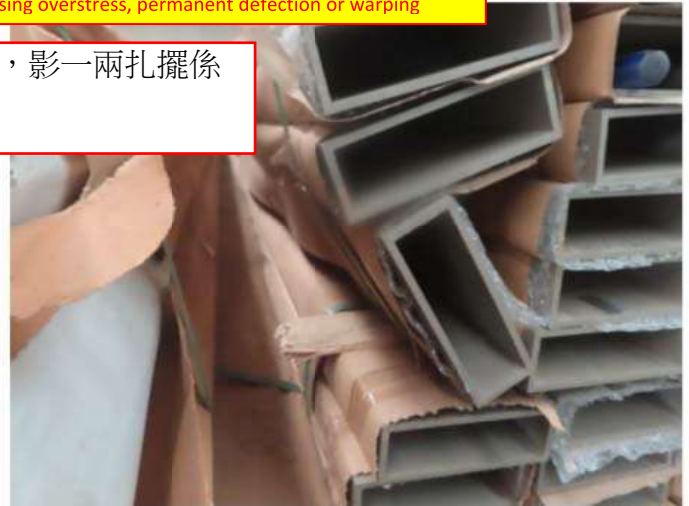
4_Raw materials are in messy and heavy loading condition

Action: Storage of Raw materials should be without causing overstress, permanent defection or warping

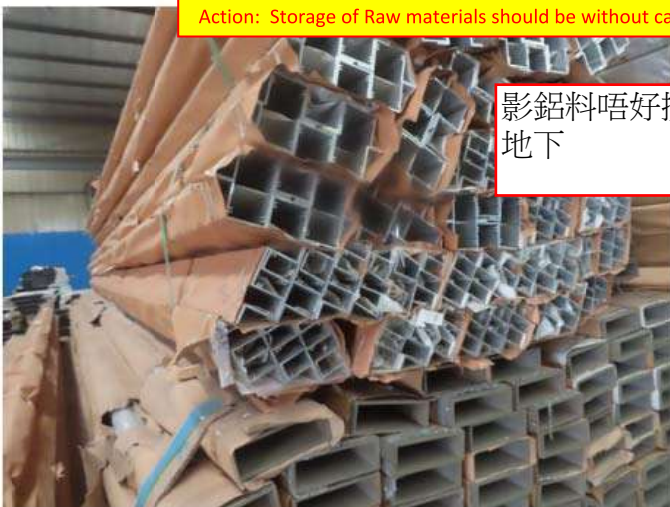
5_Raw materials are in messy and heavy loading condition

影鋁料唔好擺咁高，影一兩扎擺係地下

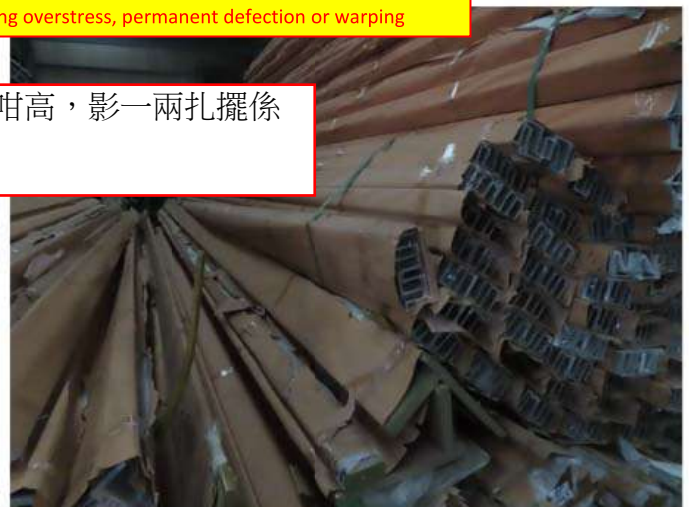
6_Raw materials are in messy and heavy loading condition

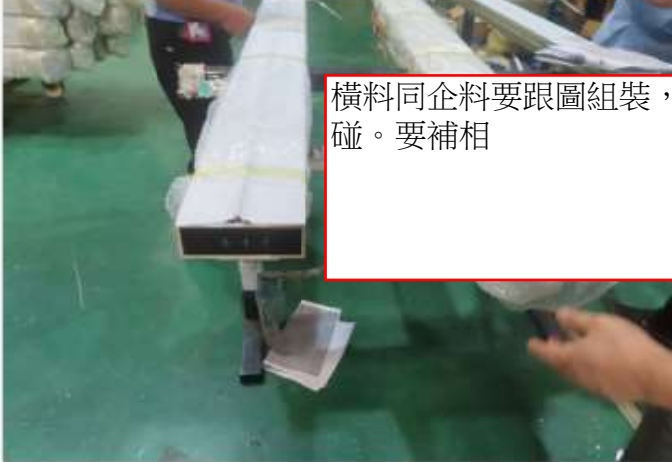
3_ one side of mullion was found consealed

Action: Midi is required to strictly follow the agreement during tender stage for principle design to seal-up end position of Transom and Mullion

橫料同企料要跟圖組裝，是有避位直碰。要補相

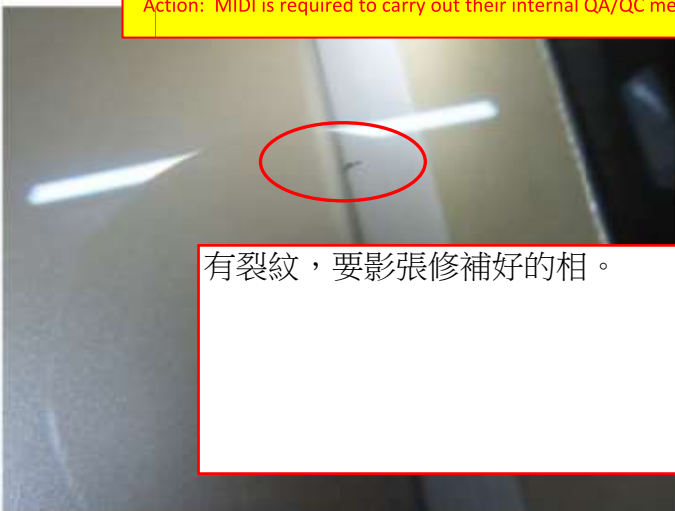
23_Blemish was observed to be existed at spandrel sealant

Action: MIDI is required to carry out their internal QA/QC method to repair the defect of on spandrel sealant and back pan

有裂紋，要影張修補好的相。

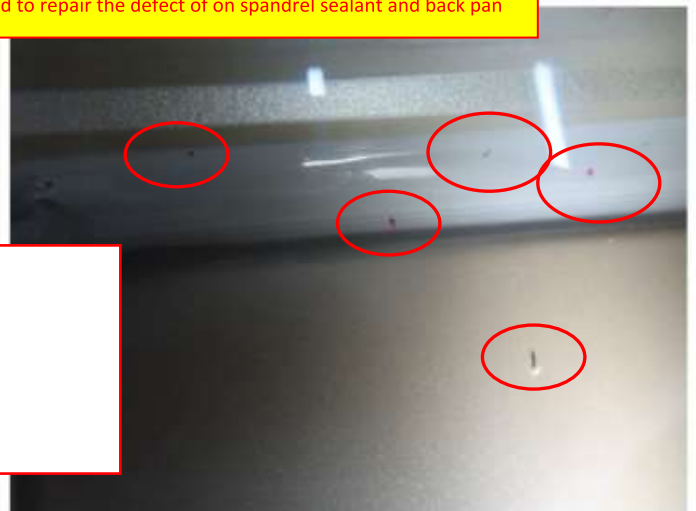
24_Blemish was observed to be existed at spandrel sealant

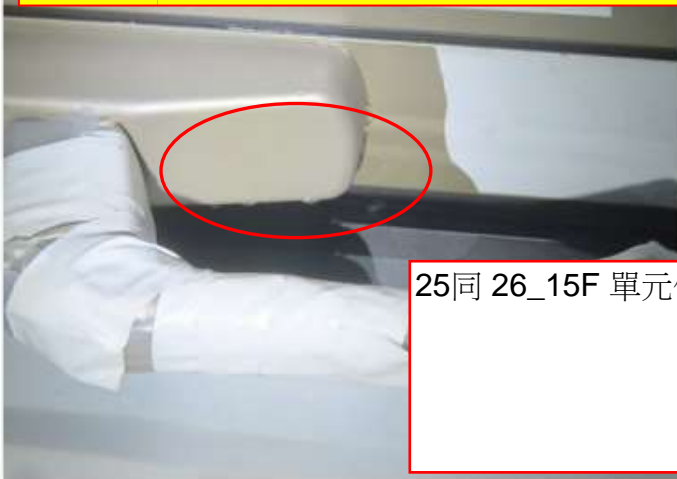
25_15F-T1BCW4 AS-01 water leakage

Action: MIDI is required to carry out their internal QA/QC method to repair the leakage unitized panel, MIDI needs to improve workmanship for

25同 26_15F 單元件入水, 要補相。

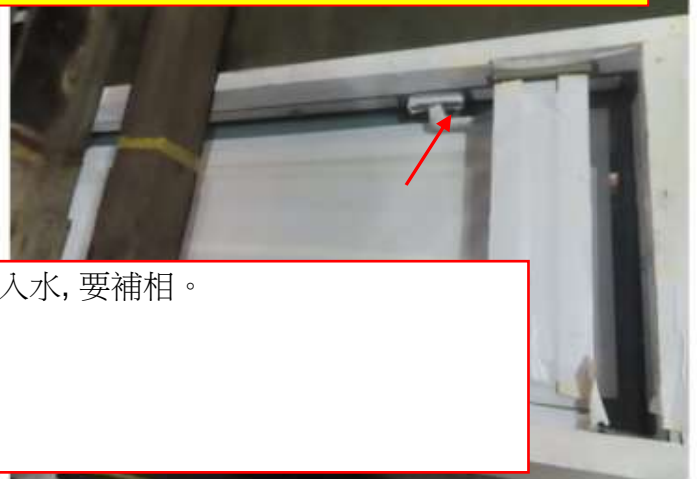
26_15F-T1BCW4 AS-01 water leakage

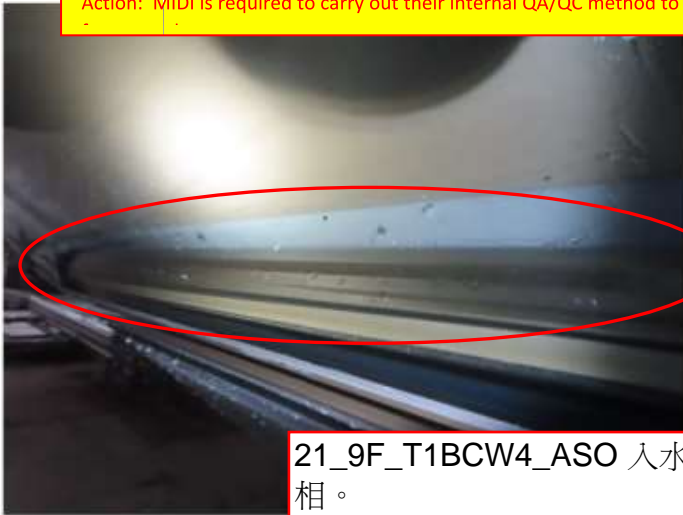
19_Water leakage was found inside spandrel backpan

Action: MIDI is required to carry out their internal QA/QC method to repair the leakage unitized panel, MIDI needs to improve workmanship for

21_9F_T1BCW4_AS0 入水, 執好後影相。

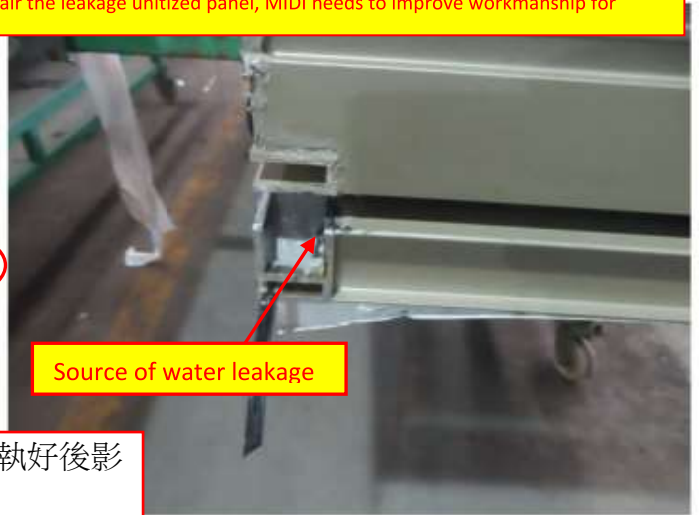
Source of water leakage

20_Damage sealant was found at end position of mullion

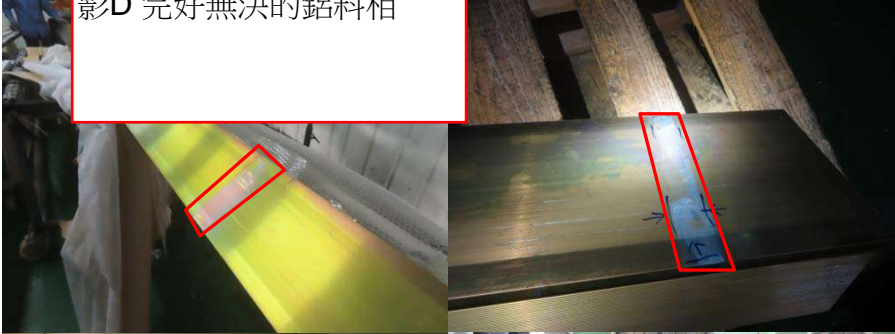
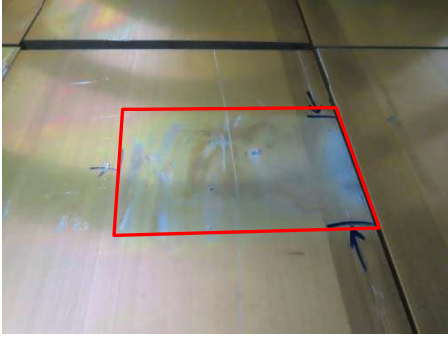
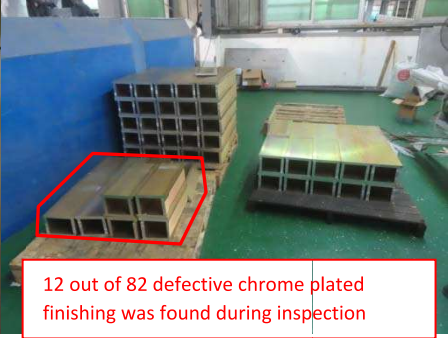
<p>Photo 13</p>

<p><u>Description:</u> 12 out of 82 defective chrome plated finishing was found during factory inspection</p>

<p data-bbox="1002 824 1417 898">12 out of 82 defective chrome plated finishing was found during inspection</p>

<p><u>Action:</u> - MIDI is required to carry out their internal QA/QC method to repair the defective chrome plated finishing and improve workmanship for future works.</p>

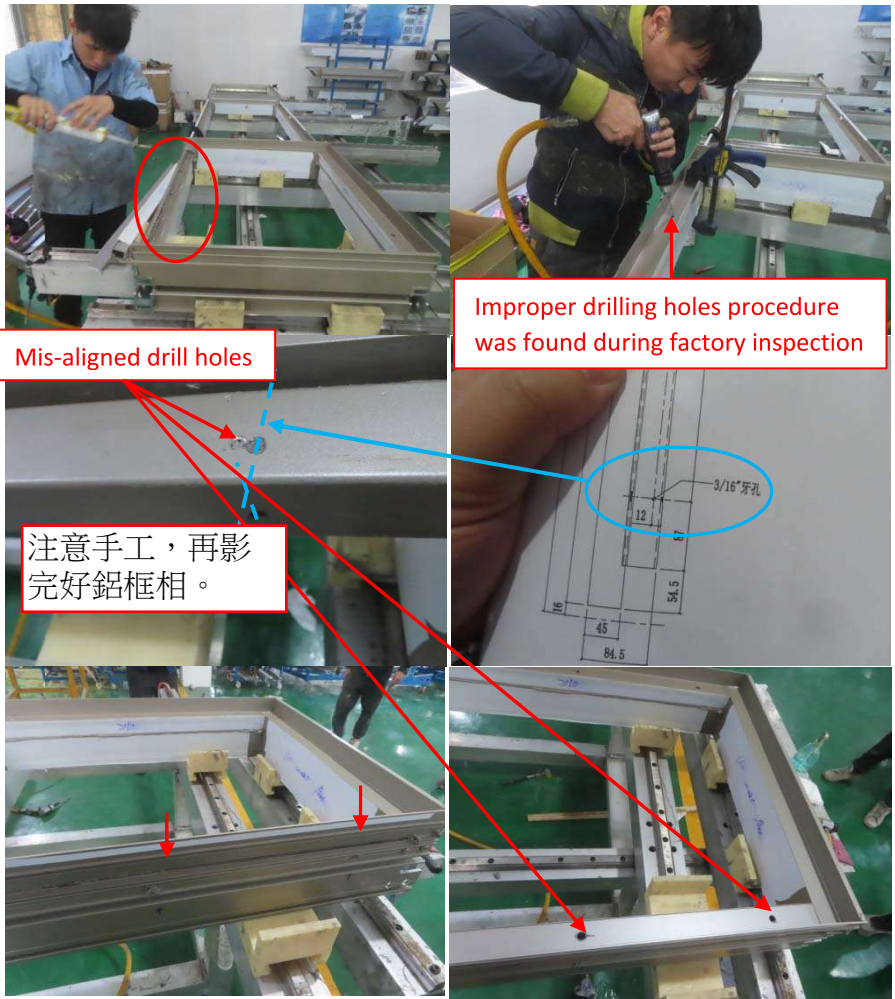
Photo 16

Description:
Improper holes drilling procedure was found during factory inspection

Action:
- MIDI is required to carry out their internal QA/QC method to improve workmanship for future works.

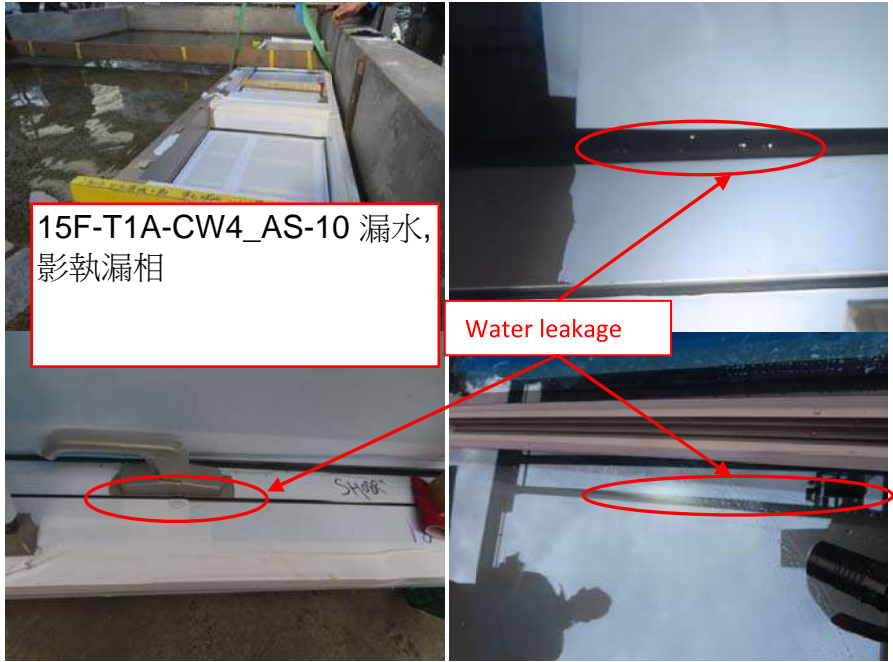
Photo 11

Description:
Water leakage was found during flooding test for Panel number 15F-T1A-CW4_AS-10

Action:
- MIDI is required to carry out their internal QA/QC method to improve workmanship for future works

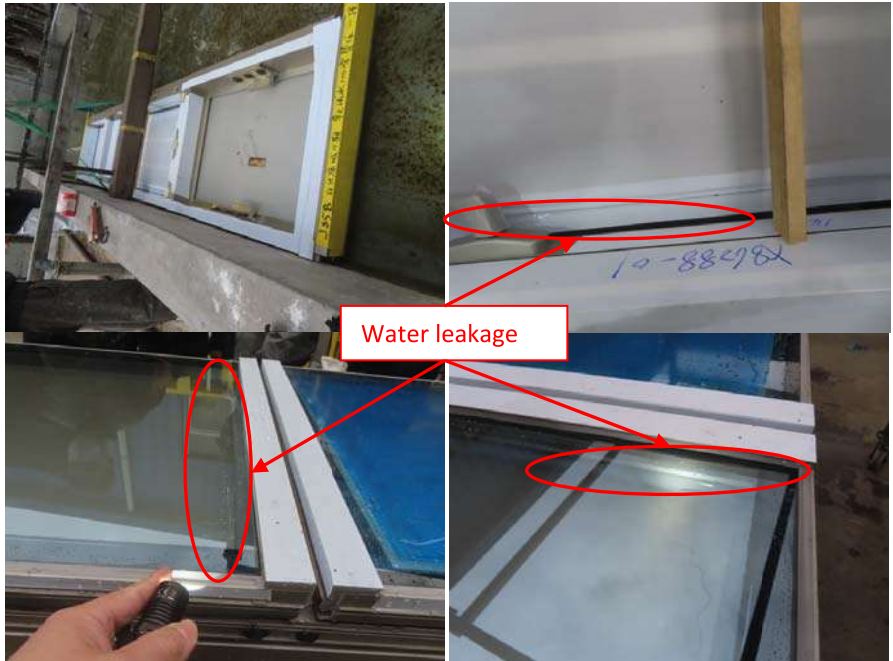
Photo 12

Description:
Water leakage was found during flooding test for Panel number 16F-T1A-CW4_AS-10

Action:
- MIDI is required to carry out their internal QA/QC method to improve workmanship for future works

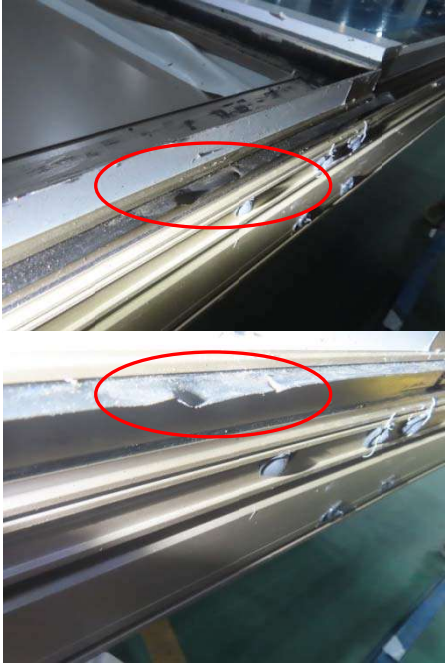
<p>Photo 3</p>

<p><u>Item:</u> Observation</p>	
<p><u>Description:</u> Defective gasket was found during factory inspection for Zone M02</p>	
<p><u>Action:</u> - MIDI is required to replace the defective gasket</p>

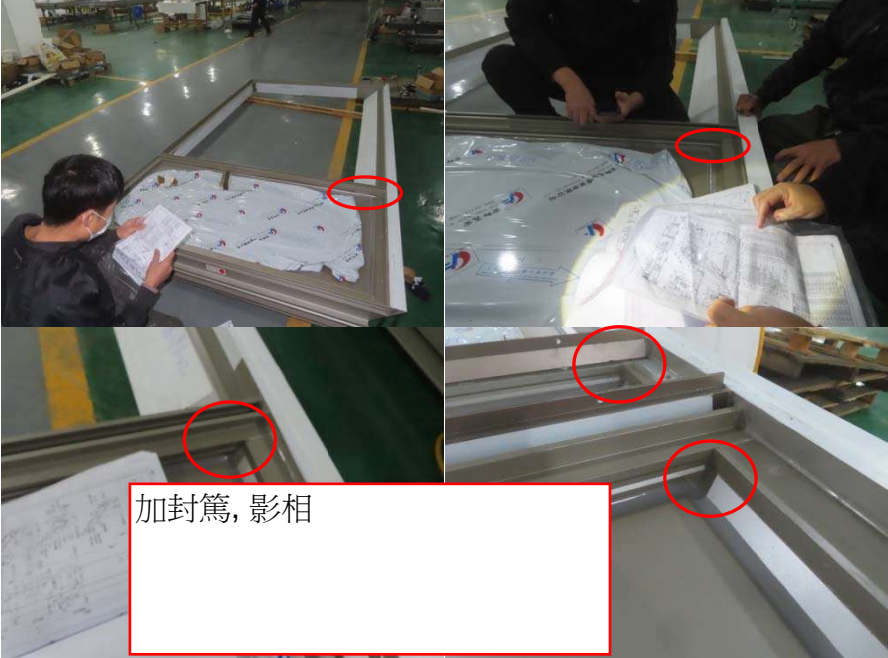
<p>Photo 4</p>

<p><u>Item:</u> Observation</p>	
<p><u>Description:</u> 18 nos. of corner unitized panels for Zone M02 were found missing drain holes at back pan portion</p>	
<p><u>Action:</u> - MIDI is required to carry out remedial works before fixing of glass panels</p>	<div data-bbox="663 1709 1145 1883" style="border: 1px solid red; padding: 5px;"> <p>加封篤, 影相</p> </div>

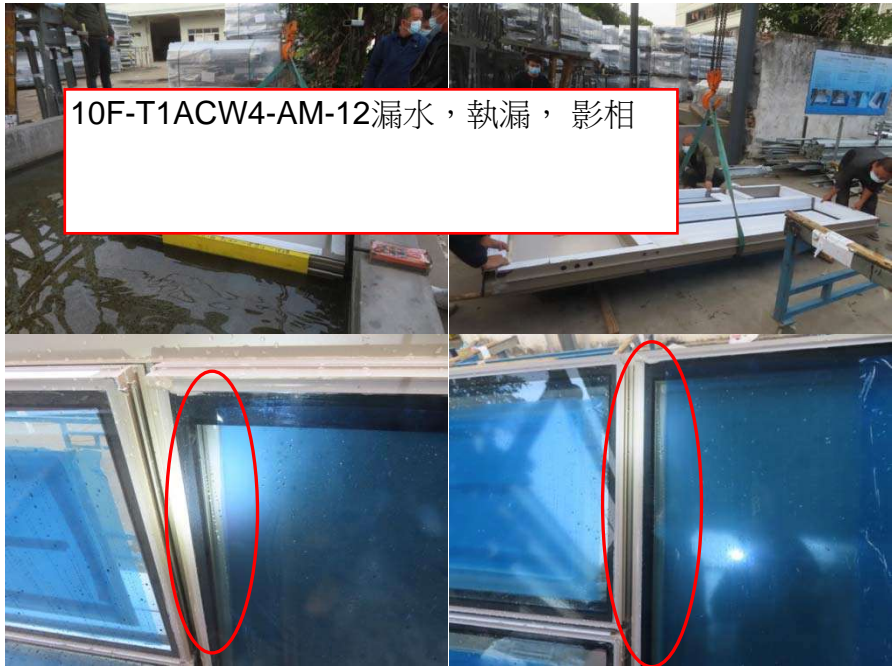
Photo 12

Description:
Water leakage was found during flooding test for Panel number 10F-T1ACW4-AM-12

Action:
- MIDI is required to carry out their internal QA/QC method to improve workmanship for future works

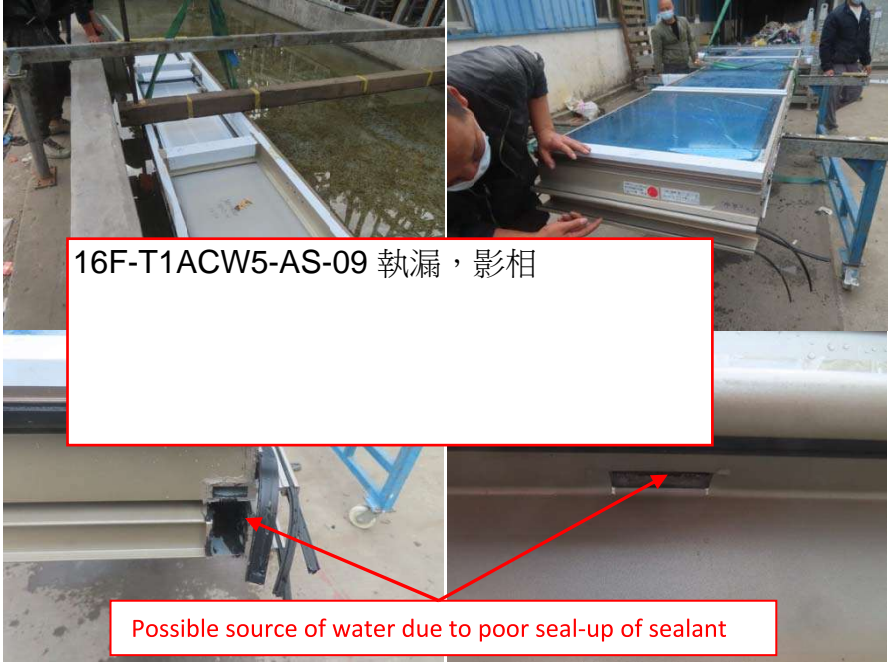
Photo 13

Description:
Water leakage was found during flooding test for Panel number 16F-T1ACW5-AS-09

Action:
- MIDI is required to carry out their internal QA/QC method to improve workmanship for future works

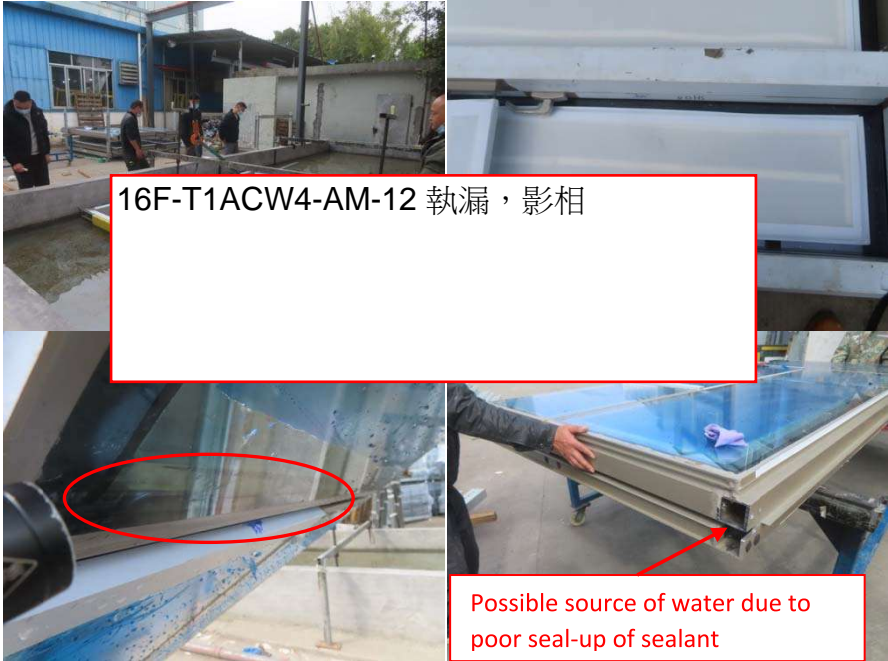
Photo 14

Description:
Water leakage was found during flooding test for Panel number 16F-T1A CW4-AM12

Action:
- MIDI is required to carry out their internal QA/QC method to improve workmanship for future works

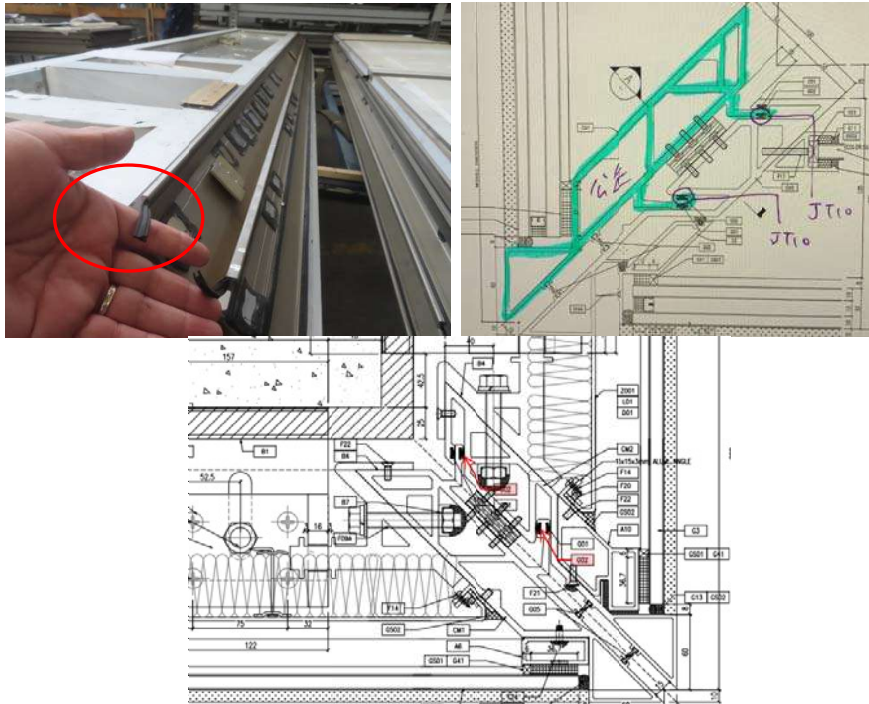
Photo 6

Gasket of unitized panels for Zone M01 & 02 were found not match with design drawing

Action:
-MIDI is reminded to carry out the remedial works prior products delivery and to improve workmanship for future works

影跟圖款一樣膠條相

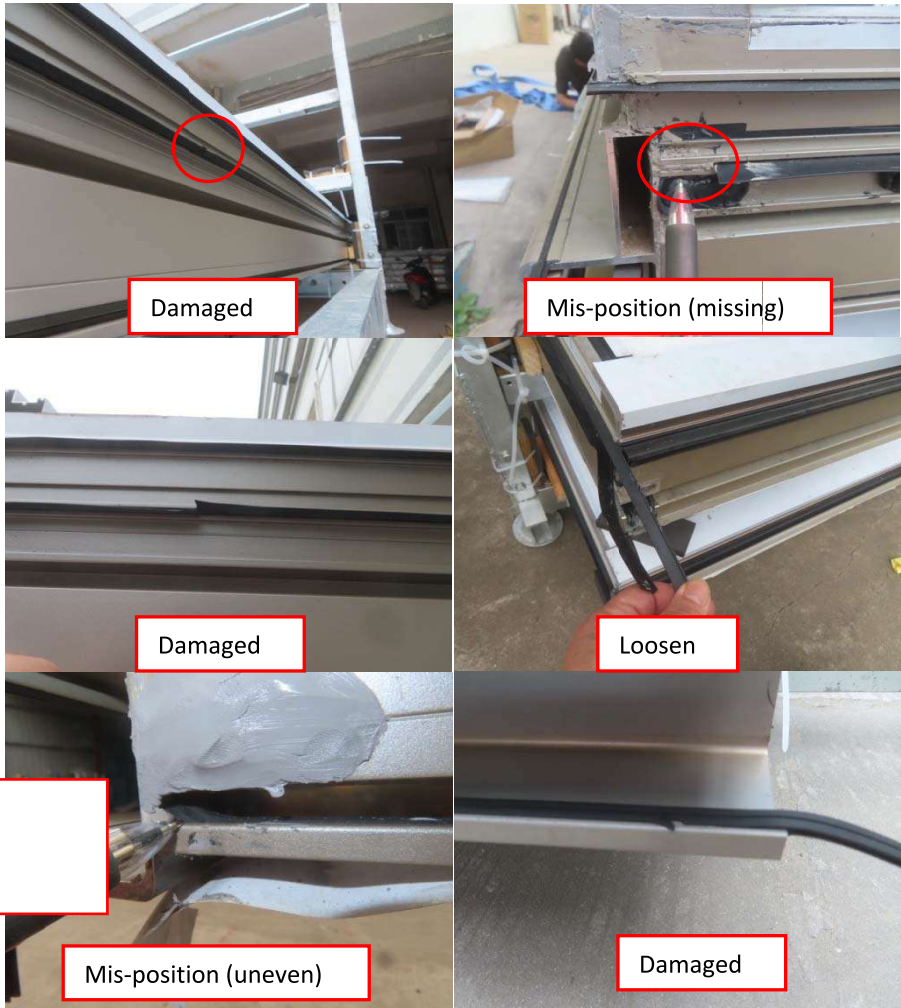
Photo 4

Description:
Defective gaskets for 2nd log unitized panels were found during final inspection and packing

Action:
- MIDI is reminded to carry out the remedial works prior products delivery and to improve workmanship for future works

影做好保護相

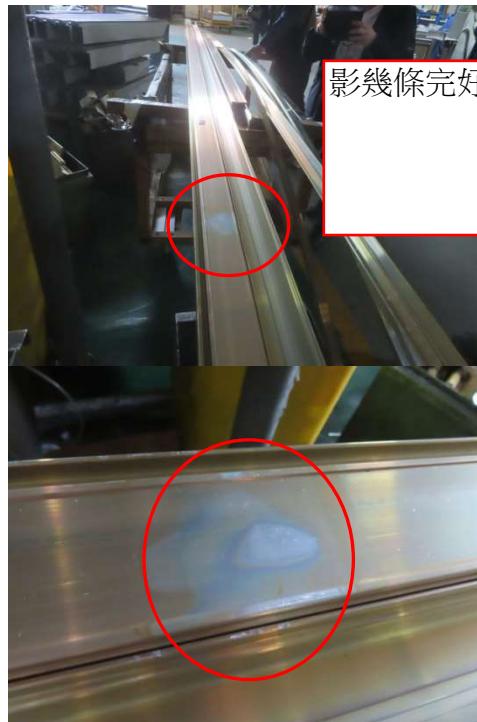
Photo 6

Description:
Defective chrome plated finishing for gutter sleeve was found during factory inspection

Action:
- MIDI is required to carry out their internal QA/QC method to repair the defective chrome plate finishing and improve workmanship for future works

影幾條完好的鉻化防水片相

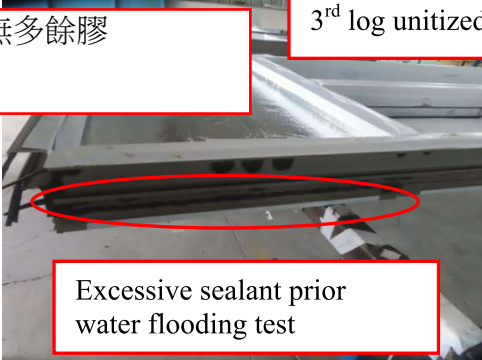
Description:
Defective sealant for 2nd & 3rd log unitized panels were found during final inspection and packing

Excessive sealant prior water flooding test

Action:
- MIDI is reminded to carry out the remedial works prior products delivery and to improve workmanship for future works

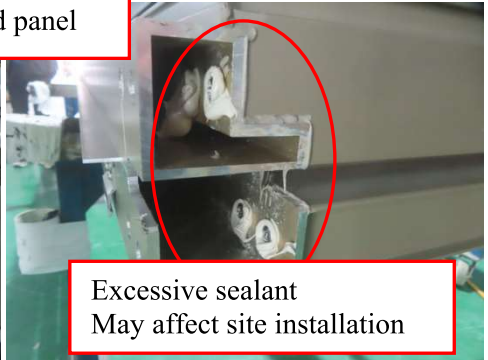
Excessive sealant May affect site installation

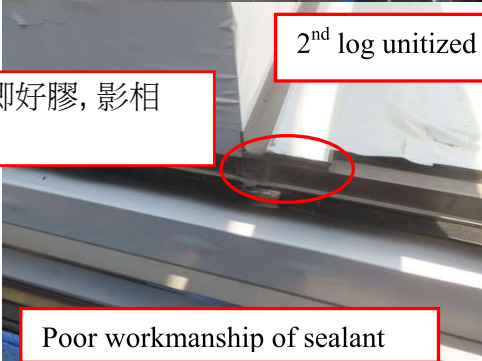
Poor workmanship of sealant

啱好膠, 影相

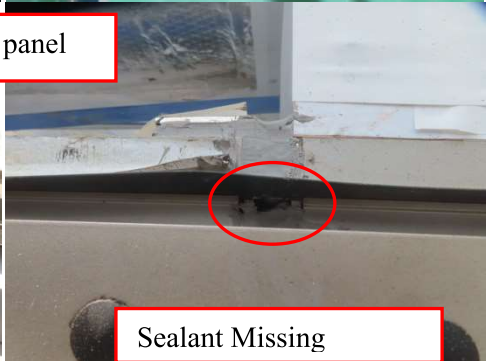
Sealant Missing

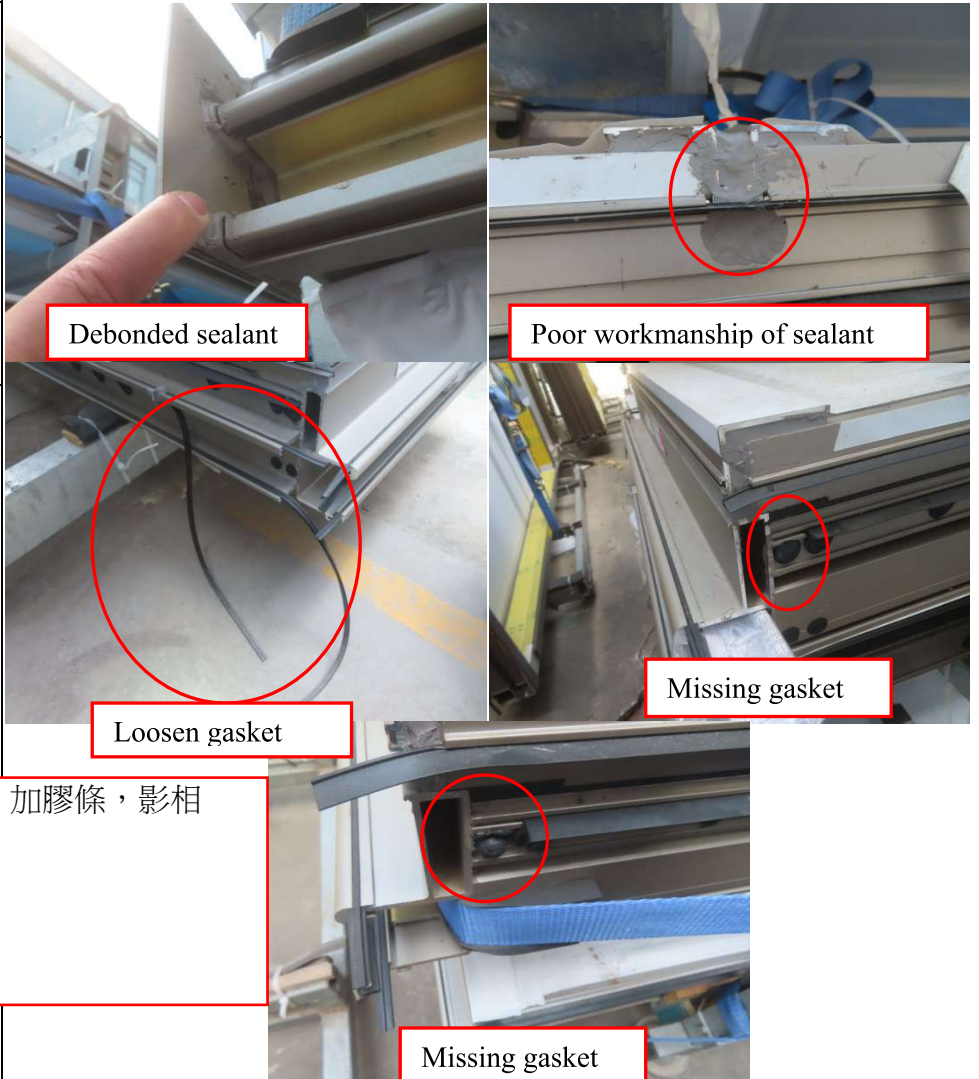
Photo 10

Description:
Defective sealant and gasket for 2nd & 3rd log unitized panels were found during final inspection and packing

Action:
- MIDI is reminded to carry out the remedial works prior products delivery and to improve workmanship for future works

啱好膠，加膠粒，加膠條，影相

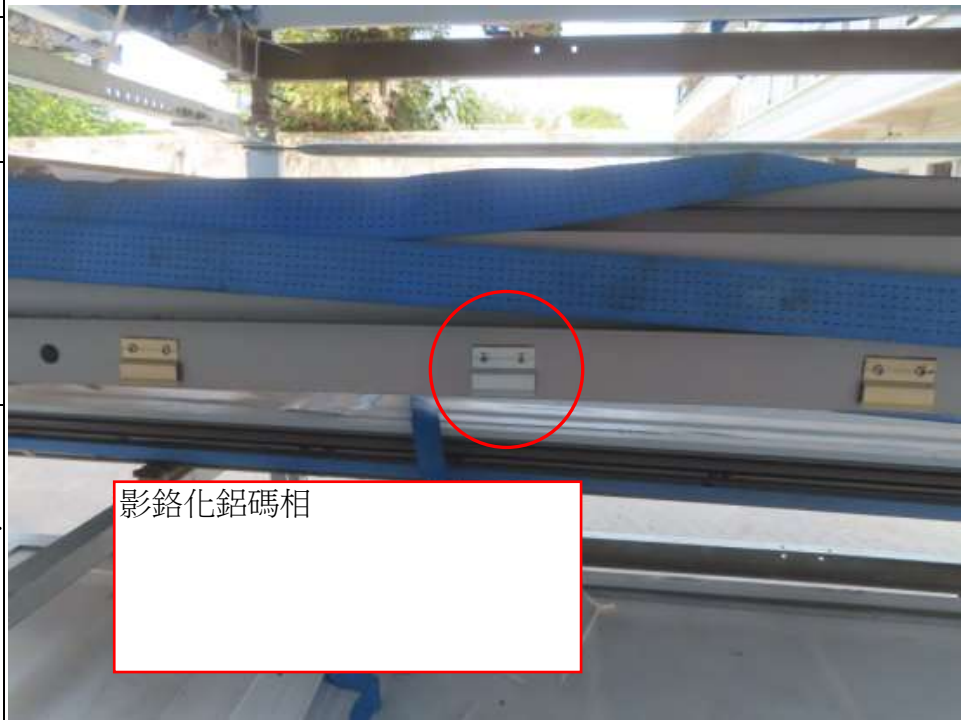
Photo 11

Description:
Defective chrome plated finishing for extrusion clip was found during factory inspection

Action:
- MIDI is required to carry out their internal QA/QC method to repair the defective chrome plate finishing and improve workmanship for future works

影銘化鋁碼相

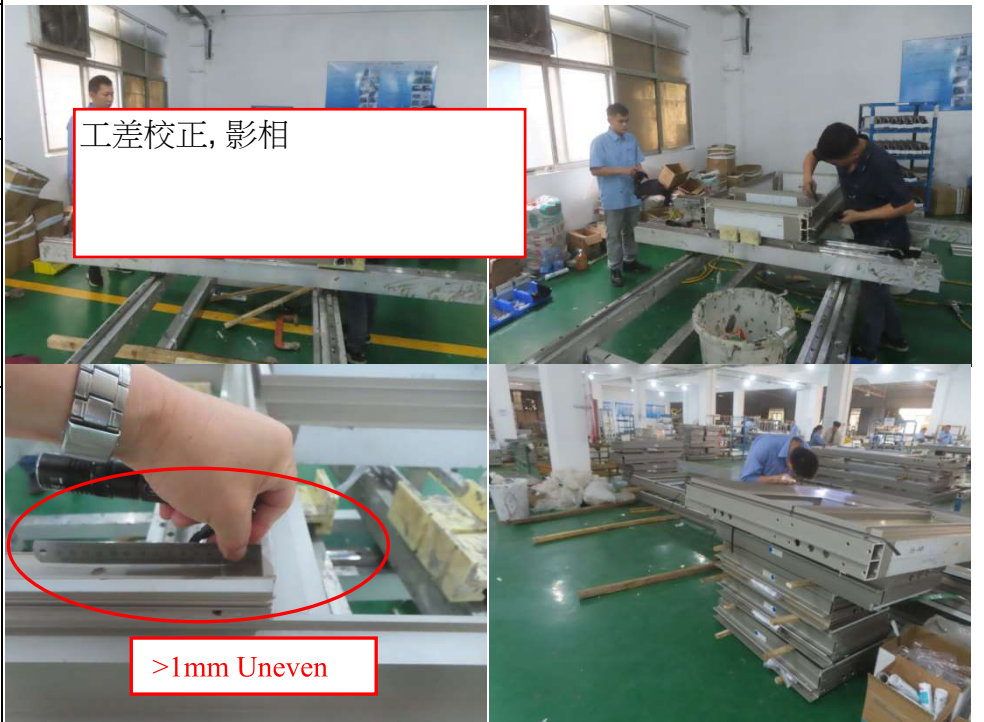
Photo 6

Description:
Uneven of components was found during factory inspection

Action:
- MIDI is required to improve workmanship for further works

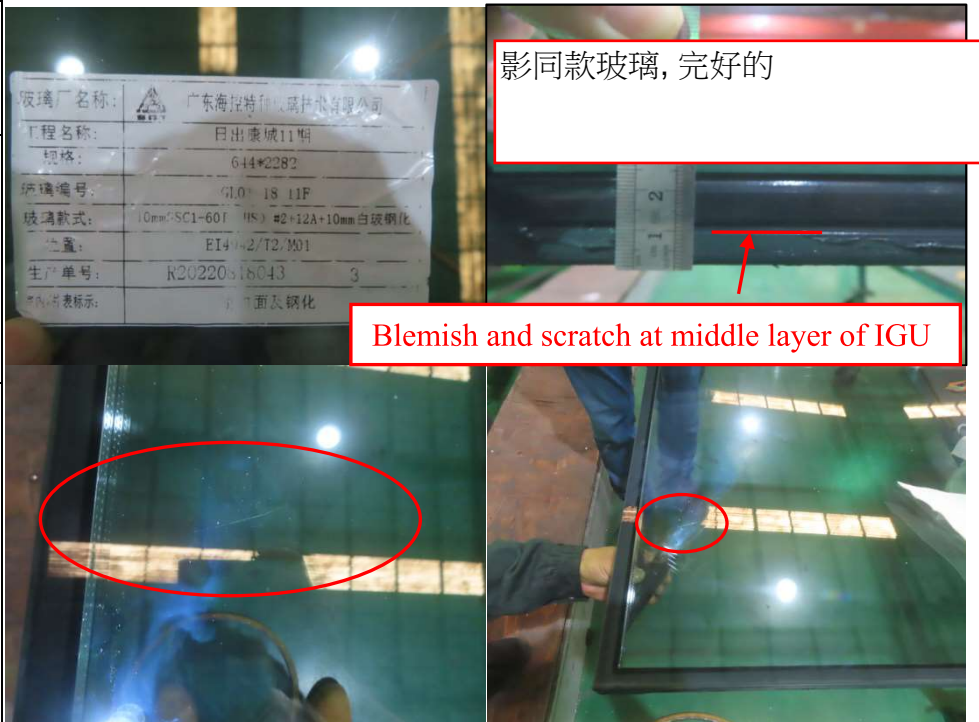
Photo 10

Description:
Blemish and scratch was found at middle layer of IGU

Blemish and scratch at middle layer of IGU

Action:
- MIDI is required to improve workmanship for further works

影同款玻璃, 完好的

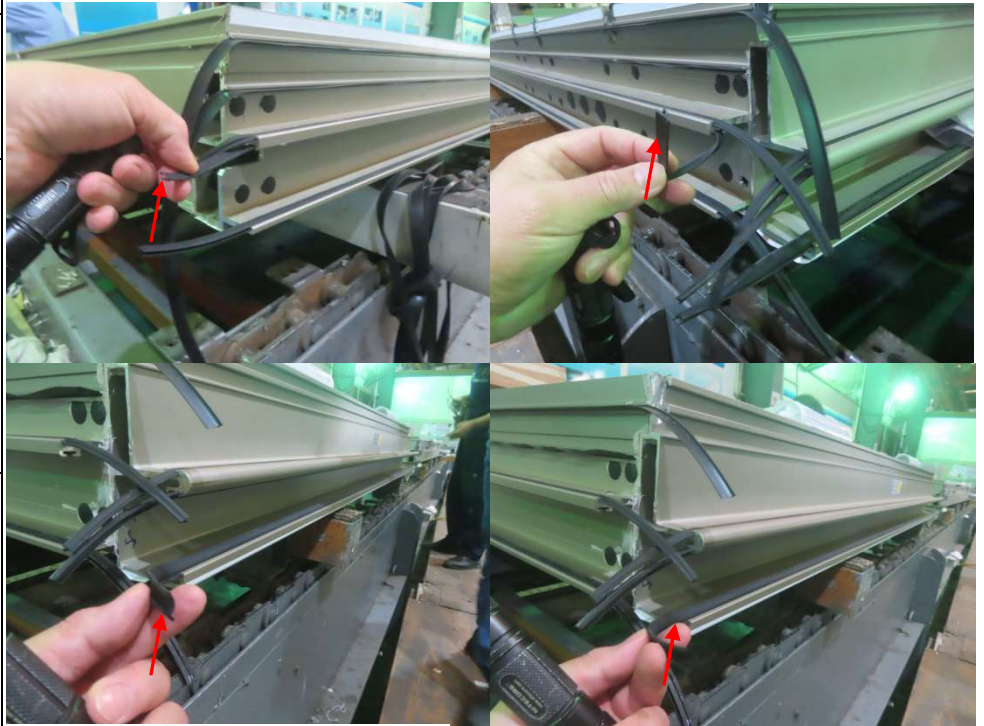
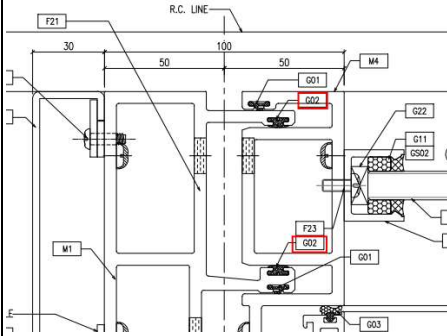
Photo 11

Description:
Gasket of 2 numbers of unitized panel were found not match with design drawing during factory inspection

Action:
- MIDI is reminded to carry out the remedial works prior products delivery and to improve workmanship for future works

更換正確的膠條, 影相

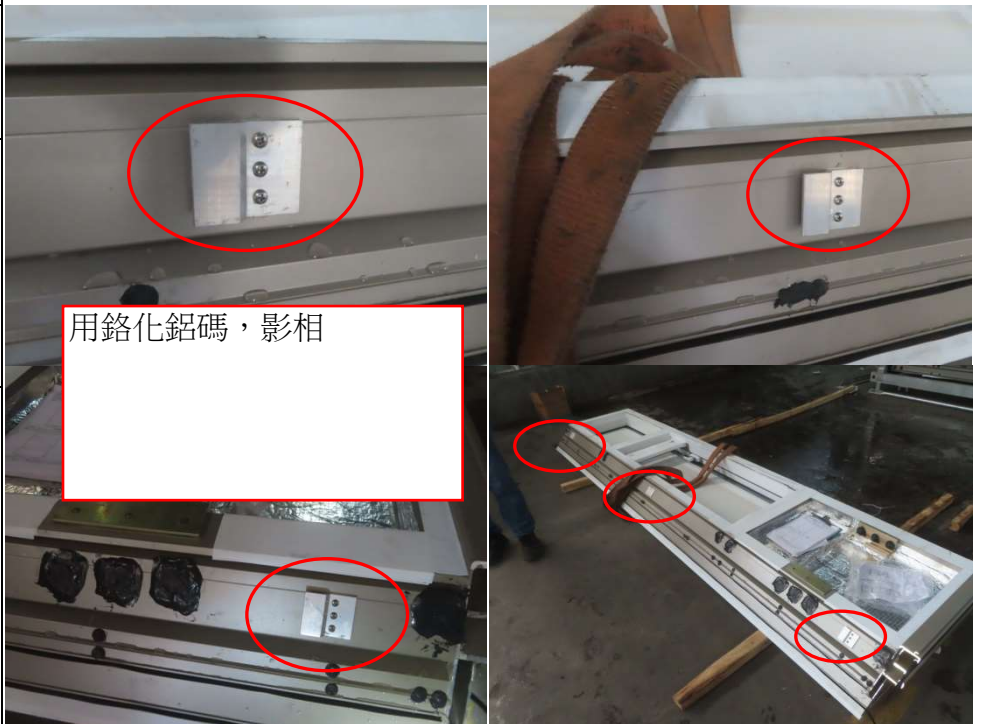
Photo 12

Description:
Defective chrome plated finishing for extrusion clip was found during factory inspection

Action:
- MIDI is required to carry out their internal QA/QC method to repair the defective chrome plate finishing and improve workmanship for future works

用鍍化鋁碼, 影相

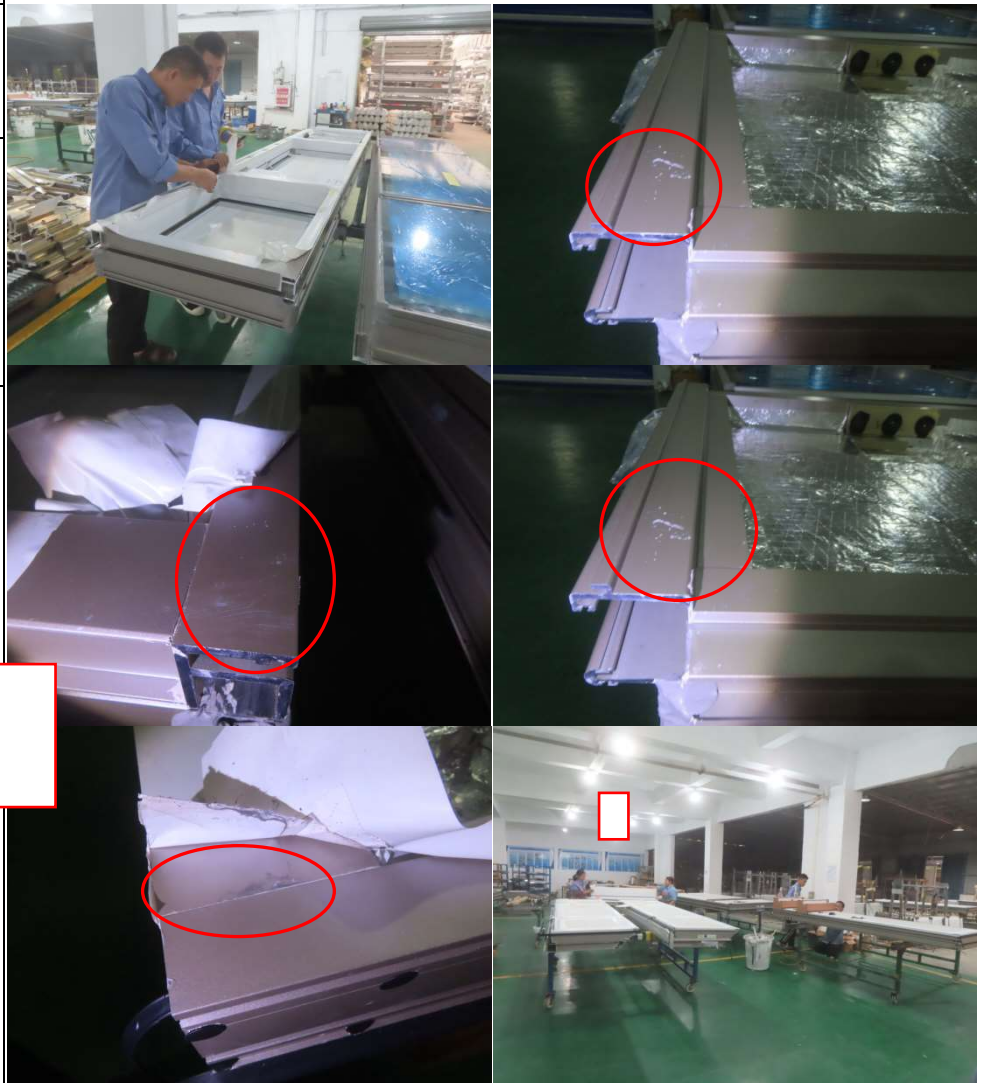
Photo 10

Description:
Excessive sealant and stain was found on unitized panel surface after packing

Action:
- MIDI is required to improve workmanship for further works

影完好框相
