工程指示 / 要求簡箋(E.I.)

工程指示編號：EI / 5937 / 23      修改版次：  
 工程編號      : J - 858      工程名稱      : 將軍澳日出康城 11  
 工程項目      : 顧問上廠報告 (18/11-24/3) 精華版加完整版  
 收件人      : 生統 / Doris      發件人      : Paul Wong      日期      : 29/03/2023

# Midi Factory Inspection on 18-Nov-2022 - Report No. R01

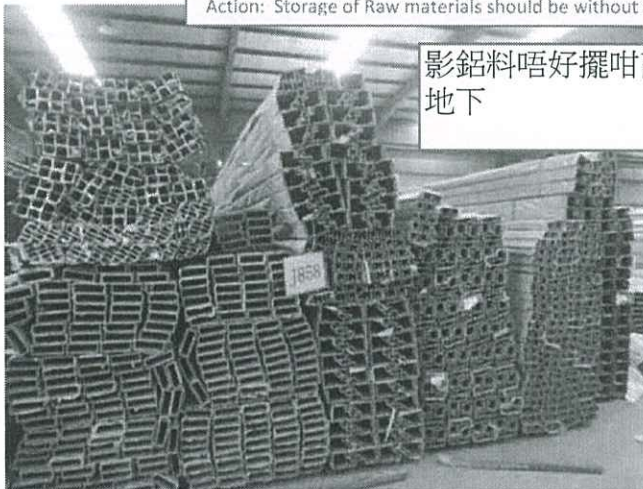
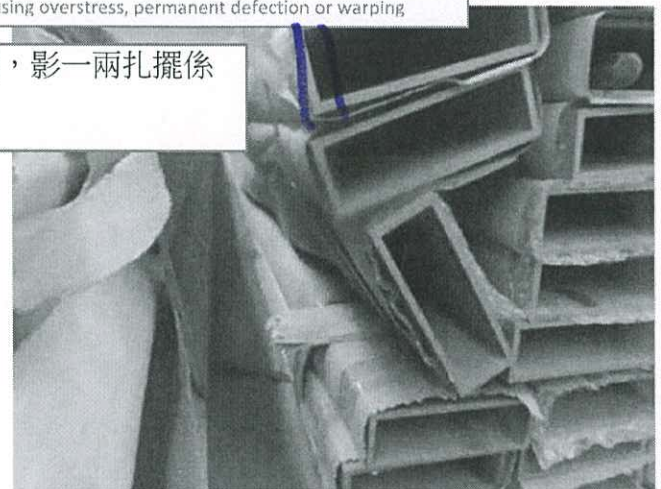
3\_Raw materials are in messy and heavy loading condition

4\_Raw materials are in messy and heavy loading condition

Action: Storage of Raw materials should be without causing overstress, permanent defection or warping

影鋁料唔好擺咁高，影一兩扎擺係地下

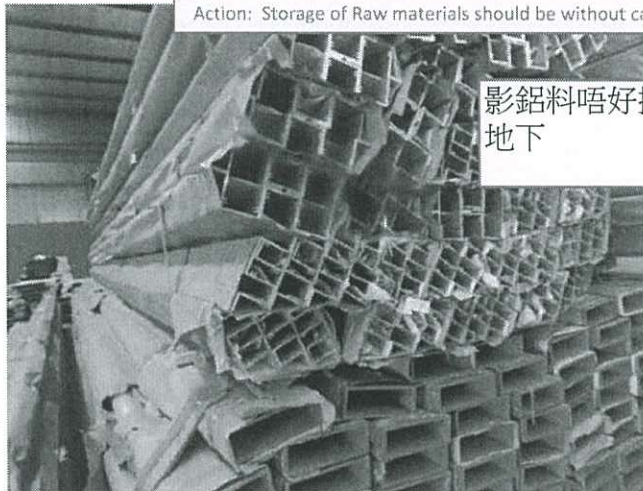
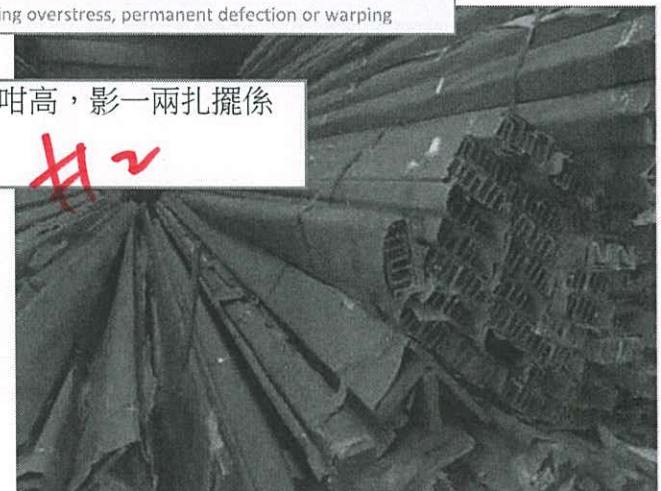
5\_Raw materials are in messy and heavy loading condition

6\_Raw materials are in messy and heavy loading condition

Action: Storage of Raw materials should be without causing overstress, permanent defection or warping

影鋁料唔好擺咁高，影一兩扎擺係地下

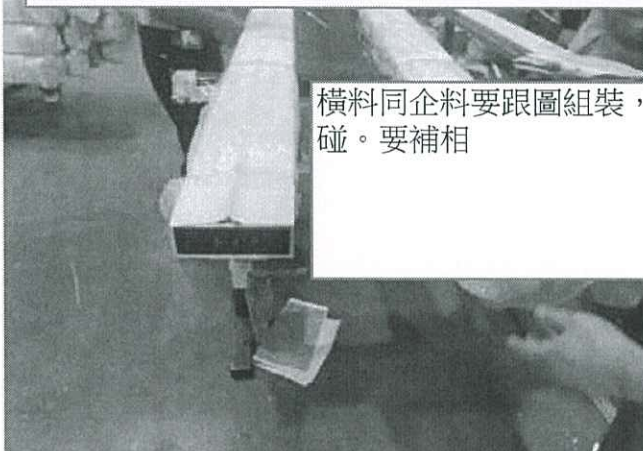
3\_ one side of mullion was found consealed

Action: Midi is required to strictly follow the agreement during tender stage for principle design to seal-up end position of Transom and Mullion

橫料同企料要跟圖組裝，是有避位直碰。要補相

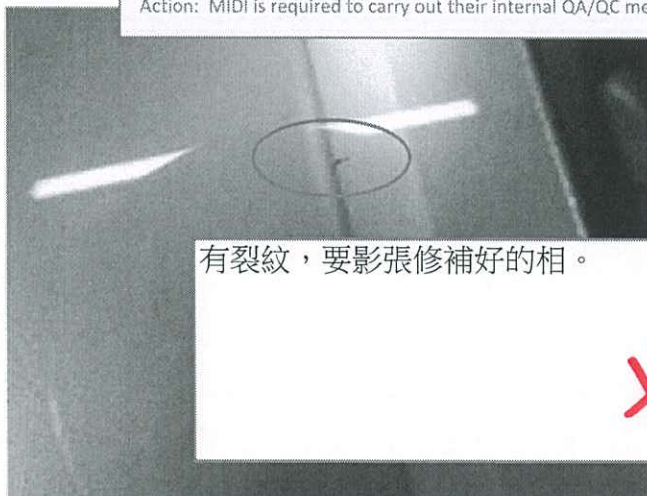
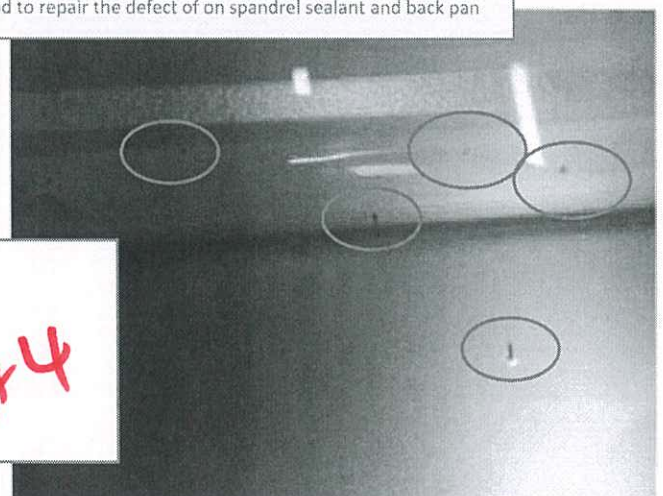
有裂紋，要影張修補好的相。

23\_Blemish was observed to be existed at spandrel sealant

24\_Blemish was observed to be existed at spandrel sealant

Action: MIDI is required to carry out their internal QA/QC method to repair the defect of on spandrel sealant and back pan

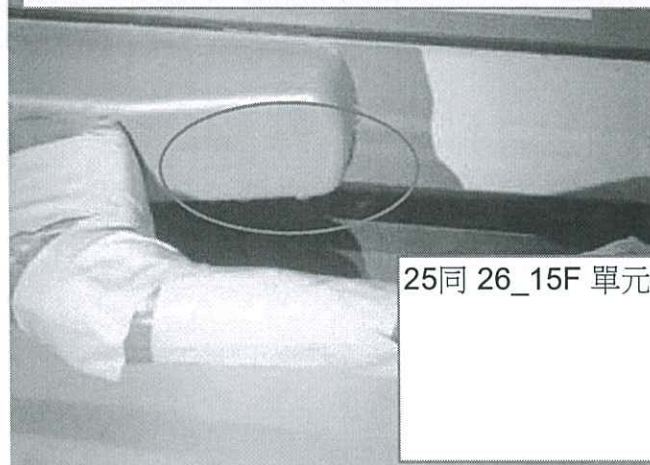
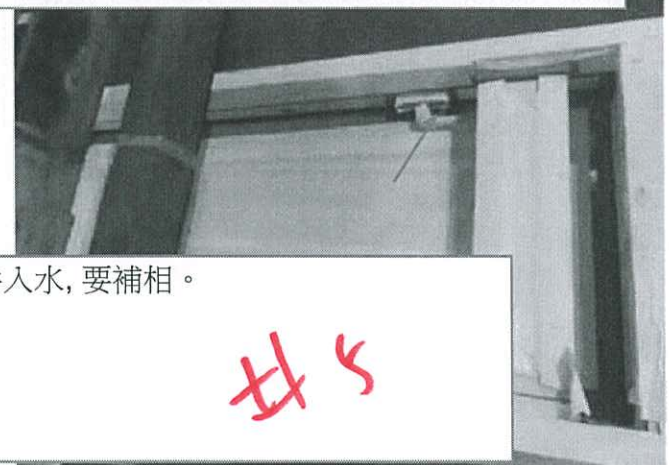
25\_15F-T1BCW4 AS-01 water leakage

26\_15F-T1BCW4 AS-01 water leakage

25同 26\_15F 單元件入水, 要補相。

Action: MIDI is required to carry out their internal QA/QC method to repair the leakage unitized panel, MIDI needs to improve workmanship for

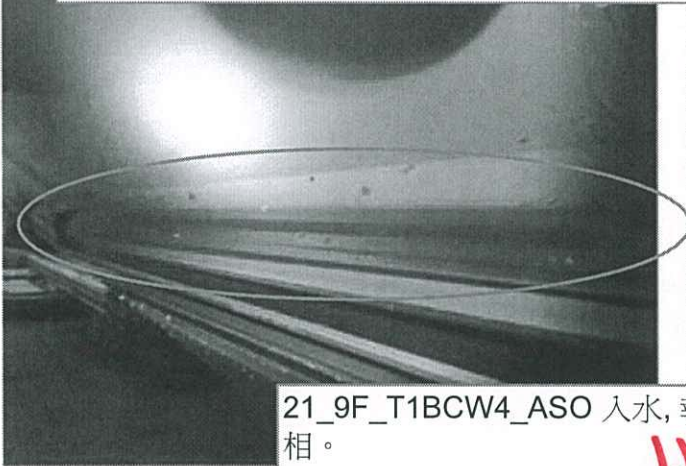
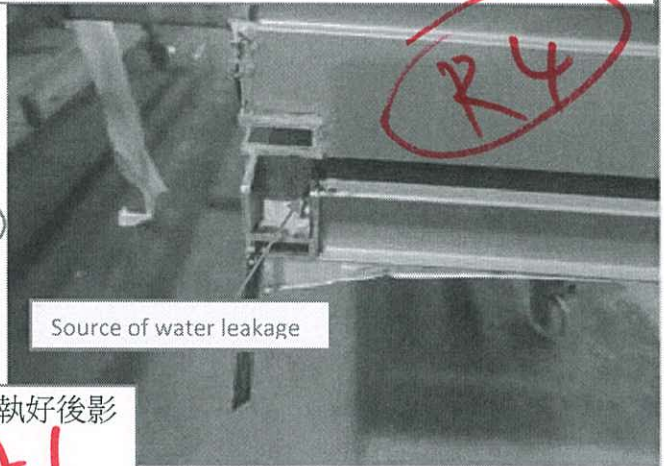
Source of water leakage

21\_9F\_T1BCW4\_AS0 入水, 執好後影相。

19\_Water leakage was found inside spandrel backpan

20\_Damage sealant was found at end position of mullion

Action: MIDI is required to carry out their internal QA/QC method to repair the leakage unitized panel, MIDI needs to improve workmanship for

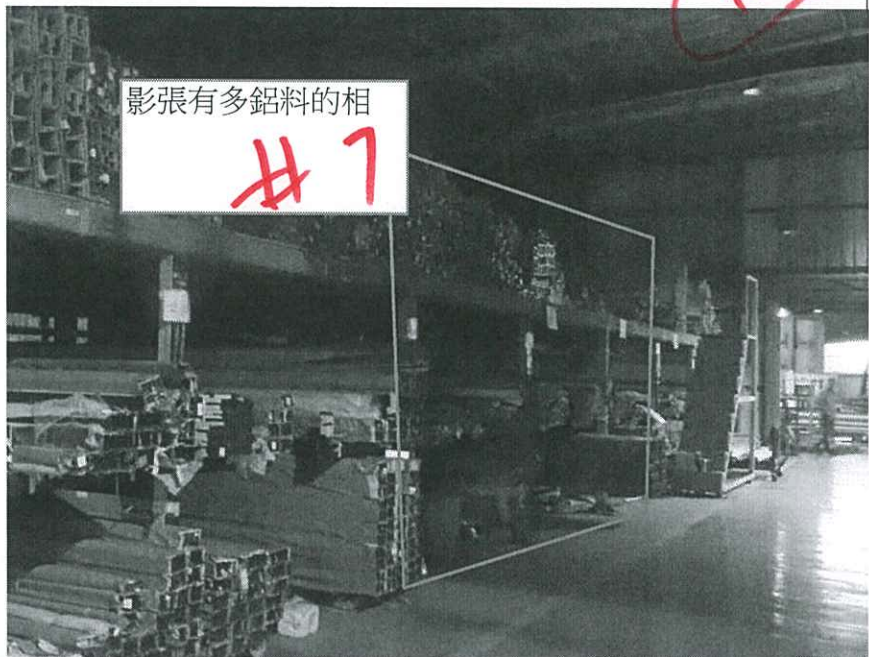
**Photo 9**

Description:  
Temporary storage area may not be sufficient for LP11 facade project

Action:  
- MIDI is required to ensure storage area are enough and proper storage before peak production period

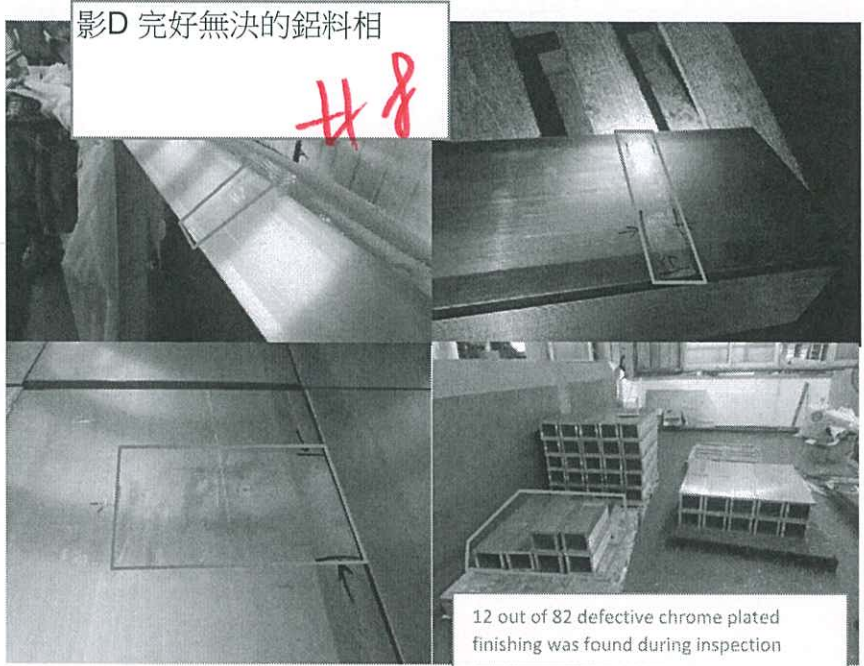
**Photo 13**

Description:  
12 out of 82 defective chrome plated finishing was found during factory inspection

Action:  
- MIDI is required to carry out their internal QA/QC method to repair the defective chrome plated finishing and improve workmanship for future works.

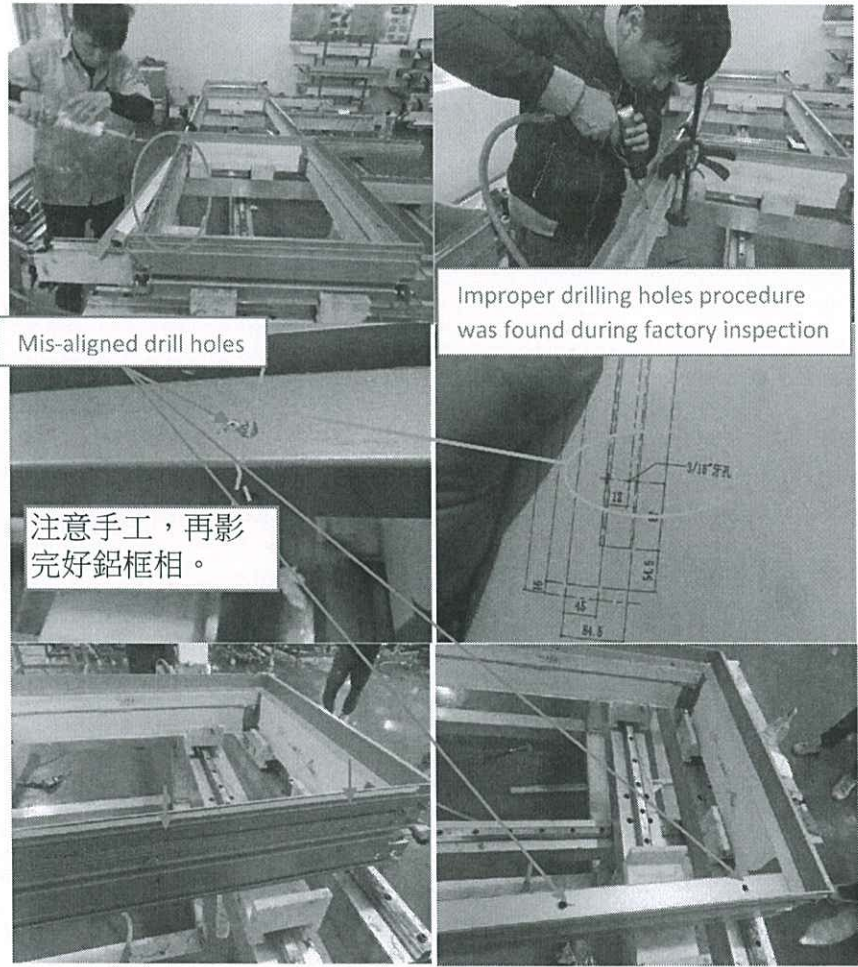
**Photo 16**

Description:  
Improper holes drilling procedure was found during factory inspection

Action:  
- MIDI is required to carry out their internal QA/QC method to improve workmanship for future works.

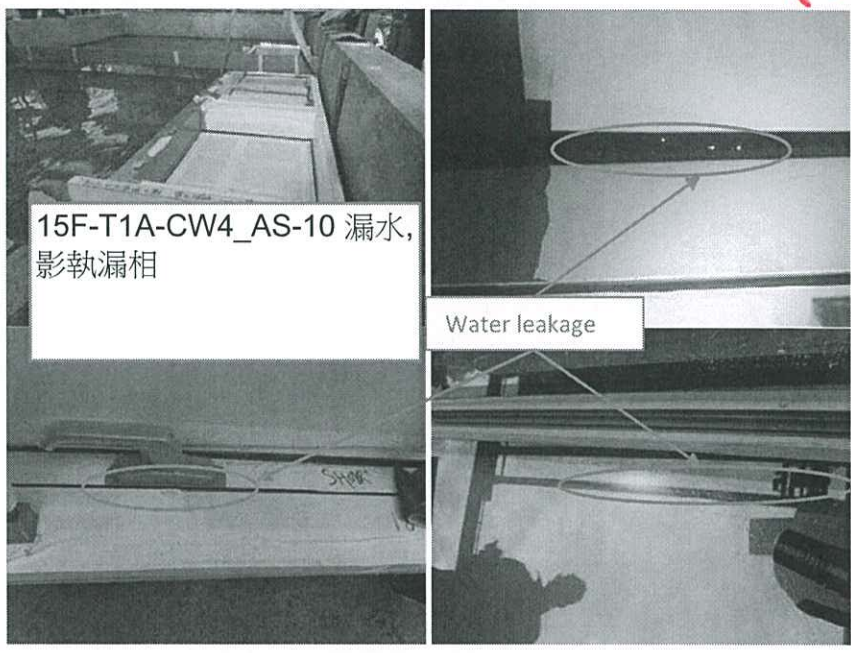
**Photo 11**

Description:  
Water leakage was found during flooding test for Panel number 15F-T1A-CW4\_AS-10

Action:  
- MIDI is required to carry out their internal QA/QC method to improve workmanship for future works

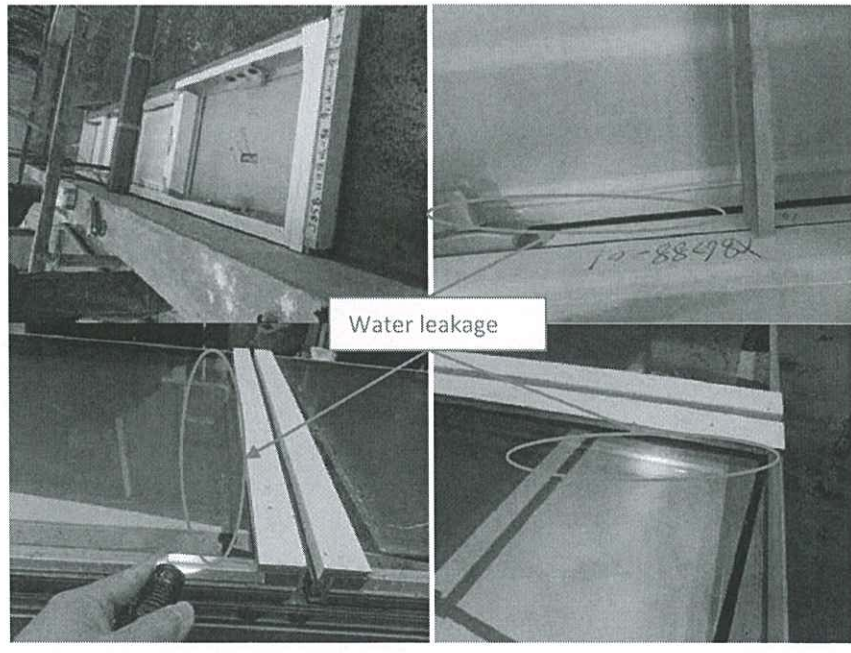
**Photo 12**

Description:  
Water leakage was found during flooding test for Panel number 16F-T1A-CW4\_AS-10

Action:  
- MIDI is required to carry out their internal QA/QC method to improve workmanship for future works

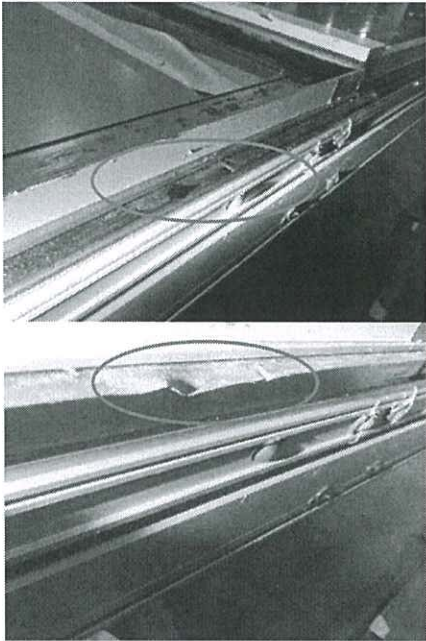
<p><b>Photo 3</b></p>

<p><u>Item:</u> Observation</p>	
<p><u>Description:</u> Defective gasket was found during factory inspection for Zone M02</p>	
<p><u>Action:</u> - MIDI is required to replace the defective gasket</p>

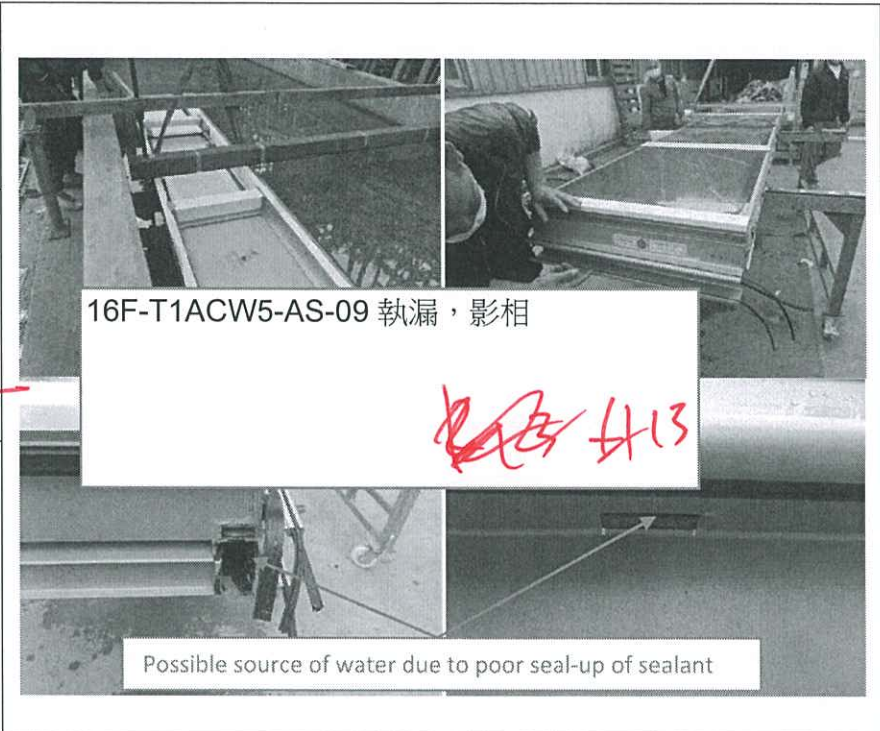
<p><b>Photo 13</b></p>

<p><u>Item:</u> Observation</p>	
<p><u>Description:</u> Water leakage was found during flooding test for Panel number 16F-T1ACW5-AS-09</p>	
<p><u>Action:</u> - MIDI is required to carry out their internal QA/QC method to improve workmanship for future works</p>	
	<p style="text-align: right; color: red; font-size: 2em;">#14.</p>
<p><b>Photo 14</b></p>

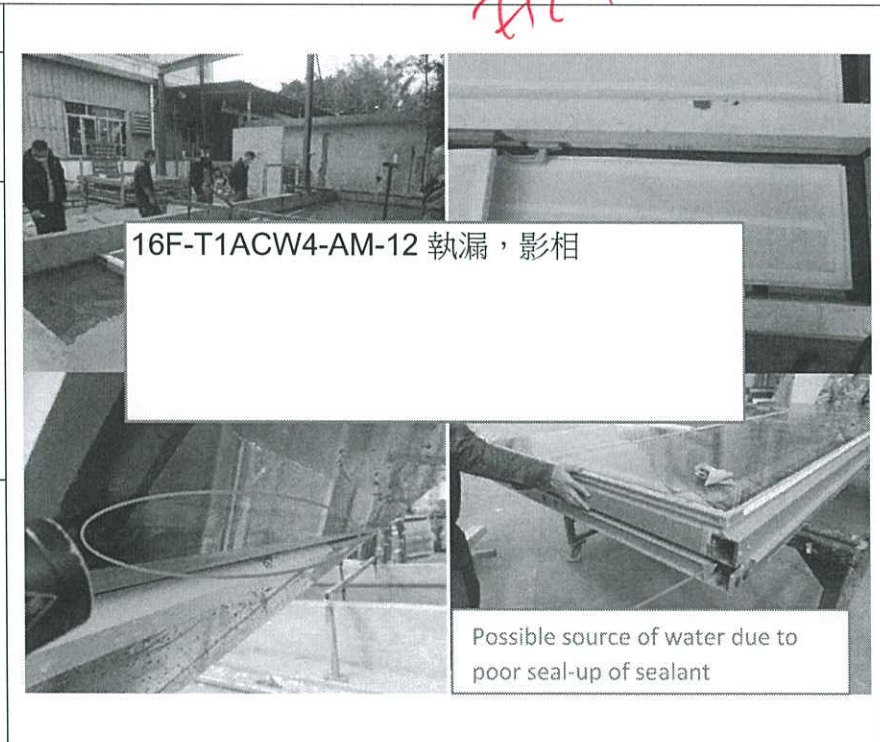
<p><u>Item:</u> Observation</p>	
<p><u>Description:</u> Water leakage was found during flooding test for Panel number 16F-T1A CW4-AM12</p>	
<p><u>Action:</u> - MIDI is required to carry out their internal QA/QC method to improve workmanship for future works</p>

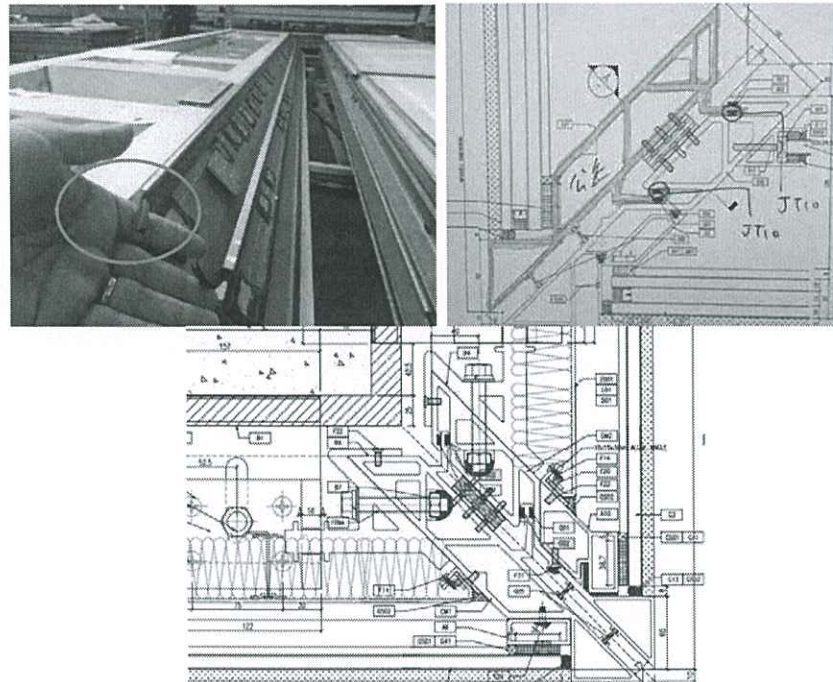
**Photo 6**

Gasket of unitized panels for Zone M01 & 02 were found not match with design drawing

-MIDI is reminded to carry out the remedial works prior products delivery and to improve workmanship for future works

影跟圖款一樣膠條相

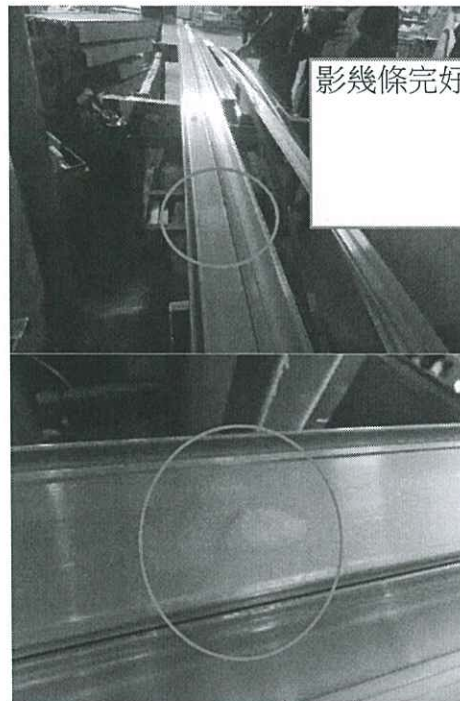
**Photo 6**

Description:  
Defective chrome plated finishing for gutter sleeve was found during factory inspection

Action:  
- MIDI is required to carry out their internal QA/QC method to repair the defective chrome plate finishing and improve workmanship for future works

影幾條完好的鉻化防水片相

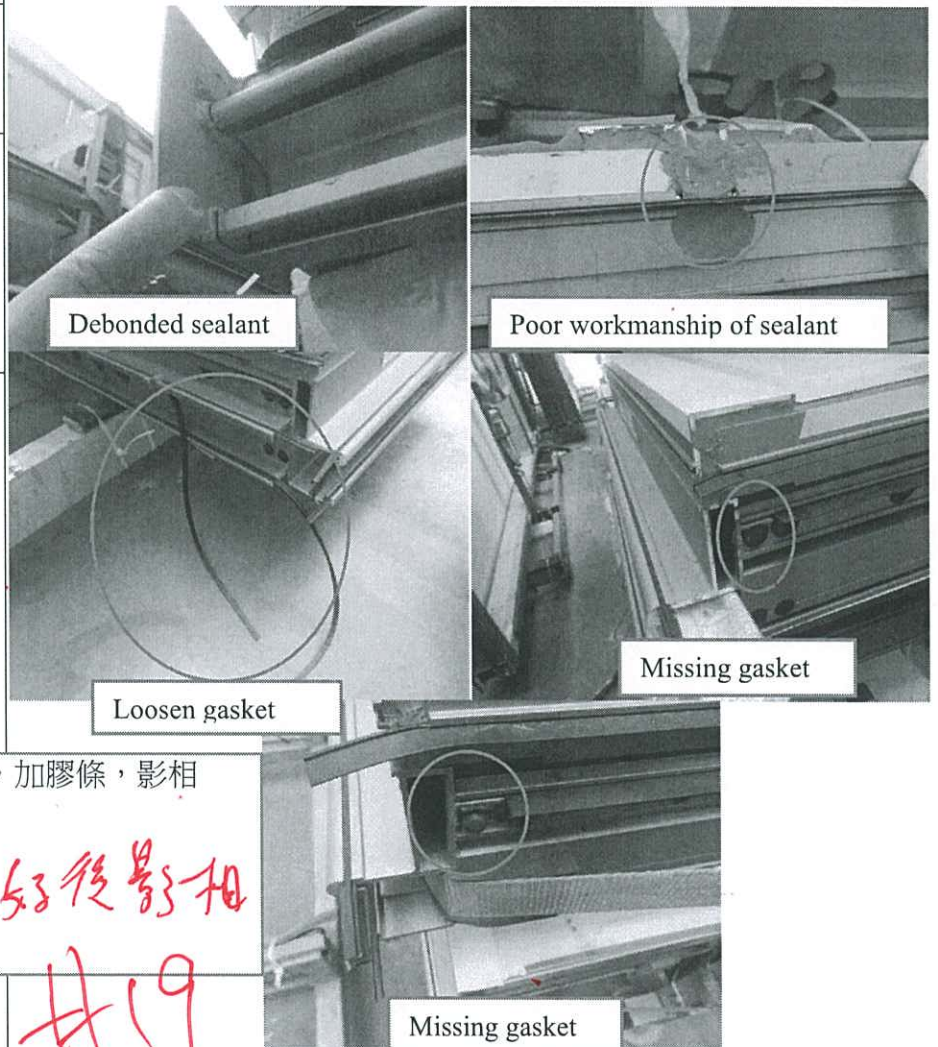
**Photo 10**

Description:  
Defective sealant and gasket for 2<sup>nd</sup> & 3<sup>rd</sup> log unitized panels were found during final inspection and packing

Action:  
- MIDI is reminded to carry out the remedial works prior products delivery and to improve workmanship for future works

啱好膠，加膠粒，加膠條，影相  
同一向畫好後影相  
詹 廿九

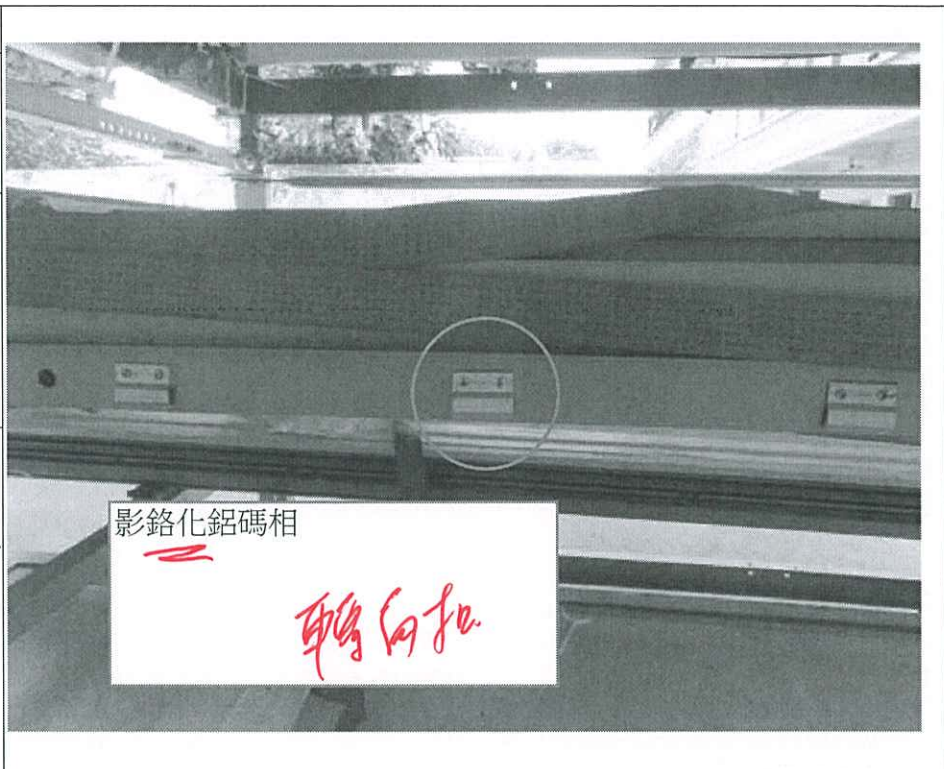
**Photo 11**

Description:  
Defective chrome plated finishing for extrusion clip was found during factory inspection

Action:  
- MIDI is required to carry out their internal QA/QC method to repair the defective chrome plate finishing and improve workmanship for future works

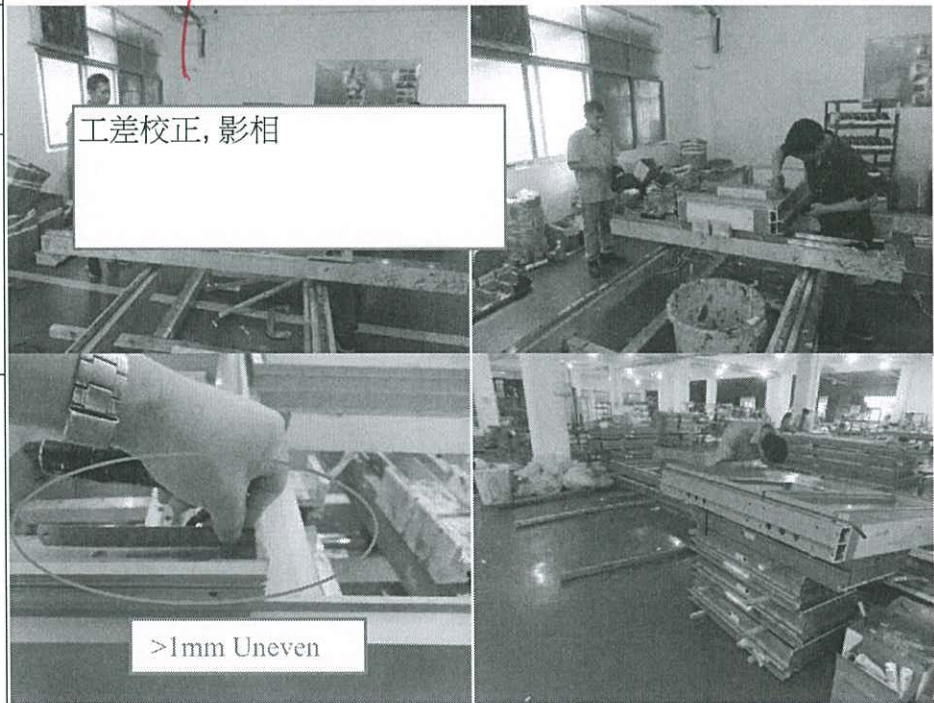
**Photo 6**

Description:  
Uneven of components was found during factory inspection

Action:  
- MIDI is required to improve workmanship for further works

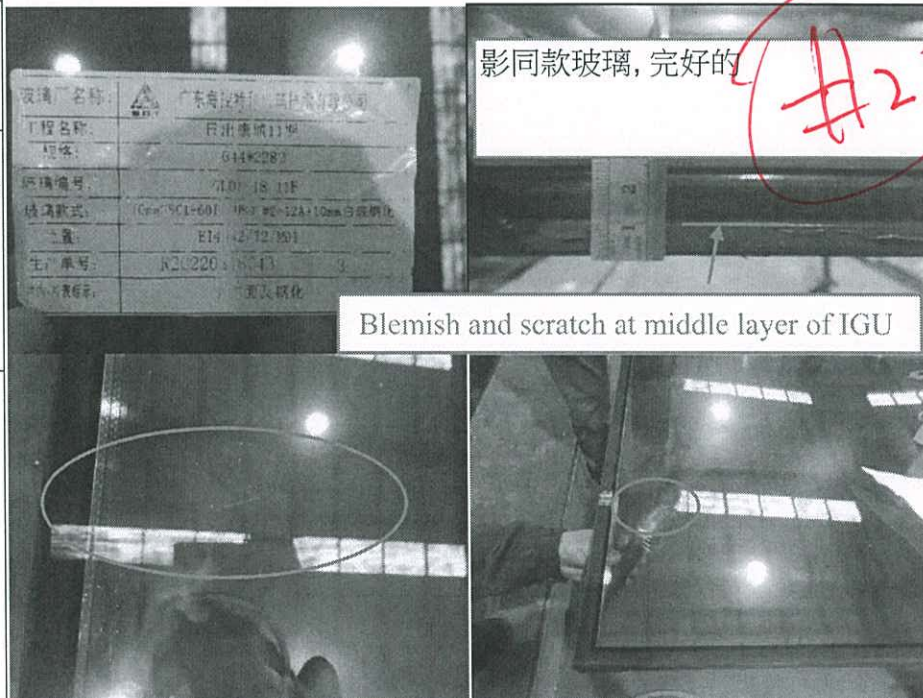
**Photo 10**

Description:  
Blemish and scratch was found at middle layer of IGU

Blemish and scratch at middle layer of IGU

Action:  
- MIDI is required to improve workmanship for further works

影同款玻璃, 完好的

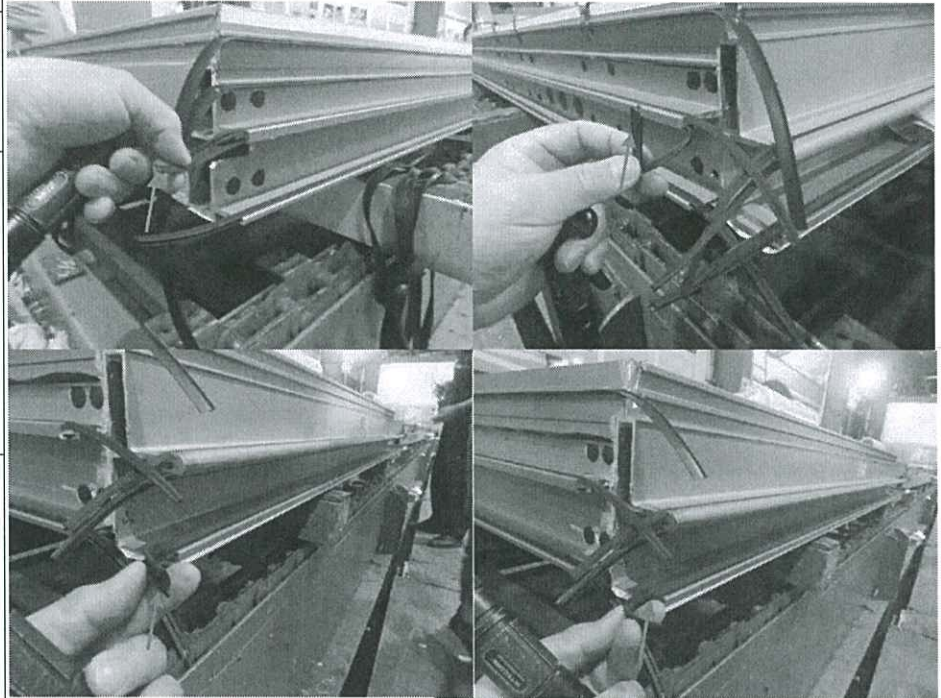
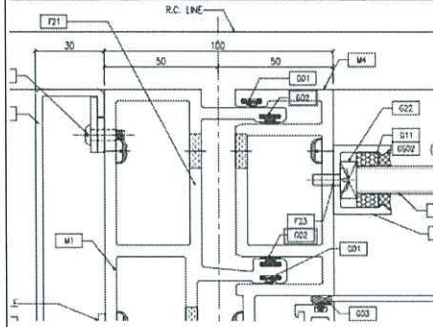
**Photo 11**

Description:  
Gasket of 2 numbers of unitized panel were found not match with design drawing during factory inspection

Action:  
- MIDI is reminded to carry out the remedial works prior products delivery and to improve workmanship for future works

更換正確的膠條, 影相  
*Handwritten signature*

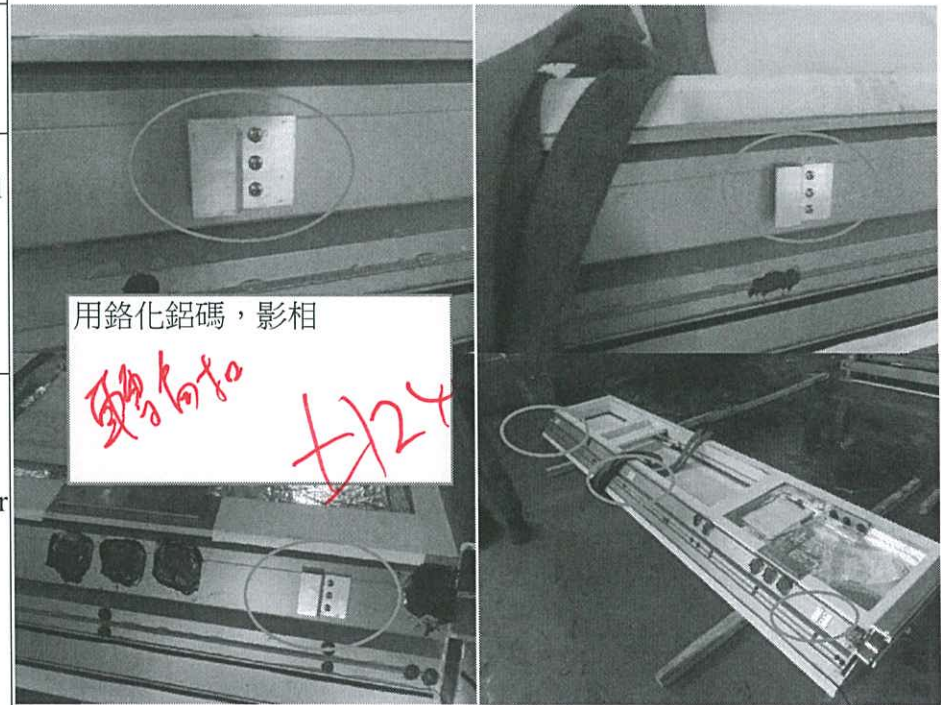
**Photo 12**

Description:  
Defective chrome plated finishing for extrusion clip was found during factory inspection

Action:  
- MIDI is required to carry out their internal QA/QC method to repair the defective chrome plate finishing and improve workmanship for future works

用鉻化鋁碼, 影相  
*Handwritten signature*

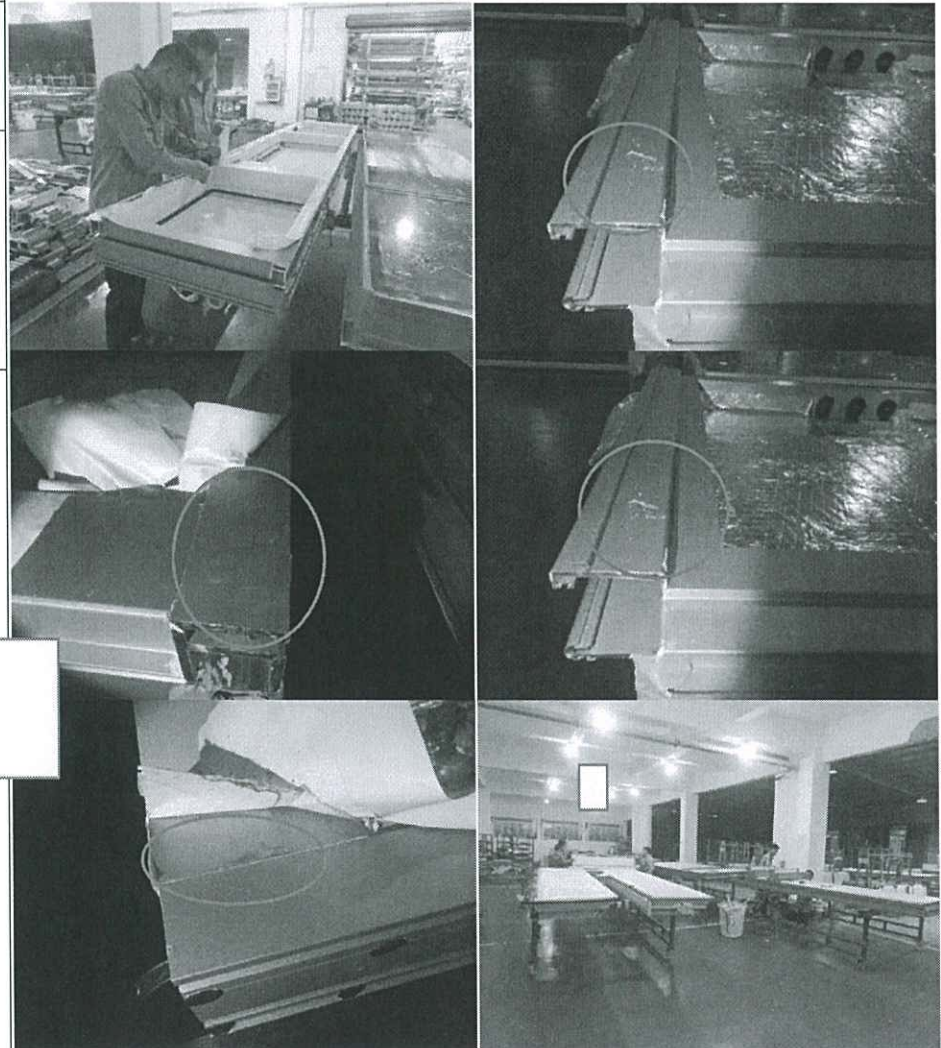
**Photo 10**

Description:  
Excessive sealant and stain was found on unitized panel surface after packing

Action:  
- MIDI is required to improve workmanship for further works

影完好框相
