工程指示 / 要求簡箋(E.I.)

工程指示編號：EI / 6088 / 23

工程名稱：將軍澳日出康城 11

工程項目：幕牆 單元件大貨廠用帆布遮蓋事宜

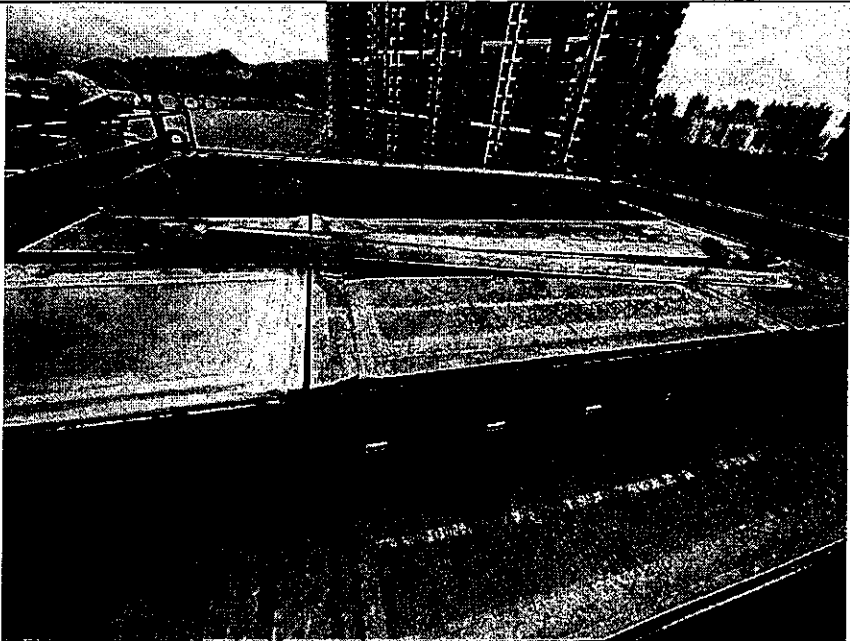
### Photo 1

The alum. angle was observed to be placed on curtain wall glass surface. MIDI is required to separately package material by types to avoid contacting damage.

已更換保護坑紙，並提醒廠注意保護坑紙品質

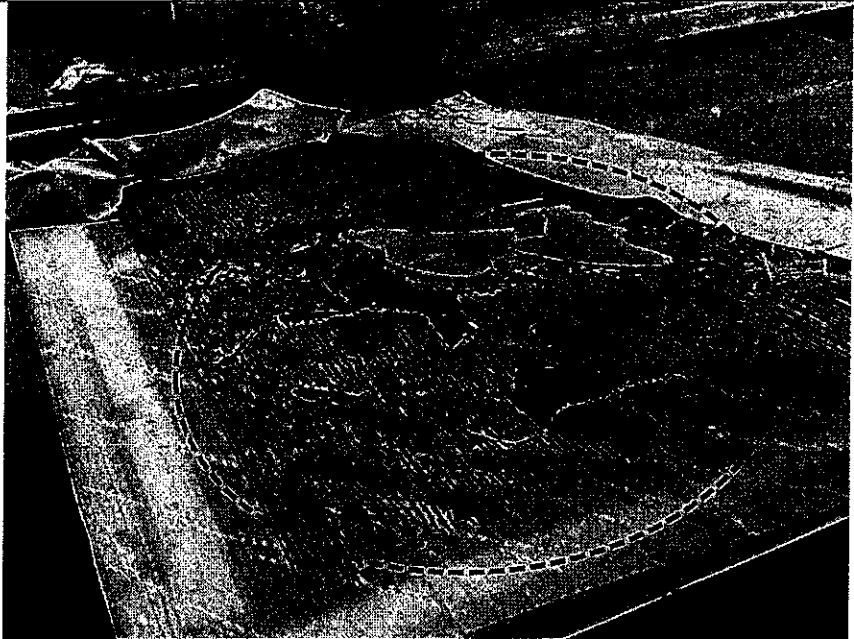
**Photo 3**

The protection hollow board was observed to be seriously senescent and brickle. MIDI is required to replace with Anti-UV Hollow Board 3mm as per approved method statement for all the units.

已更換保護坑紙，並提醒廠注意保護坑紙品質

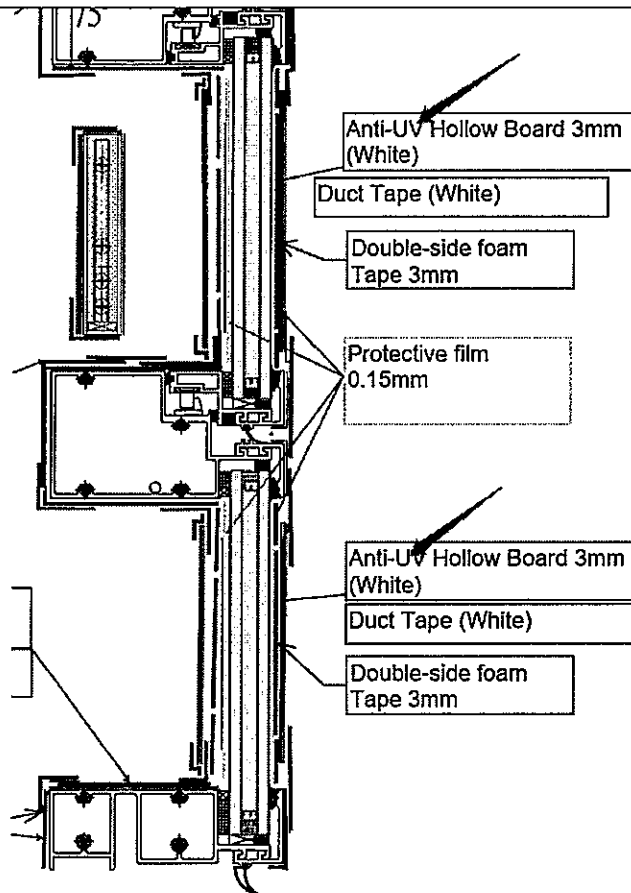
**Photo 4**

Approved method statement of protection indicates for Anti-UV Hollow Board 3mm.
