PROPOSED RESIDENTIAL
DEVELOPMENT AT TKOTL 70RP,
PHASE 11. LOHAS PARK, TSEUNG
KWAN O. N.T.

Factory Inspection Report 19

Inspection Date: 31st March 2023
Issue Date: 01st April 2023

Report Reference: 60646872-FI-R-19

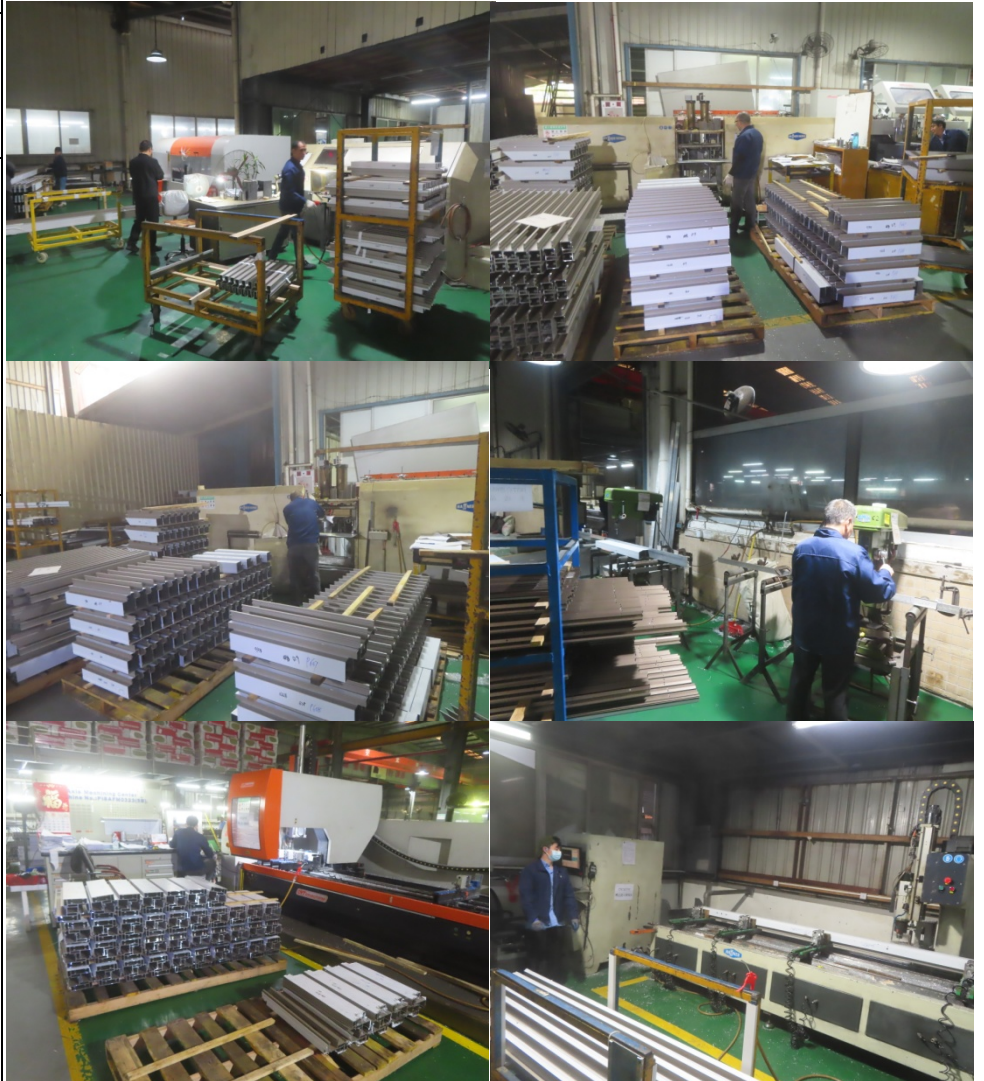
Photo 1

Description:
Materials cutting, milling and drilling of extrusions for T3 18/F to 21/F Zone M10 unitized panels (Details please refer to Appendix A)

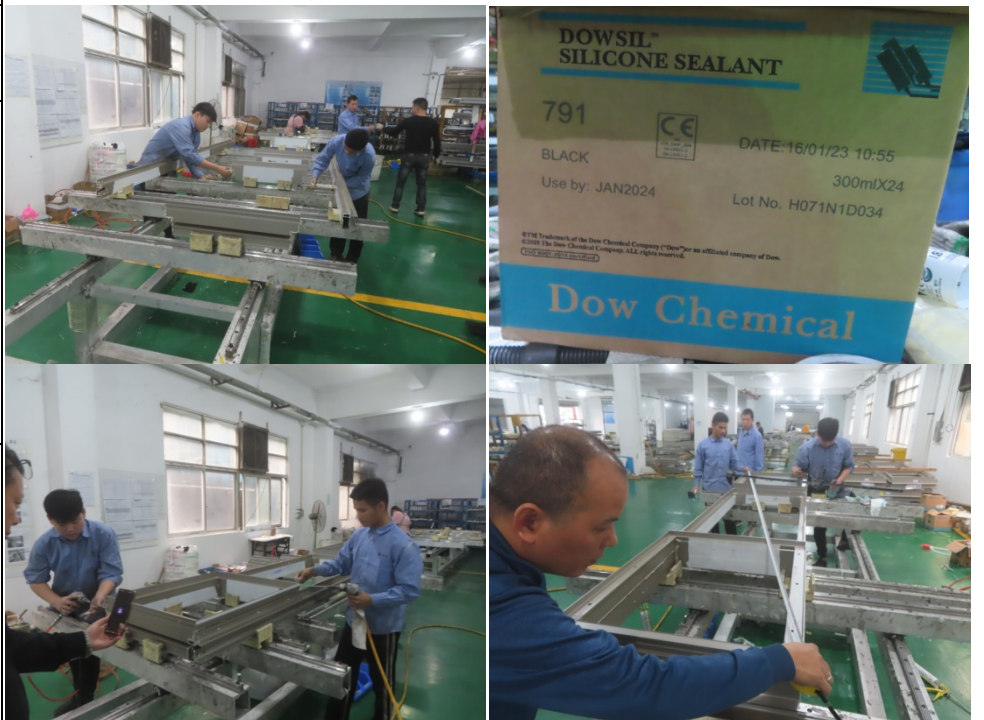
Photo 2

Description:
Fit-up assembly of Mullion and Transom for T3 12-17/F and T3 18/F to 21/F Zone M08 & M10

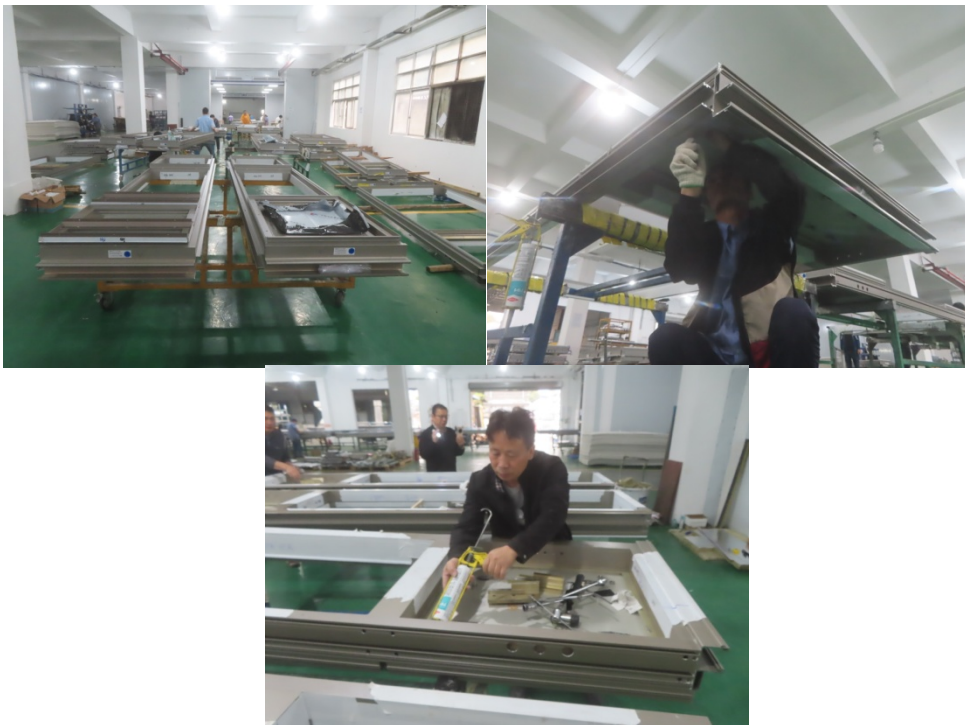
Photo 3

Description:
Fixing of back panel and sealant works for T3 12-17/F and T3 18/F to 21/F Zone M08 & M10

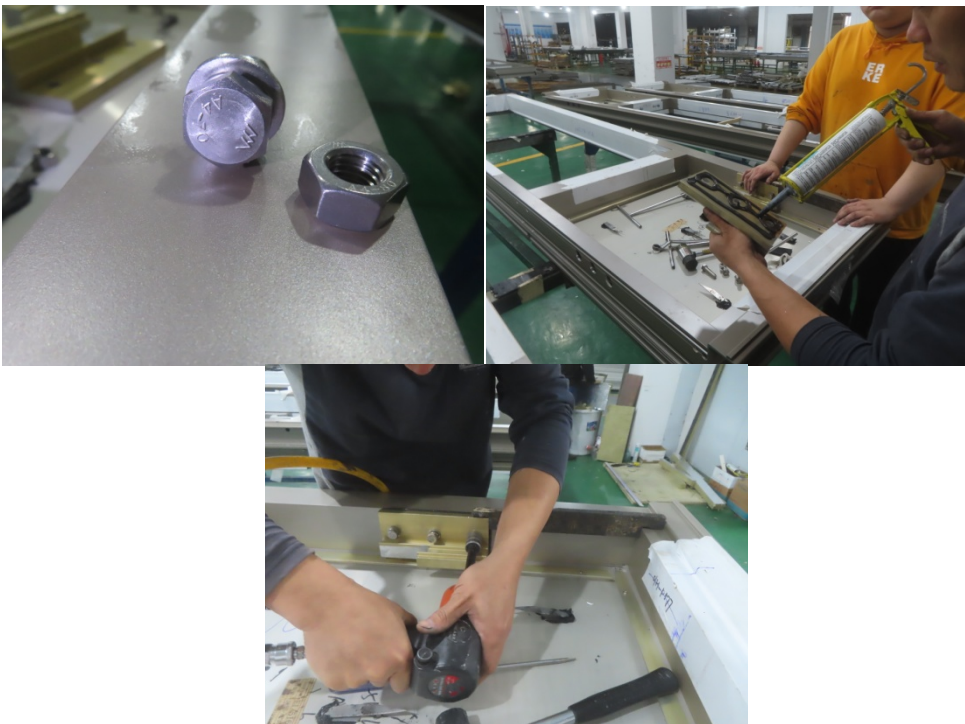
Photo 4

Description:
Fixing of hanger bracket for T3 12-17/F and T3 18/F to 21/F Zone M08 & M10

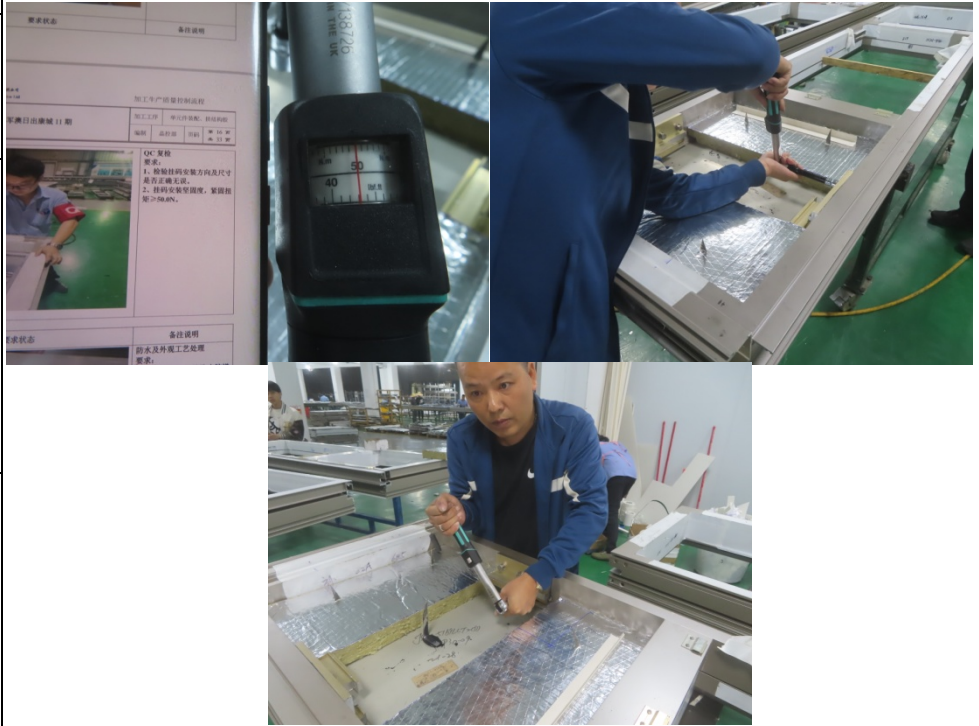
Photo 5

Description:
General inspection of torque test for M12 stainless steel bolt and nut for hanger bracket

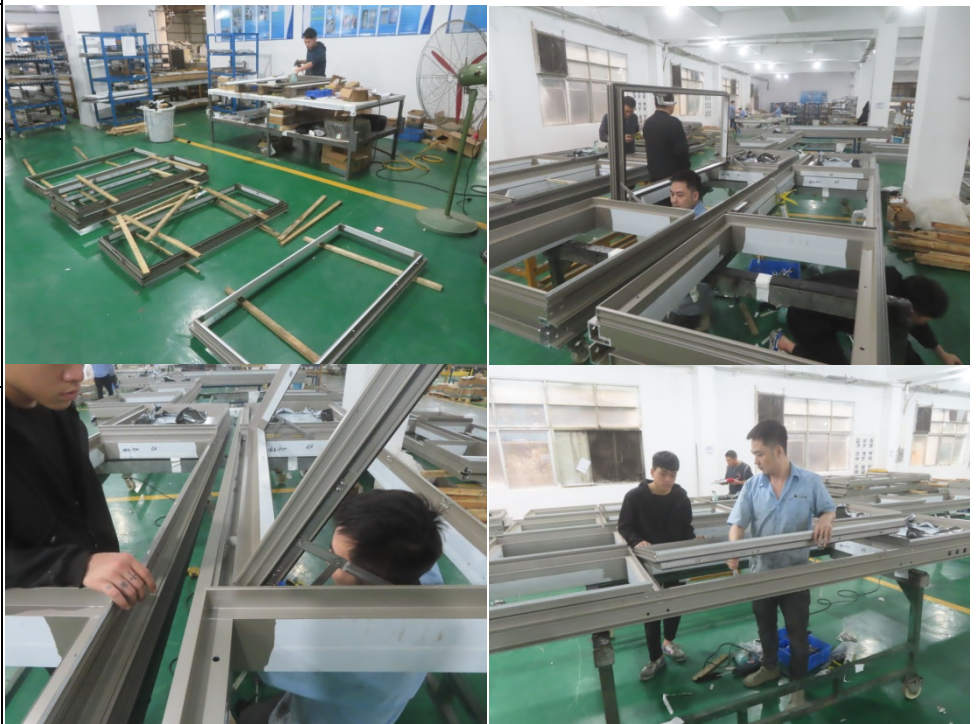
Photo 6

Description:
Fit-up assembly of operable window frame for T3 12-17/F and T3 18/F to 21/F Zone M08 & M10

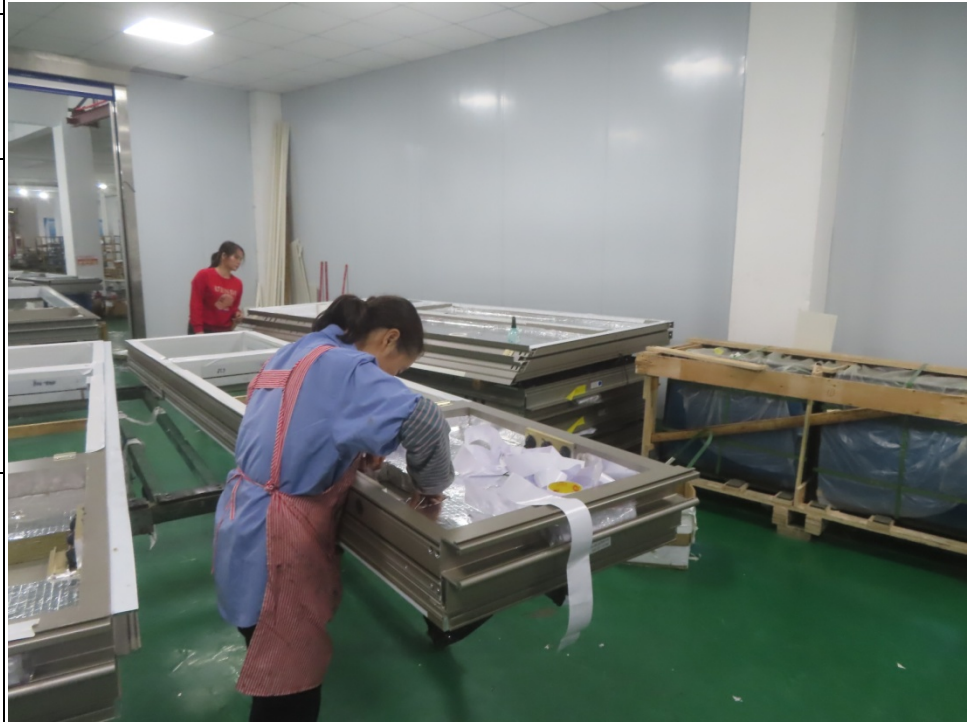
Photo 7

Description:
Quality checking of thermal insulation for back panel

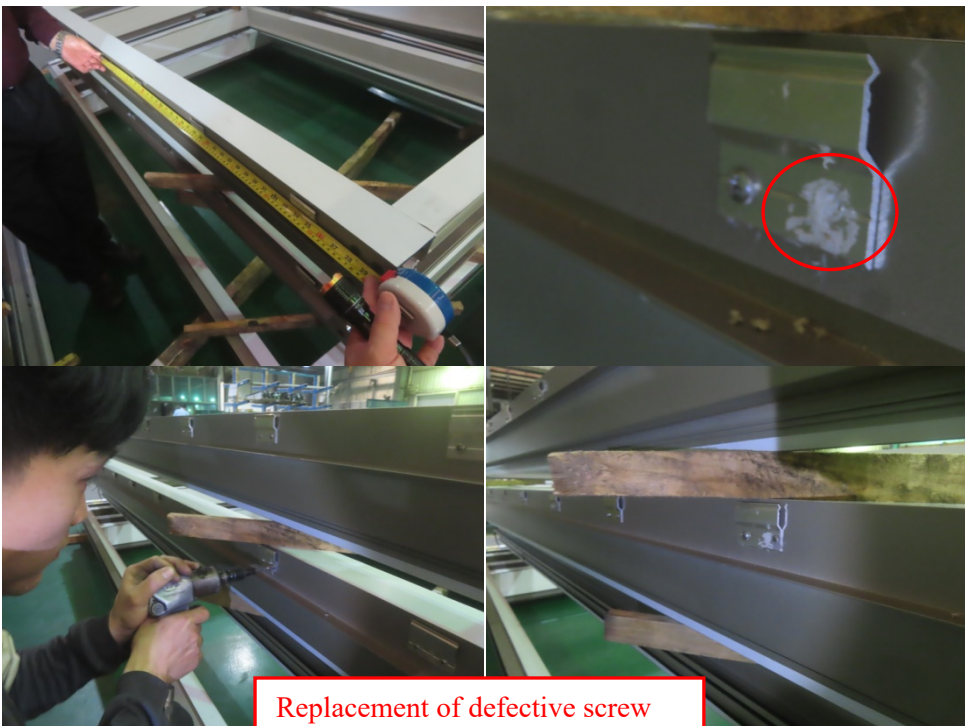
Photo 6

Description:
Damaged screw head was found on buckling clip BC03 during factory inspection

Replacement of defective screw

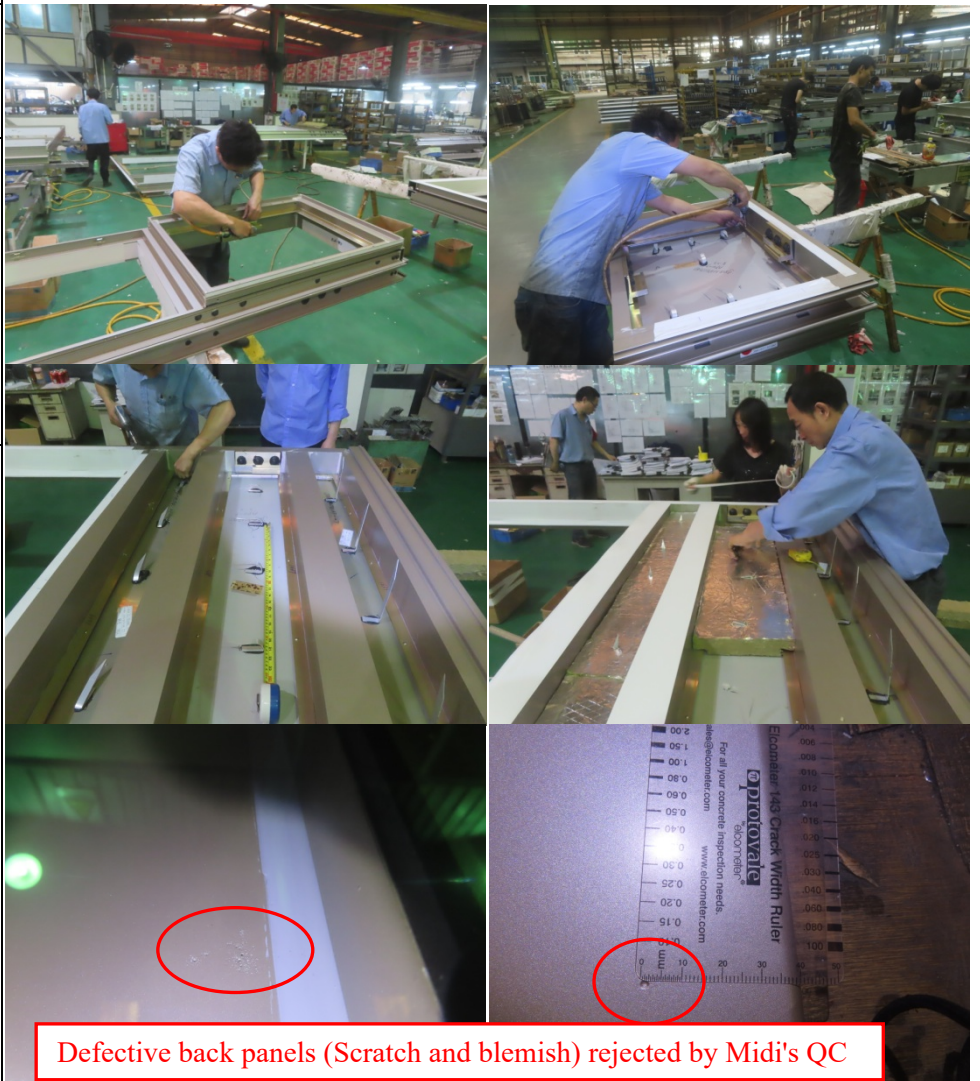
Photo 8

Description:
Fixing of back panel and insulation for T1 17/F to 21/F Zone M011

Defective back panels (Scratch and blemish) rejected by Midi's QC

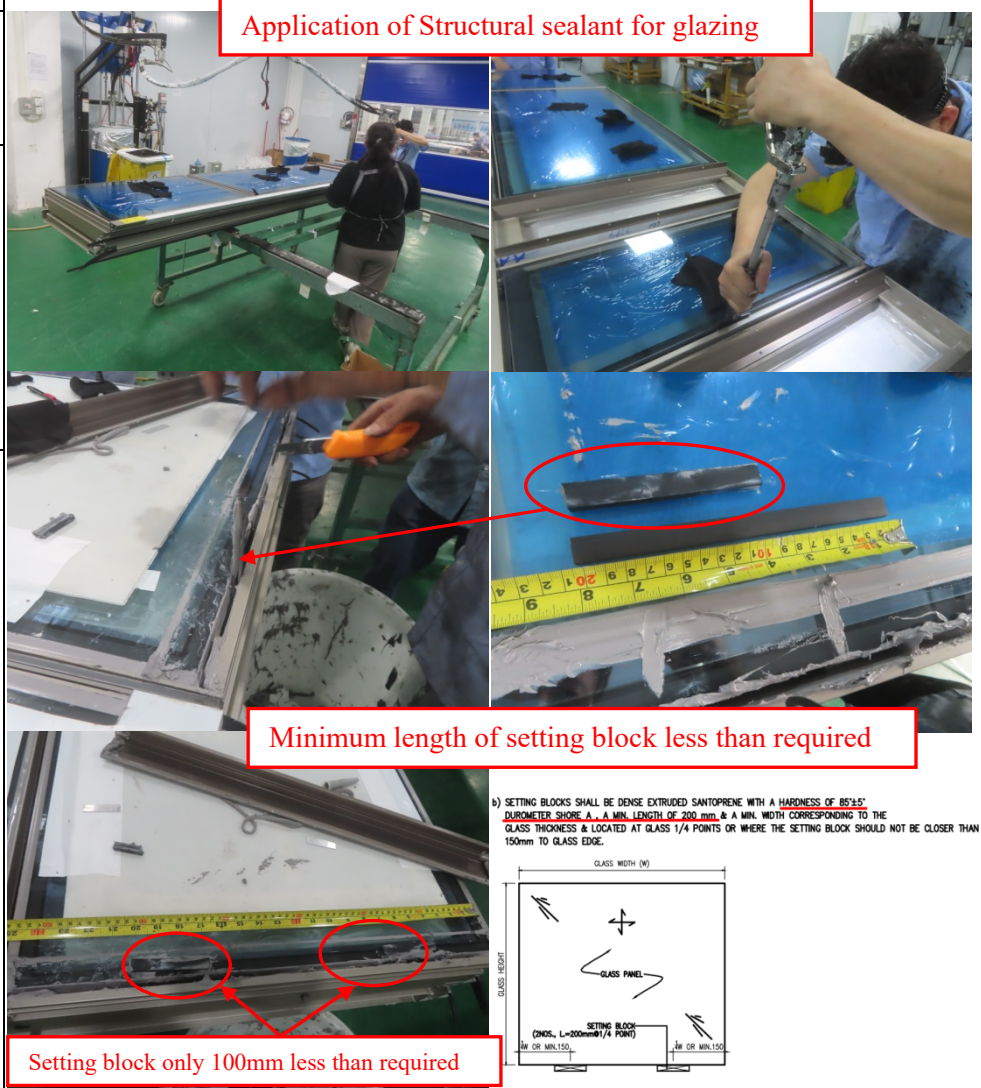
Description:
Application of structural sealant for T3 18-21/F Zone M10, T3 17-21/F Zone M011

Minimum length of setting block less than required

Action:
- MIDI is reminded to carry out the remedial works prior products delivery and to improve workmanship for future works

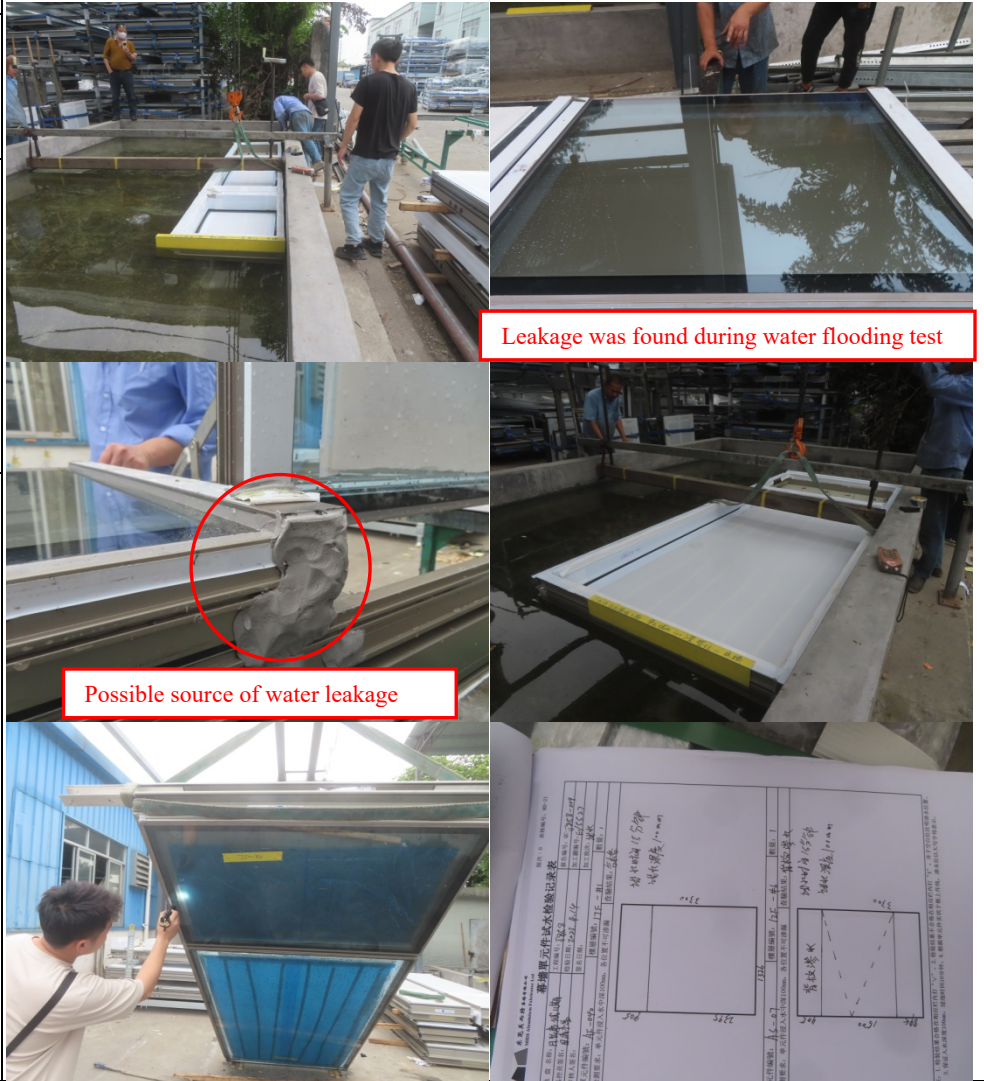
Description:
Water test of 2 numbers unitized panel.
Water leakage was found during flooding test for panel number 12/F_T3B-CW4_AS-07

Action:
- MIDI is required to carry out their internal QA/QC method to improve workmanship for future works

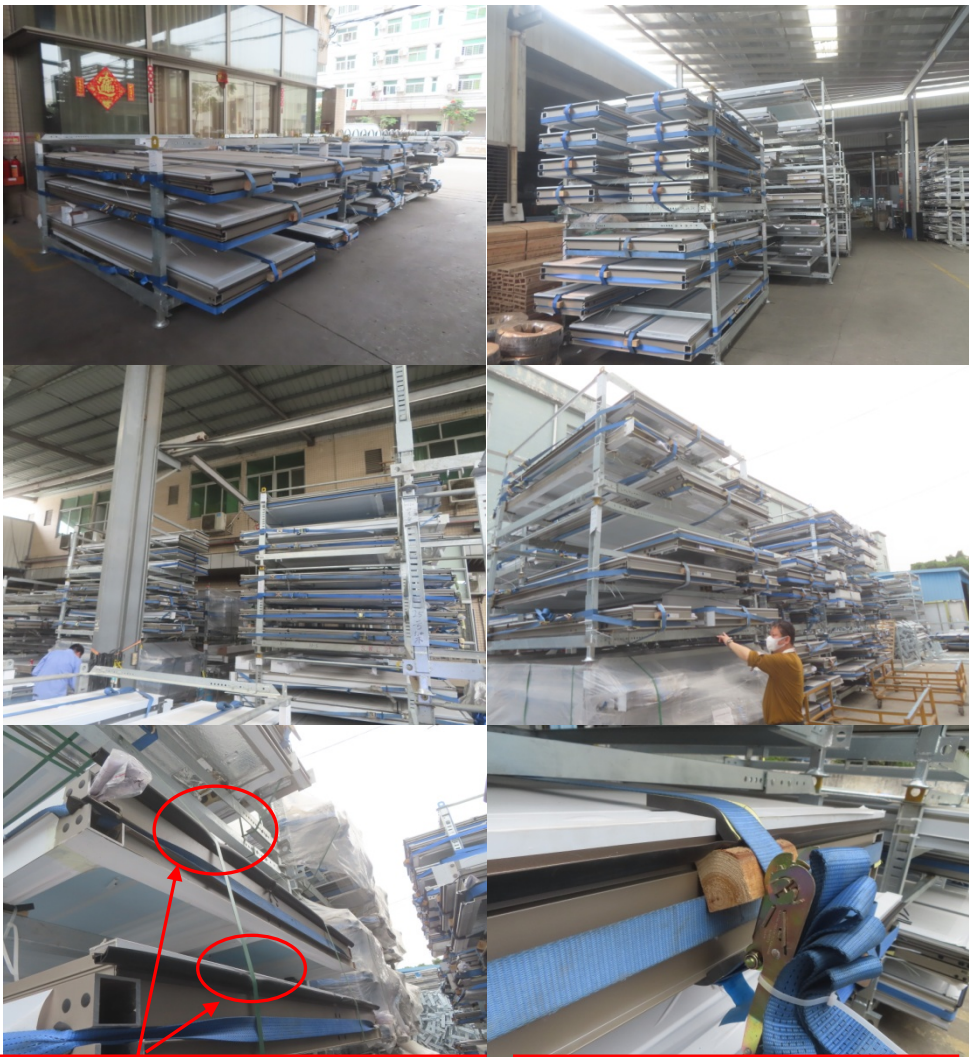
Photo 13

Description:
Final inspection of unitized panels for T2 9 to 17/F (Zone M05 & M06) and T3 12 to 17/F (Zone M08)

Missing wooden block for protection of gasket

Action:
- MIDI is reminded to carry out the remedial works prior products delivery and to improve workmanship for future works

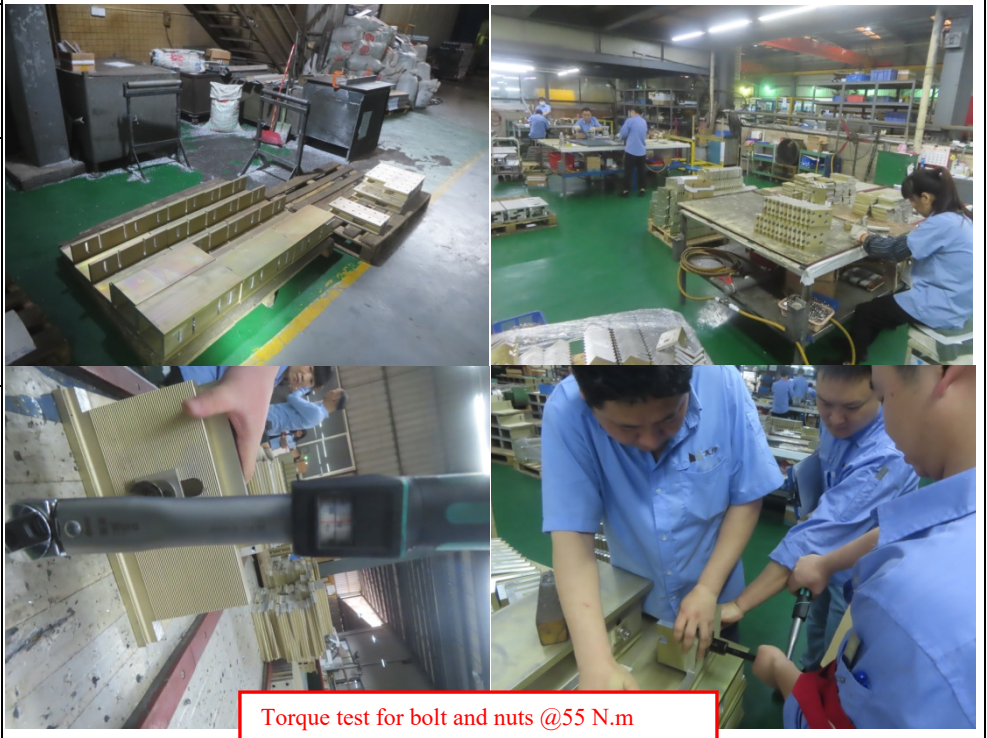
Photo 16

Description:
General inspection of bracket during fabrication

Torque test for bolt and nuts @55 N.m

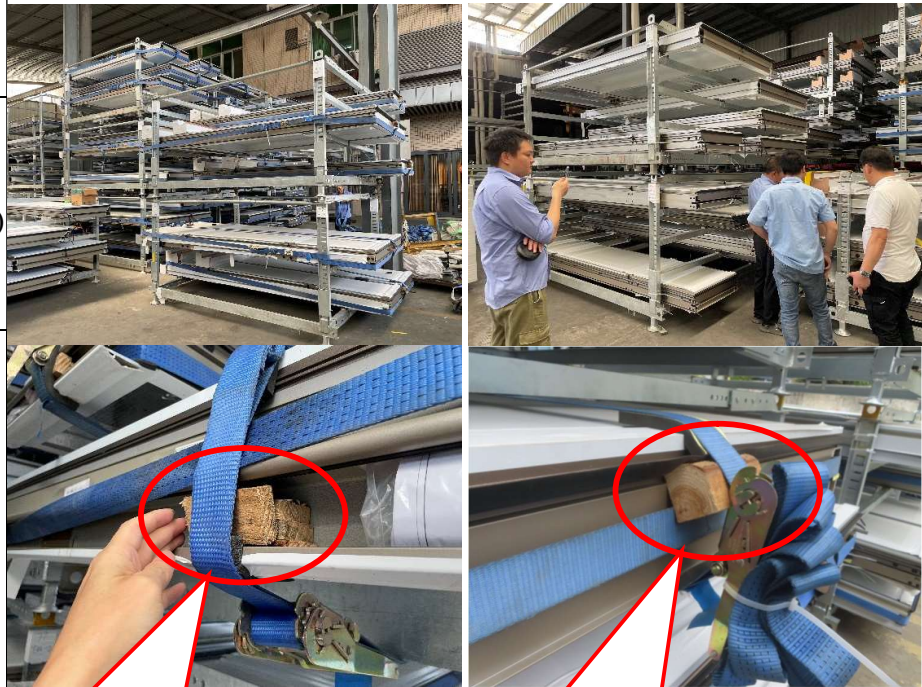
Undersize setting block was found during factory inspection

Action:
- MIDI is reminded to carry out the remedial works prior products delivery and to improve workmanship for future works
