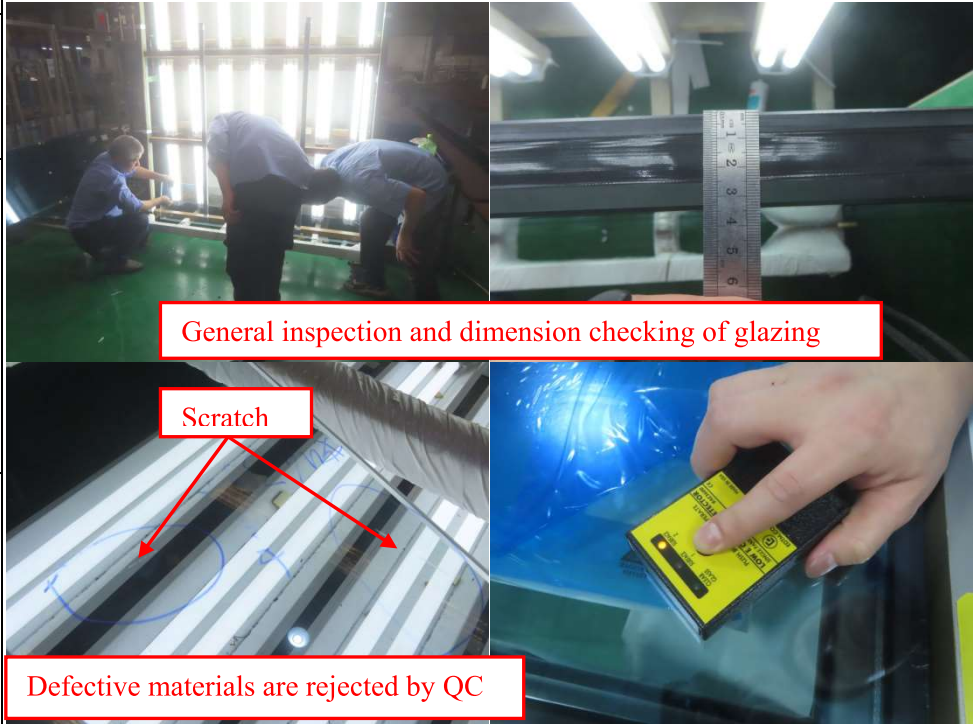
Photo 9

Description:
Quality and dimension checking of glazing prior sealant work

General inspection and dimension checking of glazing

Scratch

Defective materials are rejected by QC

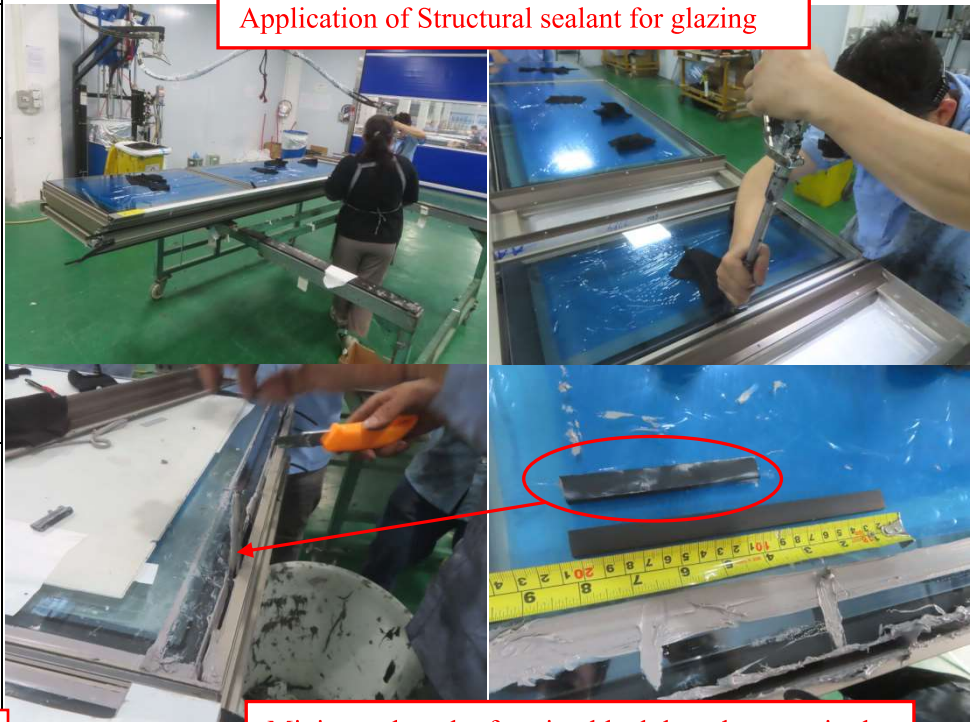
Photo 10

Description:
Application of structural sealant for T3 18-21/F Zone M10, T3 17-21/F Zone M011

Application of Structural sealant for glazing

Minimum length of setting block less than required

Action:
- MIDI is reminded to carry out the remedial works prior products delivery and to improve workmanship for future works

#1:
黑膠墊最少要長 200mm, 補相

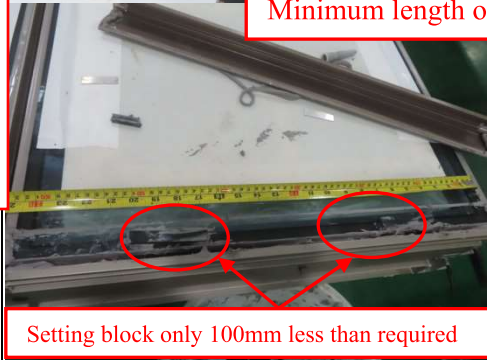
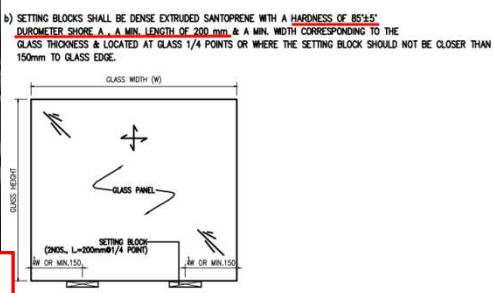
Setting block only 100mm less than required

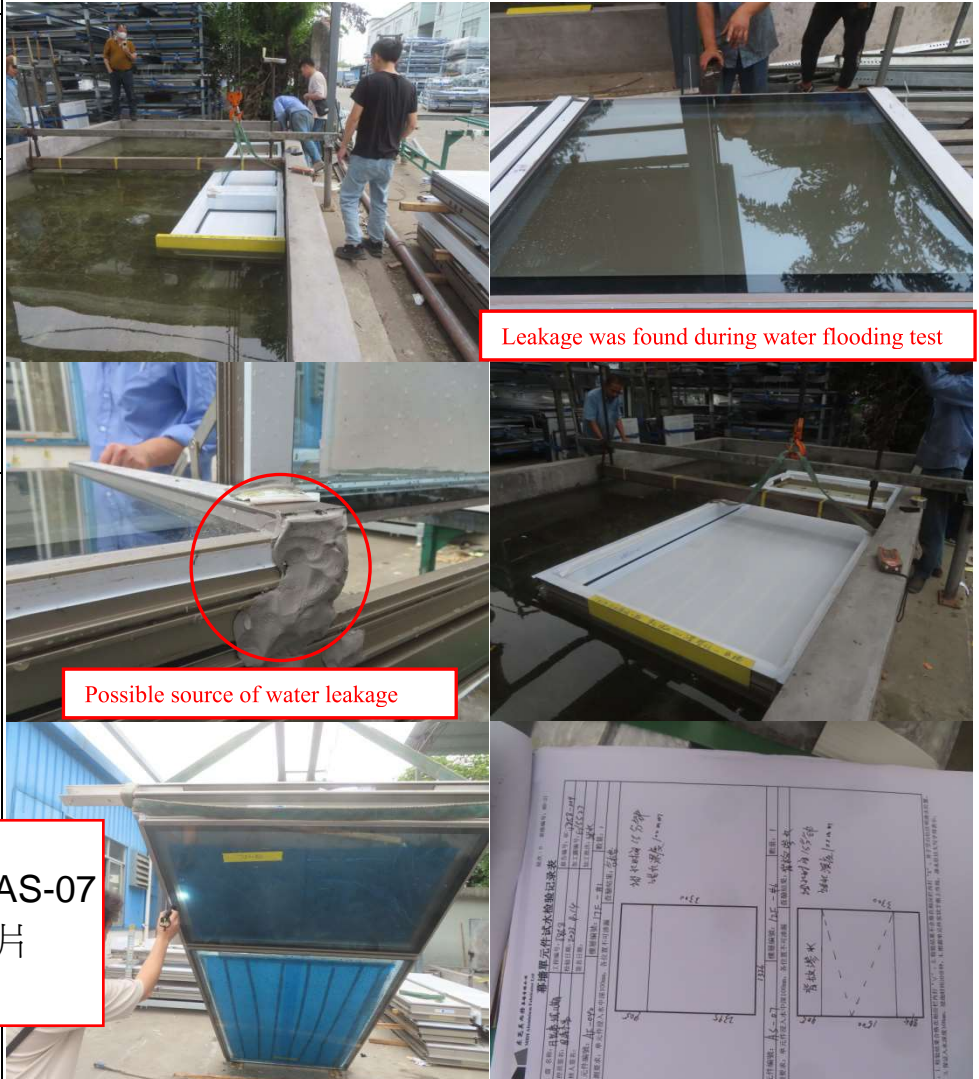
Photo 11

Description:
Water test of 2 numbers unitized panel.
Water leakage was found during flooding test for panel number 12/F_T3B-CW4_AS-07

Leakage was found during water flooding test

Possible source of water leakage

Action:
- MIDI is required to carry out their internal QA/QC method to improve workmanship for future works

#2:
單元件12/F_T3B-CW4_AS-07
入水, 影合格試水紀錄照片

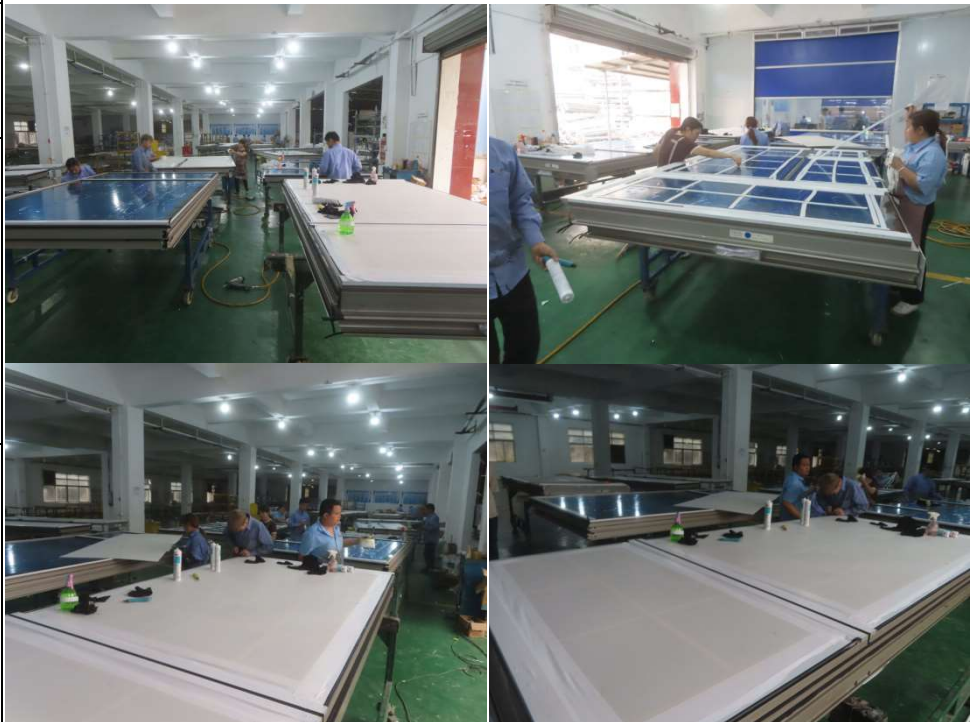
Photo 12

Description:
Fixing of capping and application of weather sealant "Dowsil 791" for T3 18-21/F Zone M10, T3 17-21/F Zone M011 unitized panels

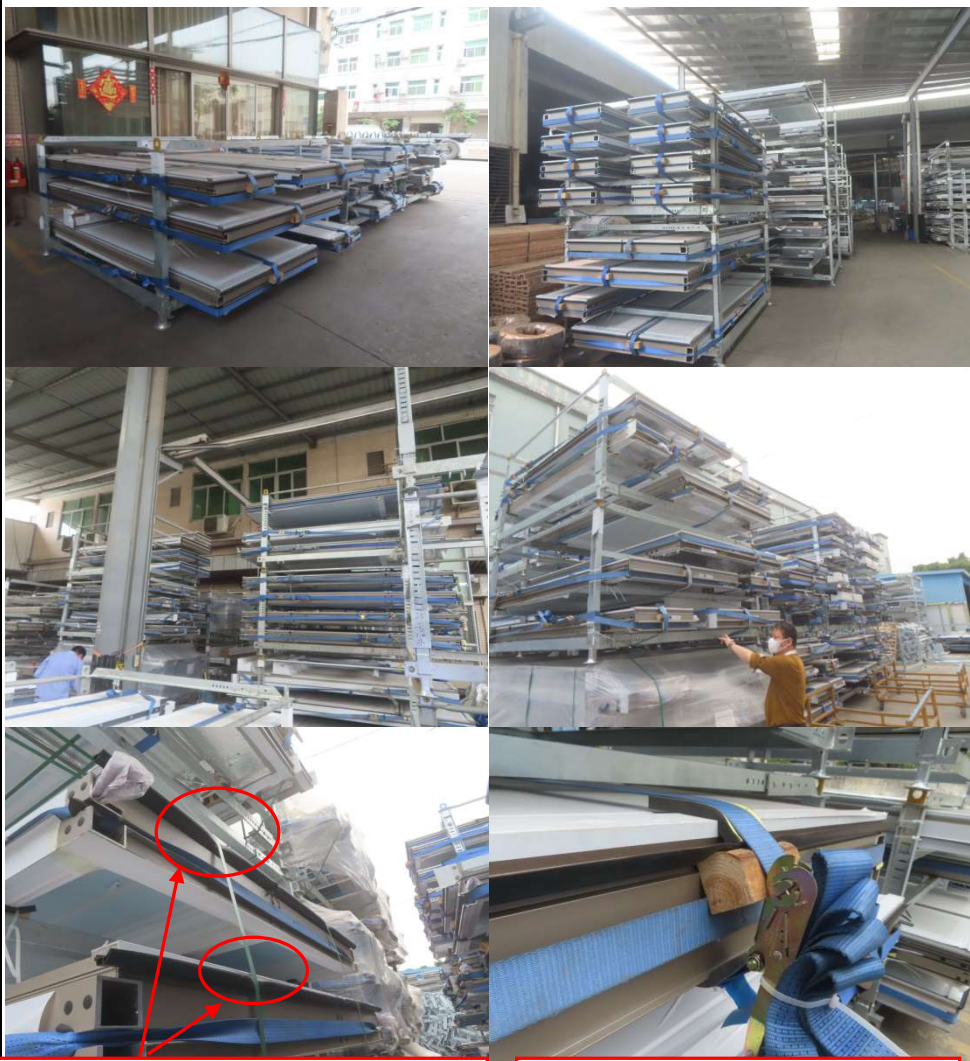
Photo 13

Description:
Final inspection of
unitized panels for T2 9
to 17/F (Zone M05 &
M06) and T3 12 to 17/F
(Zone M08)

Missing wooden block for protection of gasket

Approved packing and general protection

Action:
- MIDI is reminded to
carry out the remedial
works prior products
delivery and to improve
workmanship for future
works

#3: 對膠條保護再做好一點，飛機帶跟木壓到膠條的位置做點保護，影相。

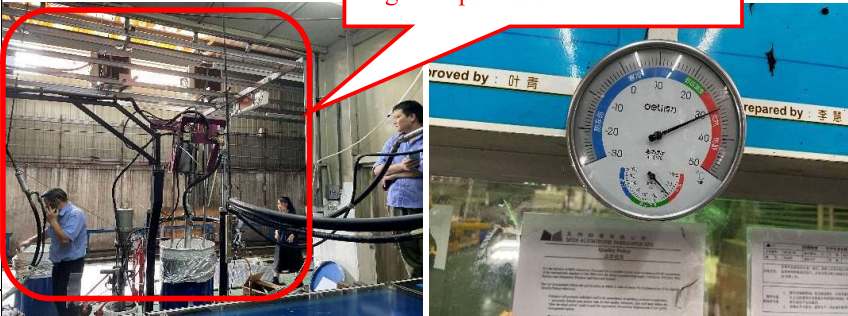
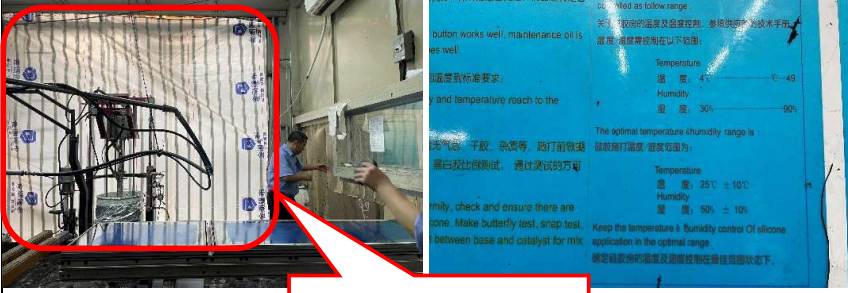
<p>Photo 8</p>		
<p><u>Location:</u> Observation</p>	<p>Glue workshop is not a closed space, resulting in more dust and high temperature</p>	
<p><u>Description:</u> Application of structural sealant for T1 17 to 21/F (Zone MO11)</p>

<p>After rectification, can continue to work</p>

<p><u>Action:</u> - MIDI is reminded to carry out the remedial works prior products delivery and to improve workmanship for future works</p>

#4: 影一張唧膠部的相是密封和溫度適中的空間。

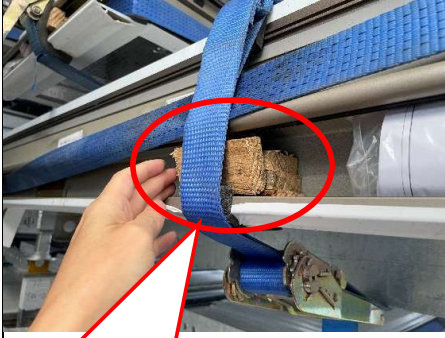
<p style="border: 1px solid red; padding: 2px; color: red; text-align: center;">Undersize setting block was found during factory inspection</p>

<p><u>Action:</u> - MIDI is reminded to carry out the remedial works prior products delivery and to improve workmanship for future works</p>

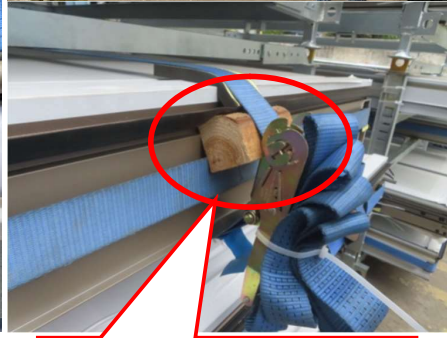
<p style="border: 1px solid red; padding: 2px; color: red; text-align: center;">Approved packing and general protection</p>
