工程指示 / 要求簡箋(E.I.)

工程指示編號：EI / 6187 23

工程名稱：將軍澳日出康城 11

工程項目：顧問上廠報告 (31/3-5/5) 精華版加完整版

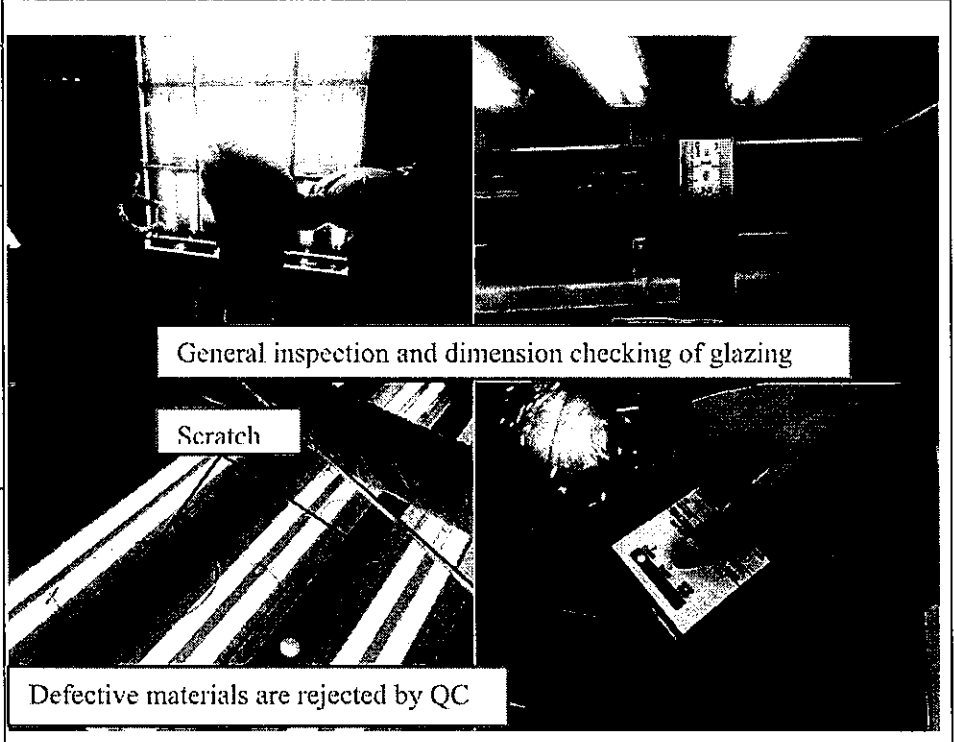
Photo 9

Description:
Quality and dimension checking of glazing prior sealant work

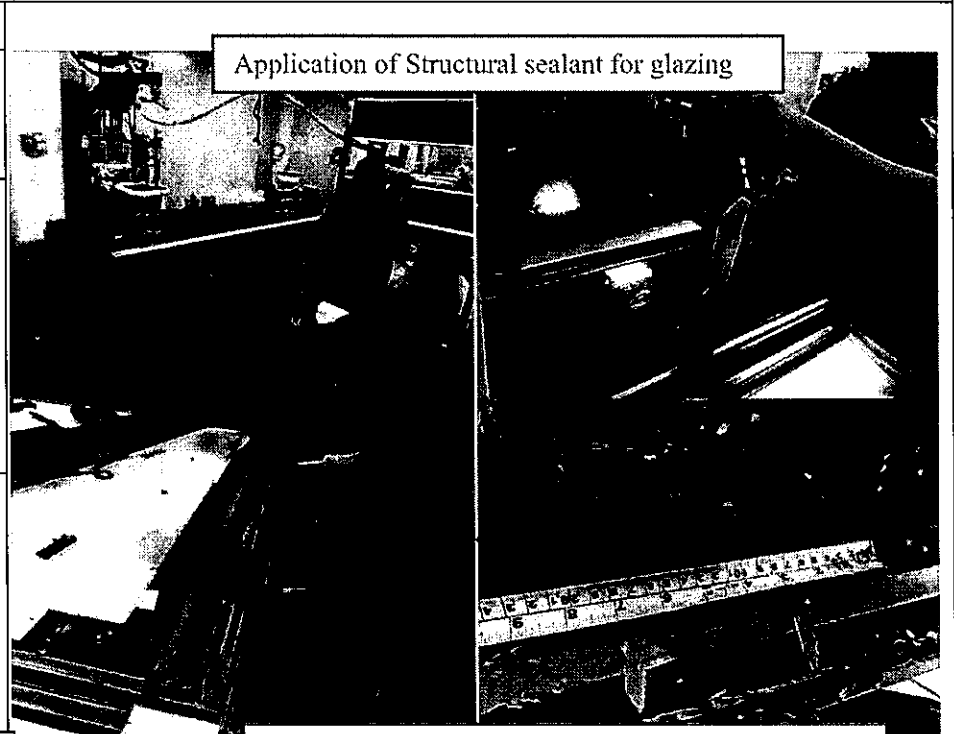
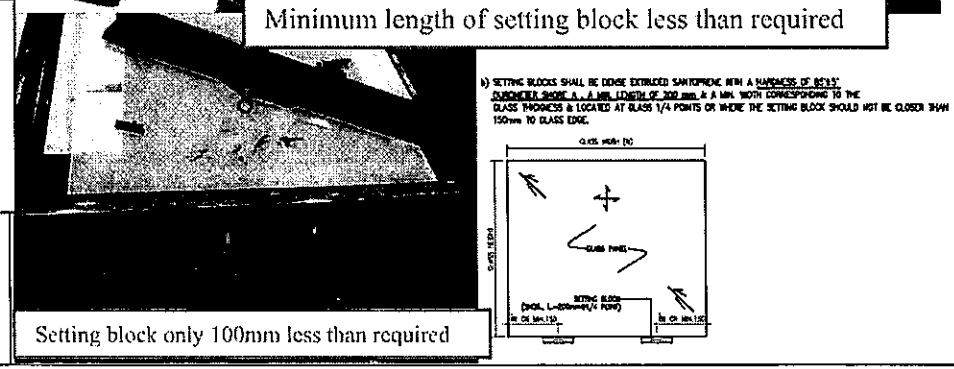
Photo 10

Description:
Application of structural sealant for T3 18-21/F Zone M10, T3 17-21/F Zone M011

#1:
黑膠墊最少要長 200mm, 補相

Action:
- MIDI is reminded to carry out the remedial works prior products delivery and to improve workmanship for future works

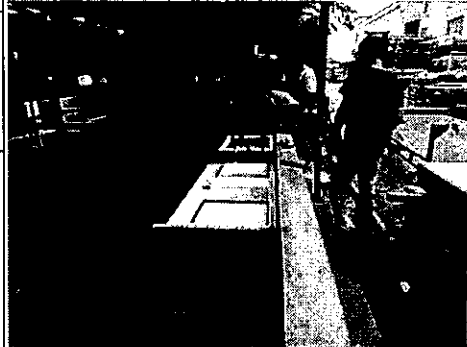
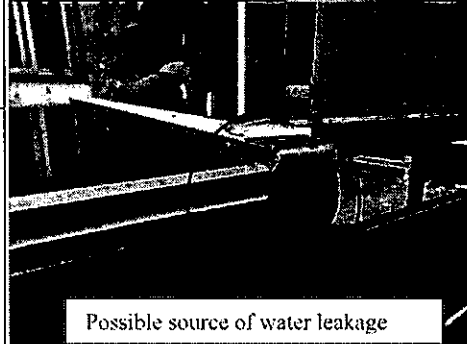
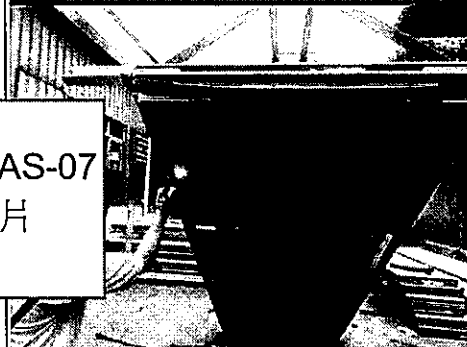
Photo 11

Description:
Water test of 2 numbers unitized panel.
Water leakage was found during flooding test for panel number 12/F_T3B-CW4_AS-07

Leakage was found during water flooding test

#2:
單元件12/F_T3B-CW4_AS-07
入水, 影合格試水紀錄照片

Action:
- MIDI is required to carry out their internal QA/QC method to improve workmanship for future works

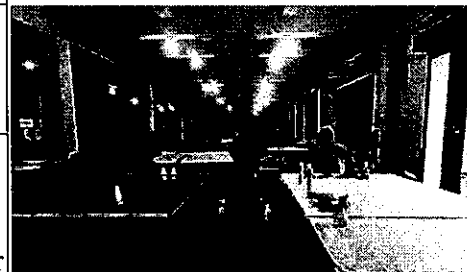
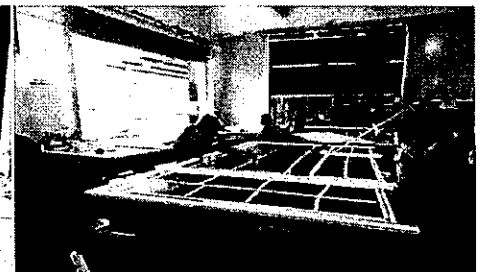
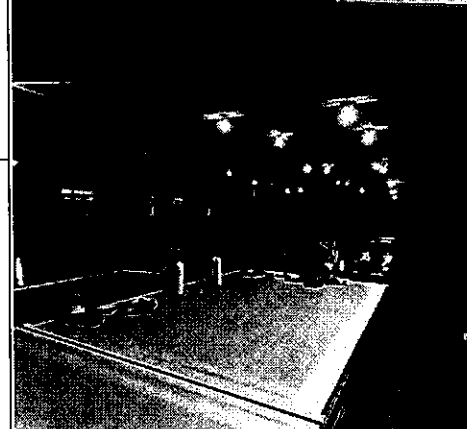
Photo 12

Description:
Fixing of capping and application of weather sealant "Dowsil 791" for T3 18-21/F Zone M10, T3 17-21/F Zone M011 unitized panels

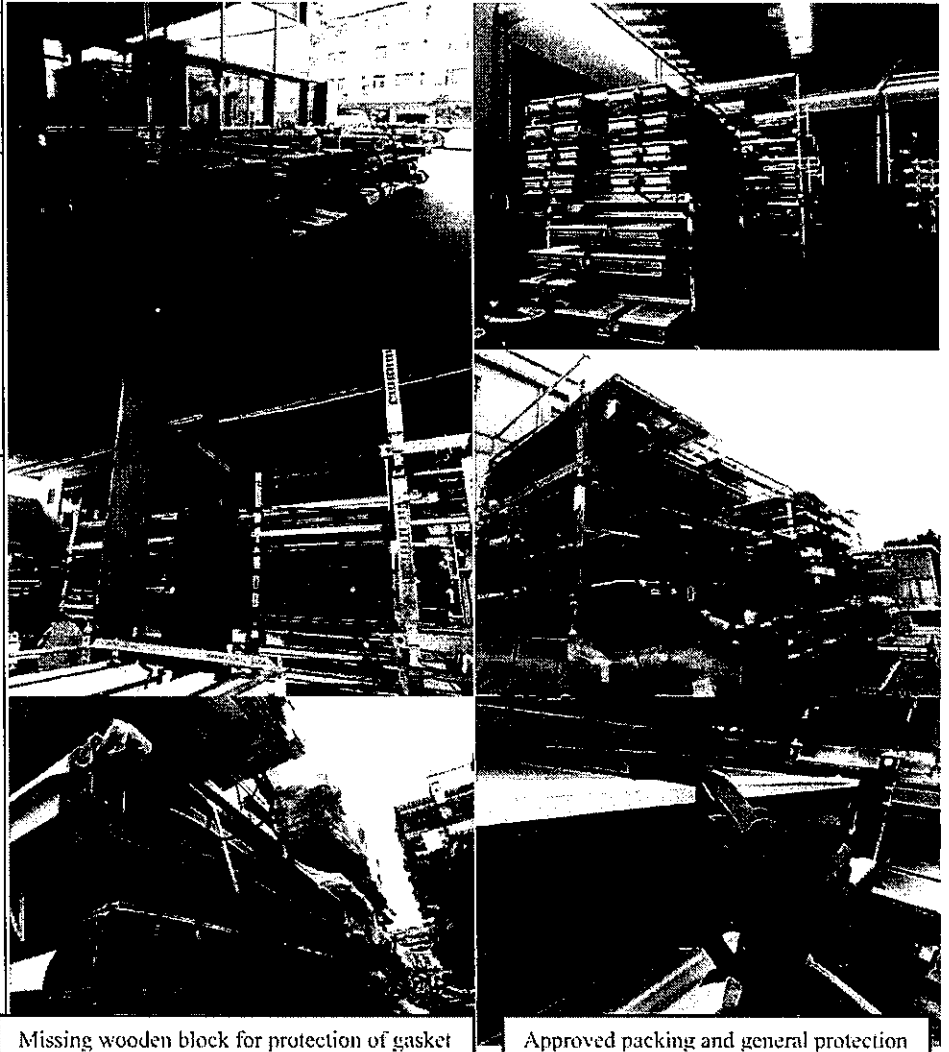
Photo 13

Description:
Final inspection of
unitized panels for T2 9
to 17/F (Zone M05 &
M06) and T3 12 to 17/F
(Zone M08)

Missing wooden block for protection of gasket

#3: 對膠條保護再做好一點，飛機帶跟木壓到膠條的位置做點保護，影相。

Action:
- MIDI is reminded to
carry out the remedial
works prior products
delivery and to improve
workmanship for future
works

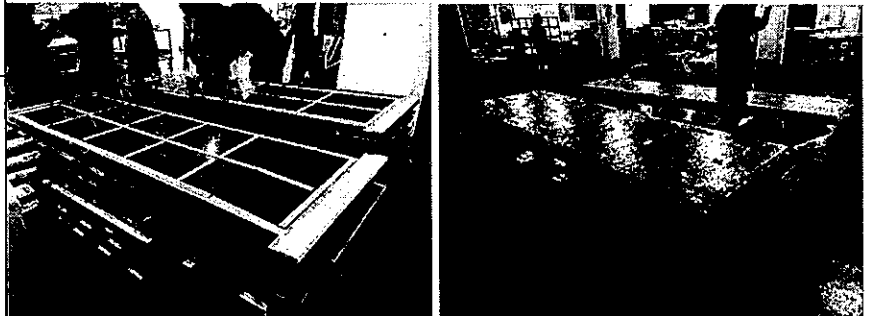
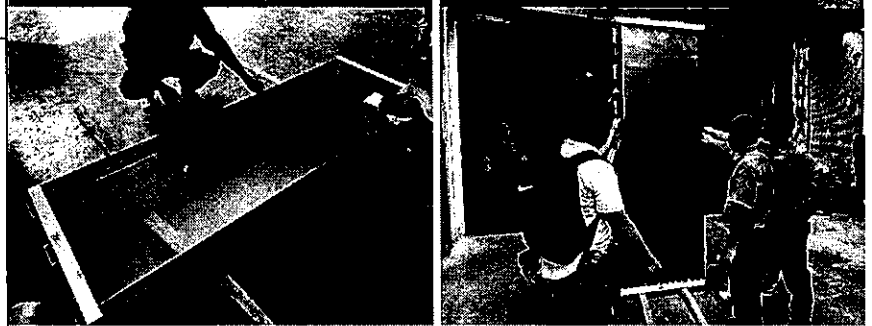
<p>Photo 9</p>		
<p><u>Location:</u> <u>Observation</u></p>

<p><u>Description:</u> Quality inspection of glass wall</p>		
<p><u>Action:</u></p>

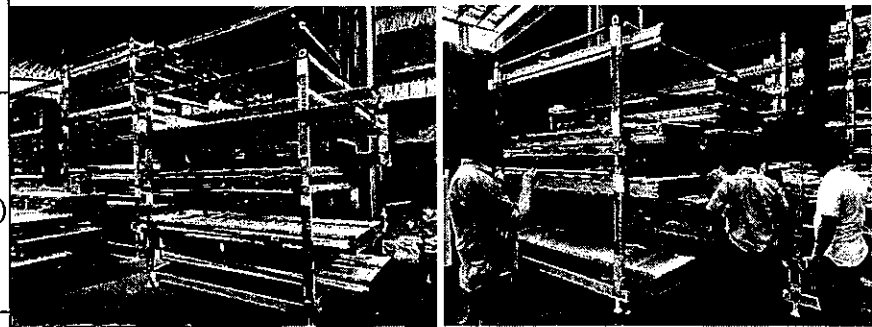
<p>Photo 10</p>		
<p><u>Location:</u> <u>Observation</u></p>

<p><u>Description:</u> Final inspection of unitized panels for T1 17 to 21/F (Zone MO11)</p>		
<p><u>Action:</u> - MIDI is reminded to carry out the remedial works prior products delivery and to improve workmanship for future works</p>

<p>Undersize setting block was found during factory inspection</p>

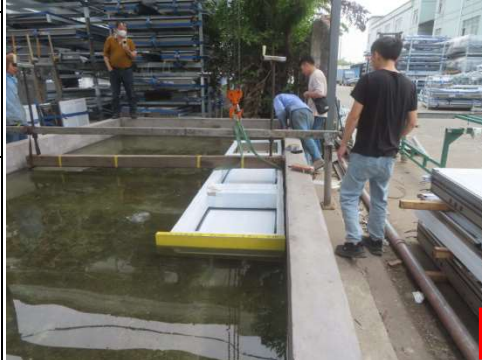
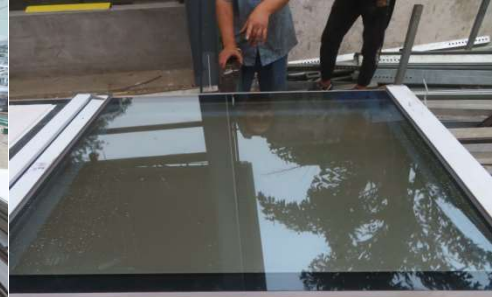
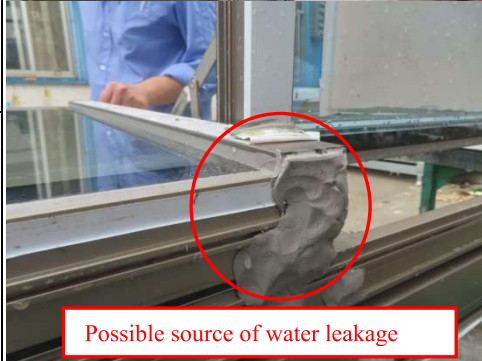
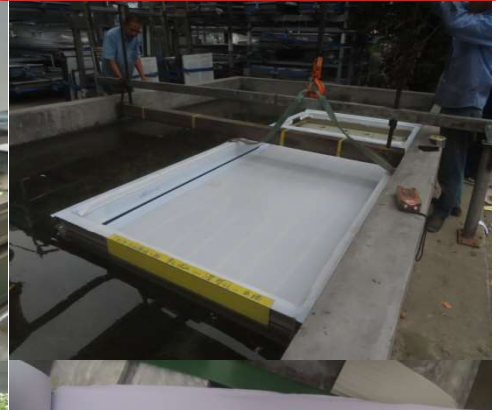
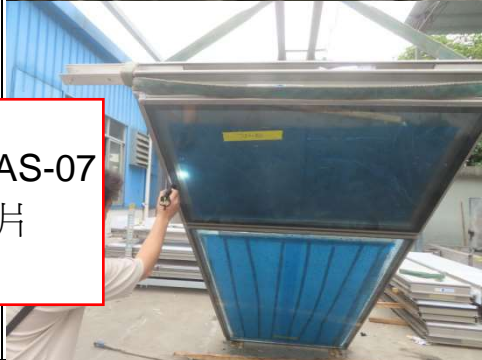
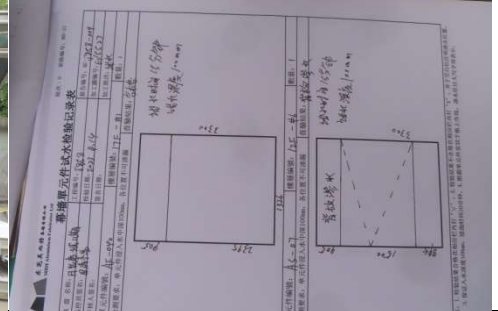
Photo 11

Description:
Water test of 2 numbers unitized panel.
Water leakage was found during flooding test for panel number 12/F_T3B-CW4_AS-07

Leakage was found during water flooding test

Possible source of water leakage

#2:
單元件12/F_T3B-CW4_AS-07
入水, 影合格試水紀錄照片

Action:
- MIDI is required to carry out their internal QA/QC method to improve workmanship for future works

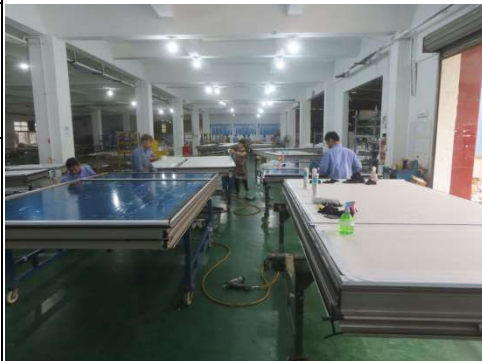
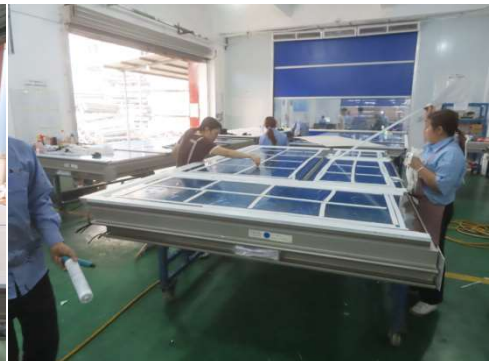
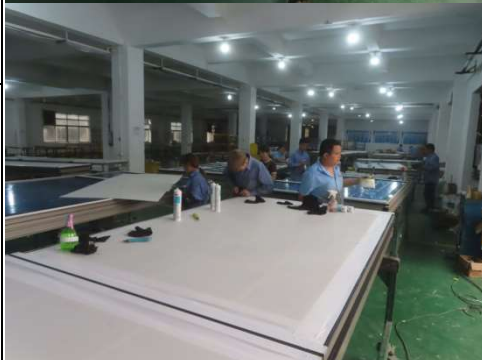
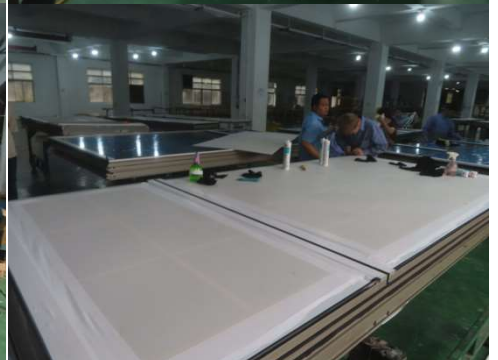
Photo 12

Description:
Fixing of capping and application of weather sealant "Dowsil 791" for T3 18-21/F Zone M10, T3 17-21/F Zone M011 unitized panels

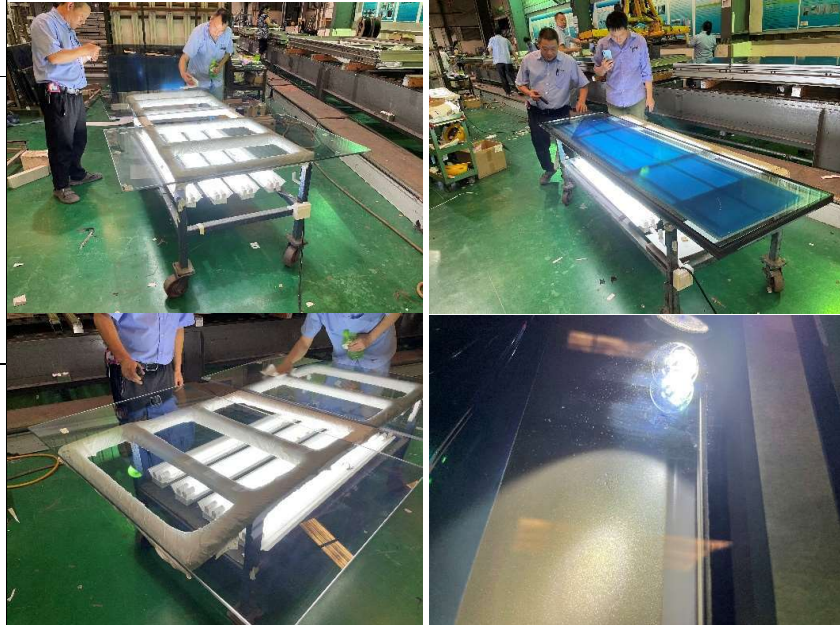
Photo 7

Description:
Quality and dimension checking of glazing prior sealant work

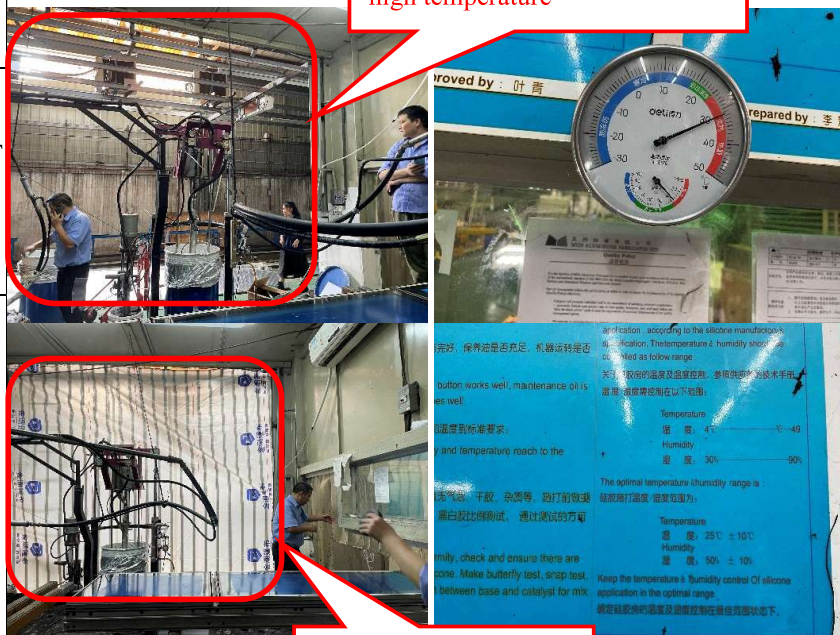
Photo 8

Description:
Application of structural sealant for T1 17 to 21/F (Zone MO11)

Glue workshop is not a closed space, resulting in more dust and high temperature

After rectification, can continue to work

#4: 影一張唧膠部的相是密封和溫度適中的空間。

Action:
- MIDI is reminded to carry out the remedial works prior products delivery and to improve workmanship for future works

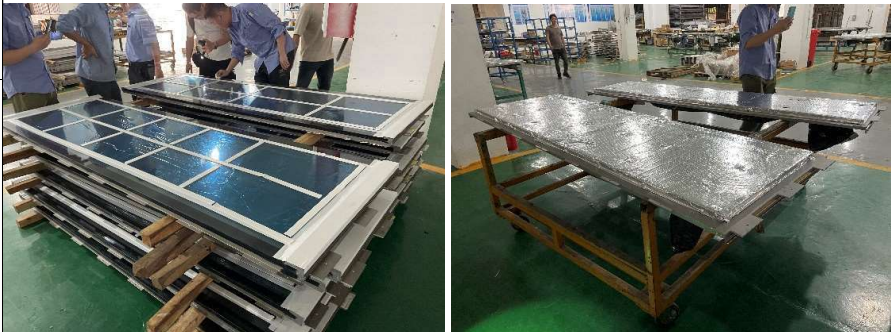
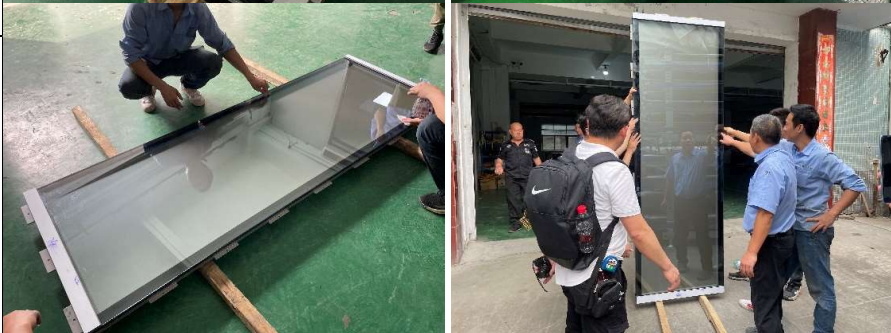
<p>Photo 9</p>		
<p><u>Location:</u> Observation</p>

<p><u>Description:</u> Quality inspection of glass wall</p>		
<p><u>Action:</u> -</p>

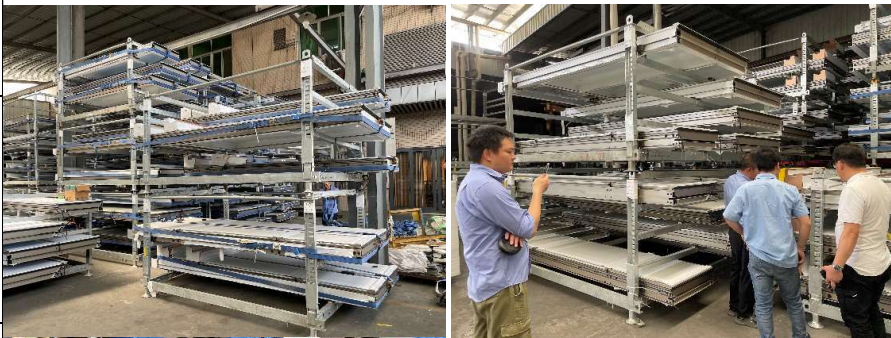
<p>Photo 10</p>		
<p><u>Location:</u> Observation</p>		
<p><u>Description:</u> Final inspection of unitized panels for T1 17 to 21/F (Zone MO11)</p>

<p style="border: 1px solid red; padding: 5px; color: red;">Undersize setting block was found during factory inspection</p>

<p><u>Action:</u> - MIDI is reminded to carry out the remedial works prior products delivery and to improve workmanship for future works</p>
