工程指示 / 要求簡箋(E.I.)

工程指示編號：EI / 6457 / 23

工程名稱：將軍澳日出康城 11

工程項目：顧問上廠報告 (23/5-29/6) 精華版加完整版

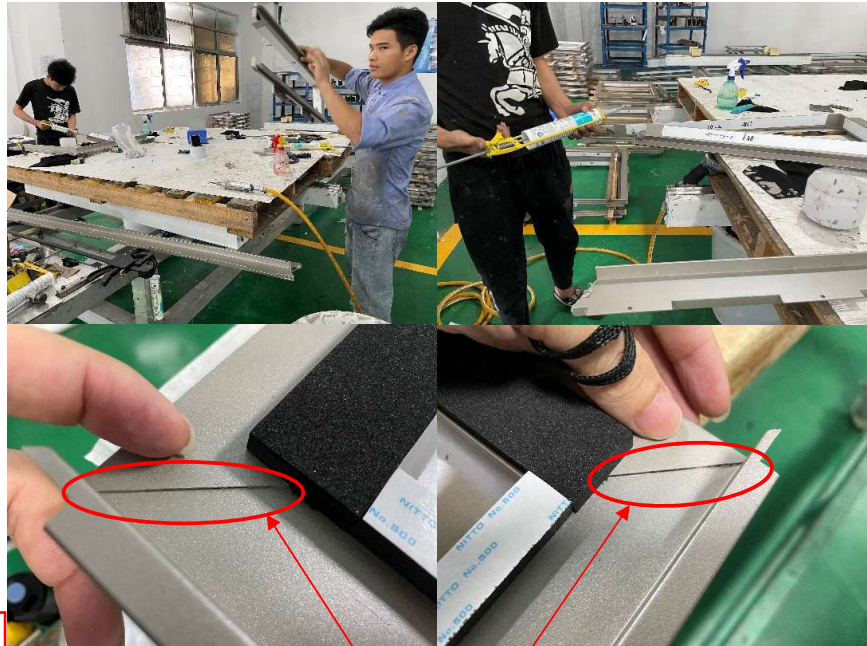
Photo 9

Description:
Fit-up assembly of glass wall Mullion and Transom for T3 22/F to 26/F Zone MO14

The splicing of two components is uneven

Action:
- MIDI is reminded to carry out the remedial works prior products delivery and to improve workmanship for future works

#1 找相同的鋁料,影夾角是一致的

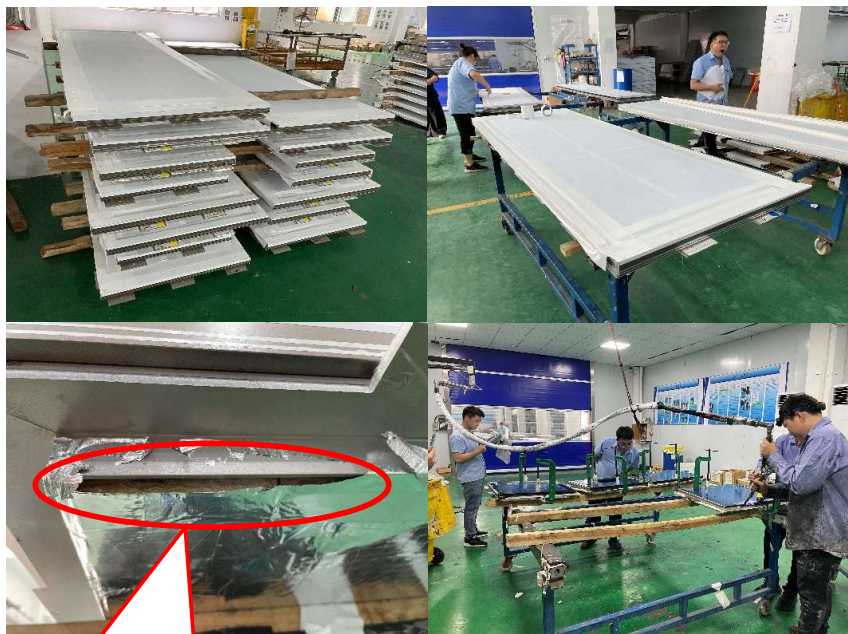
Photo 10

Description:
Quality inspection of glass wall for T2 9/F to 11/F Zone MO4

The foil wrap of the thermal insulation foam is damaged is rejected by QC

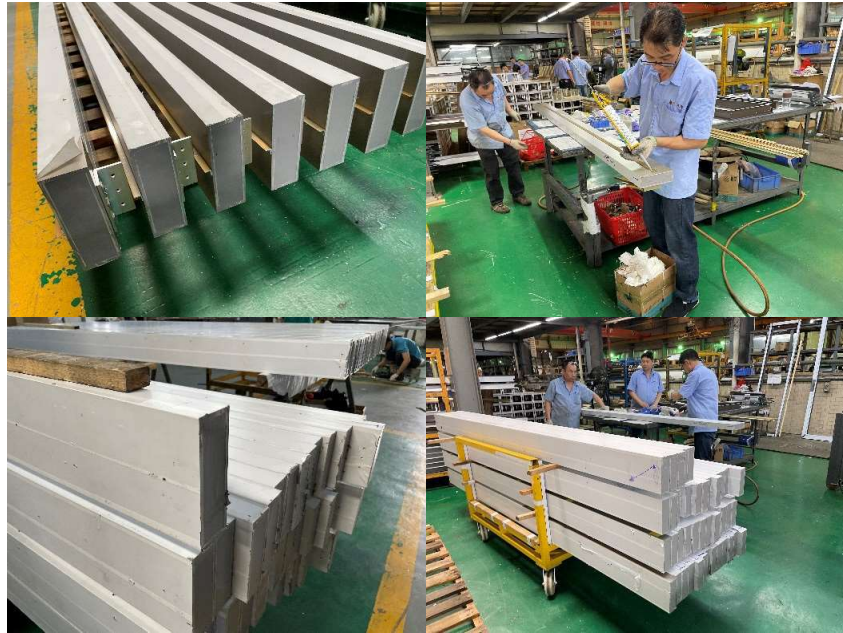
Photo 7

Description:
General inspection of transom and mullion for balcony during fabrication

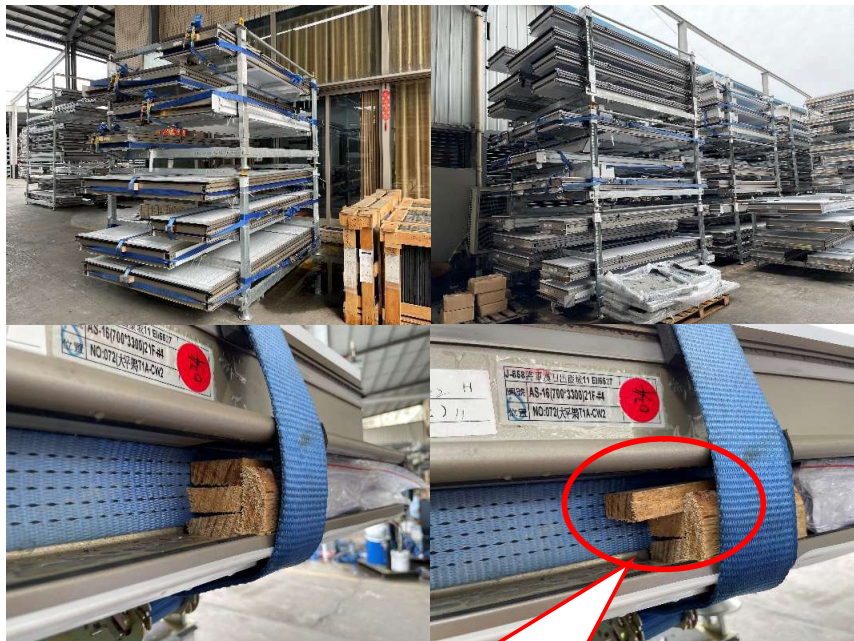
Photo 8

Description:
Final inspection of unitized panels for T1 17 to 21/F (Zone MO11)

Undersize setting block was found during factory inspection

Action:
- MIDI is reminded to carry out the remedial works prior products delivery and to improve workmanship for future works; It is the same question as Report-R-26 Photo 10

#2 影合適尺寸的木方

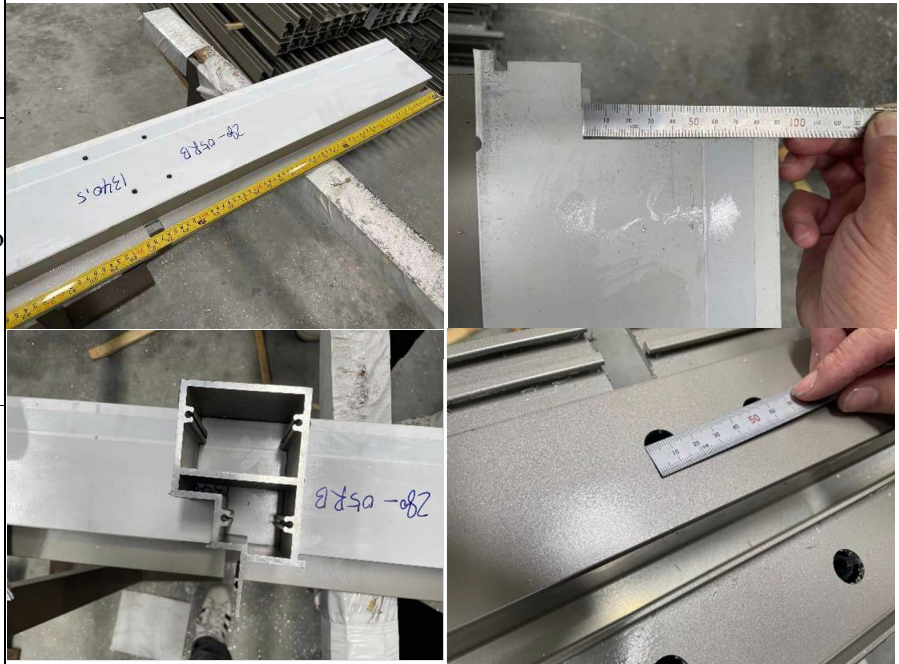
Photo 1

Description:
Materials cutting, milling and drilling of extrusions for T1 43/F to 53/F (Details please refer to Appendix A)

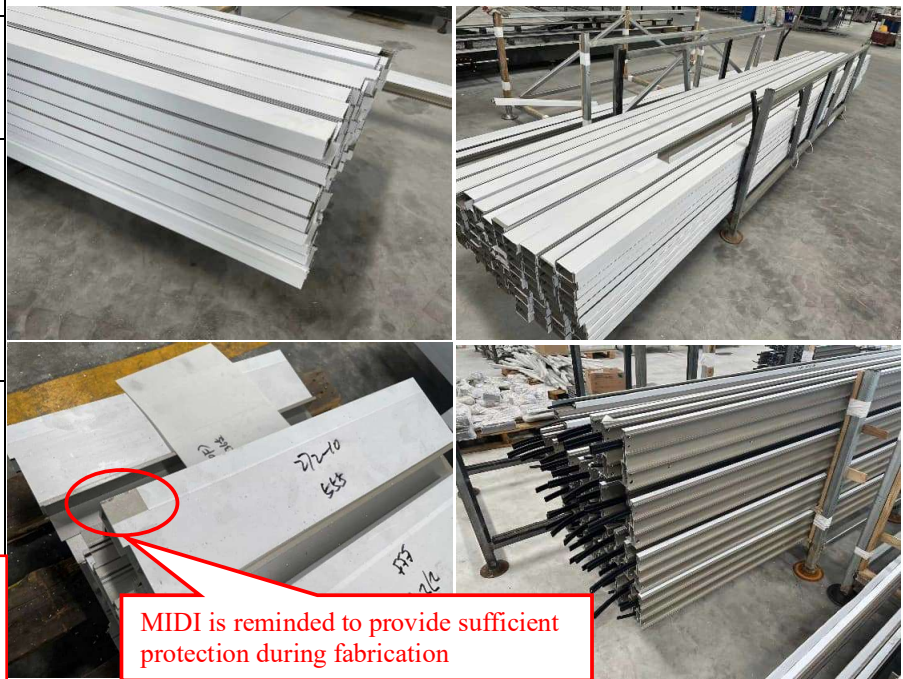
Photo 2

Description:
General inspection of transom and mullion during fabrication

Action:
MIDI is reminded to provide sufficient protection during fabrication

#3 鋁料做好保護，影相

MIDI is reminded to provide sufficient protection during fabrication
