工程指示 / 要求簡箋(E.I.)

工程編號：J - 858

工程名稱：將軍澳日出康城 11

工程項目：顧問上廠報告 (6/7-31/8) 精華版加完整版

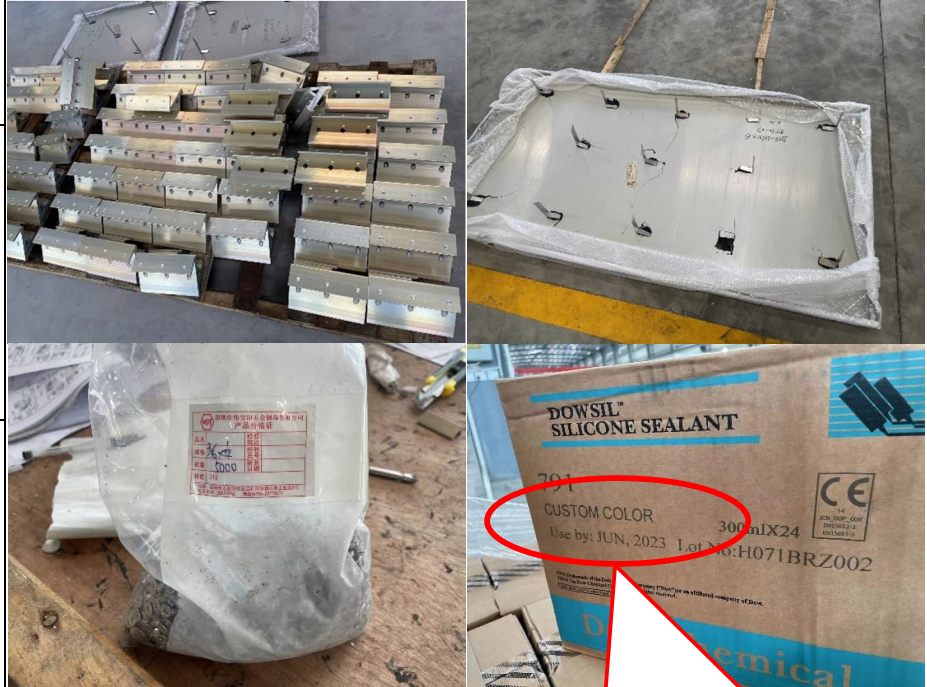
Photo 3

General inspection of bracket, back panel, weather sealant and screws during fabrication

This weather sealant is expired. MIDI is reminded that the expired sealant is not permitted to be used.

MIDI is reminded to ensure the expired sealant is not permitted to be used.

清: 影沒有過期的膠及工人使用未過期的膠。

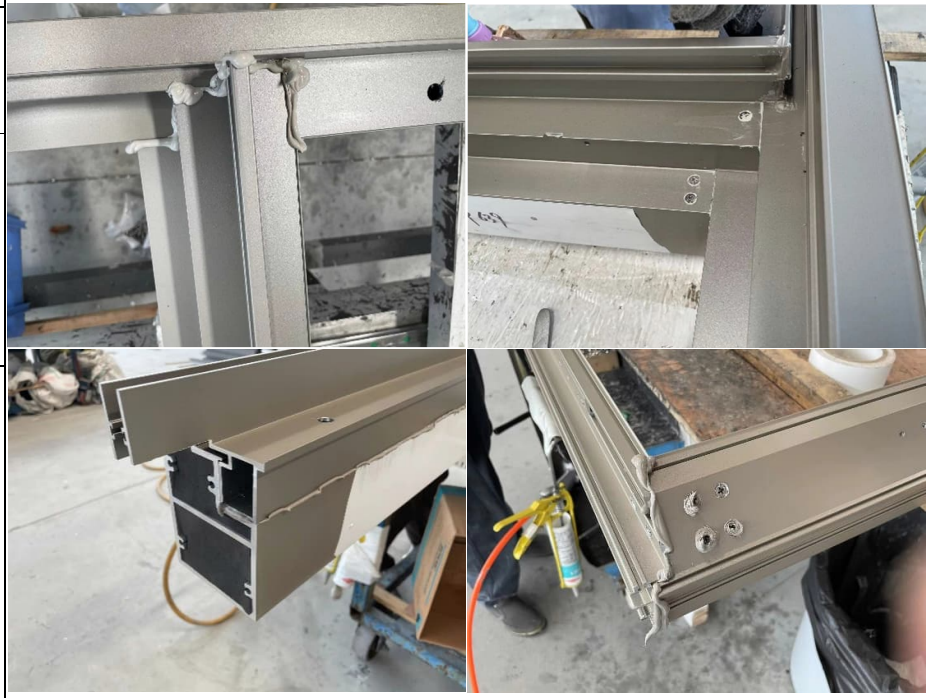
Photo 4

Fit-up assembly of Mullion and Transom for T3 31/F to 35/F MO20

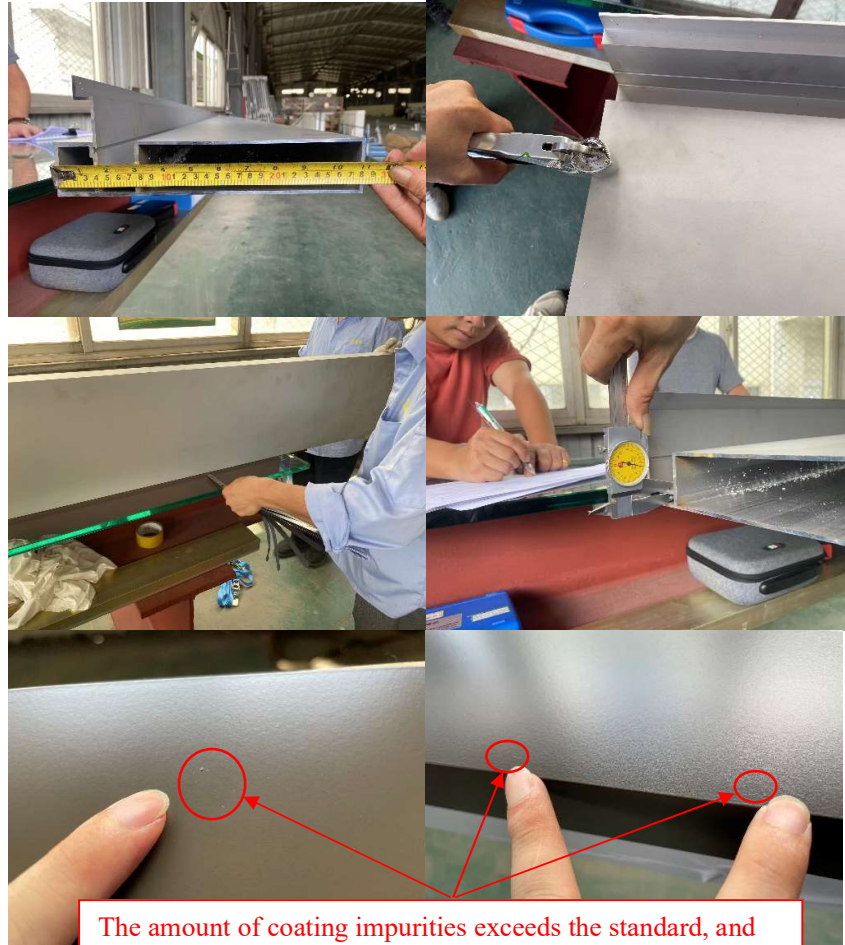
Photo 5

Description:
General inspection,
dimension checking and
testing of raw materials

The amount of coating impurities exceeds the standard, and the supplier should improve the quality standard

Action:
- The amount of coating
impurities exceeds the
standard, and the supplier
should improve the quality
standard

清: 影返相關鋁
料，影靚仔面的。

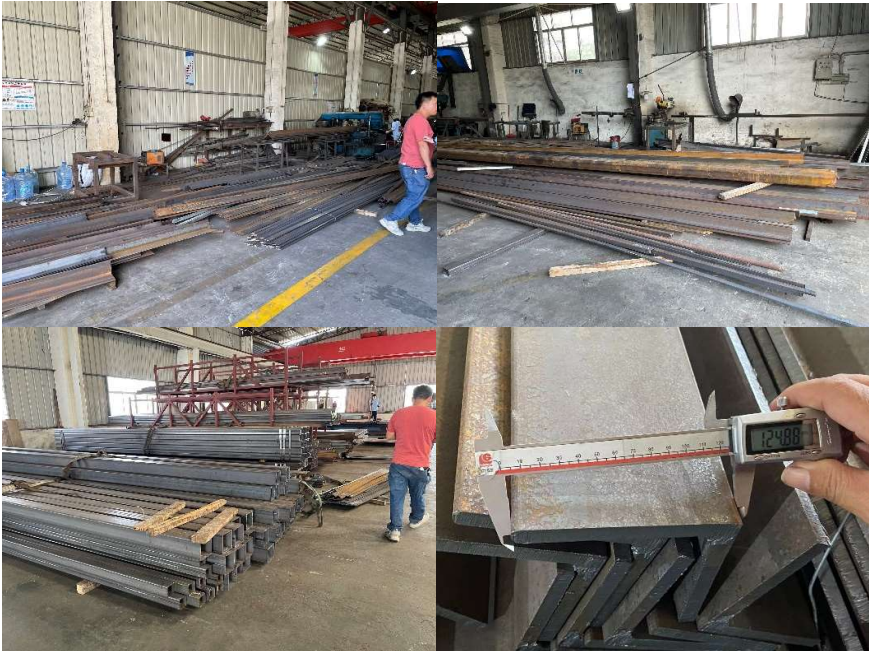
Photo 6

Description:
General inspection of
raw materials

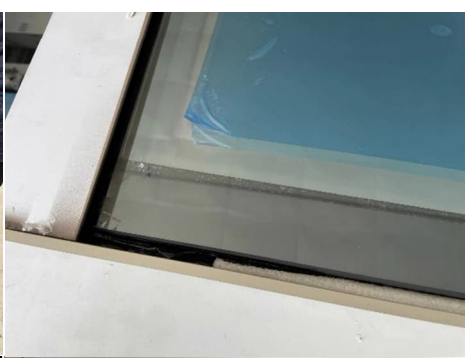
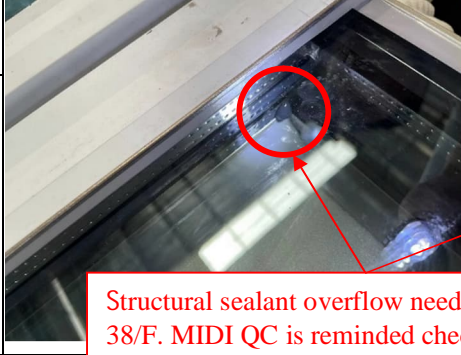
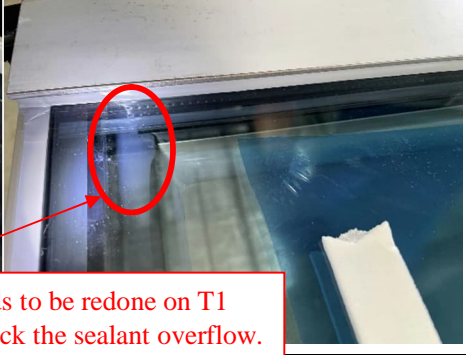
<p>Photo 7</p>		
<p><u>Location:</u> 湖南廠</p>

<p><u>Observation</u> <u>Description:</u> Apply structural sealant for T1 36/F to 40/F MO21</p>

<p><u>Action:</u> MIDI is reminded to carry out the remedial works prior products delivery and to improve workmanship for future works</p>	<p style="color: red; border: 1px solid red; padding: 5px;">Structural sealant overflow needs to be redone on T1 38/F. MIDI QC is reminded check the sealant overflow.</p>

清: T1 38F 影張無膠的相。

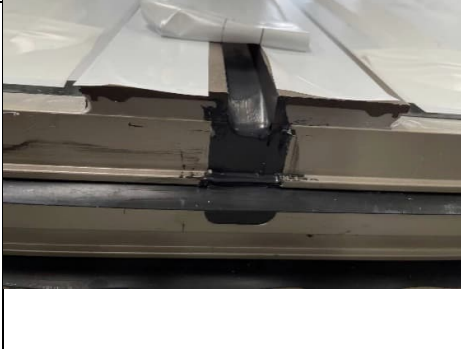
<p>Photo 8</p>		
<p><u>Location:</u> 湖南廠</p>		
<p><u>Observation</u> <u>Description:</u> Packing and curing of the units</p>	 	 
<p><u>Action:</u> -</p>

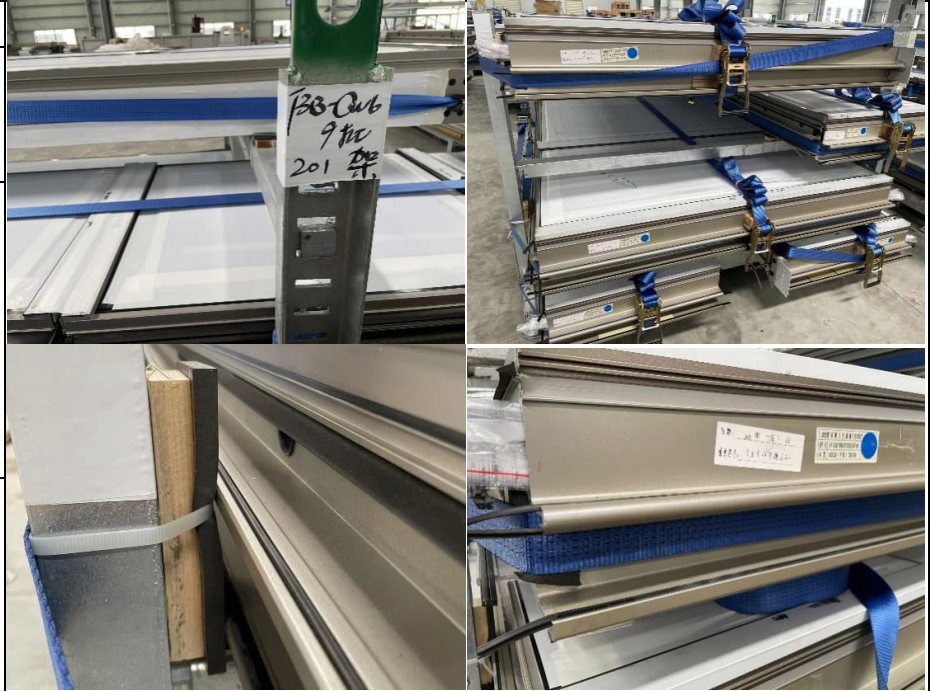
Photo 9

Final inspection of unitized panels for T3 31/F to 35/F MO20

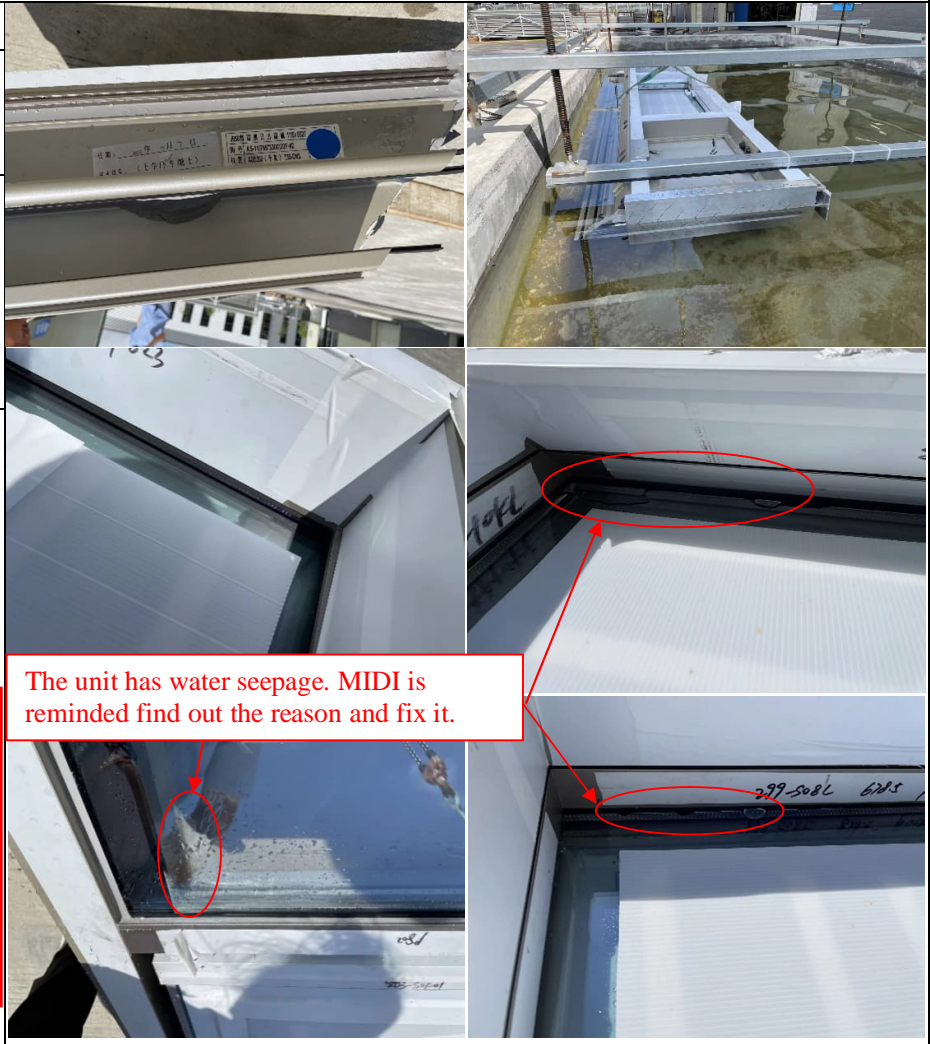
Photo 10

Water flooding test for unitized panel No. AS-11 T3 33/F MO20

The unit has water seepage. MIDI is reminded find out the reason and fix it.

MIDI is reminded to carry out the remedial works prior products delivery and to improve workmanship for future works

清: AS-11 T3 33F
影返試水合格報告。
