工程指示 / 要求簡箋(E.I.)

工程指示編號：EI / 7196 / 23

工程名稱：將軍澳日出康城 11

工程項目：顧問上廠報告 (11/9-25/12) 精華版加完整版

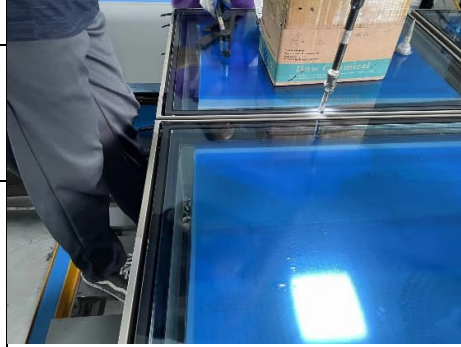
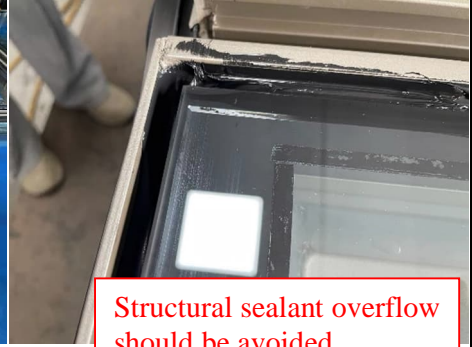
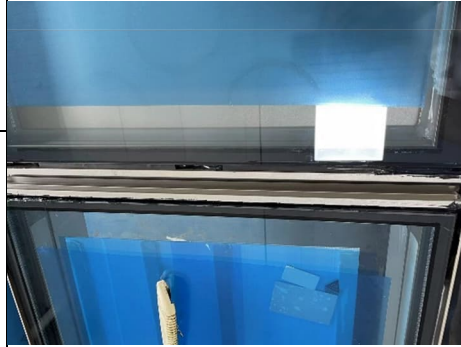
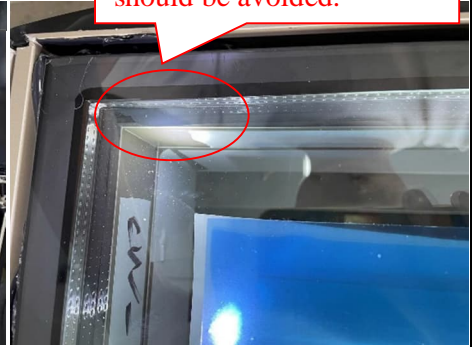
Photo 7

Apply structural sealant for T3 36/F to 40/F MO23

#1:
黑膠過多，影一條手工好的

MIDI is reminded to carry out the remedial works prior products delivery and to improve workmanship for future works

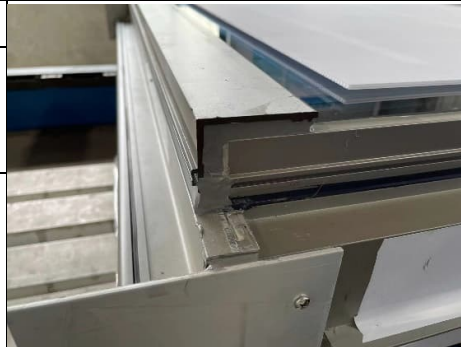
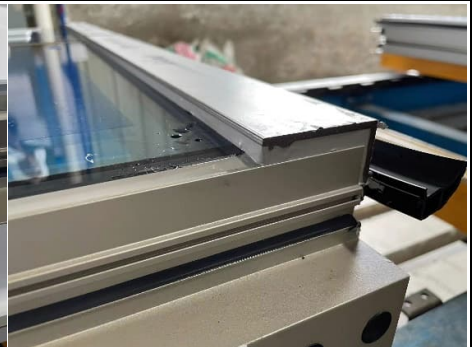
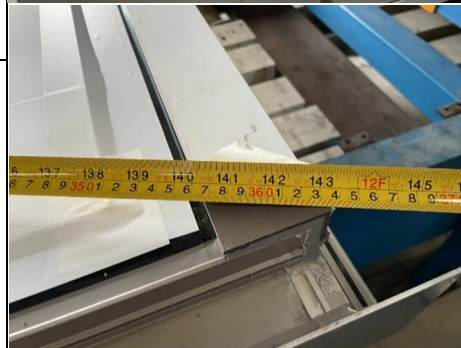
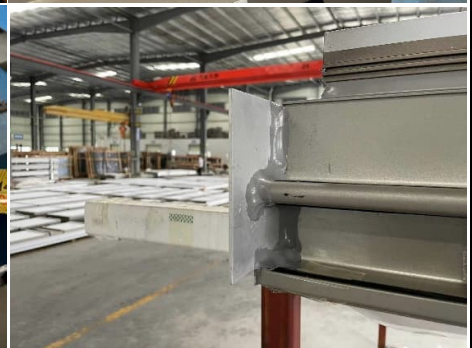
Photo 8

Capping check and dimension check after applying structural sealant

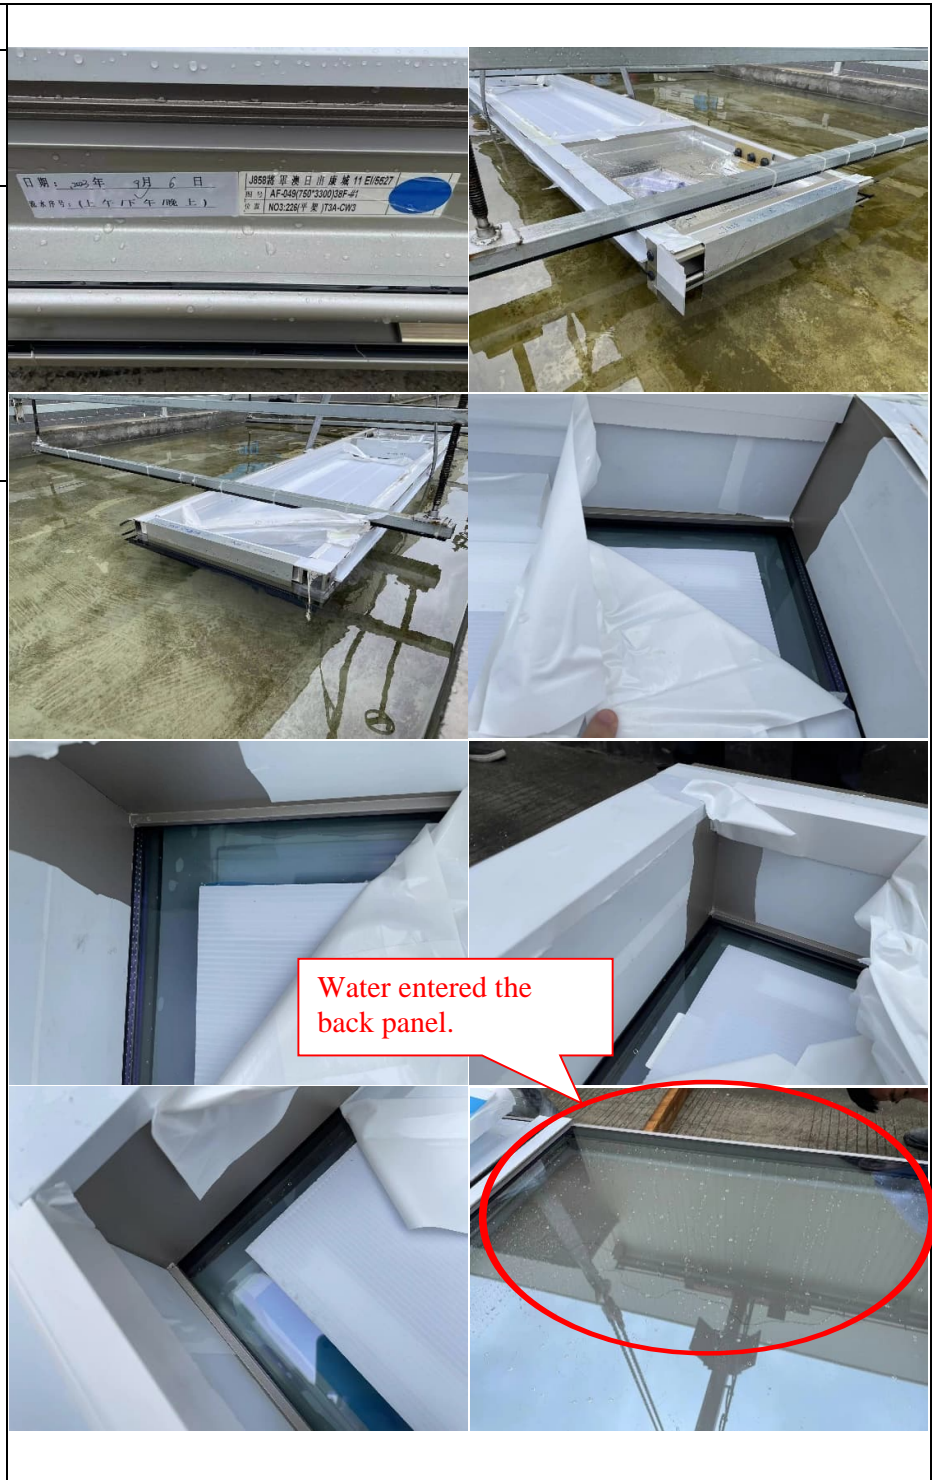
Photo 9

Description:
Water test for unitized panel No. AF-049 T3 38/F MO23

#2:
單元件AF-049 T3 38/F MO23
漏水，俾試水報告。

Water entered the back panel.

Action:
MIDI is reminded to find out the reason and test again.
