工程指示 / 要求簡箋(E.I.)

工程指示編號：EI / 5527 / 22 (原 EI 5272) 修改版次：C
 工程編號：J - 858 工程名稱：將軍澳日出康城 LP 11
 工程項目：幕牆 大貨單元件加工圖
 收件人：生統 發件人：Ant Yeung 日期：27/01/2023

"ginnychau@rlp.asia"
<ginnychau@rlp.asia>,
"wallaceng@rlp.asia" <wallaceng@rlp.asia>,
"rss19084mw@rlphk.com" <rss19084mw@rlphk.com>,
"andywchan@sino.com"
<andywchan@sino.com>,
"terrywan@sino.com" <terrywan@sino.com>,
"simonspleung@sino.com" <simonspleung@sino.com>,
"kennethleung@sino.com"
<kennethleung@sino.com>,
"stephenchow@sino.com" <stephenchow@sino.com>,
"Ko, Ryan" <Ryan.Ko@aecom.com>, "Lau, Daisy" <Daisy.Lau@aecom.com>,
"Wong,
Crystal" <crystal.wong@aecom.com>,
"Tso, Simon" <Simon.Tso@aecom.com>
Subject: LP11 - CW - onsite inspection issue
Date sent: Thu, 26 Jan 2023 05:28:37 +0000

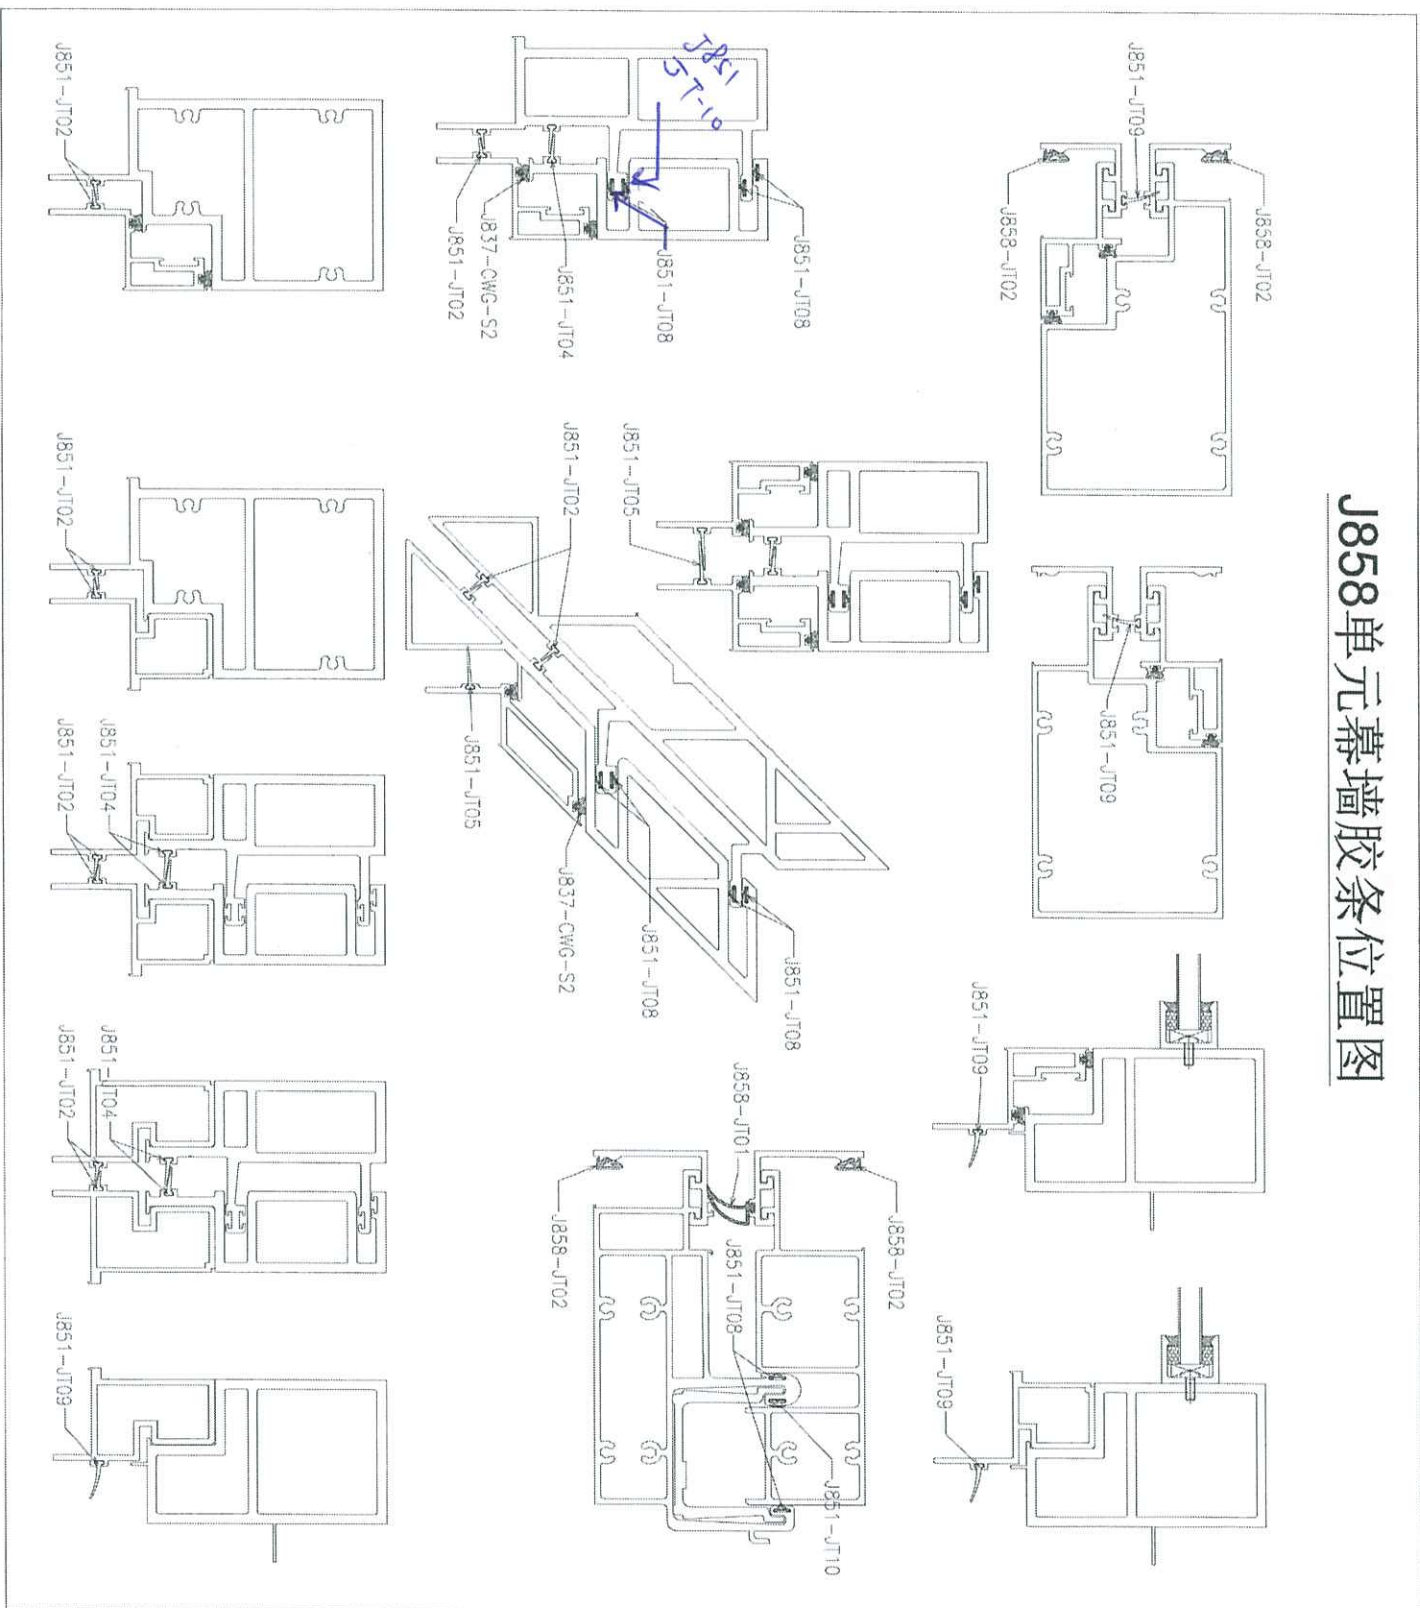
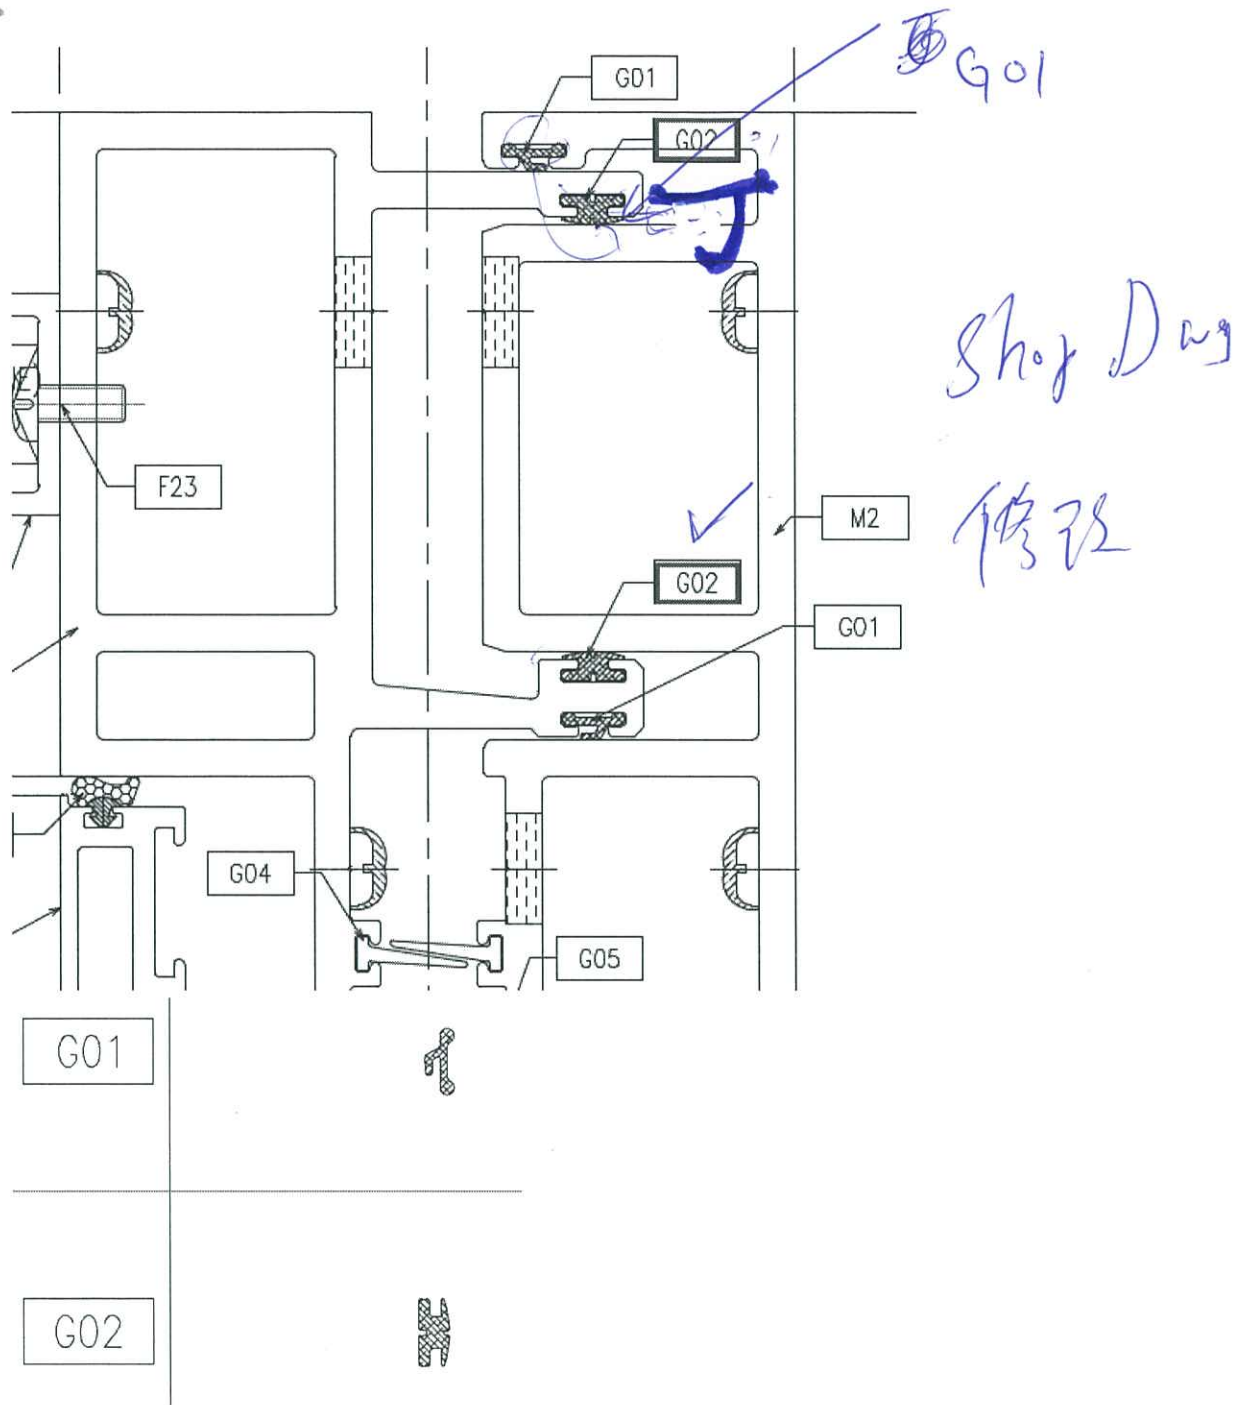
J858单元幕墙胶条位置图

The onsite pre- assembled gasket surface is observed to below the extrusion surface which cannot performance as a reliable water barrier.

The pre-assembled gaskets on male mullion is observed to be not in line with shop drawing design, which may have influence on the whole system water tightness performance.

- a. Replace the gasket on installed panels.
- b. Double check for other onsite stored units and revise is necessary.
- c. Carry out the QA/QC method at factory panel accurate fabrication work to guarantee all works are in line with approved shop drawings.
