工程指示 / 要求簡箋(E.I.)

工程名稱：將軍澳日出康城 11

工程項目：幕牆 單元件 地盆顧問報告 3/2 ~ 22/2

**Proposed Residential Development at TKOTL 70RP, Phase 11, Lohas Park,
Tseung Kwan O, N.T., Site C2**

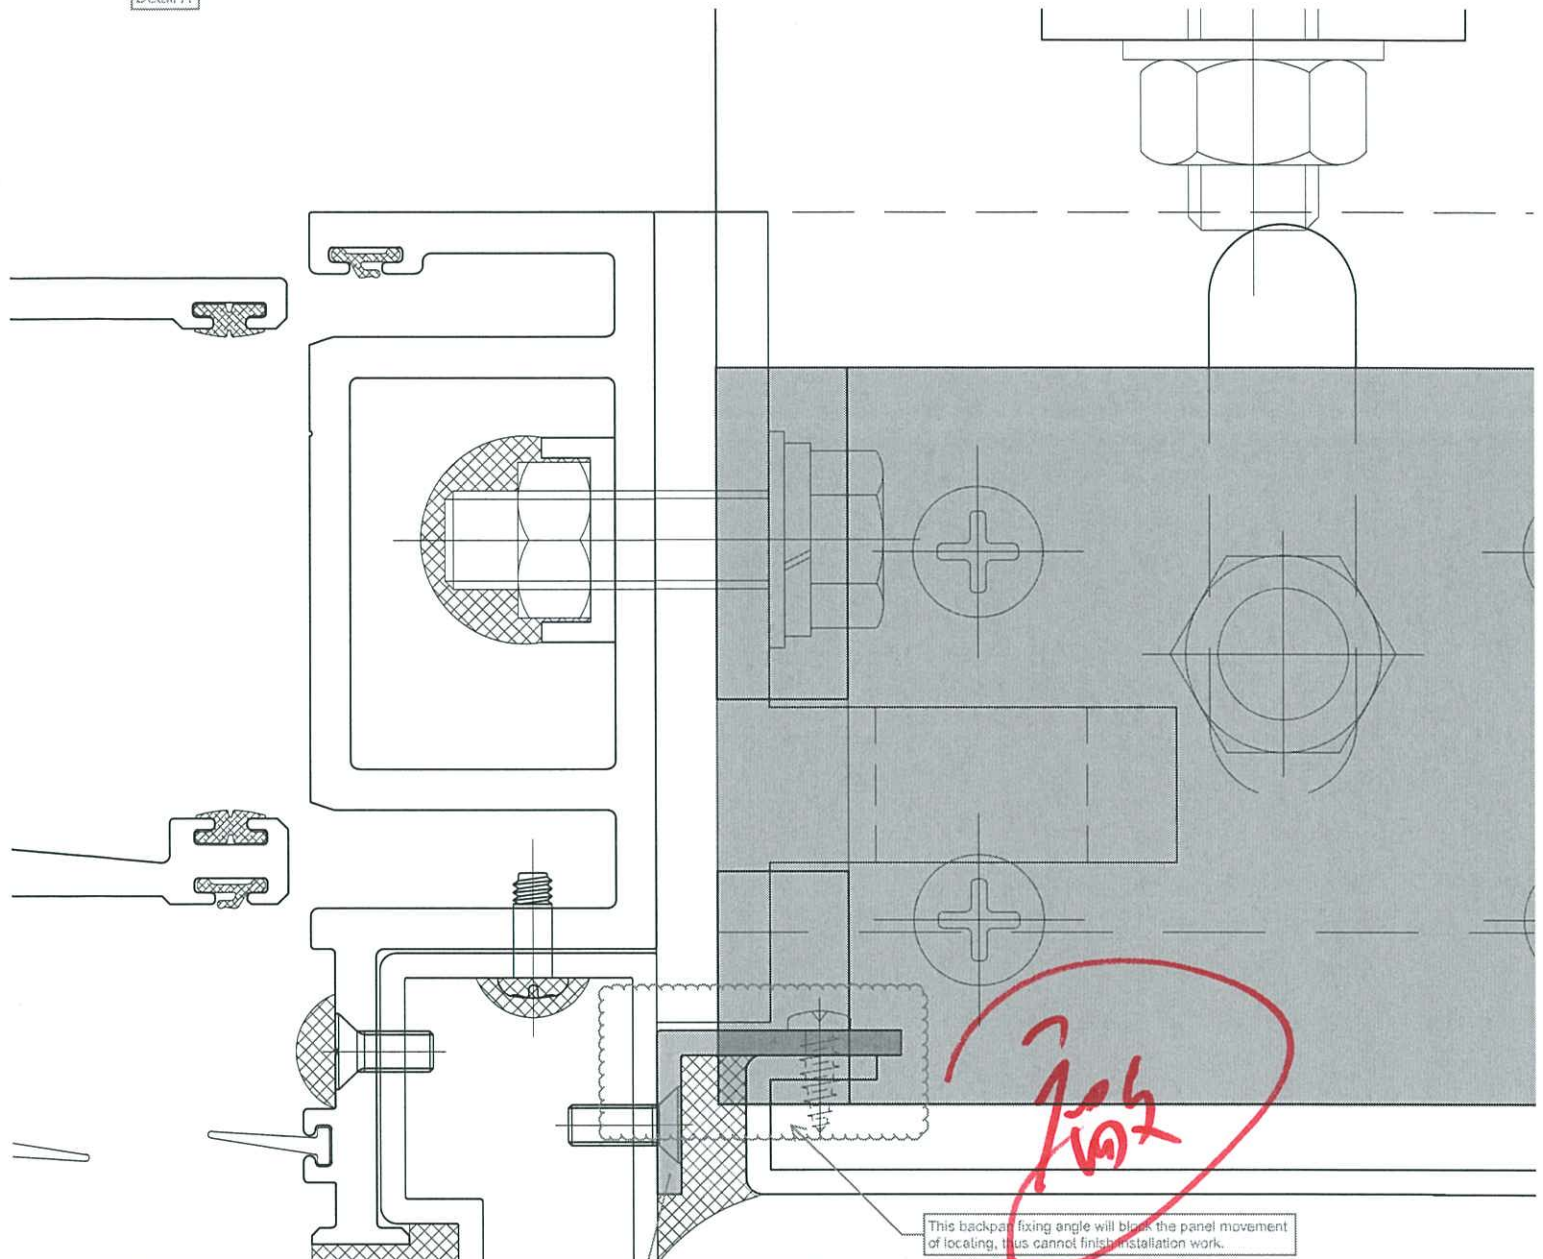
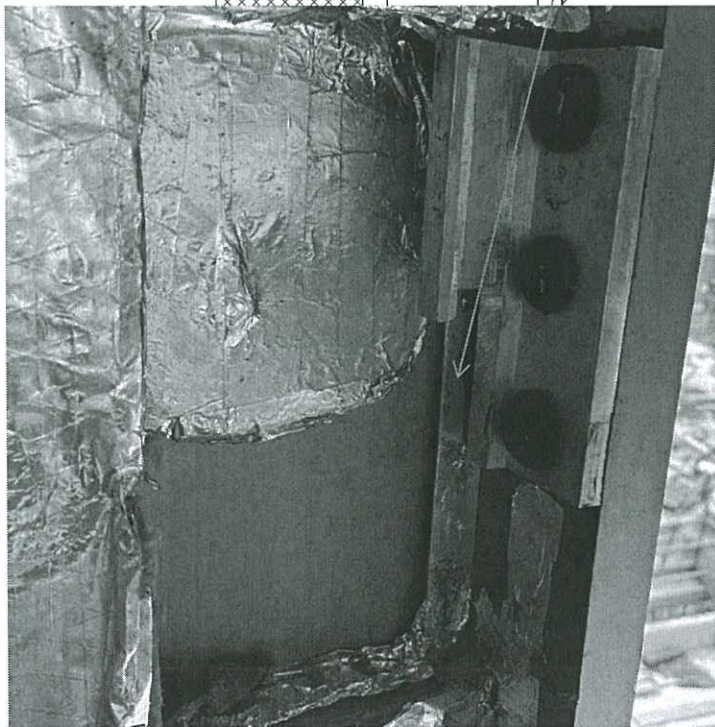
Detail A

1. It was observed that the backpan fixing angle will block the unit installation work, please refer to attachment and provide the modification method at factory for it.
2. It was observed the transom with mullion joint was applied with excessive sealant, it will lead to new installed pane cannot descend due to these sealant. Please coordinate with factory assemble work to avoid/remove excessive sealant.
