工程指示 / 要求簡箋(E.I.)

工程名稱：將軍澳日出康城 11

工程項目：幕牆單元件 水槽料保護鋁蓋 (鋁摺件不用鉻化) 樣板 *地盤用*

Site Memorandum

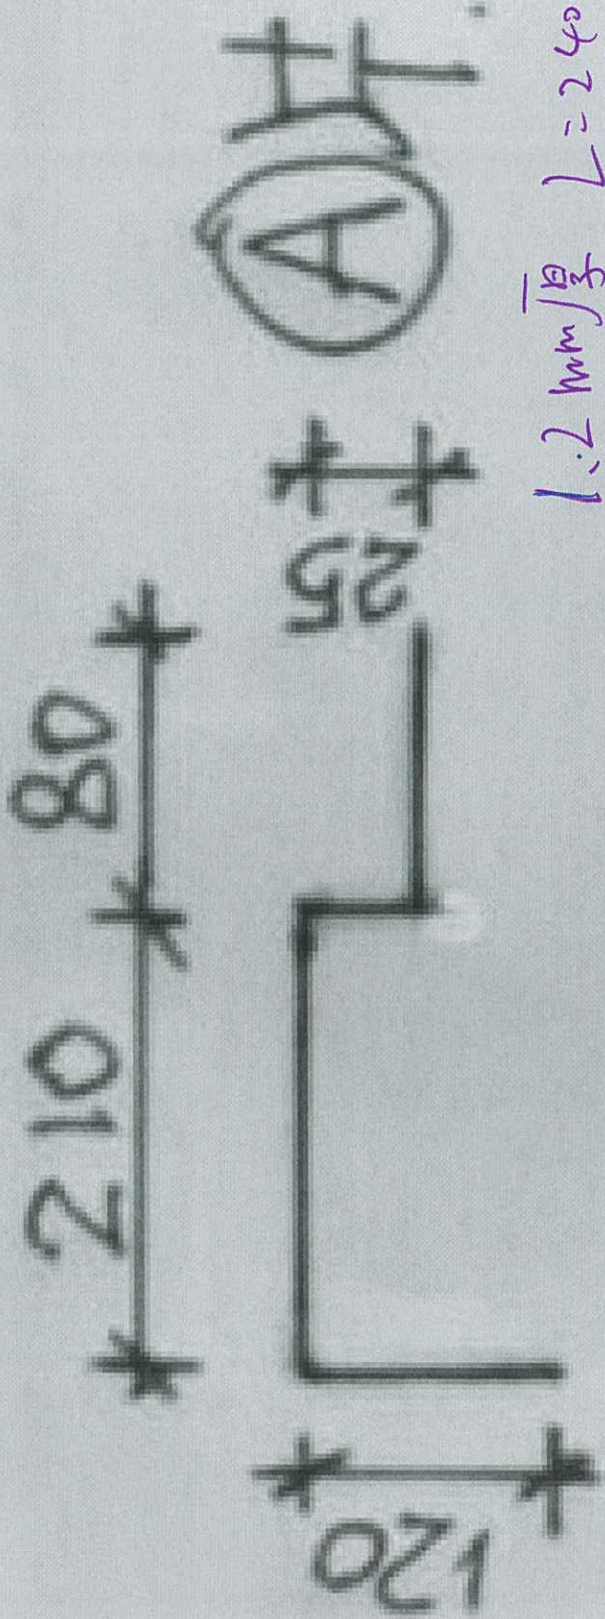
1.2 mm \sqrt{L} $L = 2400 \text{ mm}$

12.71

Mill

請按圖生產水槽料保護鋁蓋 (鋁摺件)

→ 先做樣板 A 款 12 件, B 款 12 件

L=2400mm

1.2mm 厚，不用鉻化 (臨時保護水槽料用)

因安裝後，頂部曝露多時需要保護。
