PROPOSED RESIDENTIAL
DEVELOPMENT AT TKOTL 70RP,
PHASE 11. LOHAS PARK, TSEUNG
KWAN O. N.T.

Factory Inspection Report 01

Inspection Date: 18th November 2022
Issue Date: 05th December 2022

Report Reference: 60646872-FI-R-01

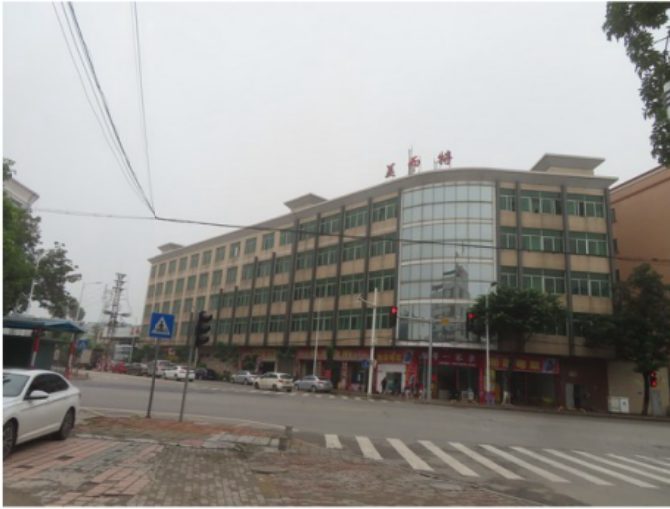
1. General view of Midi Factory

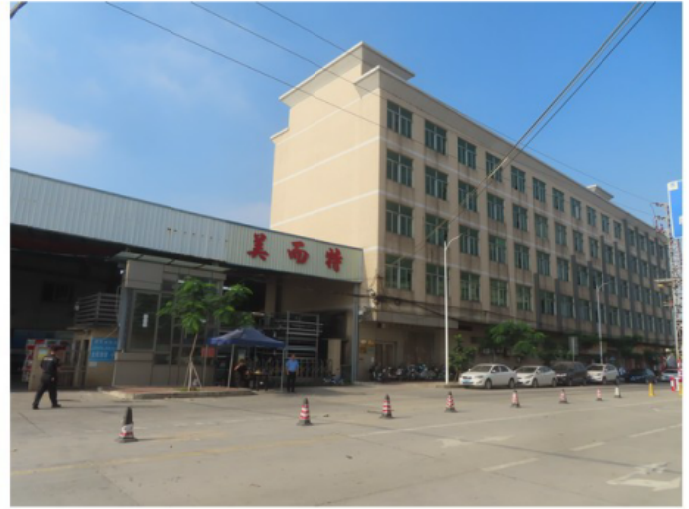
2. General view of Midi Factory

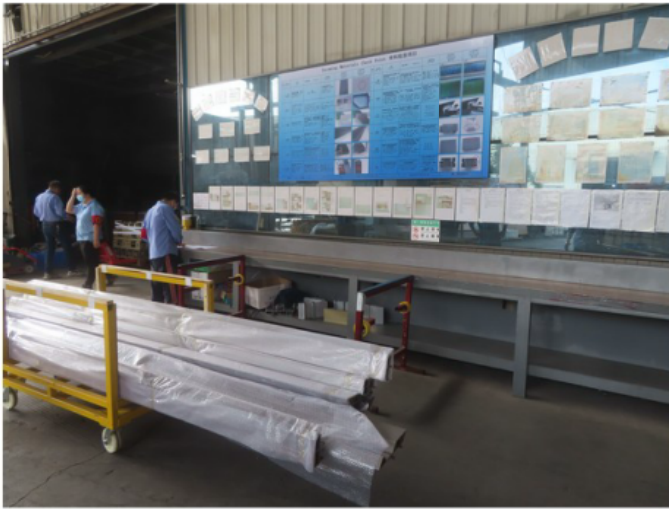
7. QC checking prior fabrication and storage

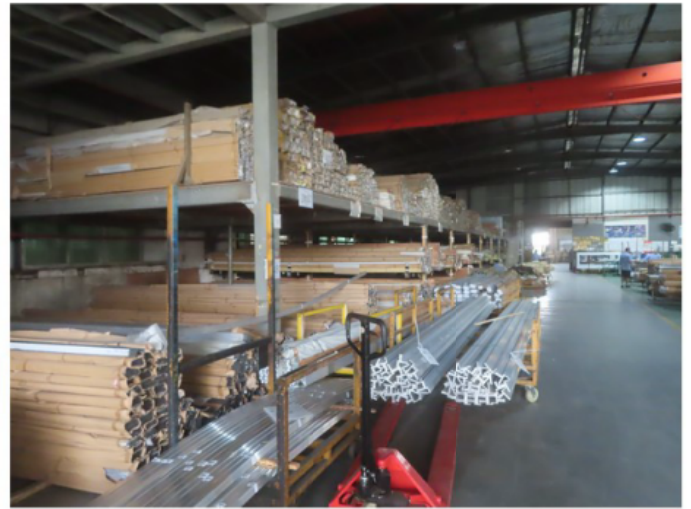
8_ Materials are stored on rack after QC checking

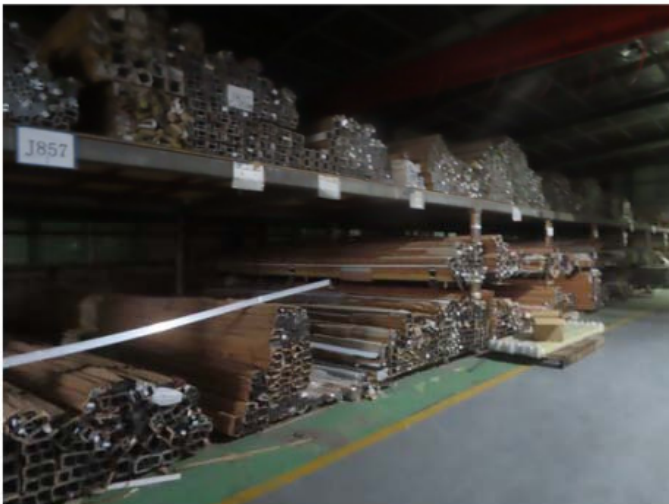
9_ Materials are stored on rack after QC checking

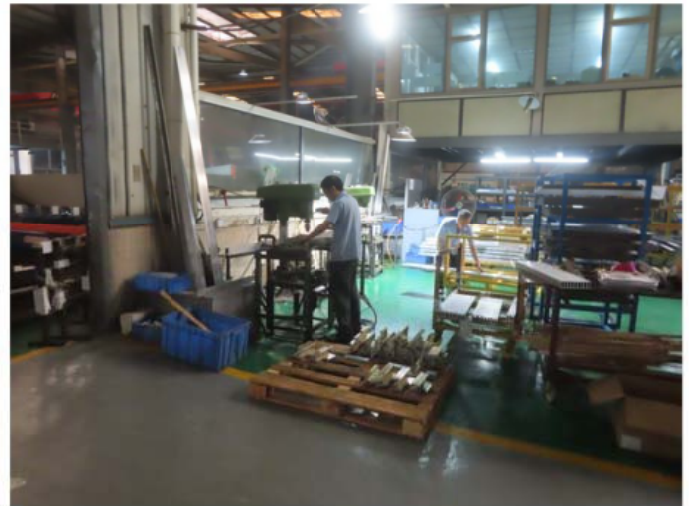
16_Drilling and punching

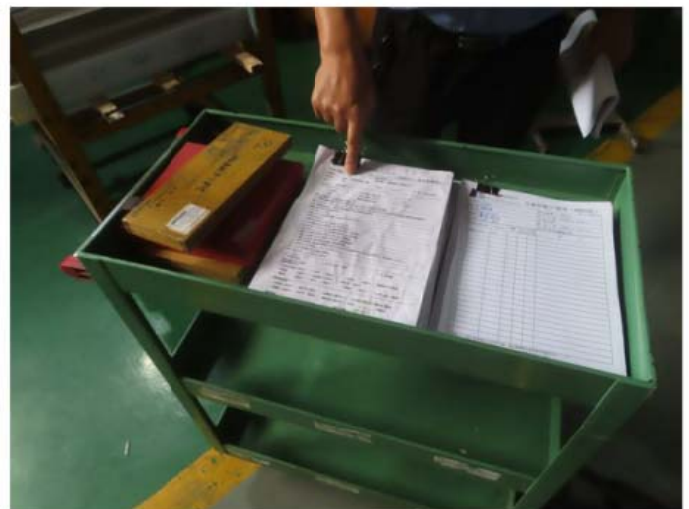
18_QC checking during fabrication

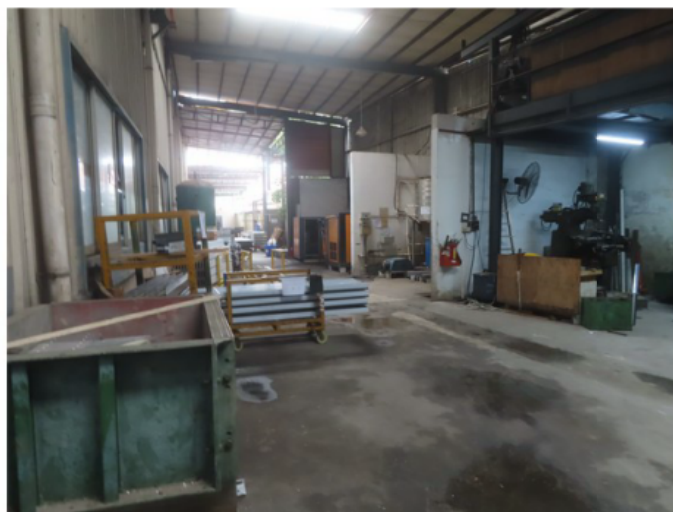
20_Degreasing prior assembly works

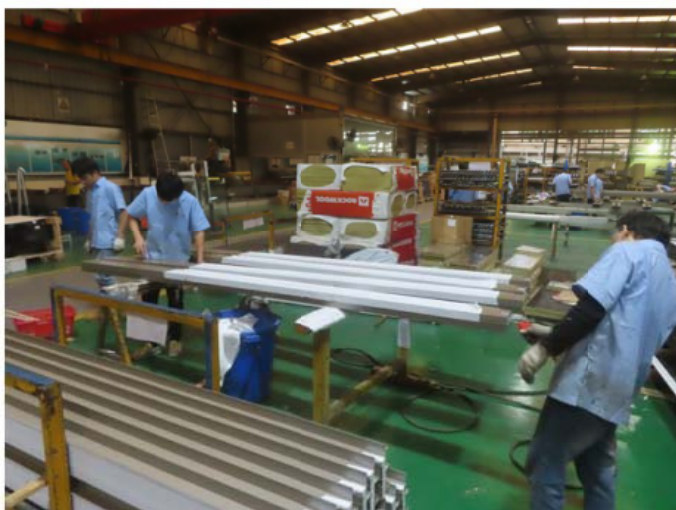
21_Temporary protection prior assembly works

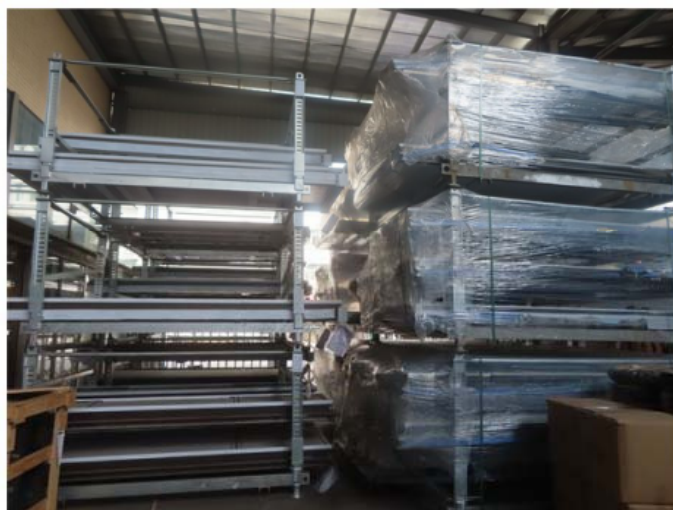
22_Assembled CW panels are stored on the rack

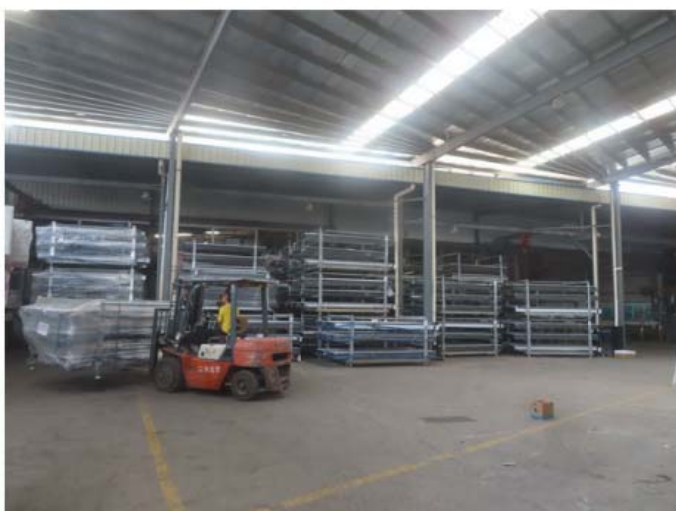
23_Assembled CW panels are stored on the rack

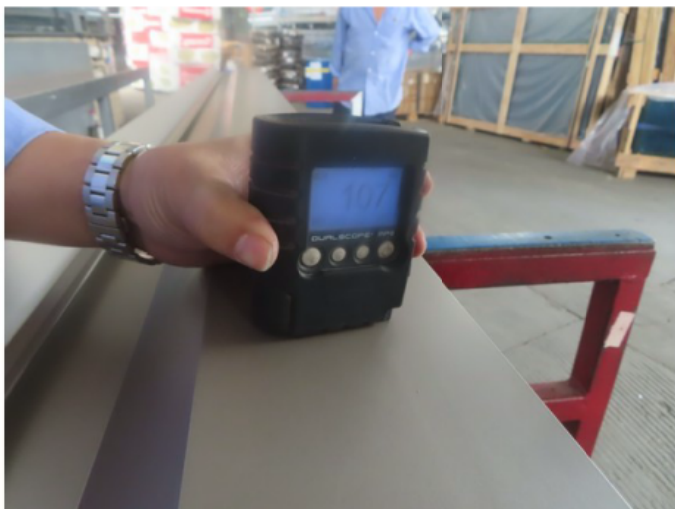
31_Coating thicknes measurement

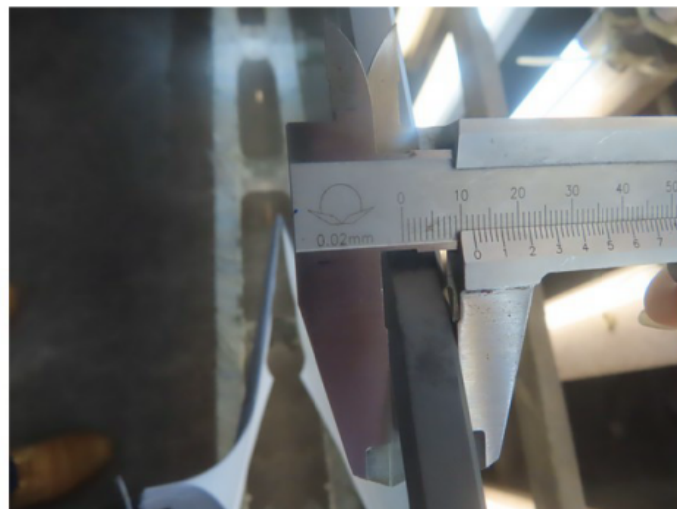
38_Check dimension of Glazing

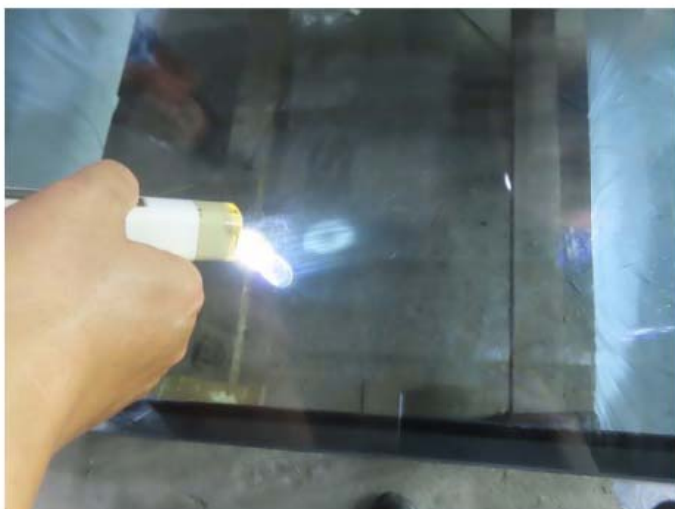
41_Check IGU arrangement and visual inspection

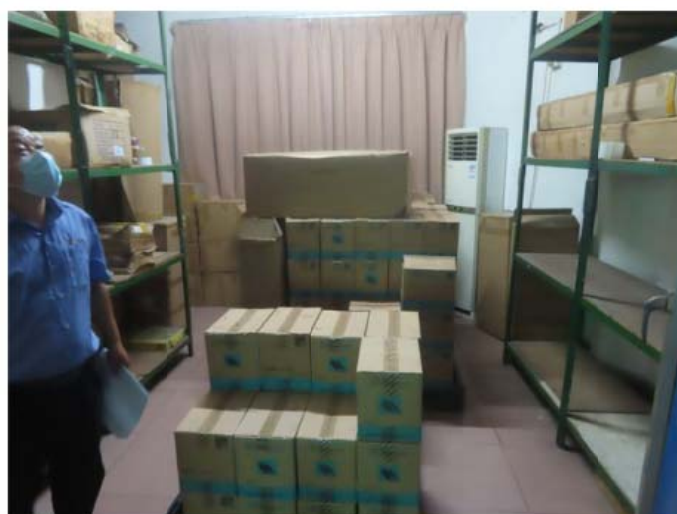
48_Check delivery condition and expire date of sealant

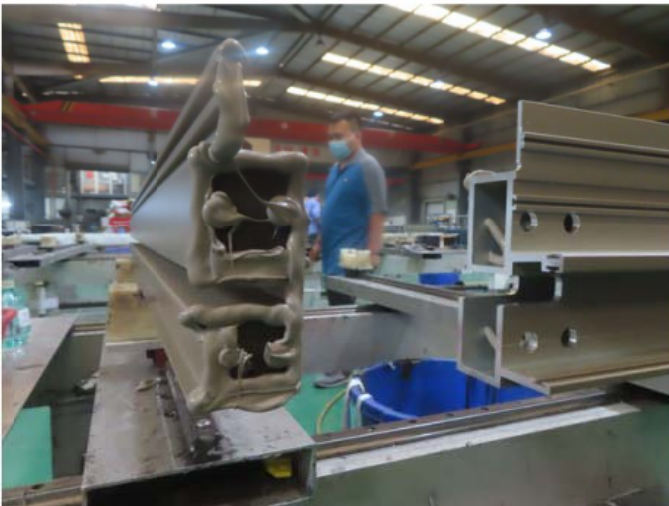
51_Check sealant at mullion and transom interfacing.

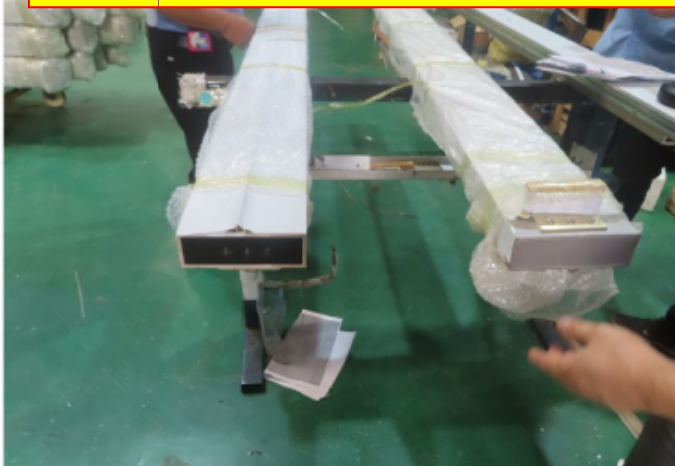
3_ one side of mullion was found concealed

- Missing seal-up end position of Mullion and transom was found during factory inspection. Midi is required to strictly follow the principle design to seal-up end position of Transom and Mullion
- Blemish was observed to be existed at spandrel sealant. MIDI is required to carry out their internal QA/QC method to repair the defect of on spandrel sealant and back pan, MIDI needs to improve workmanship for future works.

Action: Midi is required to strictly follow the agreement during tender stage for principle design to seal-up end position of Transom and Mullion

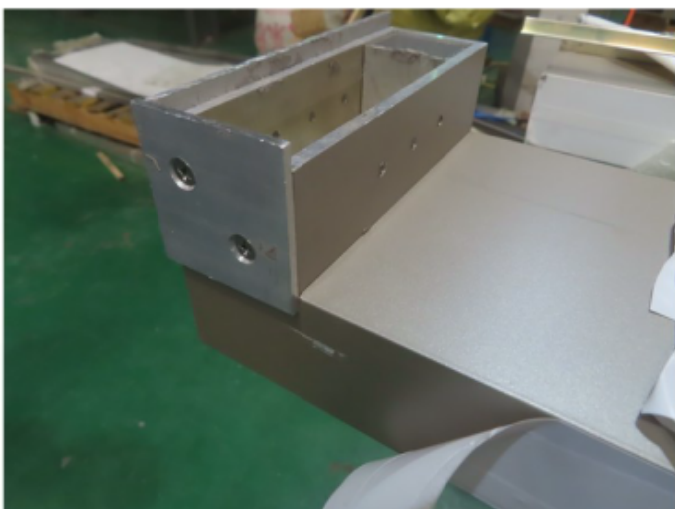
5_Trial assembly of mullion and transom for sliding door

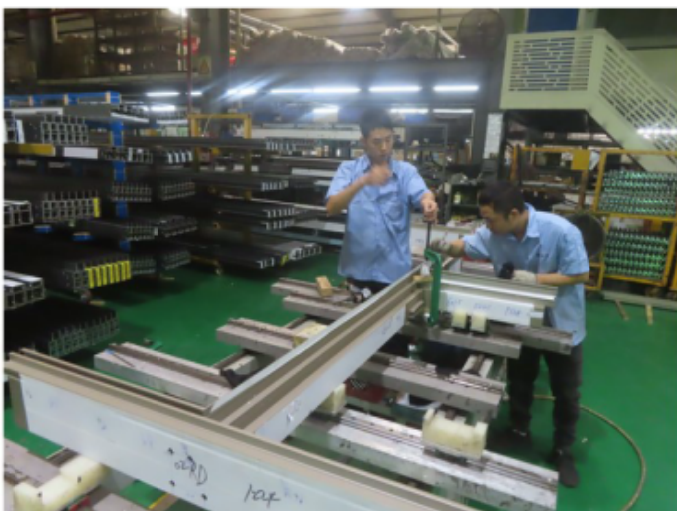
7_General inspection of sealant application at Mullion & Transom interface

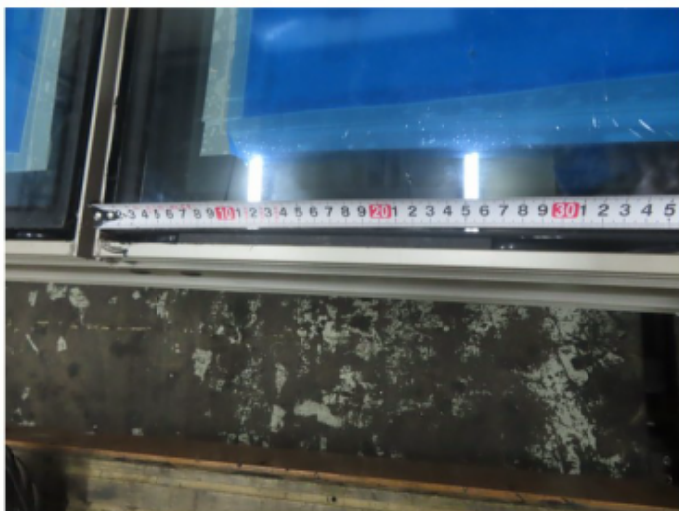
21_Check length and position of setting block

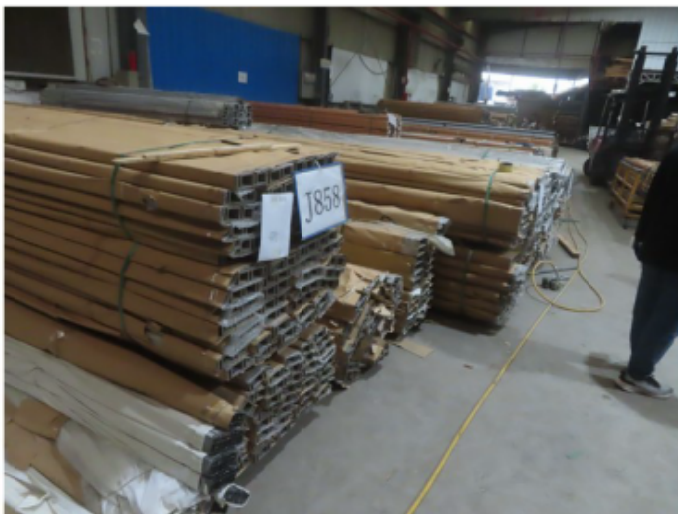
1_Raw materials were tidy-up at temporary storage area (Before QC checking)

Report-R-03 Photo 1 - 4	Completed
2	Missing seal-up at end position of Mullion and Transom for sliding door was observed during factory inspection.	Midi is required to strictly follow the principle design to seal-up end position of Transom and Mullion	Report-R-02 Photo 1-4

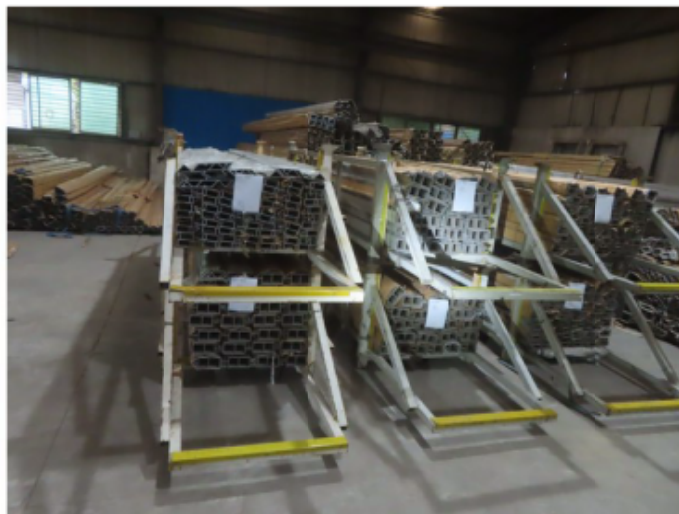
2_Raw materials were tidy-up at temporary storage area (Before QC checking)

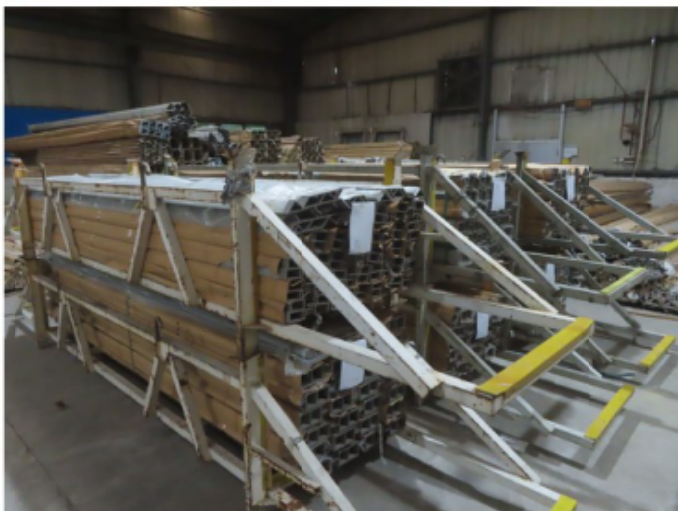
3_Raw materials were tidy-up at temporary storage area (Before QC checking)

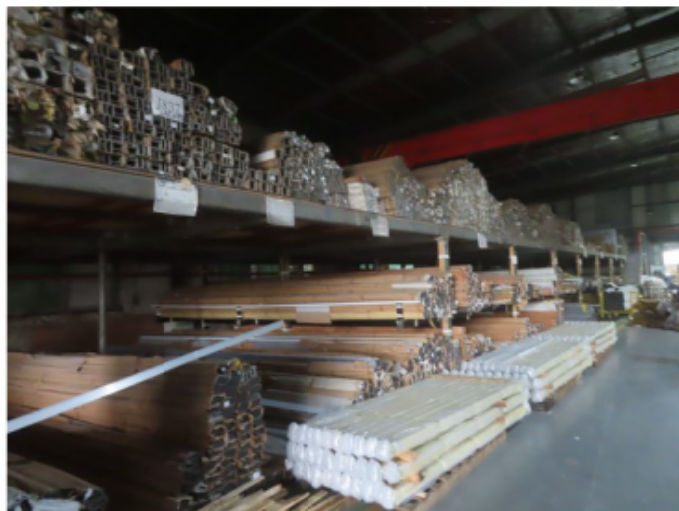
4_Materials storage area (After QC checking)

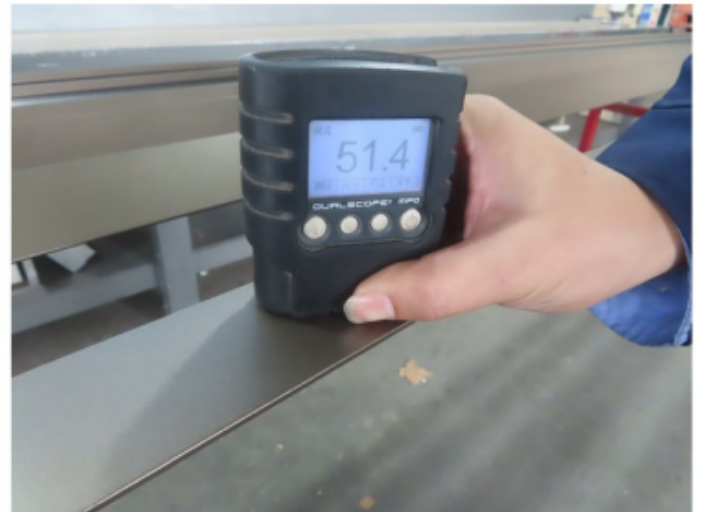
4_Coating thickness measurement
