PROPOSED RESIDENTIAL
DEVELOPMENT AT TKOTL 70RP,
PHASE 11. LOHAS PARK, TSEUNG
KWAN O. N.T.

Factory Inspection Report 19

Inspection Date: 31st March 2023
Issue Date: 01st April 2023

Report Reference: 60646872-FI-R-19

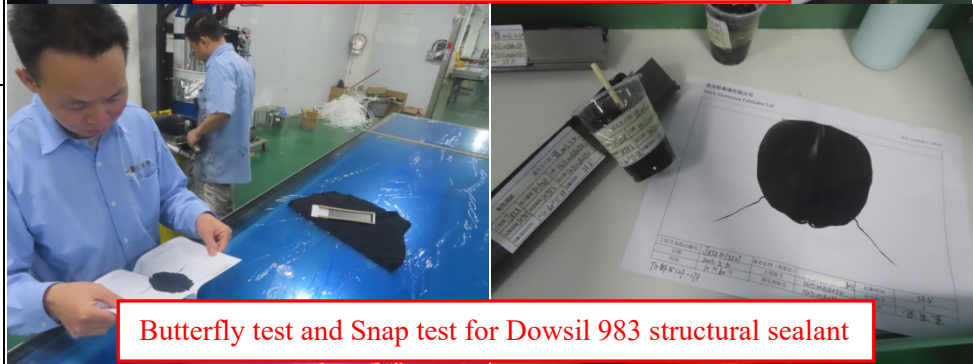
Butterfly test and Snap test for Dowsil 983 structural sealant
