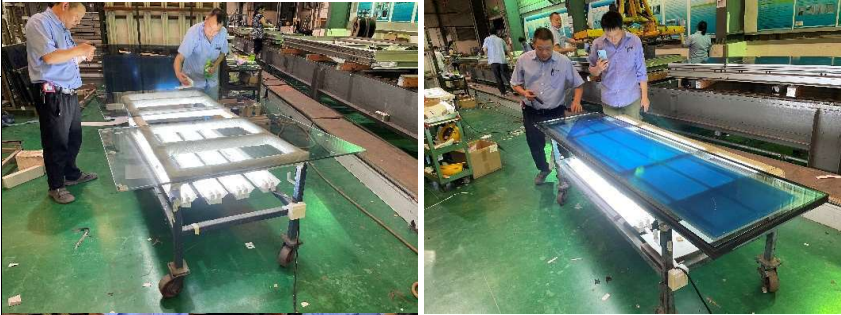
<p>Photo 7</p>		
<p><u>Location:</u> Observation</p>

<p><u>Description:</u> Quality and dimension checking of glazing prior sealant work</p>		
<p><u>Action:</u></p>
