工程指示 / 要求簡箋(E.I.)

工程指示編號：EI / 3187 / 21 修改版次：-
 工程編號：J - 852 工程名稱：亞皆老街中電
 工程項目：佛沙窗 師父板 (4th)
 收件人：生統 / 王良 發件人：Ant Yeung 日期：22/03/2021

Proposed Residential Development at 139-147 Argyle Street, Kowloon

Site Inspection Report # 06

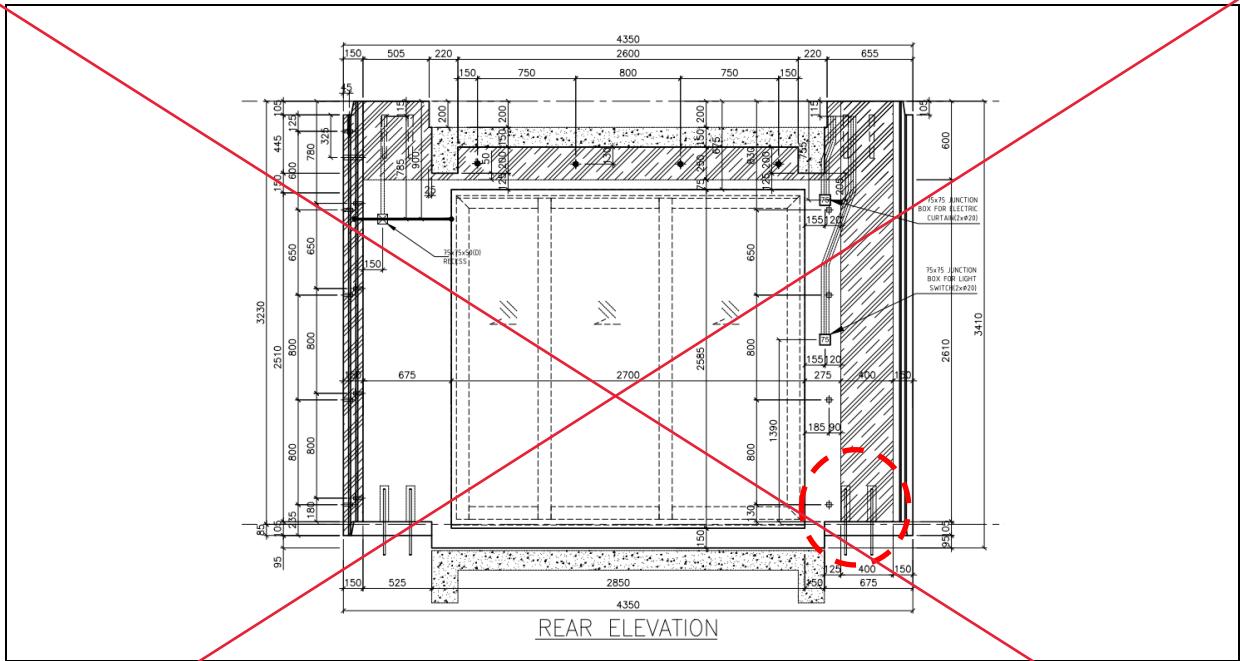
Photo #11

Observation
(T1 1/F Flat A)
