PROPOSED RESIDENTIAL
DEVELOPMENT AT TKOTL 70RP,
PHASE 11. LOHAS PARK, TSEUNG
KWAN O. N.T.

Factory Inspection Report 01

Inspection Date: 18th November 2022
Issue Date: 05th December 2022

Report Reference: 60646872-FI-R-01

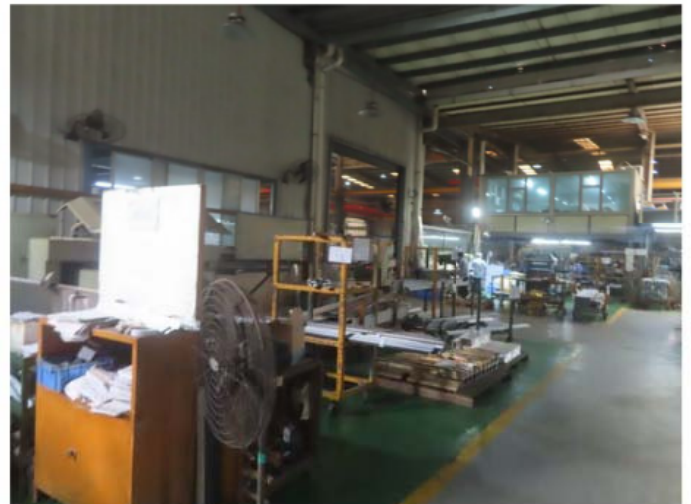
10_Raw material. under drilling fabrication process

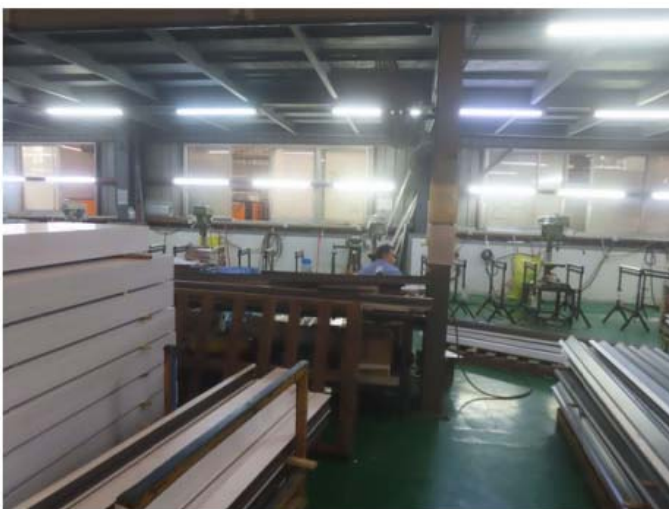
11_Raw material. under drilling fabrication process

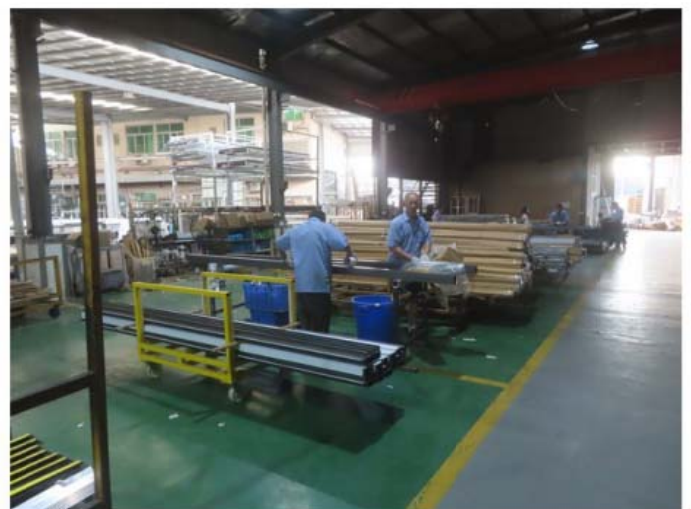
12_Raw materials QC checking

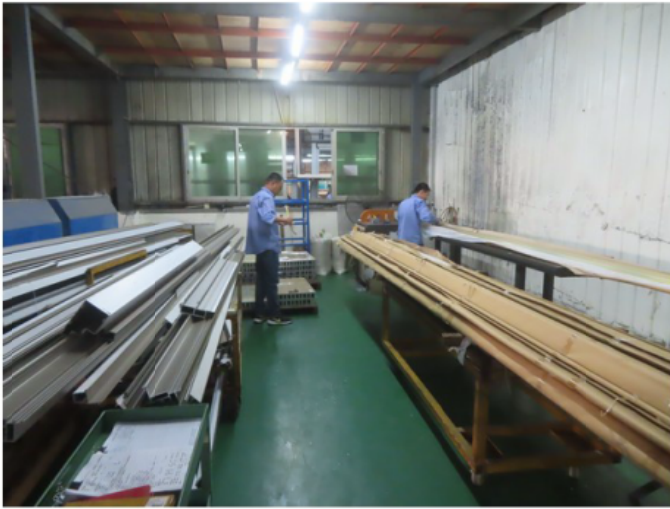
13_Raw materials QC checking

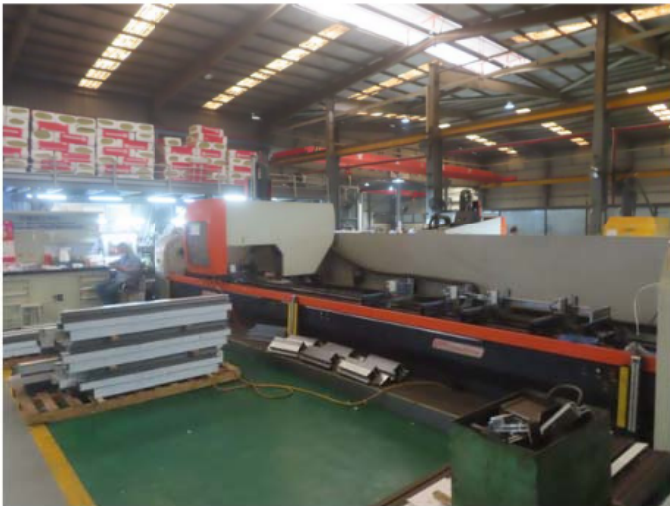
15_Milling and CNC cutting

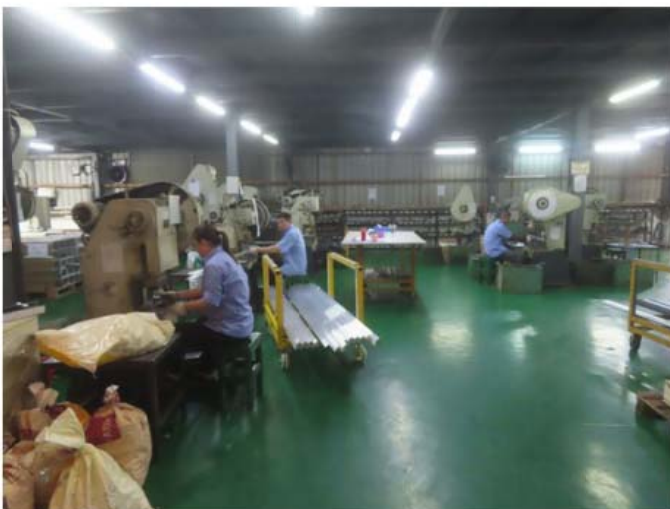
17_Drilling and punching

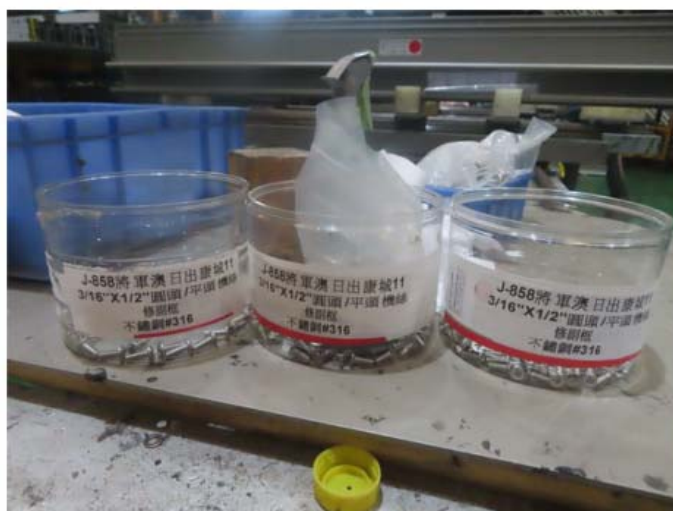
24_Stainless 316 screw

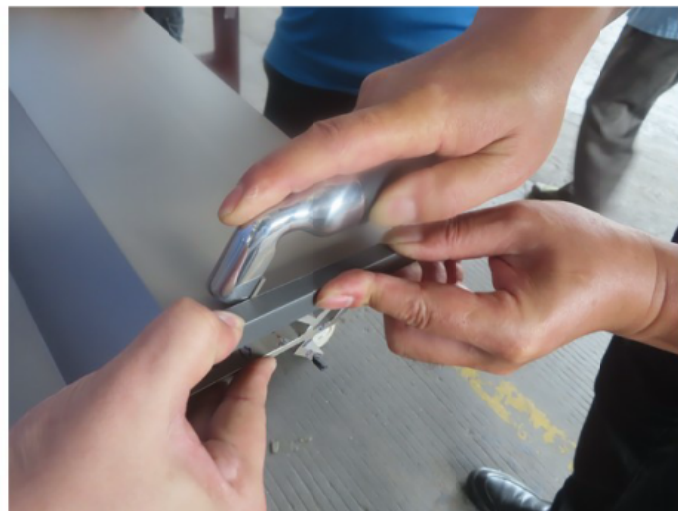
26_Adhesion test

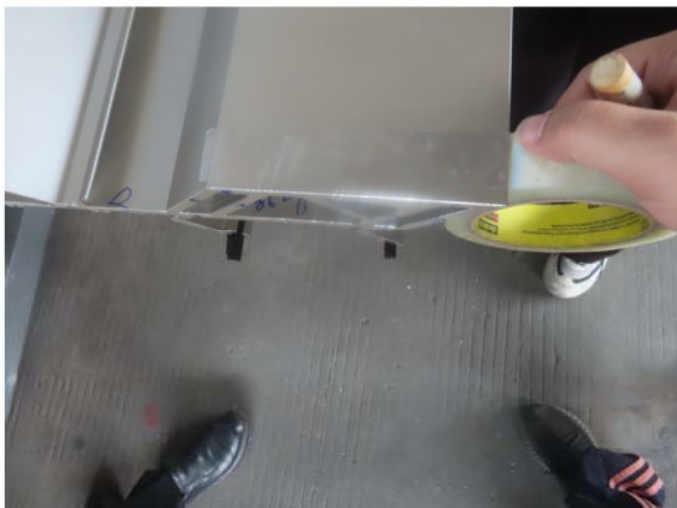
27_Adhesion test

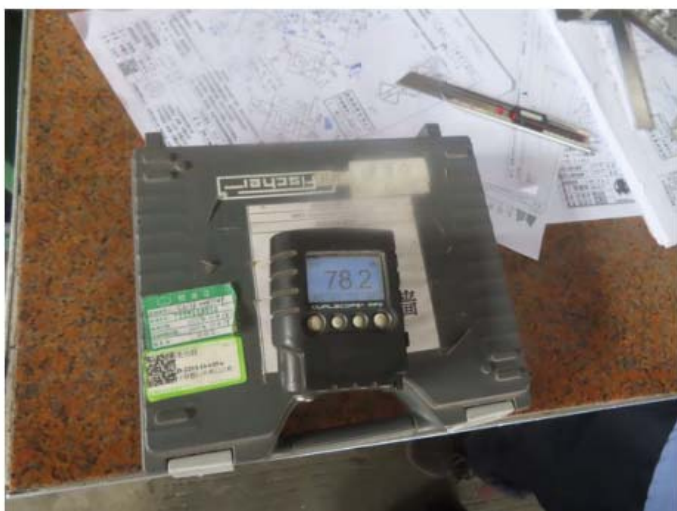
29_Check calibration certificate of thickness gauge

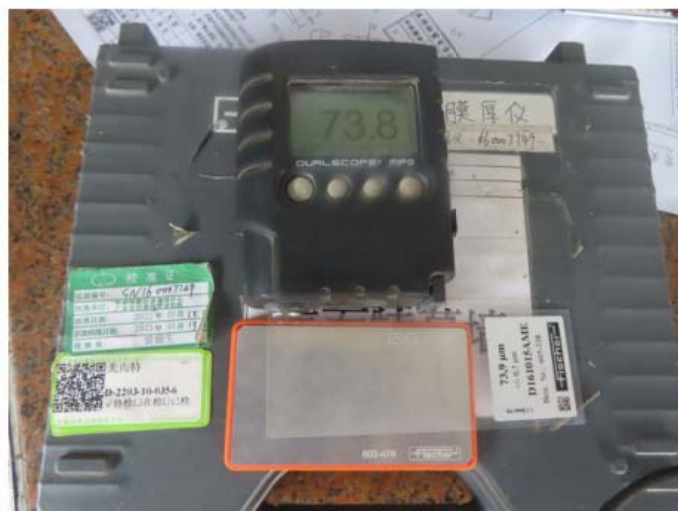
30_Calibration of thickness gauge

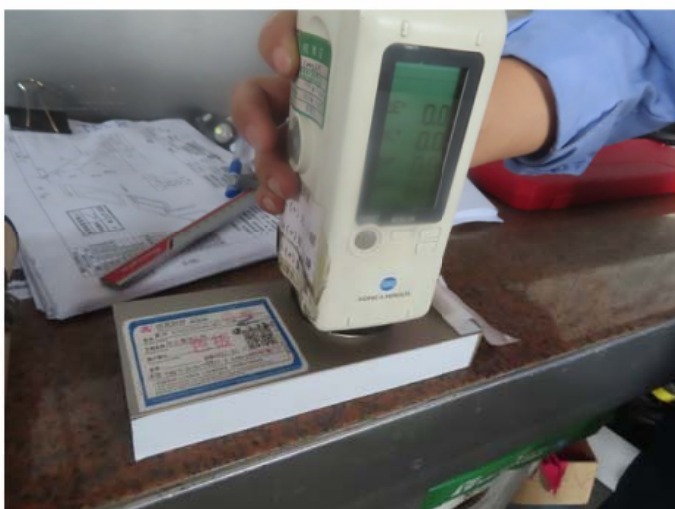
33_ Zeroing of spectrometer by using control sample

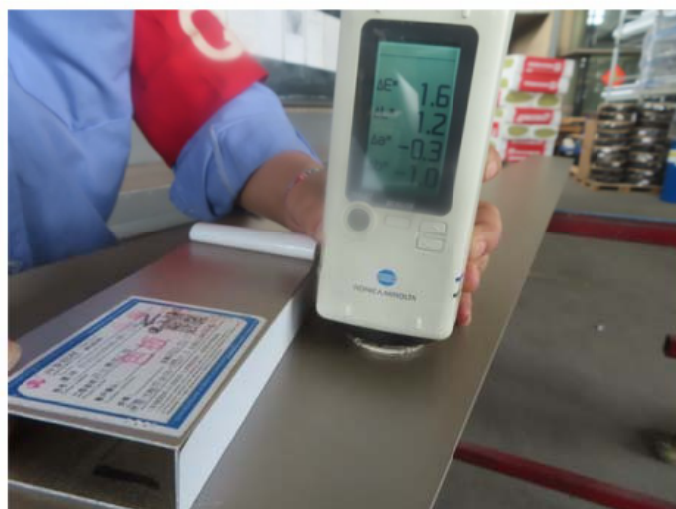
34_ Check colour uniformity compare with control sample

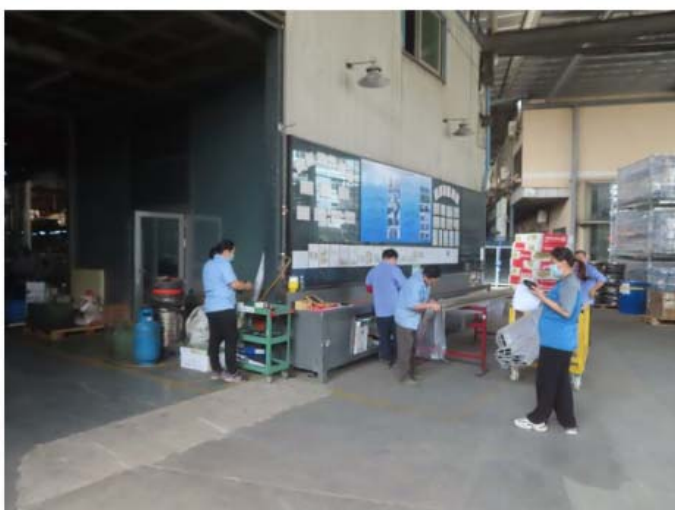
35_Check dimension of extrusion X86295

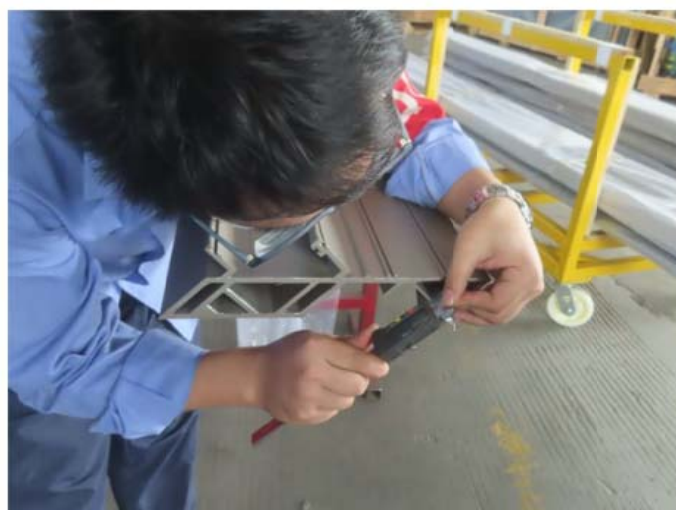
36_Check dimension of extrusion X86295

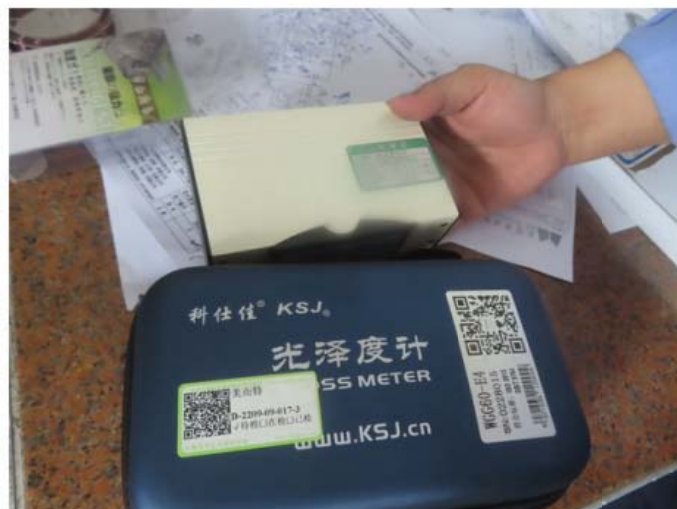
42_Check calibration of Gloss meter

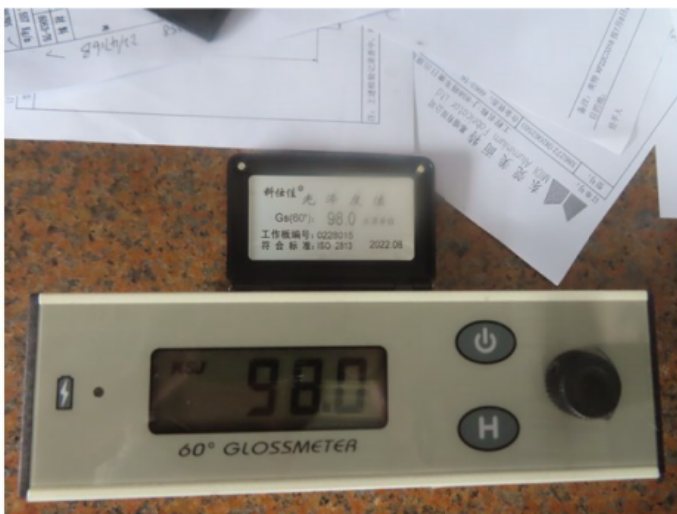
43_Calibration prior test

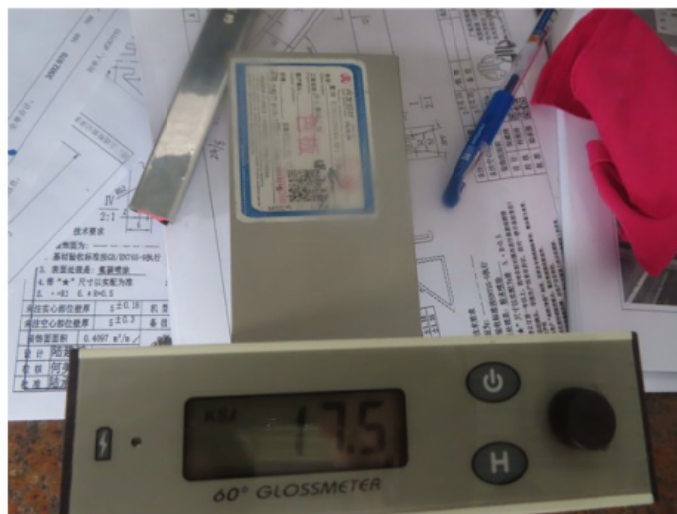
44_Initial checking of control sample

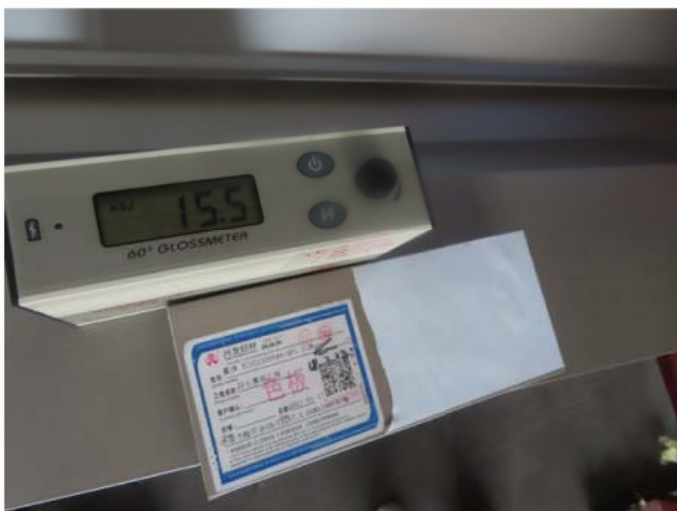
45_Gloss checking by using gloss meter

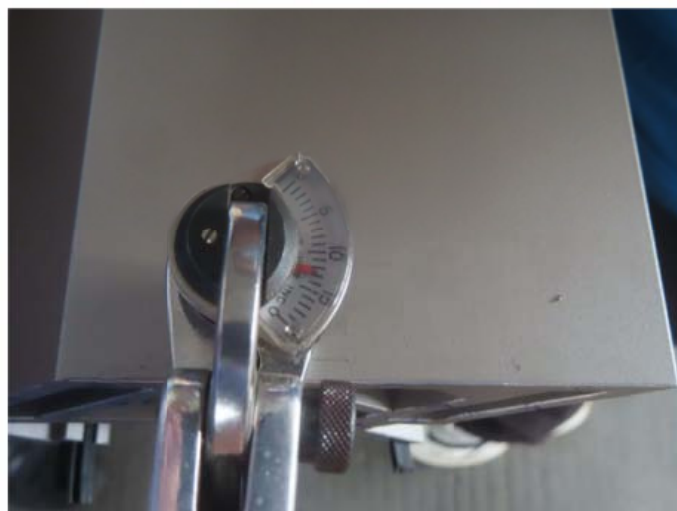
46_Check hardness of 6063-T6 extrusion

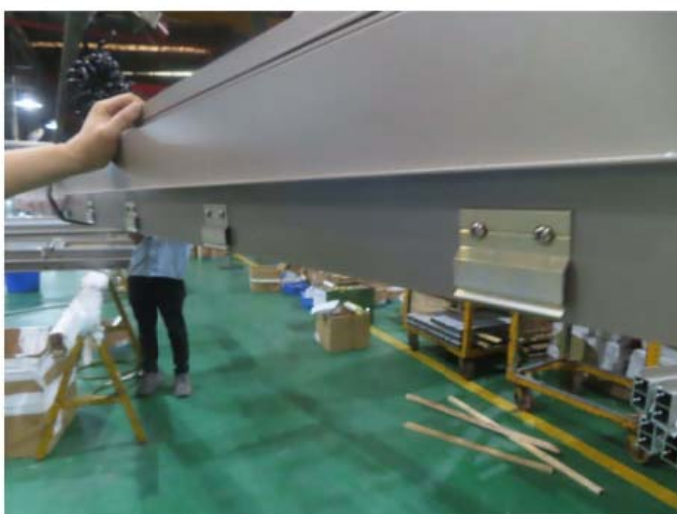
47_Check performance of chromating surface

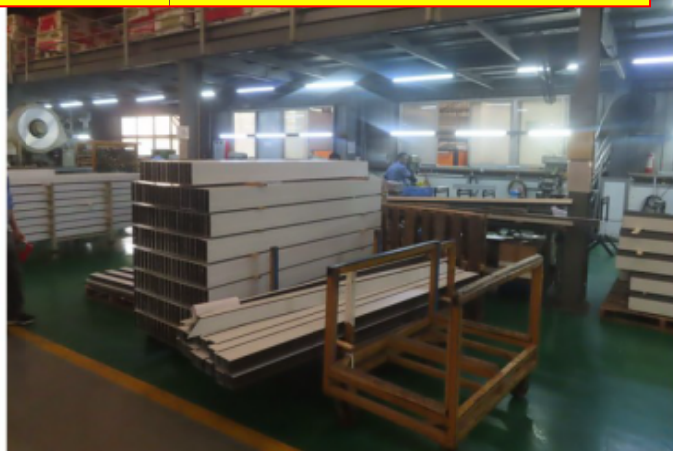
2_Mullion and Transom for sliding door

- Missing seal-up end position of Mullion and transom was found during factory inspection. Midi is required to strictly follow the principle design to seal-up end position of Transom and Mullion
- Blemish was observed to be existed at spandrel sealant. MIDI is required to carry out their internal QA/QC method to repair the defect of on spandrel sealant and back pan, MIDI needs to improve workmanship for future works.

Action: Midi is required to strictly follow the agreement during tender stage for principle design to seal-up end position of Transom and Mullion

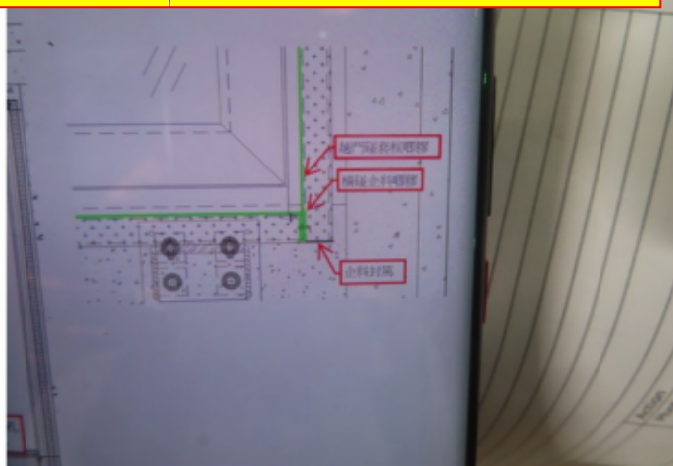
4_Original design from Midi

Action: Midi is required to strictly follow the agreement during tender stage for principle design to seal-up end position of Transom and Mullion

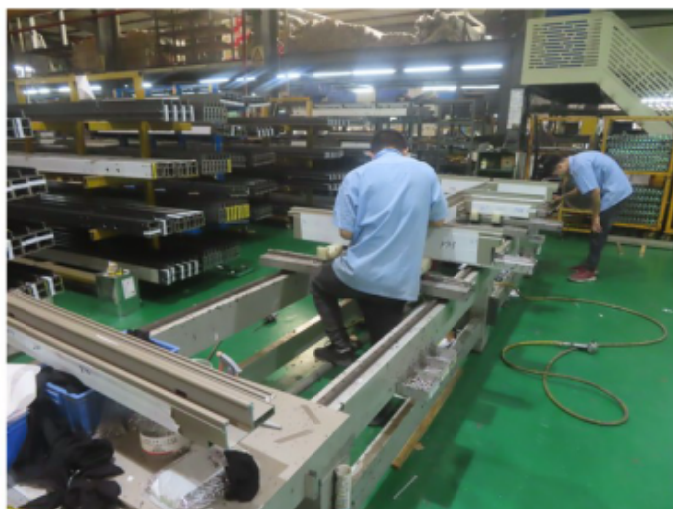
6_General inspection of sealant application at Mullion & Transom interface

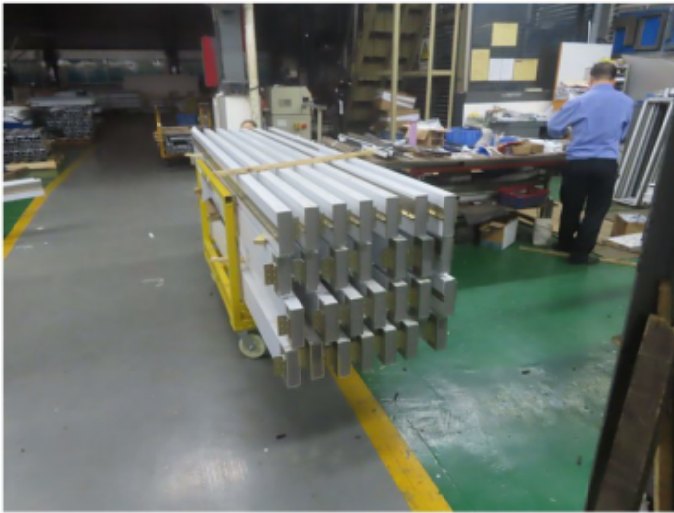
7_Seal-up end position of Transom and Mullion

Report-R-03 Photo 7 - 10	Completed
3	Blemish was observed to be existed at spandrel sealant.	MIDI is required to carry out their internal QA/QC method to repair the defect of on spandrel sealant and back pan, MIDI needs to improve	Report-R-02 Photo 23- 24

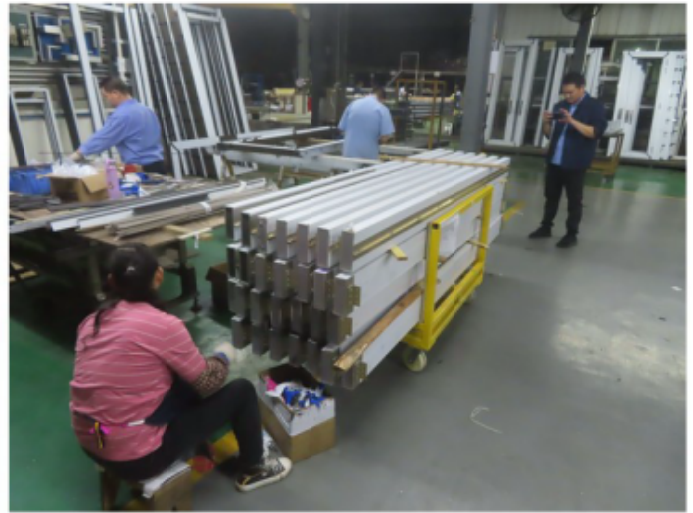
8_Seal-up end position of Transom and Mullion

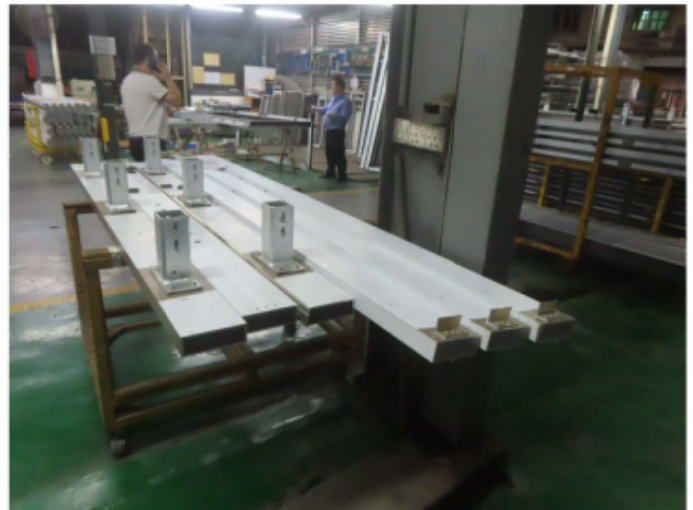
10_Seal-up end position of Transom and Mullion

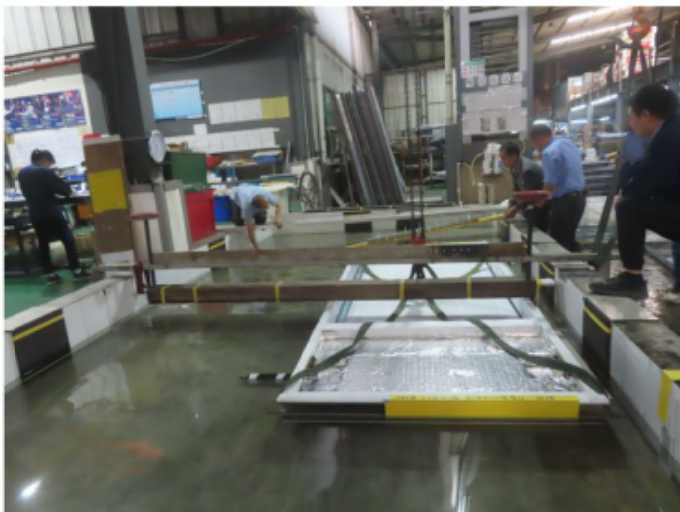
23_15F-T1BCW4 AF-25

- 9F-T1B-CW4_AS-07 No leakage was found
 - 12F-T1B-005_TM11 No leakage was found
 - 15F-T1B-CW4_AF-025 No leakage was found
 - 15F-T1B-CW4_AS-01 Leakage was found at handle of operable window,
15F-T1B-CW4_AS-01 No leakage was found after remedial work

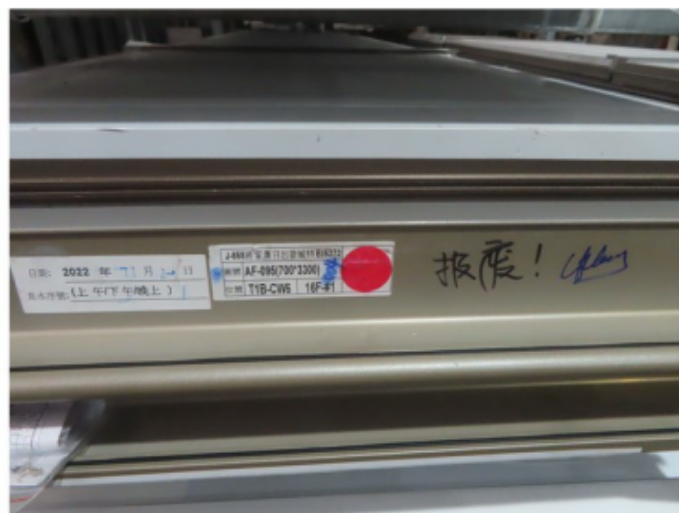
32_witness and measurement of abandon materials

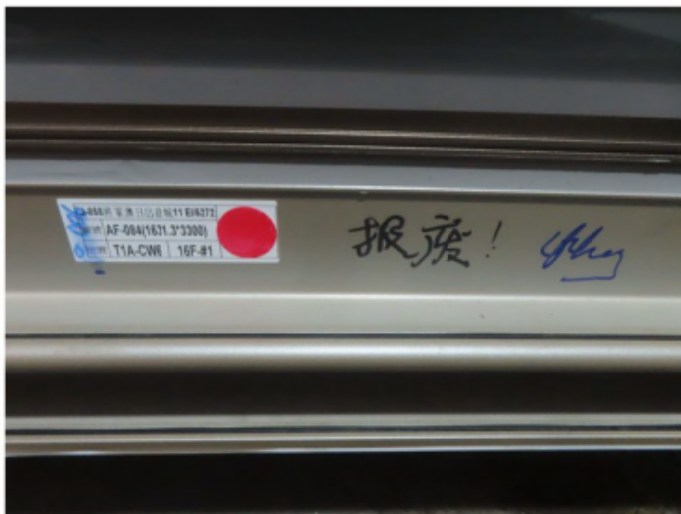
33_witness and measurement of abandon materials

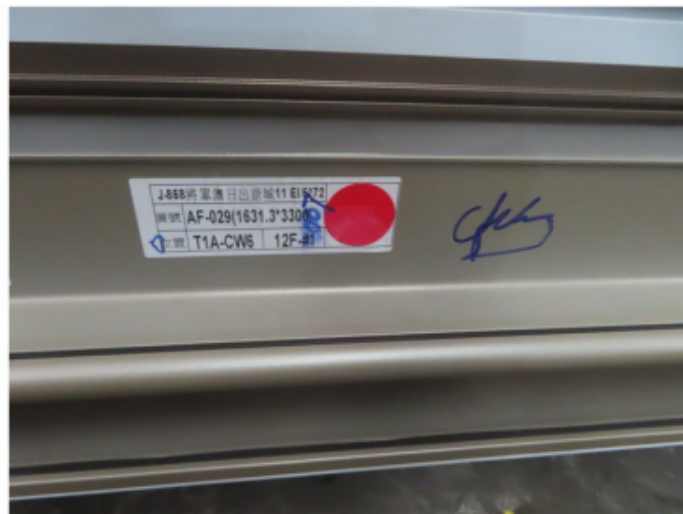
34_witness and measurement of abandon materials

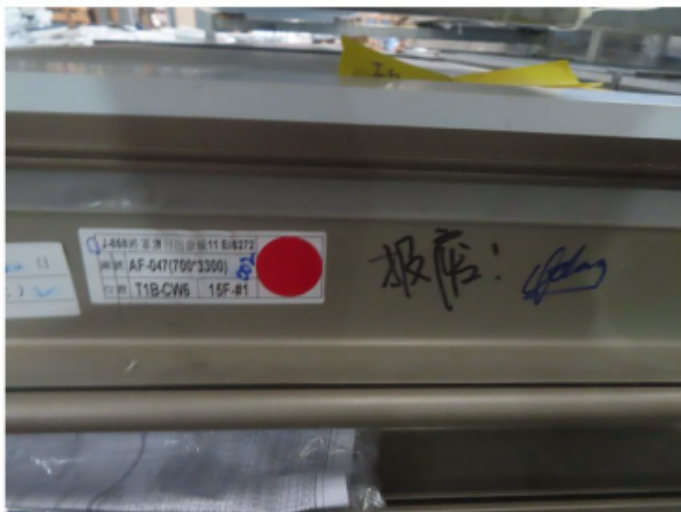
35_witness and measurement of abandon materials

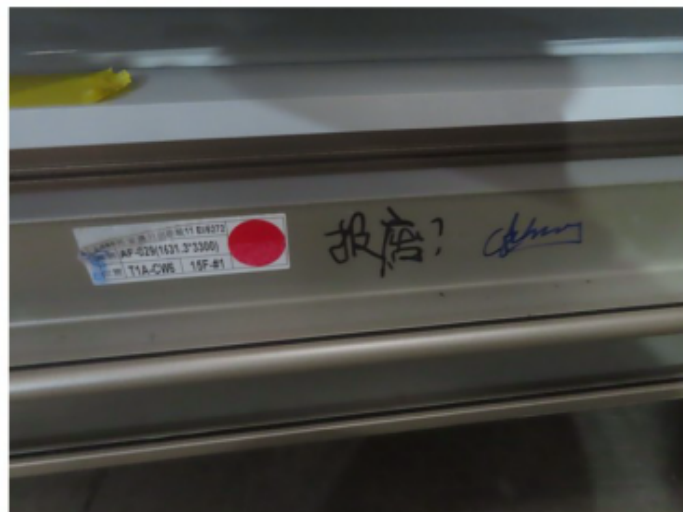
36_witness and measurement of abandon materials

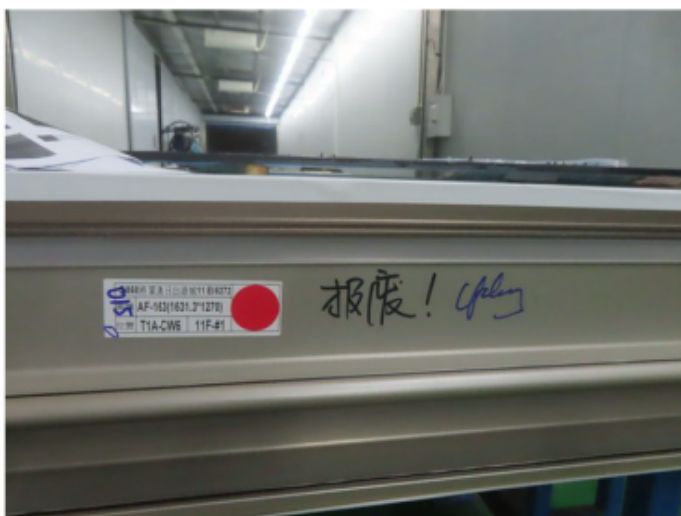
37_witness and measurement of abandon materials

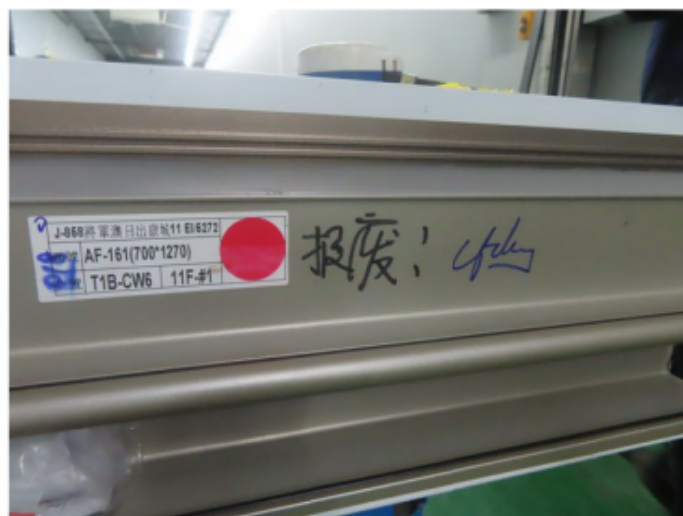
38_witness and measurement of abandon materials

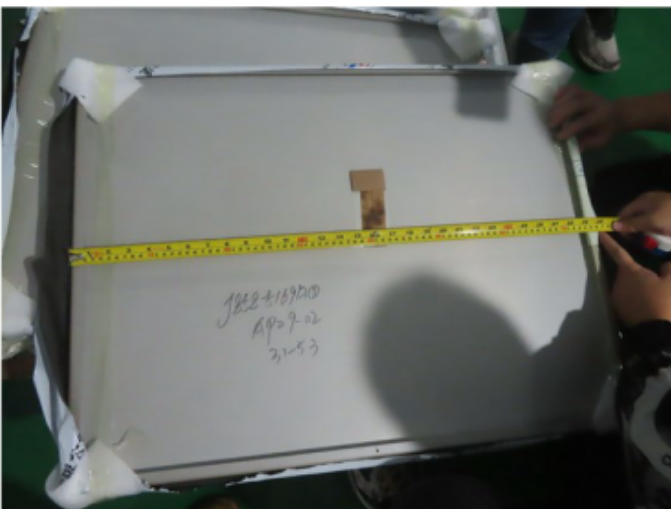
43_witness and measurement of abandon Aluminium panel

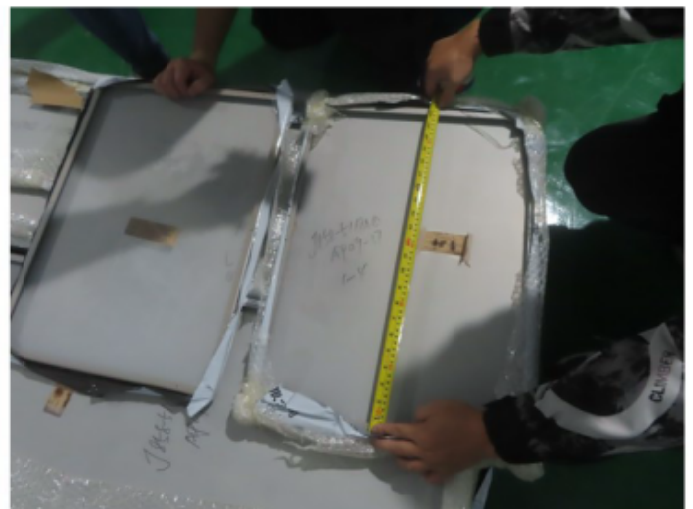
44_witness and measurement of abandon Aluminium panel

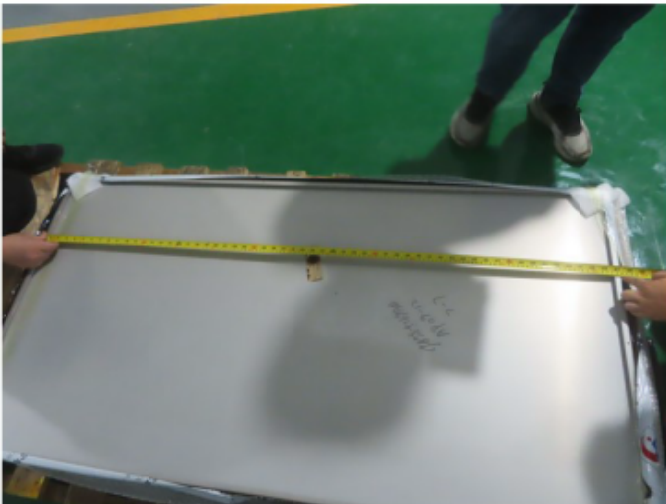
47_witness and measurement of abandon Aluminium panel

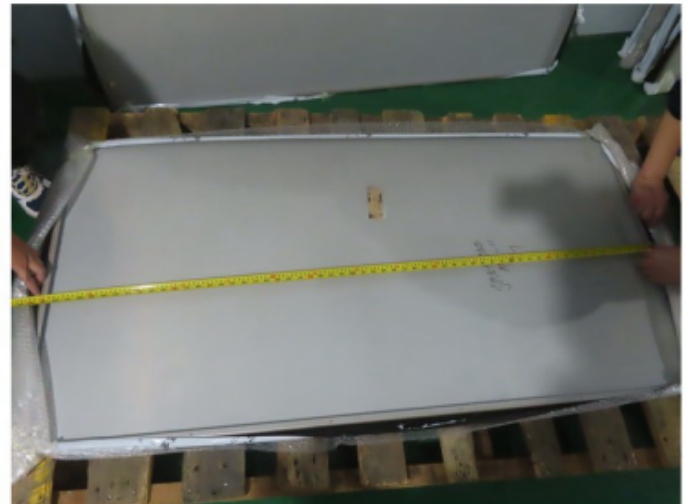
48_witness and measurement of abandon Aluminium panel

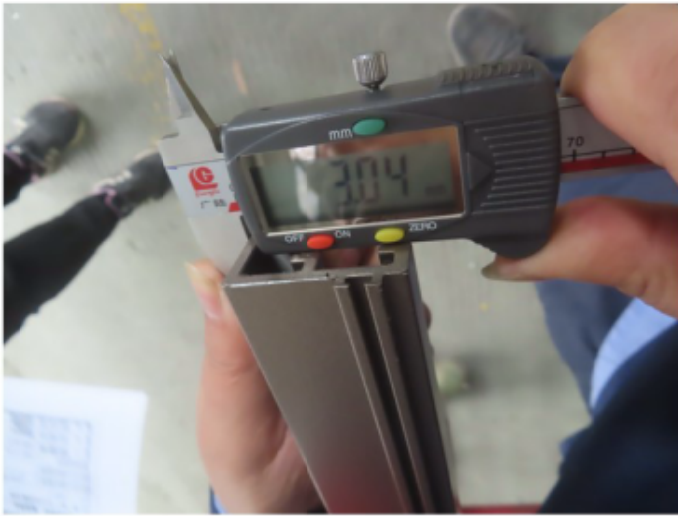
1_Dimension checking of extrusion

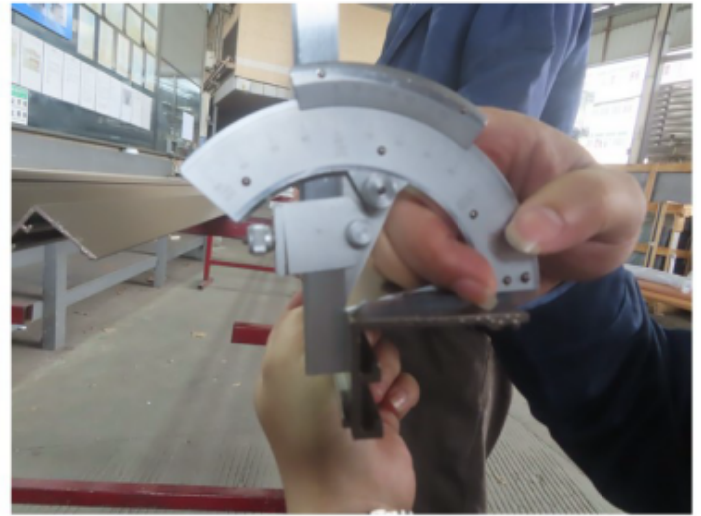
2_Dimension checking of extrusion

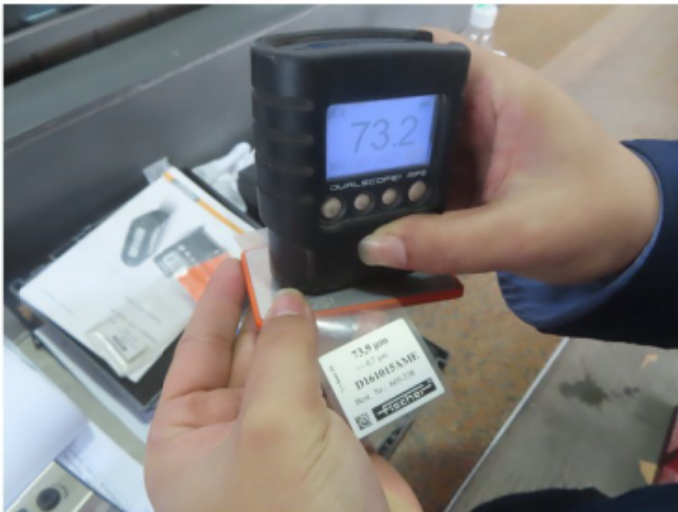
3_Calibration of thickness gauge

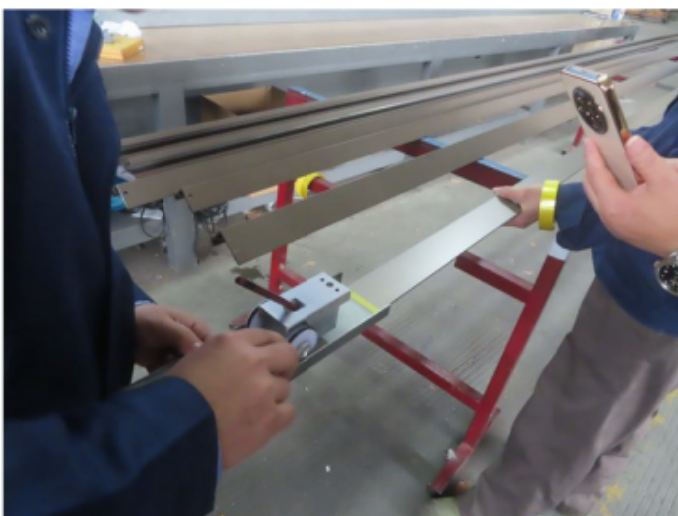
5_Check surface hardness of painting

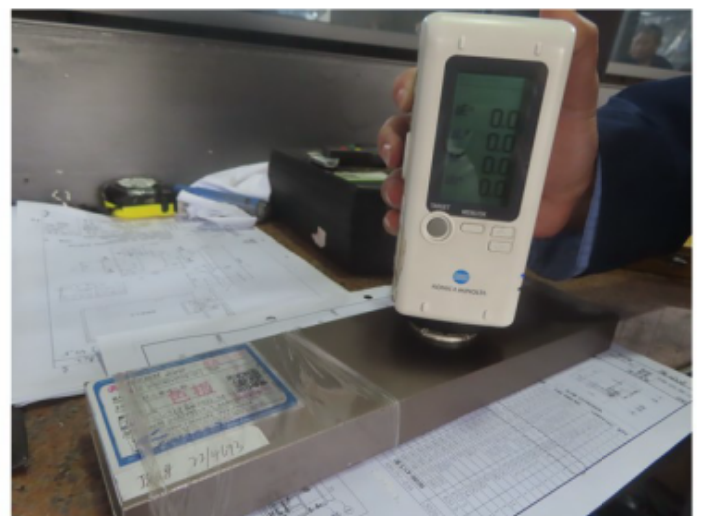
6_Zeroing of spectrometer by using control sample

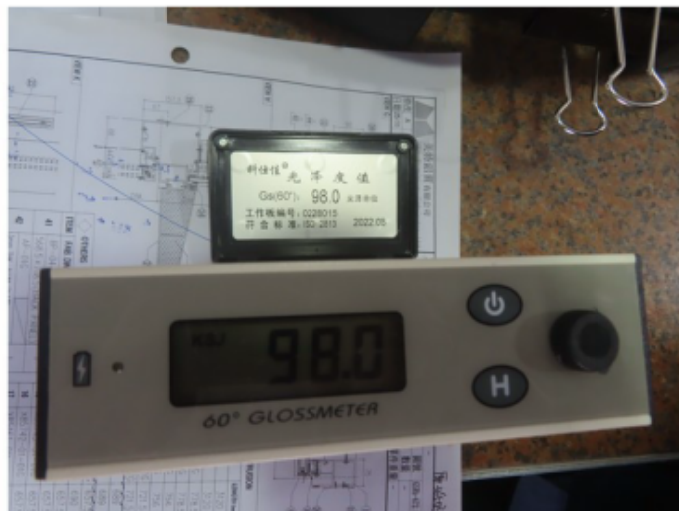
8_Calibration prior test

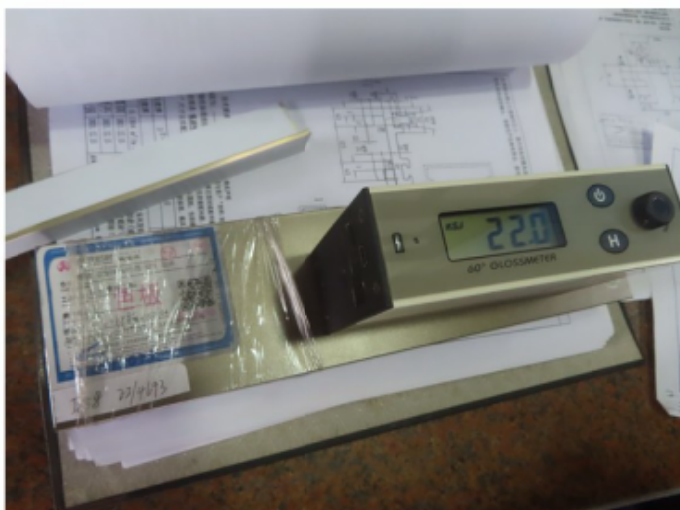
9_Initial checking of control sample

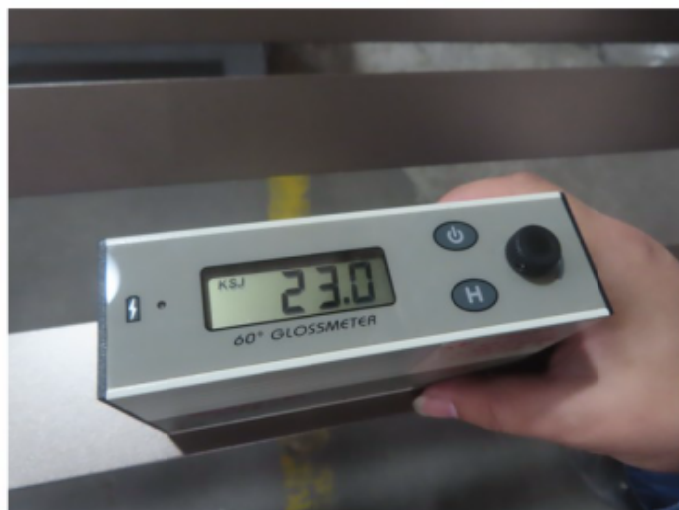
10_Gloss checking by using gloss meter

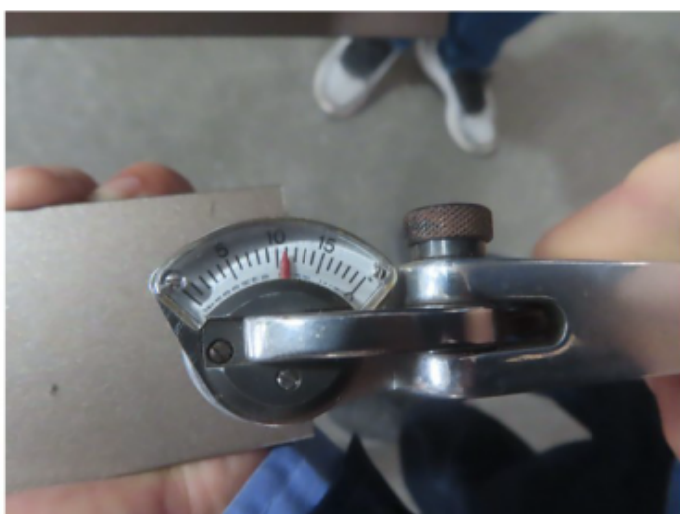
11_ Check hardness of 6063-T5 extrusion

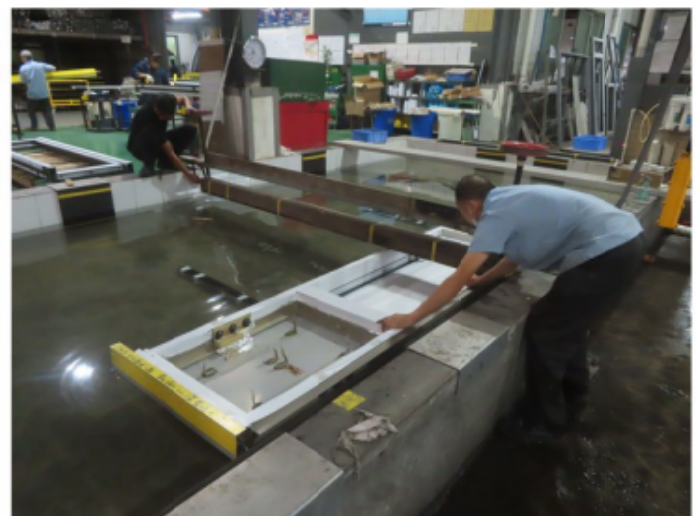
18_9F_T1BCW4_AS03

- 9F-T1B-CW4_AS-01 No leakage was found
 - 10F-T1B-CW4_AS-07 No leakage was found
 - 9F-T1B-CW4_AS-03 Leakage was found at air/ vent hole due to damaged sealant;
9F-T1B-CW4_AS-03 No leakage was found after remedial work
(Leakage from End position of Mullion)

- Water leakage was found during flooding test for Panel number 9F-T1B-CW4_AS-03. MIDI is required to carry out their internal QA/QC method to improve workmanship for future works.

Action: MIDI is required to carry out their internal QA/QC method to repair the leakage unitized panel, MIDI needs to improve workmanship for

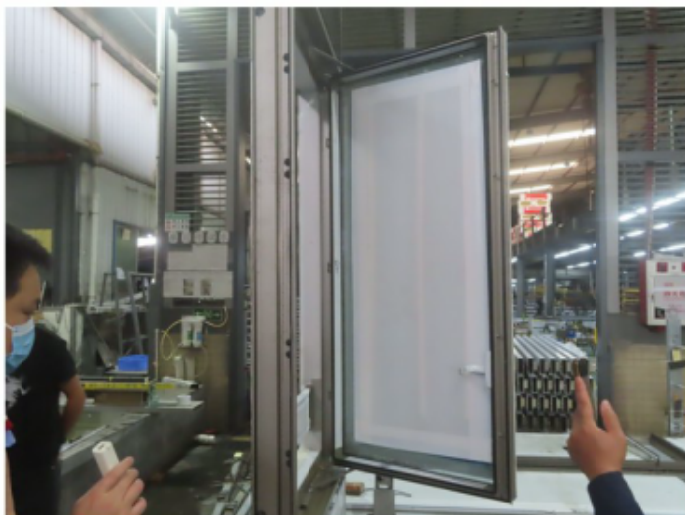
21_9F_T1BCW4_AS0_Check operable window

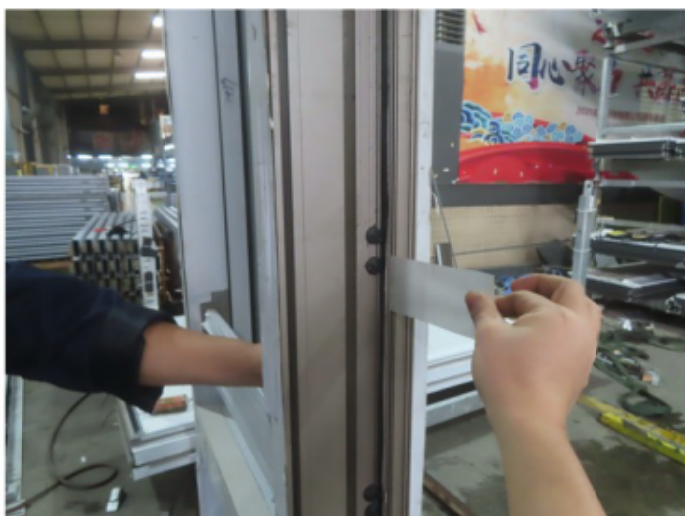
22_9F_T1BCW4_AS0_Check water leakage for operable window

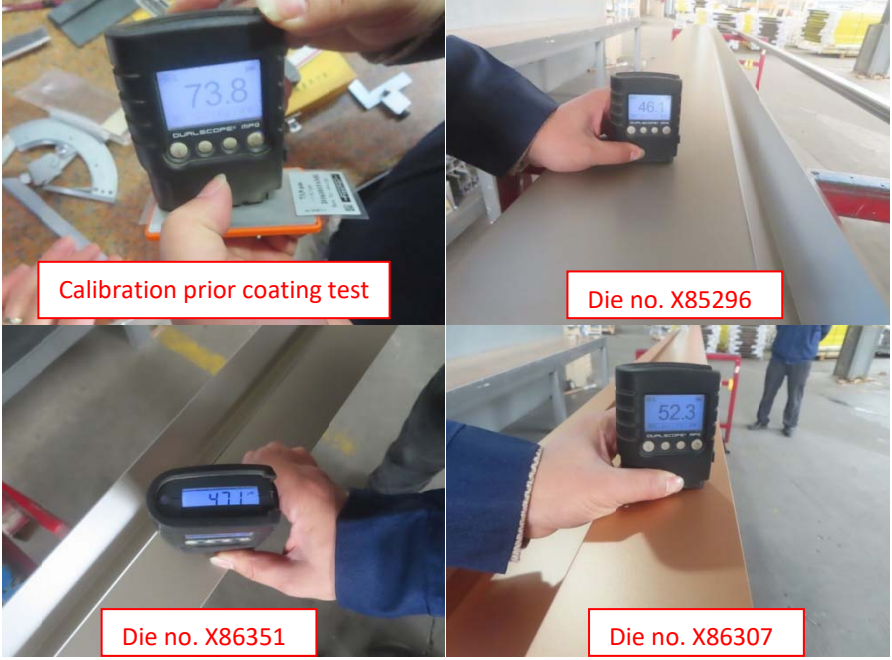
<p>Photo 2</p>		
<p><u>Item:</u> Observation</p>

<p><u>Description:</u> Coating thickness measurement for Alum. extrusion X85296, X85353 & X86305</p>		
<p><u>Action:</u> -</p>

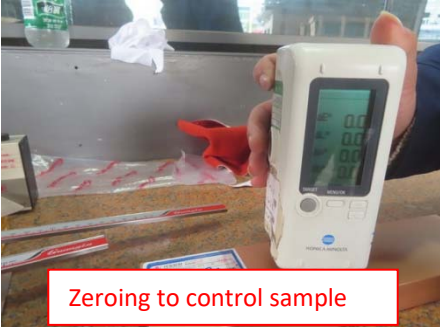
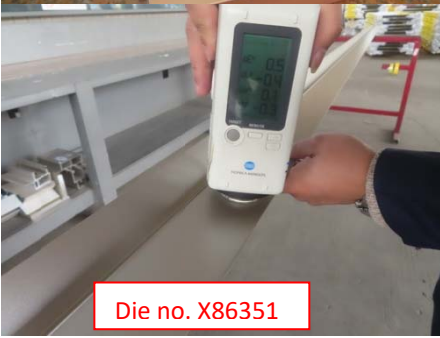
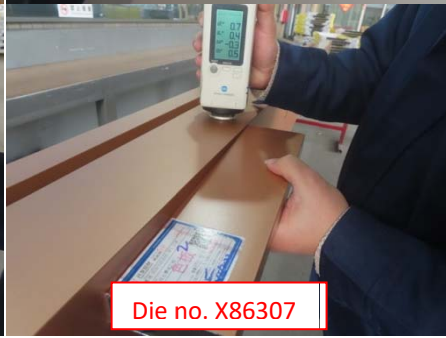
<p>Photo 5</p>		
<p><u>Item:</u> Observation</p>

<p style="text-align: center;">Zeroing to control sample</p>	
<p><u>Description:</u> Check color uniformity compare with control sample for Alum. extrusion X85296, X85353 & X86305</p>

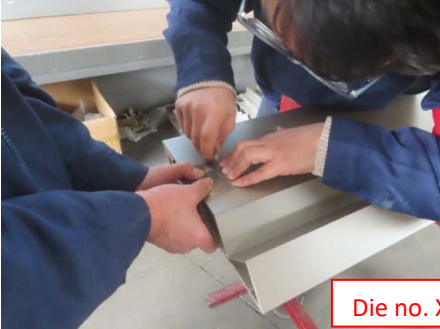
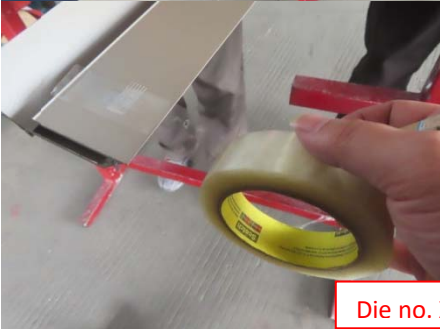
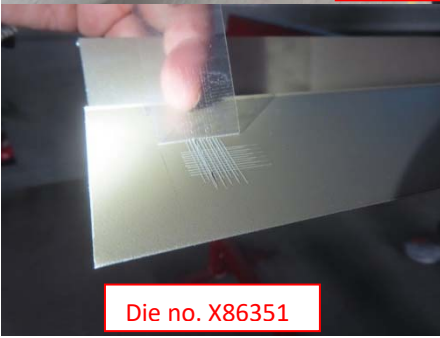
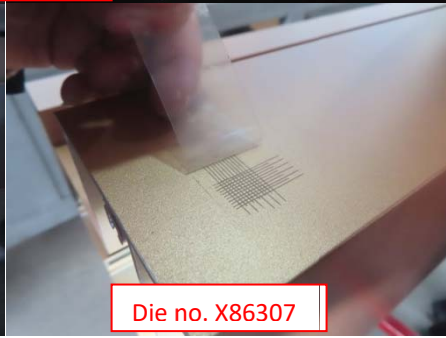
<p>Photo 6</p>		
<p><u>Item:</u> Observation</p>

<p style="text-align: center;">Die no. X85296</p>	
<p><u>Description:</u> Adhesion test for Alum. extrusion X85296, X85353 & X86305</p>

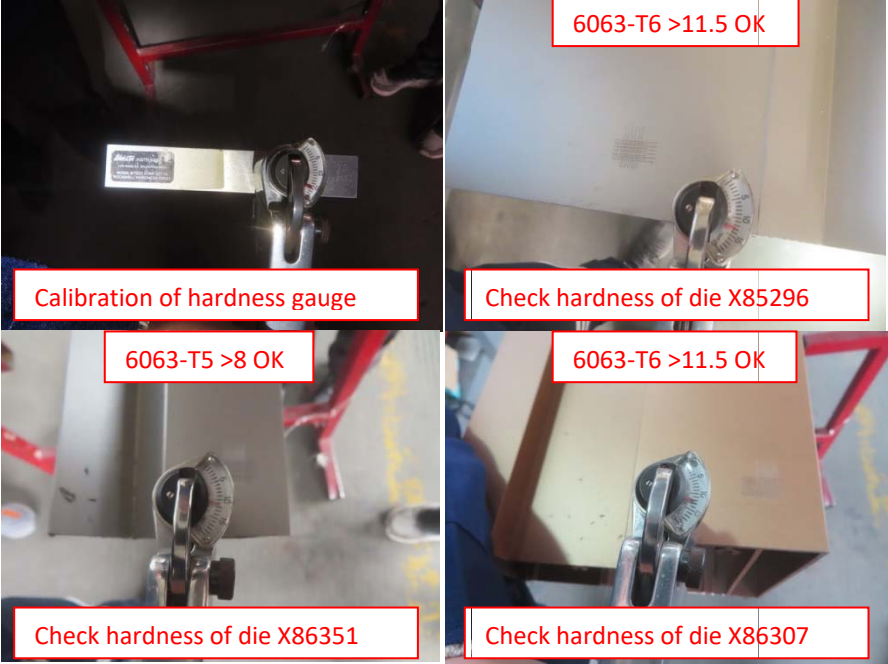
<p>Photo 7</p>

<p>6063-T6 >11.5 OK</p> <p>Calibration of hardness gauge</p> <p>6063-T5 >8 OK</p> <p>Check hardness of die X85296</p> <p>6063-T6 >11.5 OK</p> <p>Check hardness of die X86351</p> <p>Check hardness of die X86307</p>
<p><u>Item:</u> Observation</p>	
<p><u>Description:</u> Hardness check for Alum. extrusion X85296, X85353 & X86305</p>	
<p><u>Action:</u> -</p>	
<p>Photo 8</p>

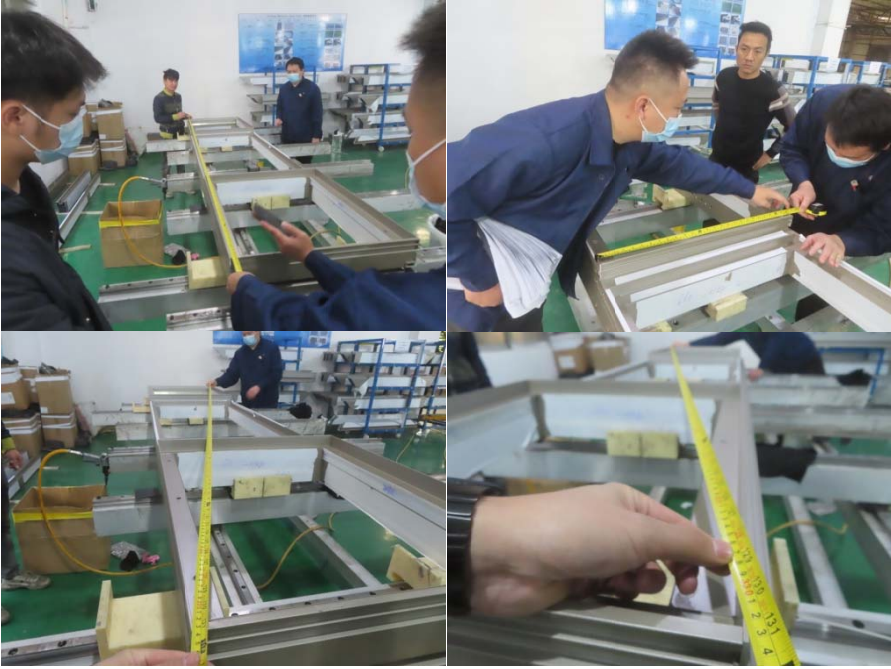
<p>Photo 15</p>

<p><u>Item:</u> Observation</p>		
<p><u>Description:</u> Dimension check for mullion and transom after assembly work</p>		
<p><u>Action:</u> -</p>

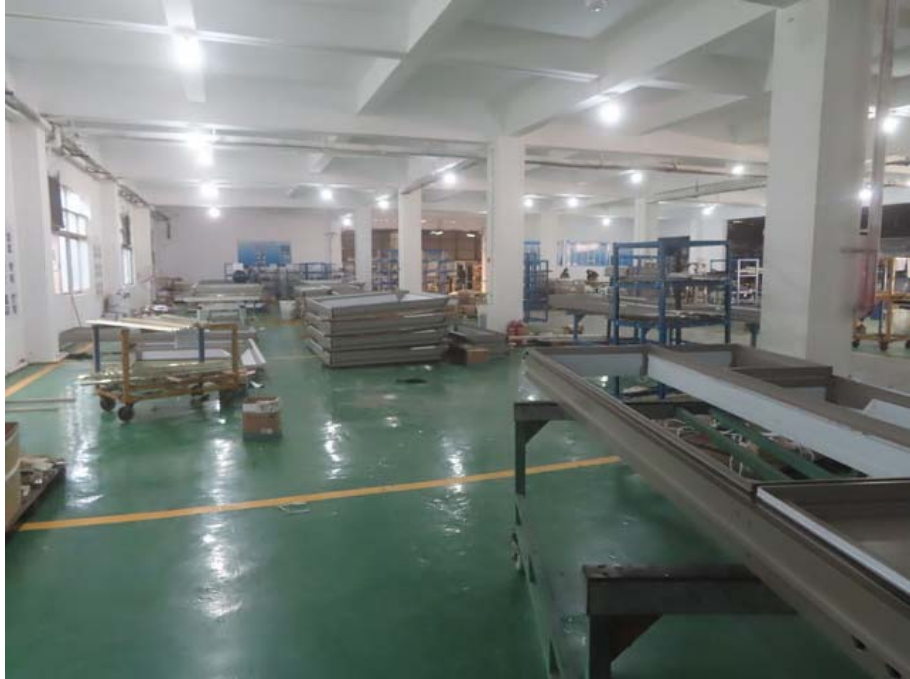
Description:
General view of assembly line for fixing of Transom and Mullion

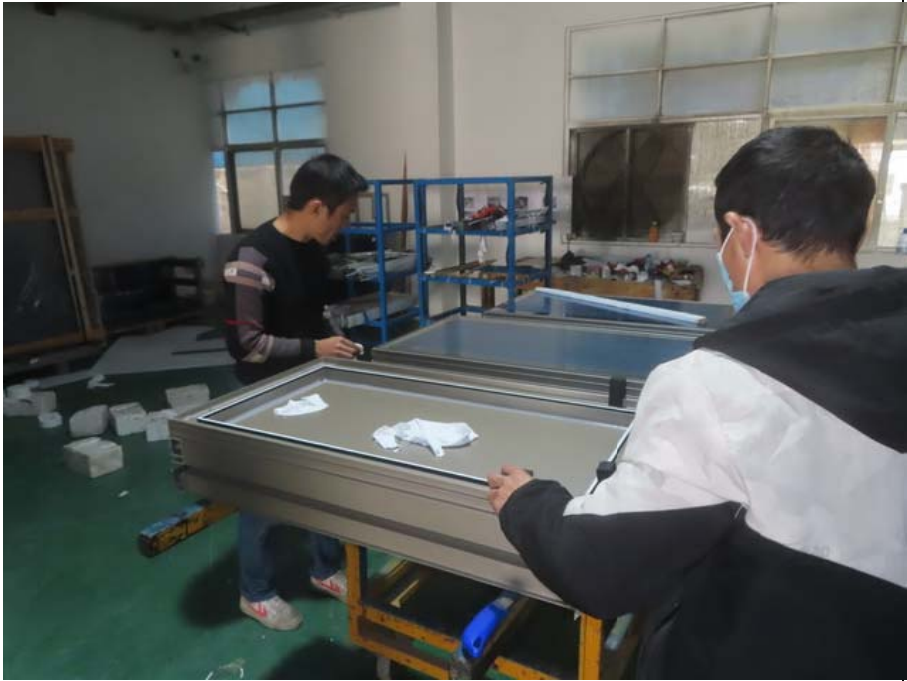
Photo 3

Description:
Final cleaning of back panel prior fixing of glazing
