PROPOSED RESIDENTIAL
DEVELOPMENT AT TKOTL 70RP,
PHASE 11. LOHAS PARK, TSEUNG
KWAN O. N.T.

Factory Inspection Report 01

Inspection Date: 18th November 2022
Issue Date: 05th December 2022

Report Reference: 60646872-FI-R-01

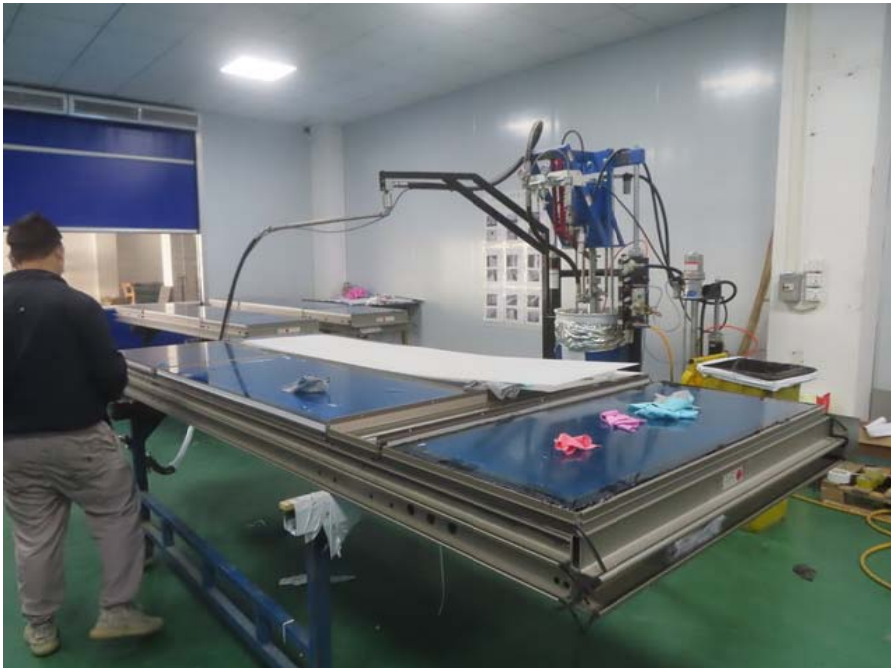
Photo 4

Description:
Application of structural sealant in progress

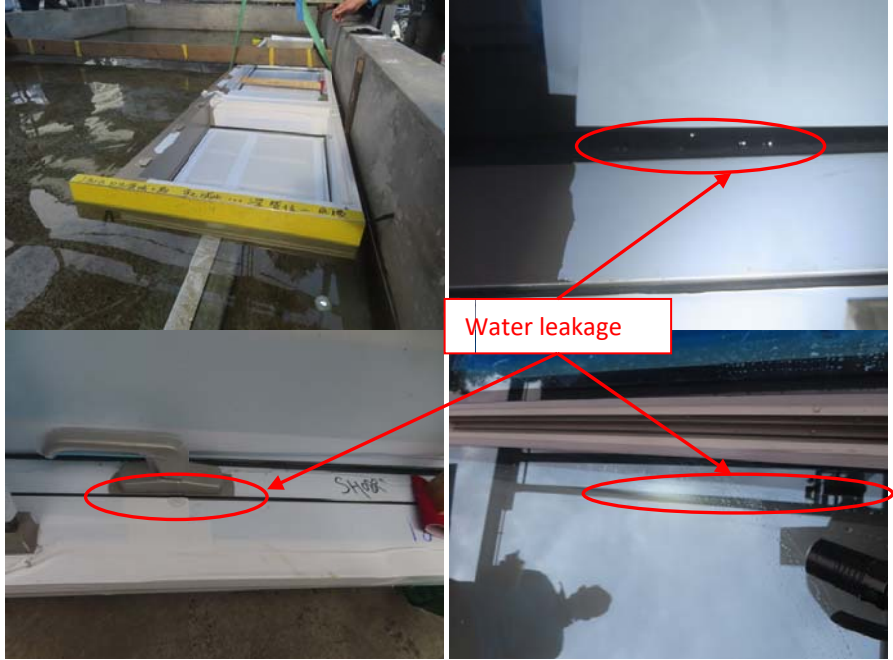
Photo 12

Description:
Water leakage was found during flooding test for Panel number 16F-T1A-CW4_AS-10

- Water leakage was found during flooding test for Panel number 16F-T1A-CW4_AS-10 and 15F-T1A-CW4_AS-10 respectively. MIDI is required to carry out their internal QA/QC method to improve workmanship for future works

Action:
- MIDI is required to carry out their internal QA/QC method to improve workmanship for future works

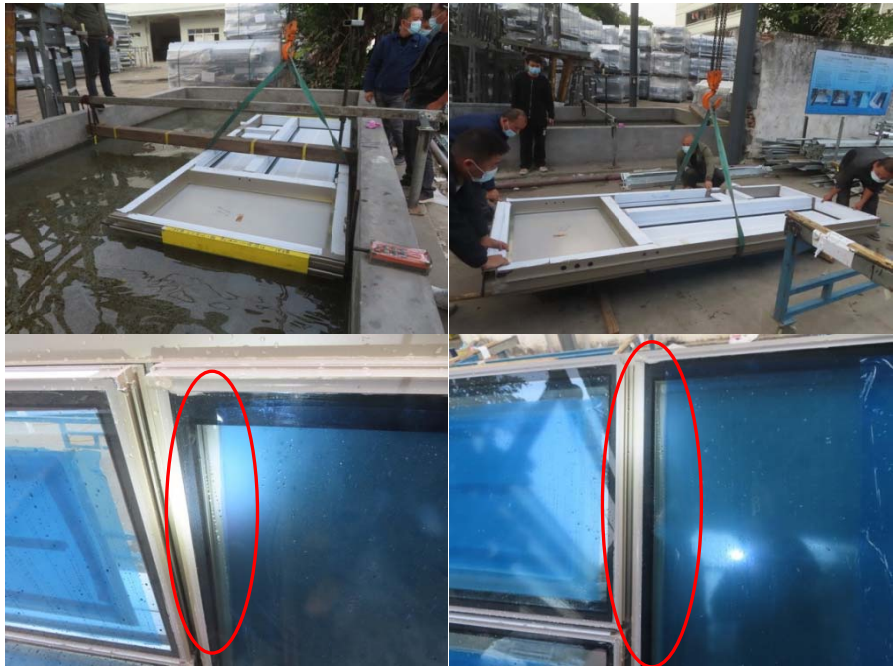
Photo 13

Description:
Water leakage was found during flooding test for Panel number 16F-T1ACW5-AS-09

Action:
- MIDI is required to carry out their internal QA/QC method to improve workmanship for future works

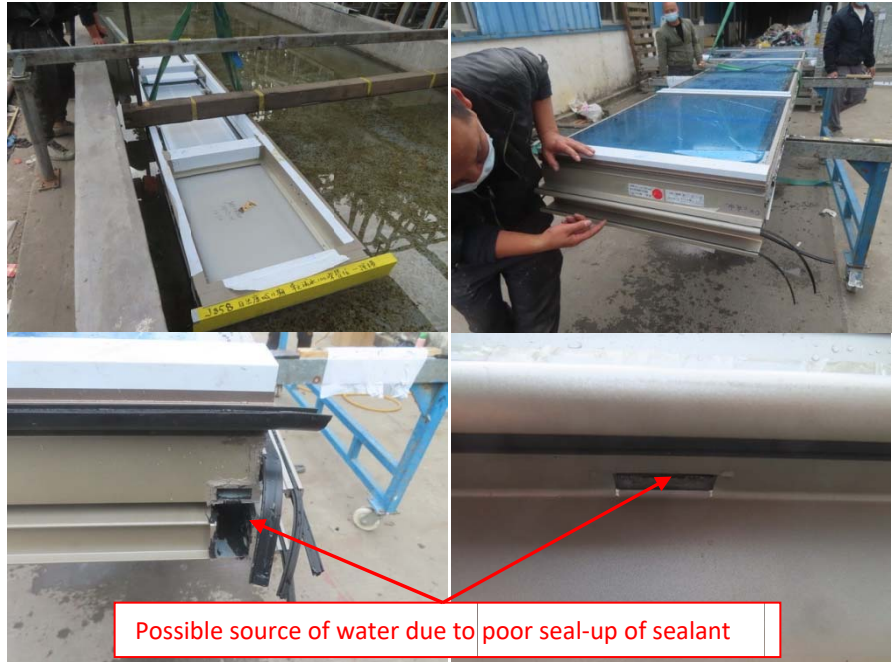
Photo 14

Description:
Water leakage was found during flooding test for Panel number 16F-T1A CW4-AM12

Action:
- MIDI is required to carry out their internal QA/QC method to improve workmanship for future works

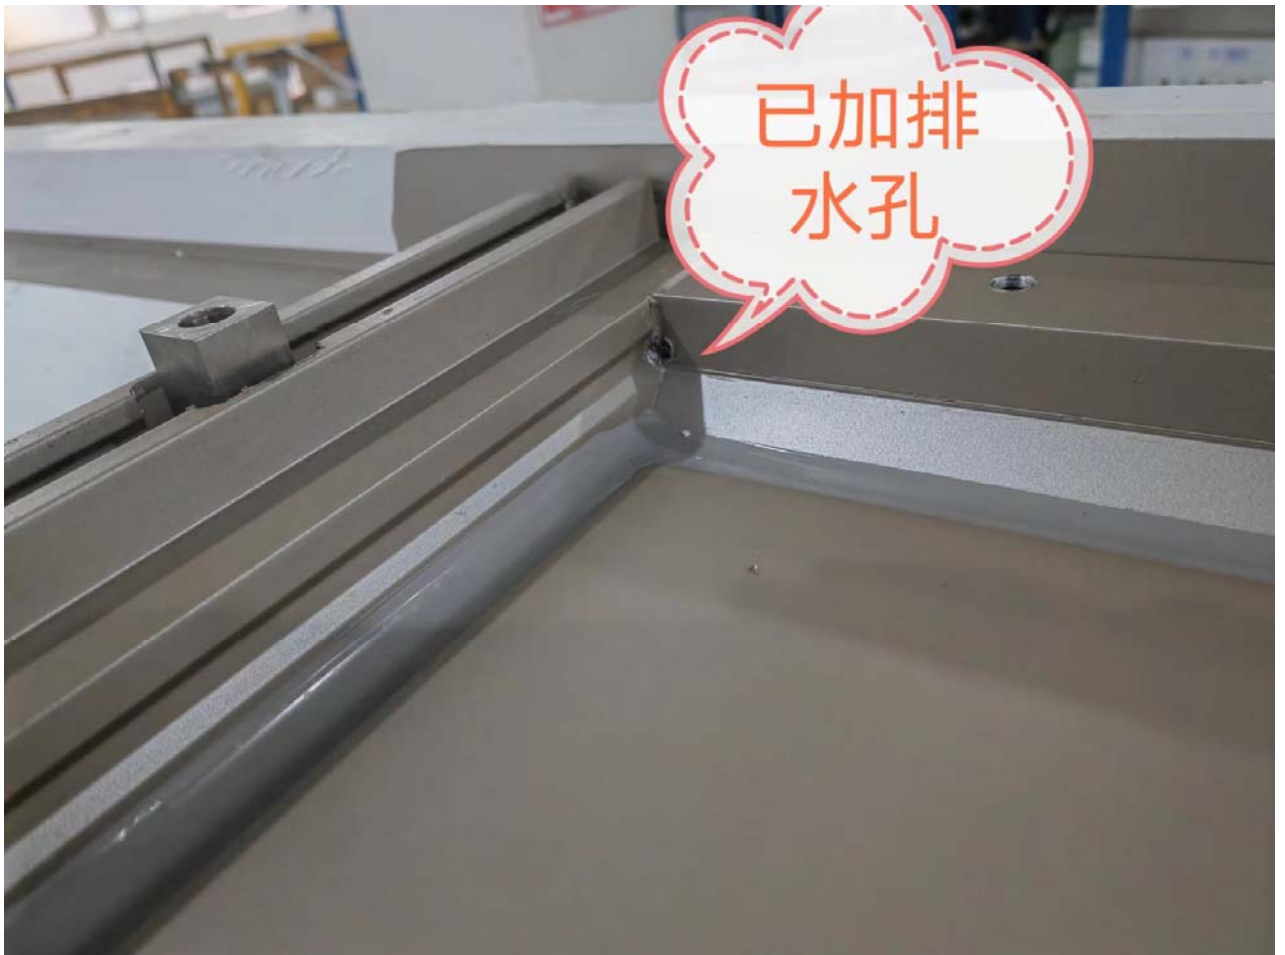
4、報告表內第 12 項（在工廠檢查中發現 MO2 轉角單元梗玻璃位少排水孔-圖紙設計問題）；

回覆：工廠已由設計人員修改加工圖及車間已加排水孔（詳見圖片）

已安排依最新圖紙要求加排水孔

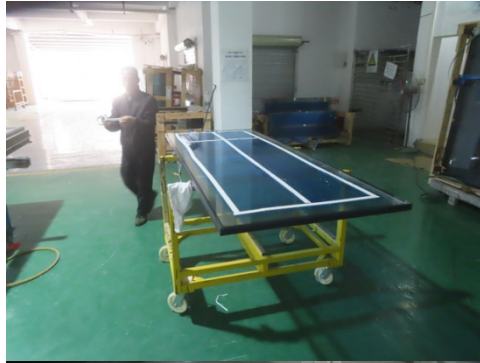
Photo 11

Description:
General view showing 3rd log packing was in progress

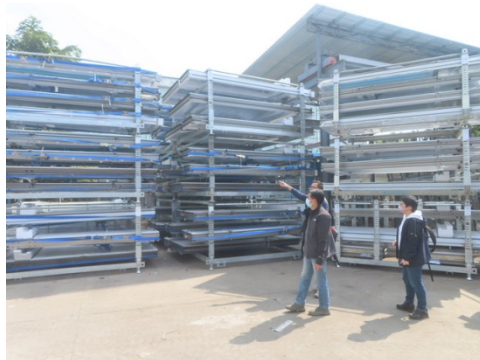
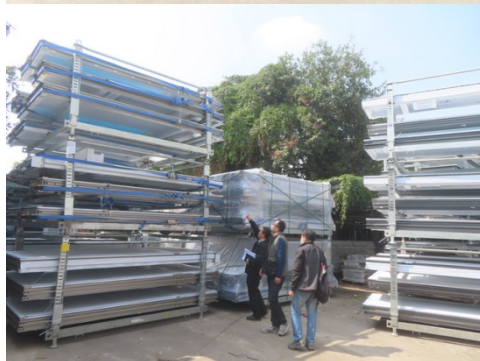
Photo 12

Description:
Final inspection of 2nd log 59 pcs. unitized panels (Zone 2)

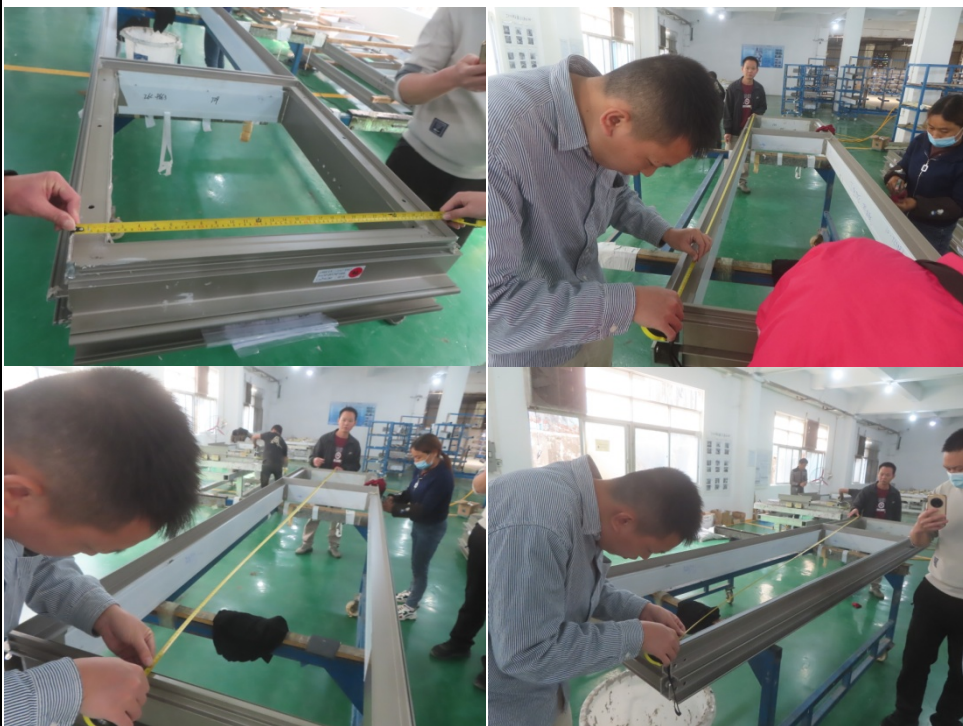
Photo 4

Description:
Dimension checking of assembled transom and mullion (3th log unitized panels for Zone M3 & 4)

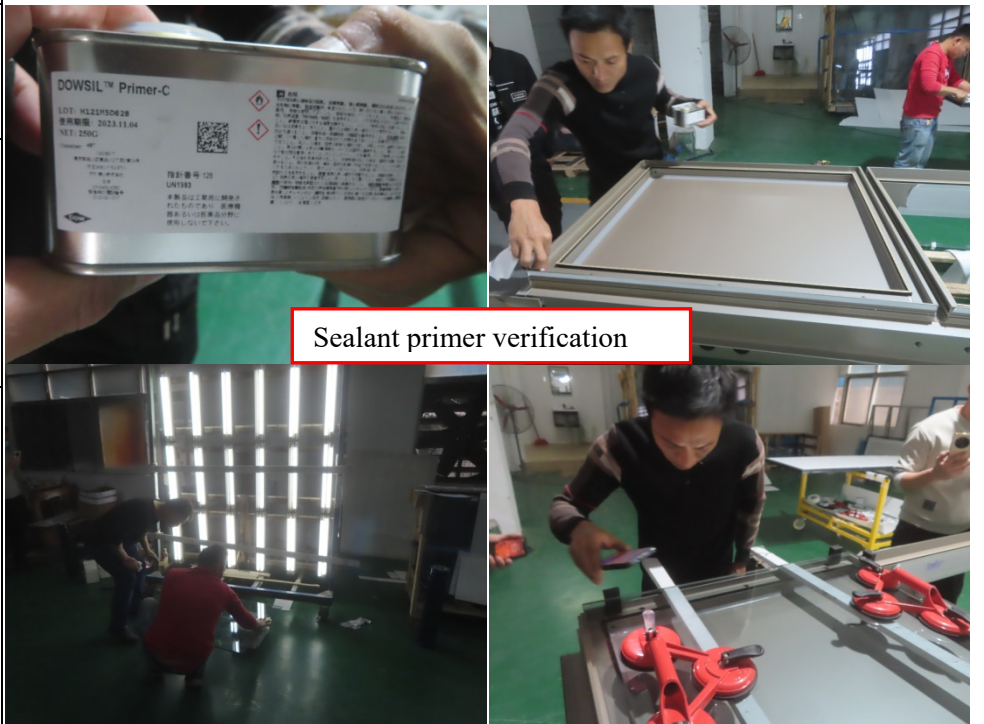
Photo 6

Description:
Fixing of glazing for Zone M01 (1st log unitized panels- 8 幅改倉)

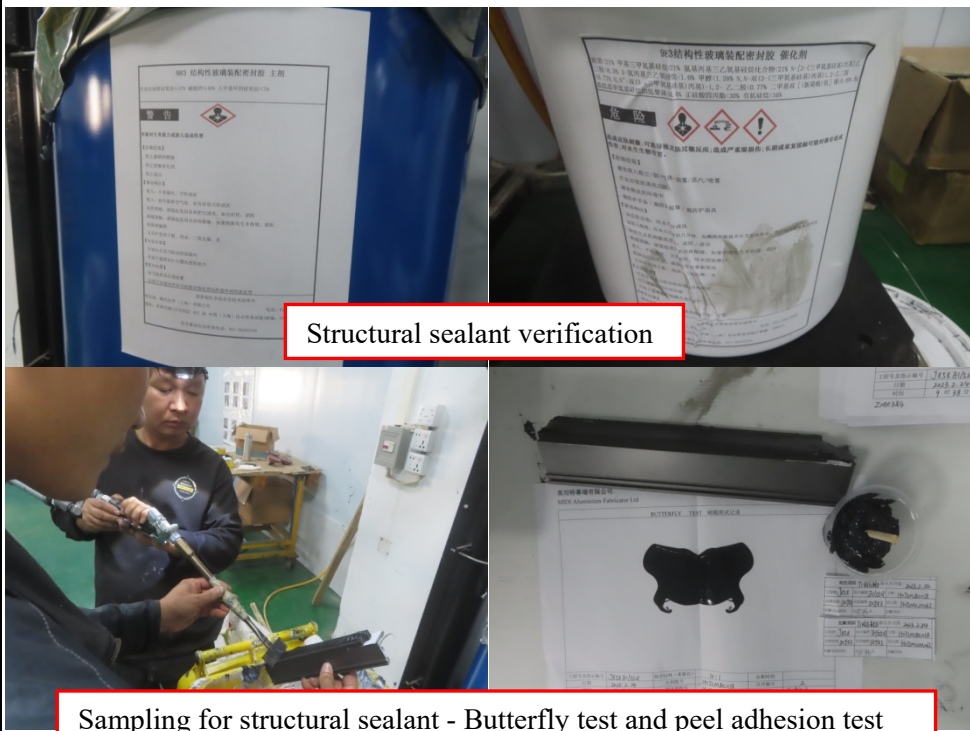
Photo 7

Description:
Sampling of structural sealant and verification

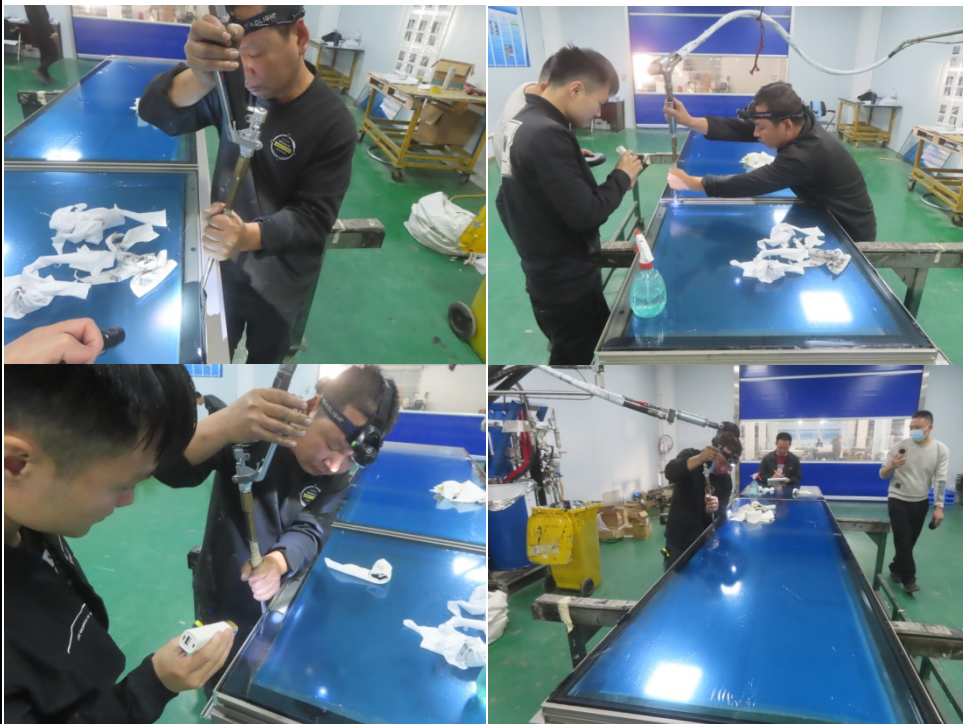
Photo 8

Description:
Application of structural sealant

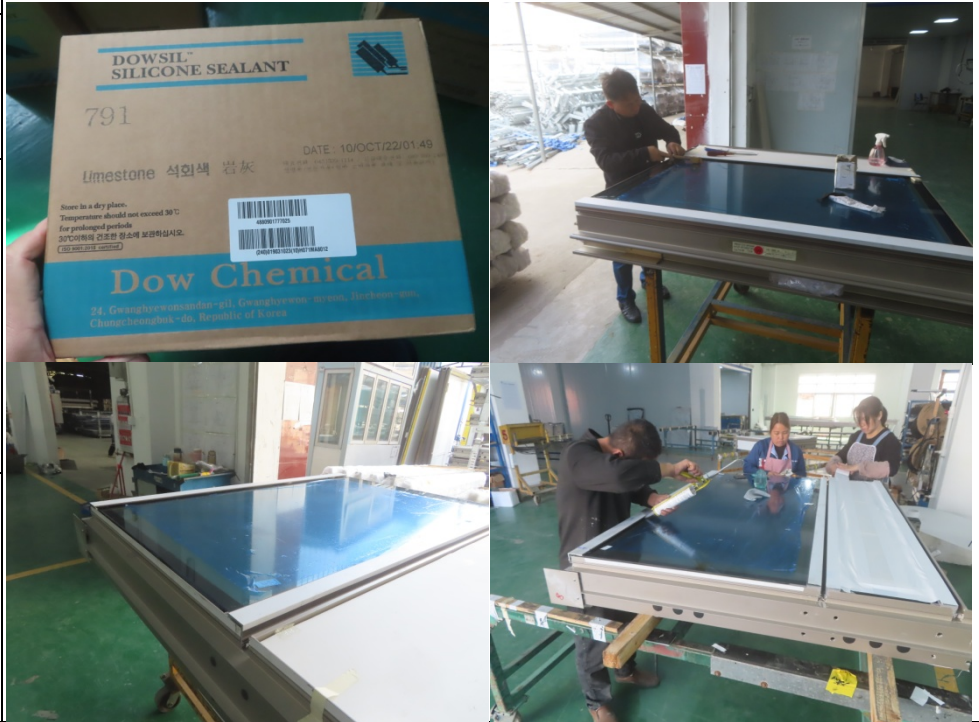
Photo 9

Description:
Application of Dowsil 791 weather sealant and final protection

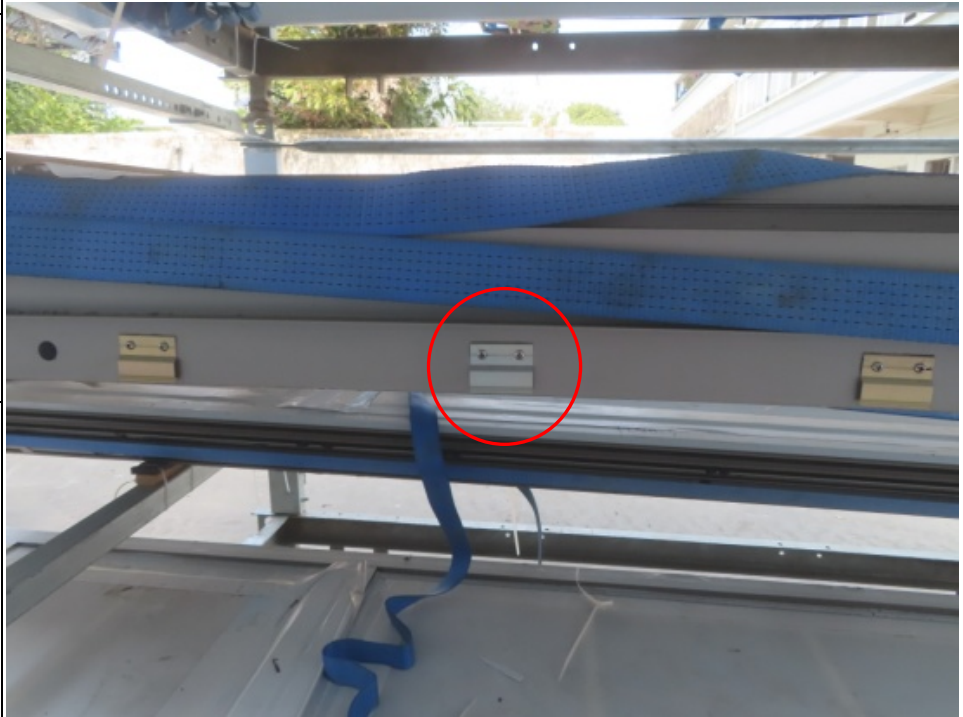
Photo 11

Description:
Defective chrome plated finishing for extrusion clip was found during factory inspection

Action:
- MIDI is required to carry out their internal QA/QC method to repair the defective chrome plate finishing and improve workmanship for future works

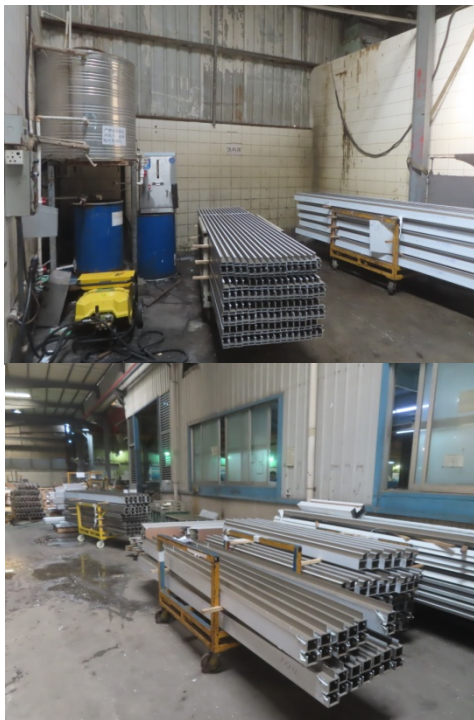
Photo 4

Description:
General inspection of cleaning and degreasing process during fabrication

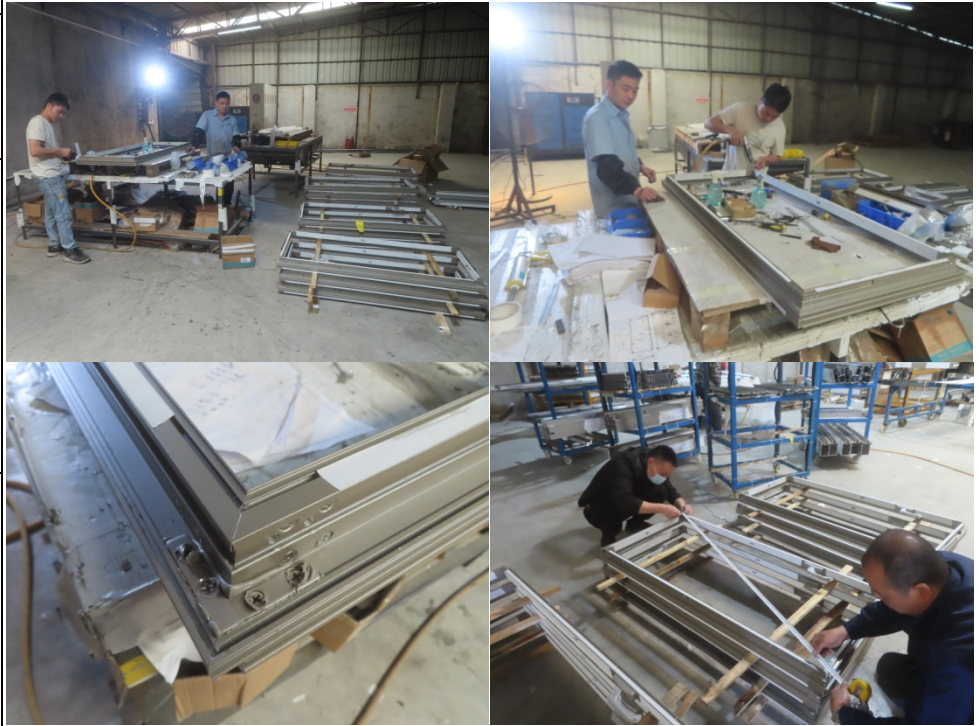
Photo 5

Description:
Fit-up assembly of operable windows for T2 9-11/F Zone M05 (4th log unitized panels)

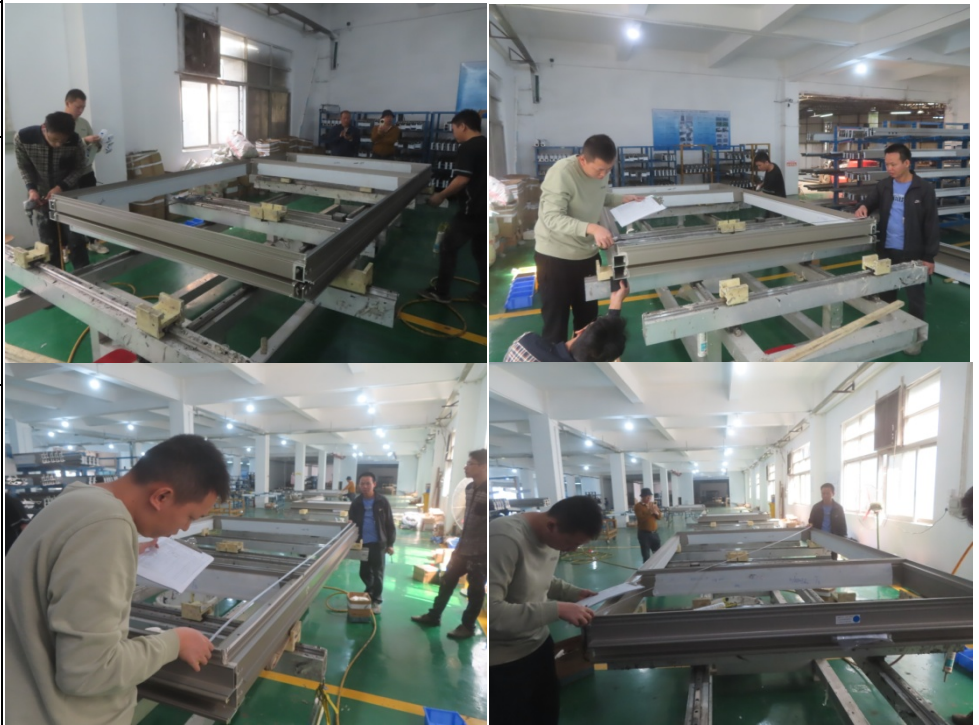
Photo 6

Description:
Fit-up assembly of Mullion and Transom for T2 9-11/F Zone M05 (4th log unitized panels)

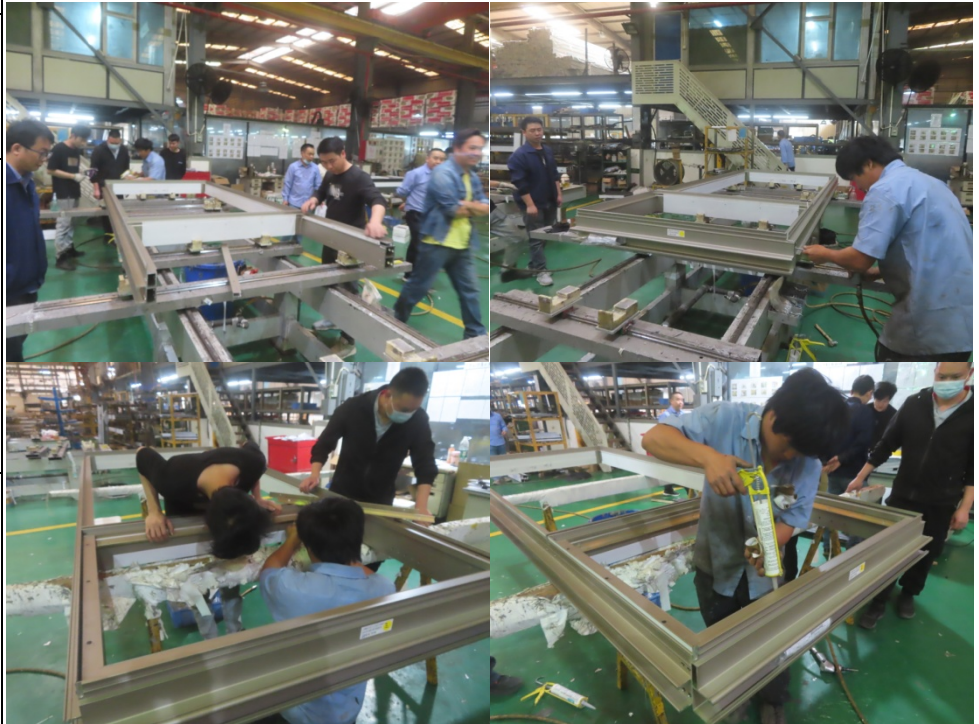
Photo 7

Description:
Fit-up assembly of Mullion and Transom for T3 9-11/F Zone M07 (6th log unitized panels)

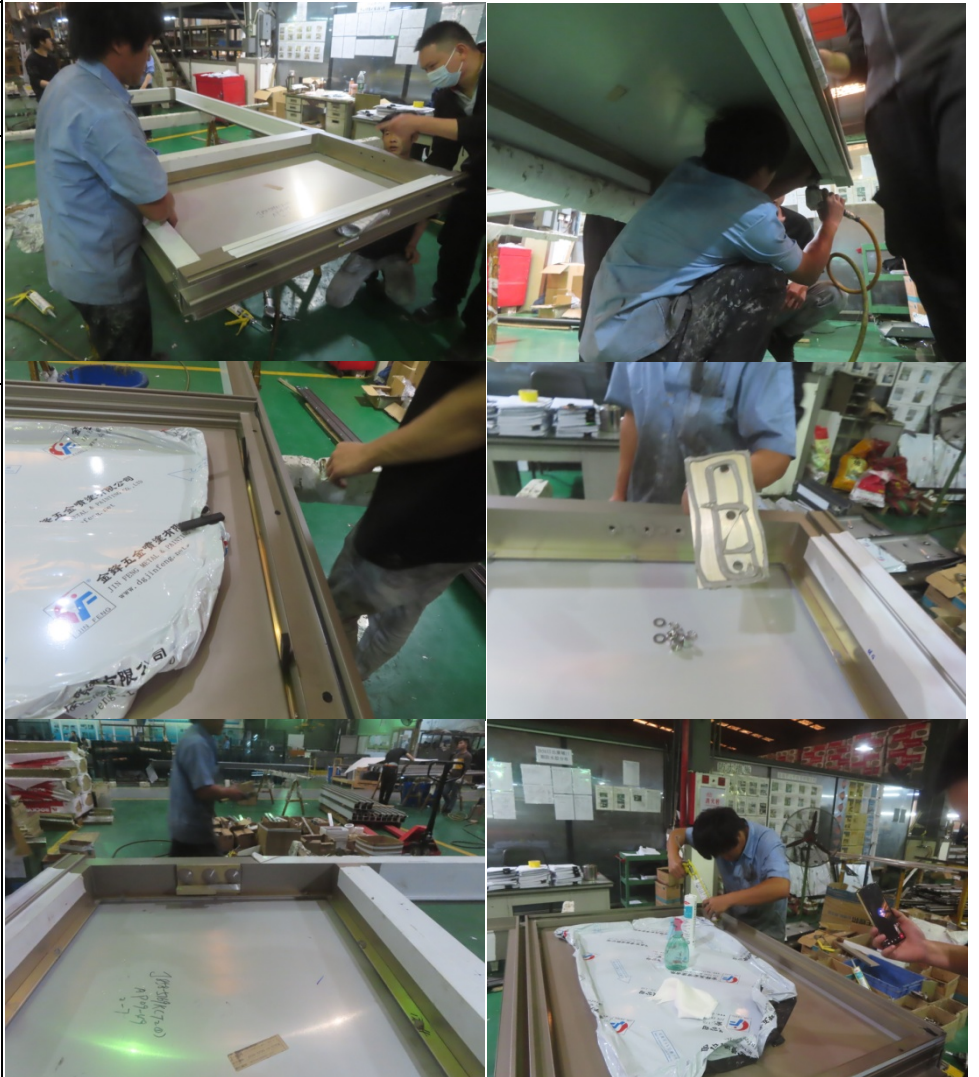
Photo 8

Description:
Fixing of back panel for 1st log unitized panels-改倉

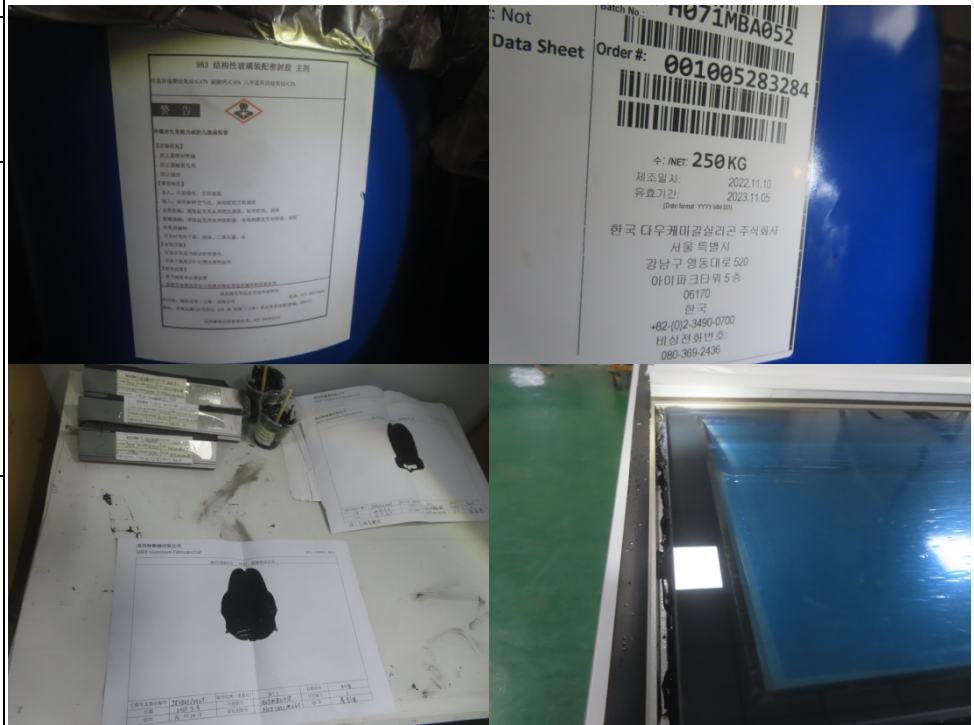
Photo 9

Description:
Application of structural sealant for Zone M3 & 4 (3rd log unitized panels)

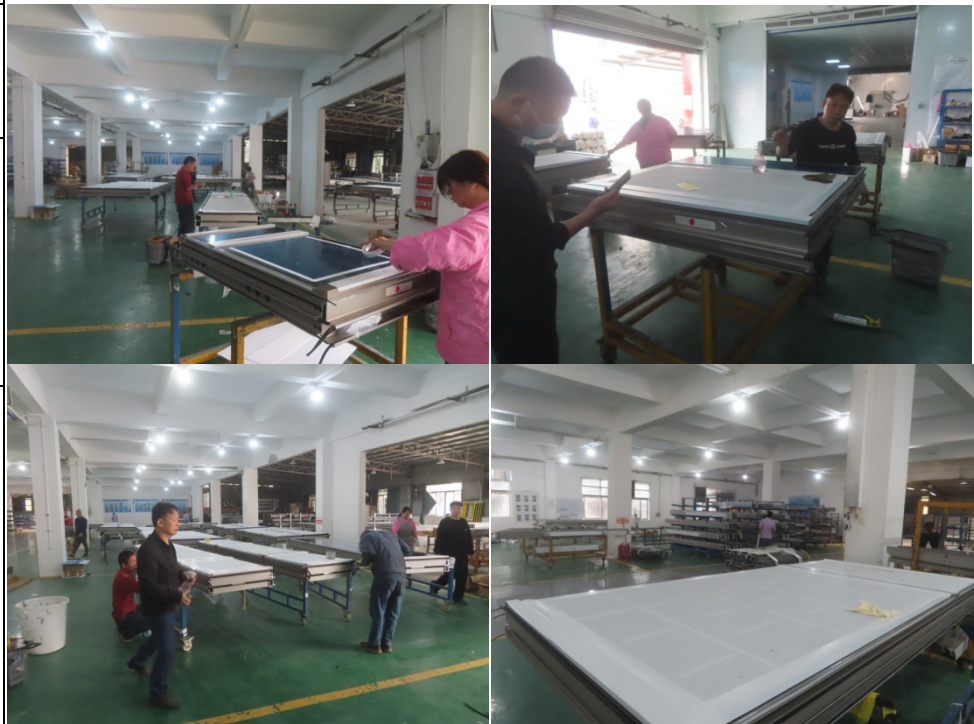
Photo 10

Description:
Application of structural sealant for 2nd & 3rd log unitized panels (Zone M02 to M04)

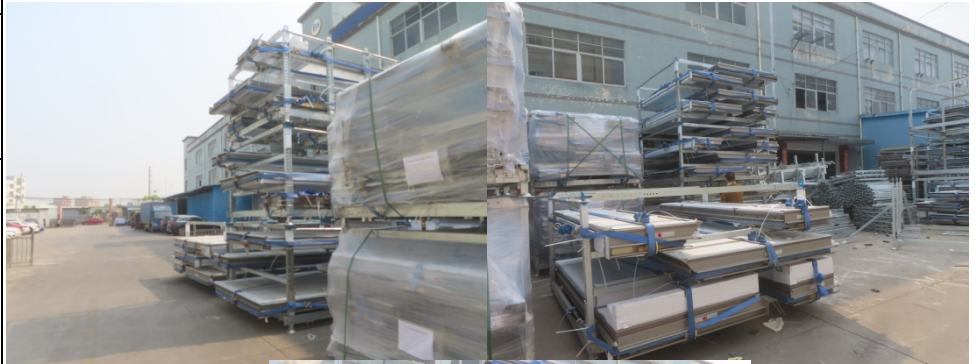
Photo 11

Description:
Final inspection of 2nd & 3rd log unitized panels (Zone M02 to M04) unitized panels after remedial works

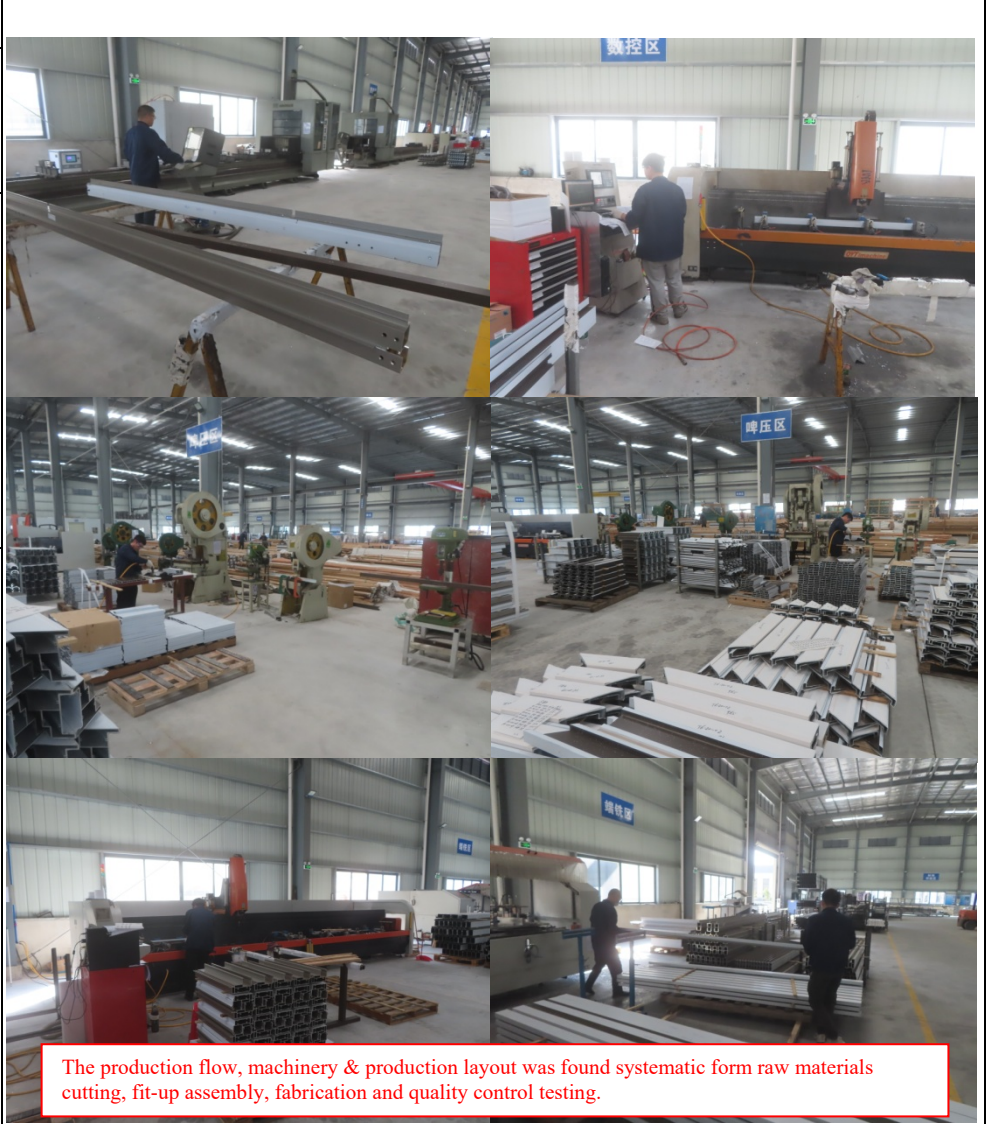
Photo 4

The production flow, machinery & production layout was found systematic form raw materials cutting, fit-up assembly, fabrication and quality control testing.

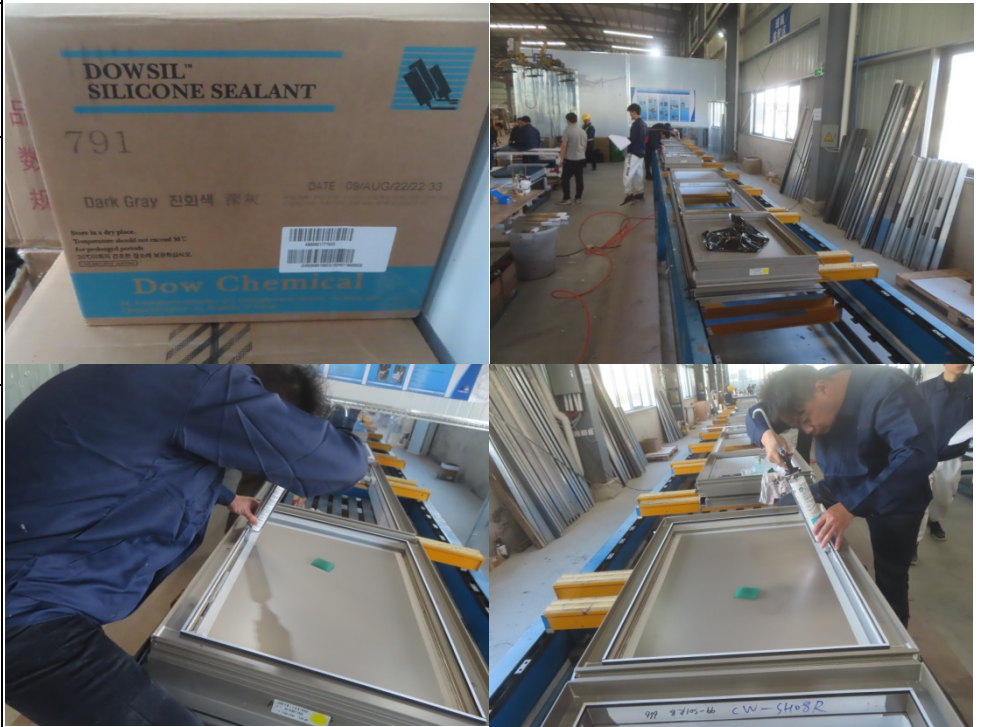
Photo 7

Fixing of back panel for T2 12-17/F Zone M06 (5th log unitized panels)

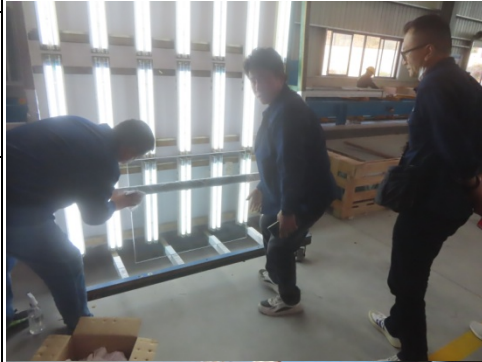
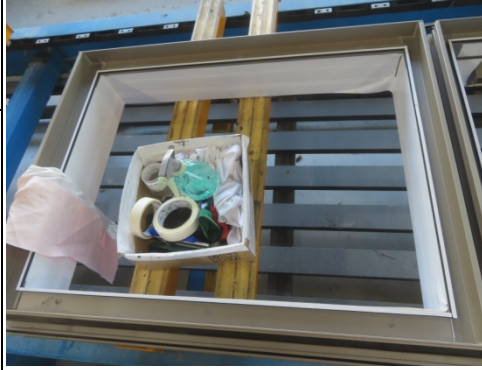
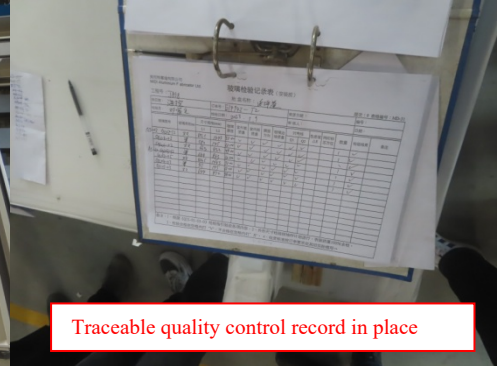
Photo 8

General inspection and dimension checking of glazing prior fit-up assembly and sealant works

Traceable quality control record in place

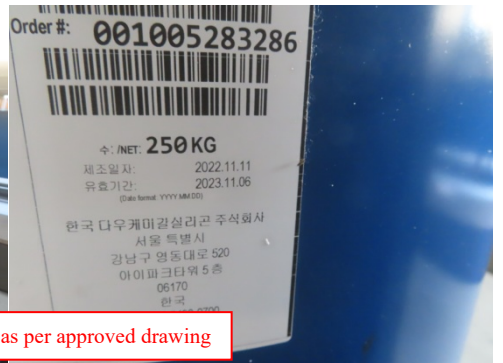
Photo 9

Application of structural sealant for T2 12-17/F Zone M06 (5th log unitized panels)

Sealant verification as per approved drawing

Butterfly test and Snap test for Dowsil 983 as per supplier's guideline

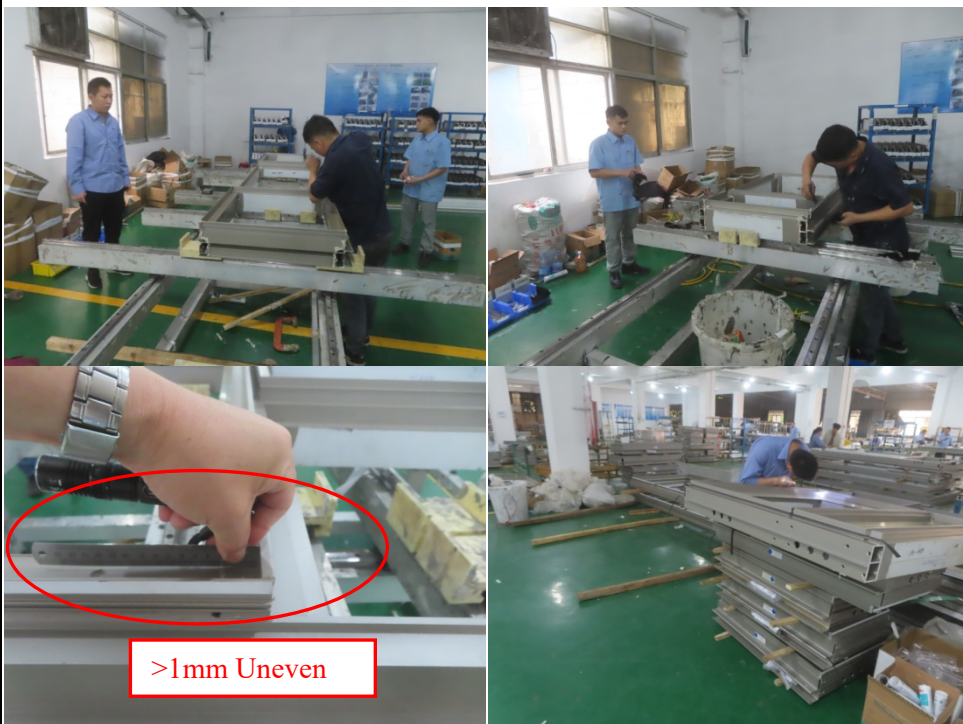
Photo 7

Description:
Uneven of components was found during factory inspection

Action:
- MIDI is required to improve workmanship for further works

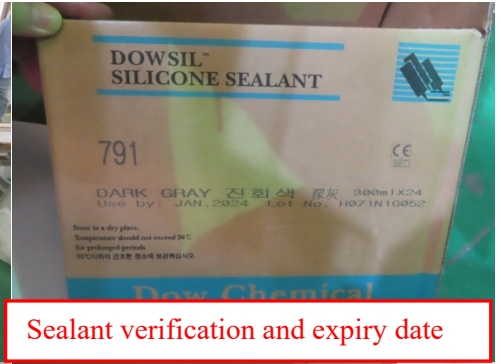
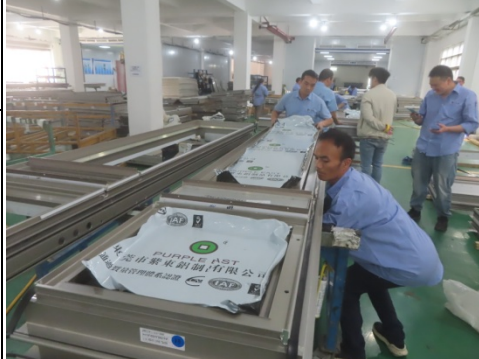
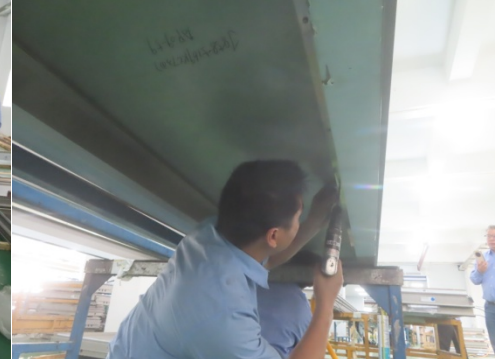
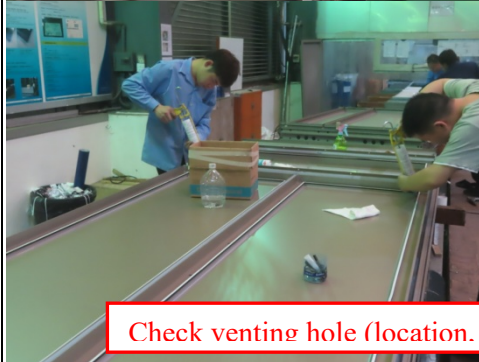
Description:
Fixing of back panel for T2 9-17/F Zone M05 and M06, T3 9-11/F Zone M07

Check venting hole (location, size and without obstruction)

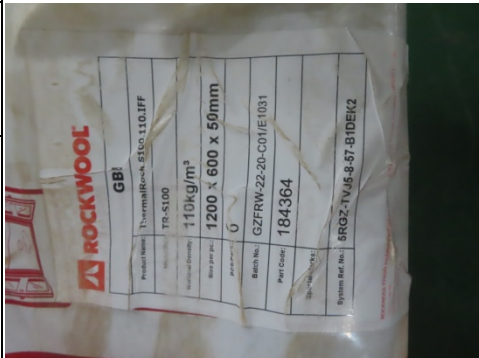
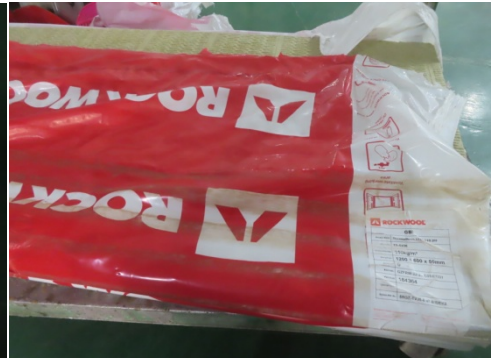
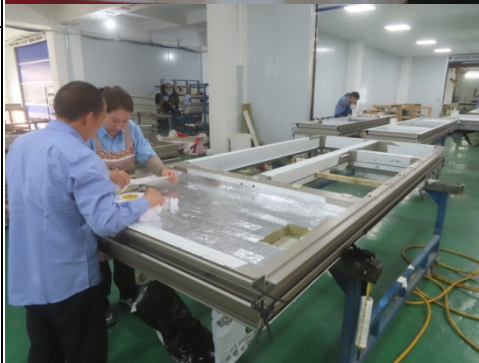
Photo 8

Description:
Check location and model of thermal insulation

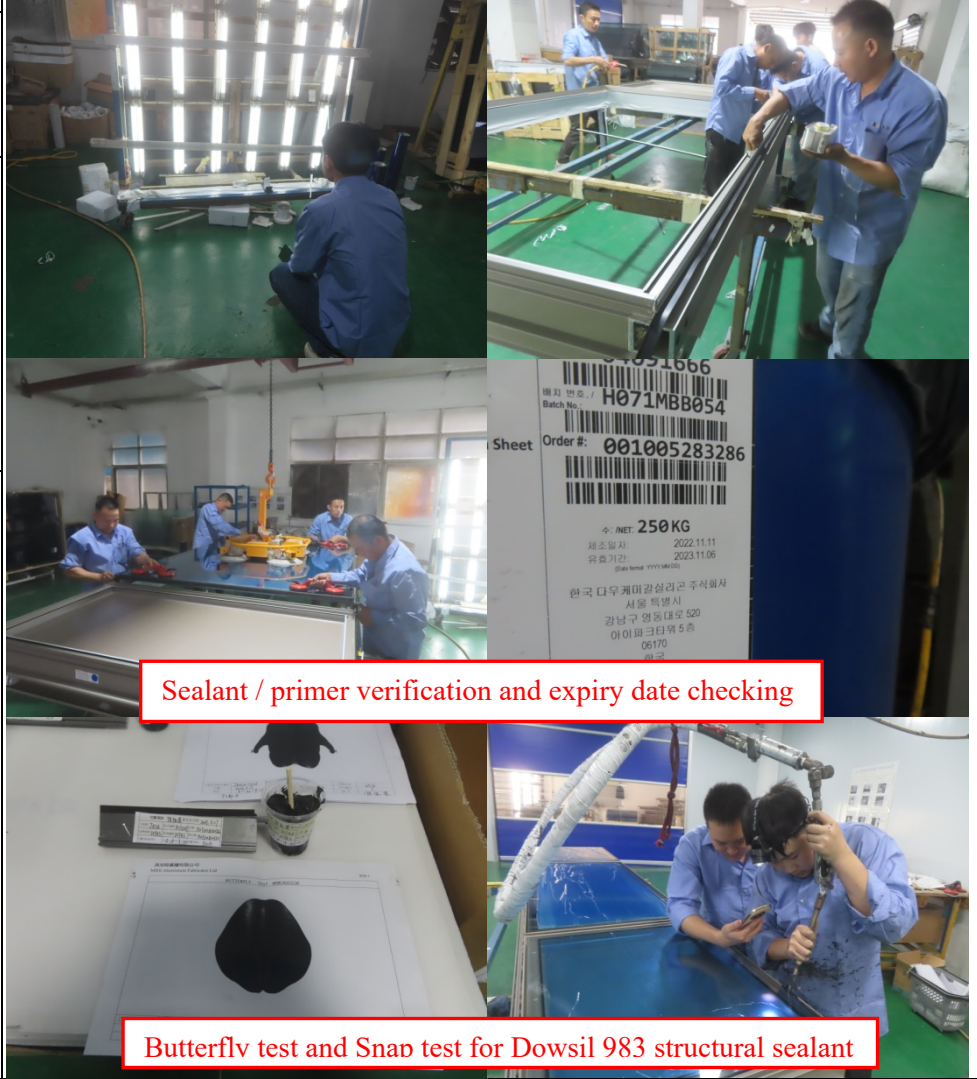
Photo 9

Description:
General inspection and dimension checking of glazing prior fit-up assembly and sealant works

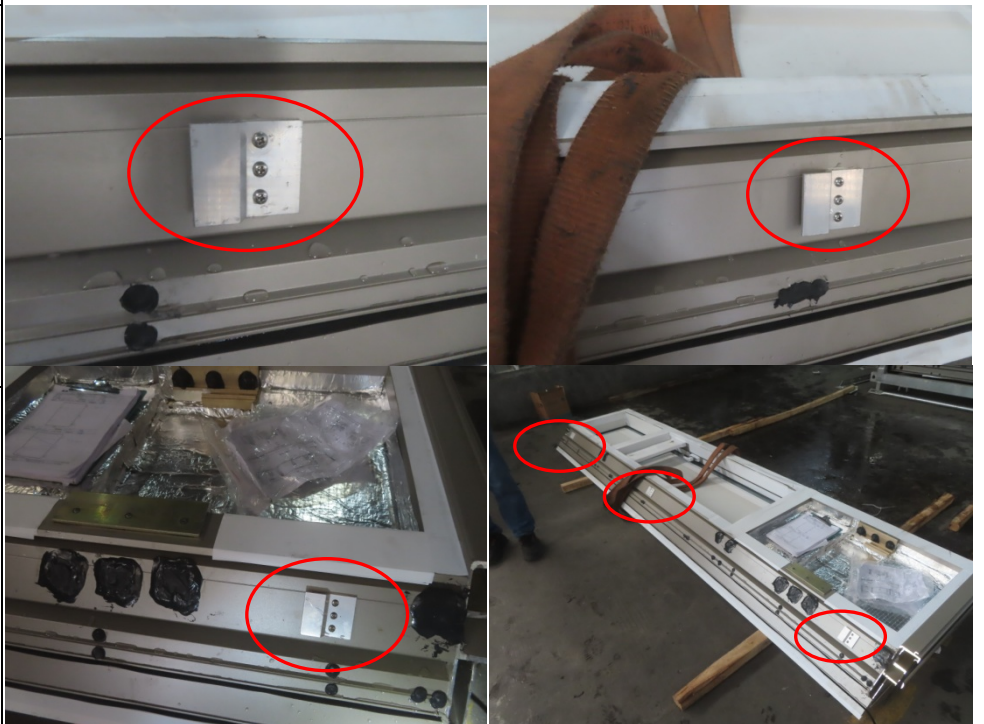
Photo 12

Description:
Defective chrome plated finishing for extrusion clip was found during factory inspection

Action:
- MIDI is required to carry out their internal QA/QC method to repair the defective chrome plate finishing and improve workmanship for future works

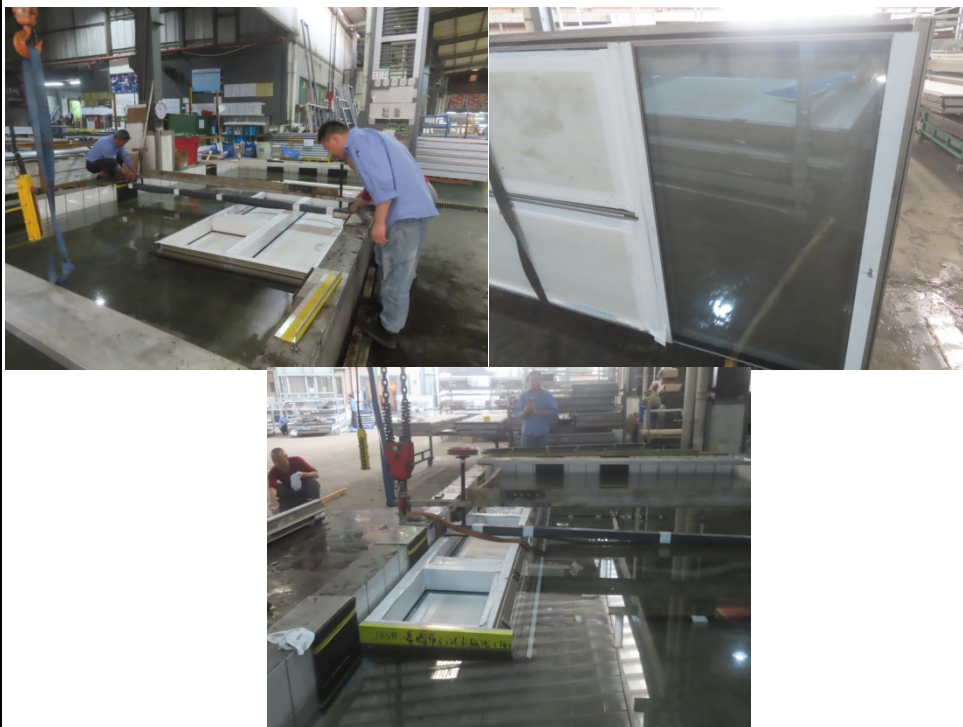
Photo 13

Description:
Water test of T2 9-11/F
Zone M05 unitized
panels

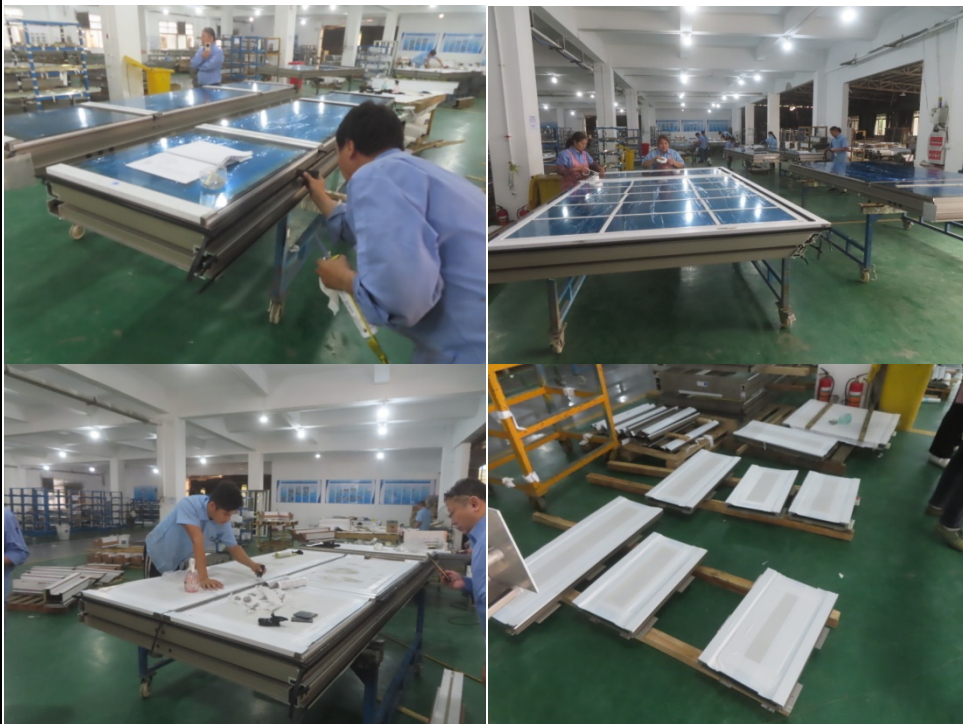
Photo 14

Description:
General inspection of T3
9-11/F Zone M07
unitized panels during
fabrication

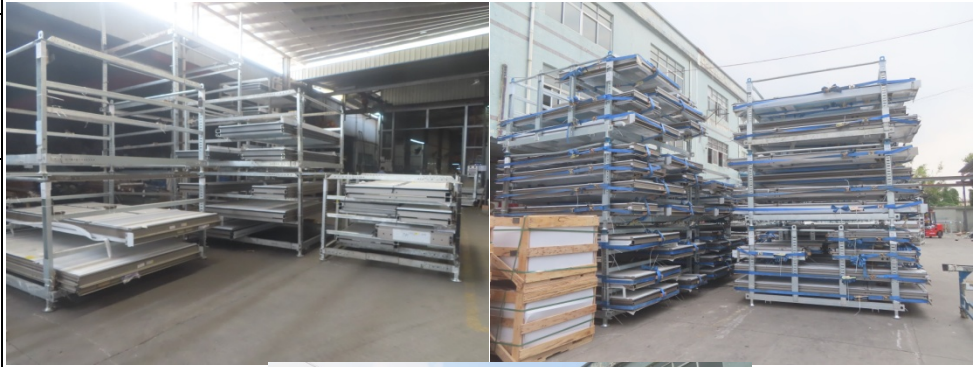
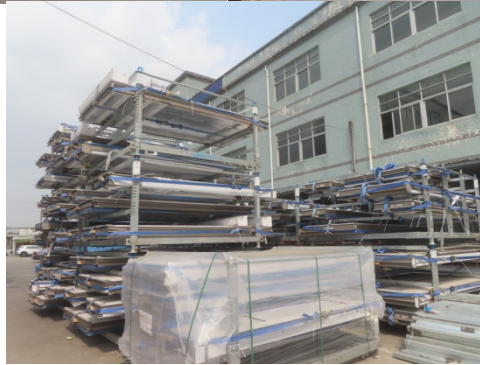
Photo 15

Description:
General inspection of
unitized panels for T2 9
to 17/F (4th & 5th log
Zone M05 & M06)
