PROPOSED RESIDENTIAL
DEVELOPMENT AT TKOTL 70RP,
PHASE 11. LOHAS PARK, TSEUNG
KWAN O. N.T.

Factory Inspection Report 01

Inspection Date: 18th November 2022
Issue Date: 05th December 2022

Report Reference: 60646872-FI-R-01

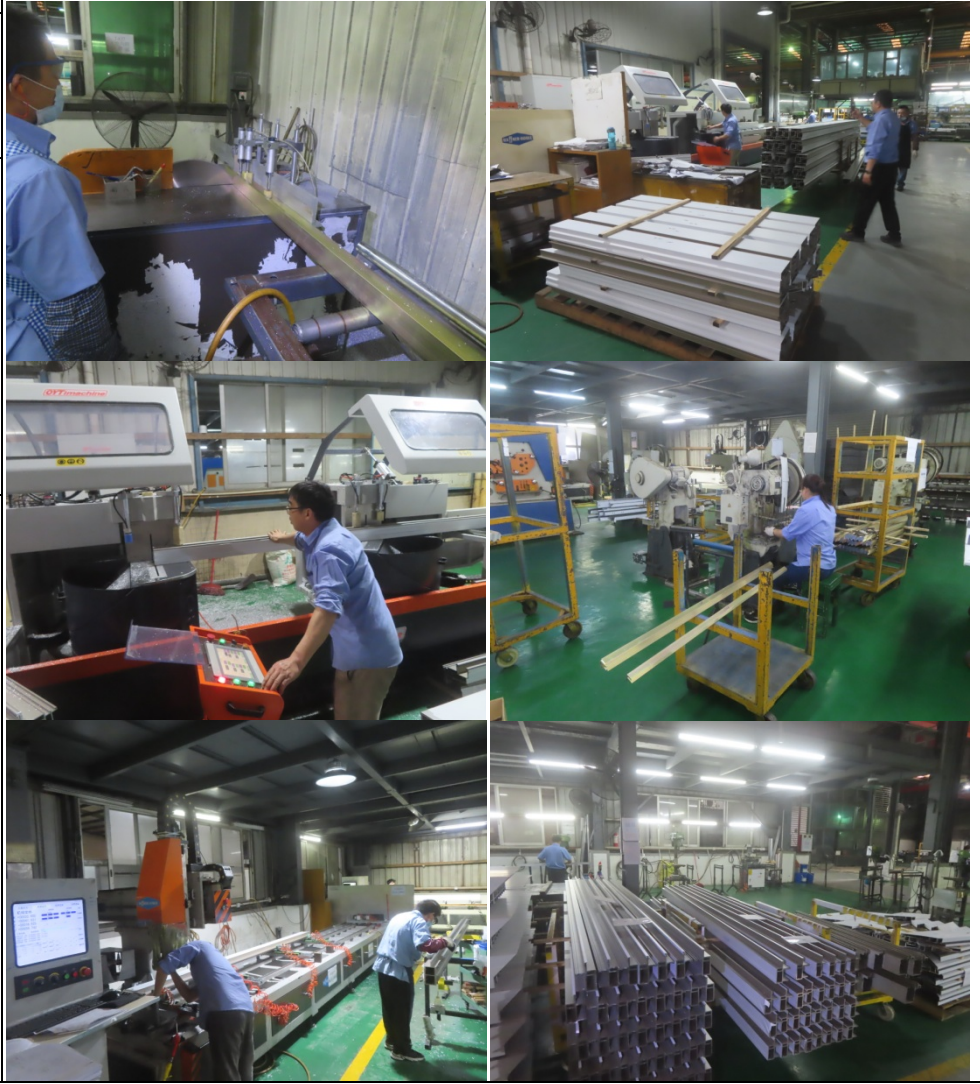
Description:
Materials cutting, milling and drilling of extrusions for T3 18/F to 21/F unitized panels (Details please refer to Appendix A)

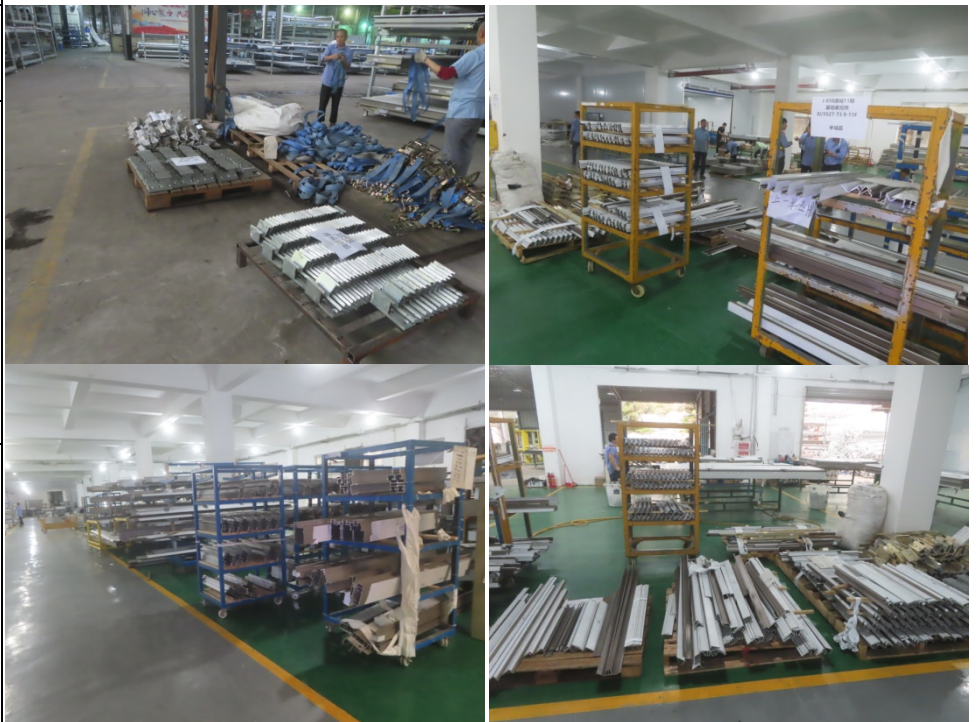
Photo 2

Description:
Quality checking and general inspection of raw materials prior fabrication

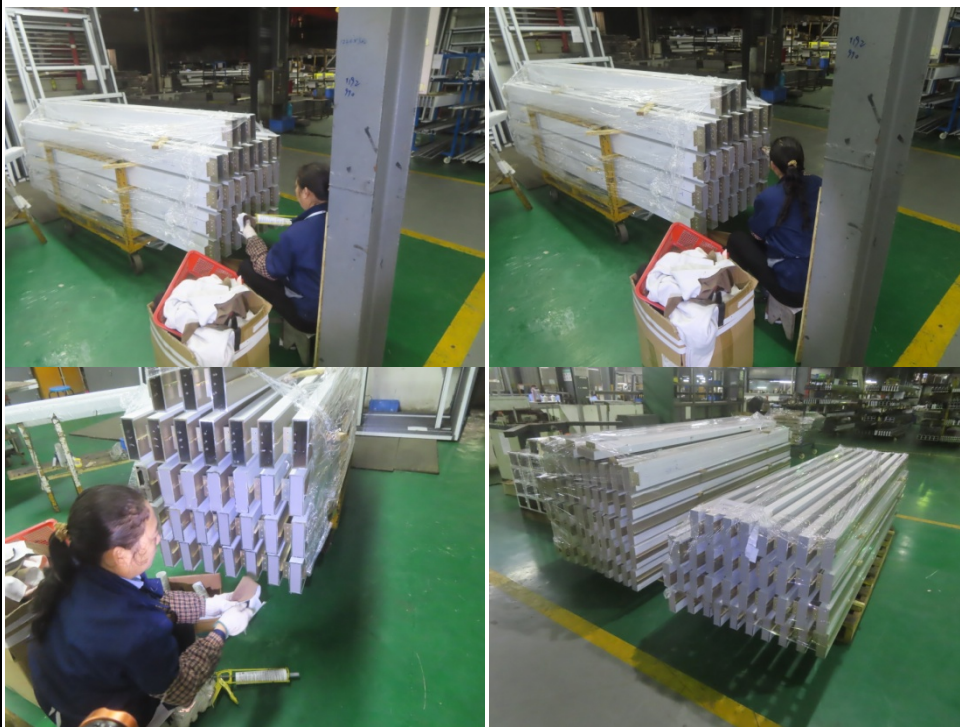
Photo 3

Description:
General inspection of transom and mullion for balcony during fabrication

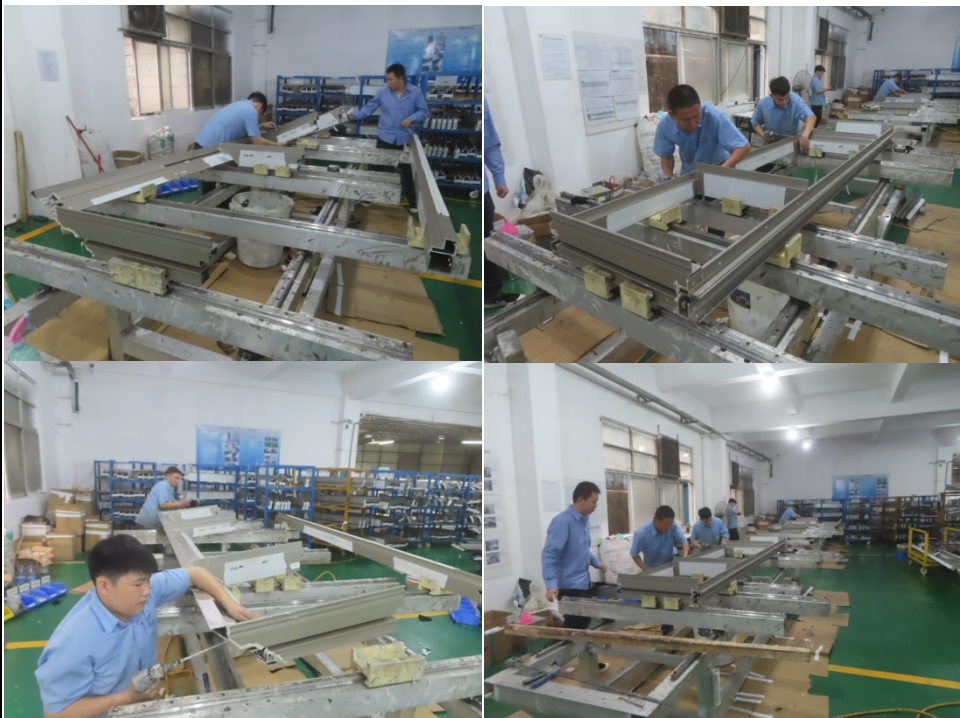
Photo 4

Description:
Fit-up assembly of Mullion and Transom for T3 12-17/F Zone M08 (7th log unitized panels)

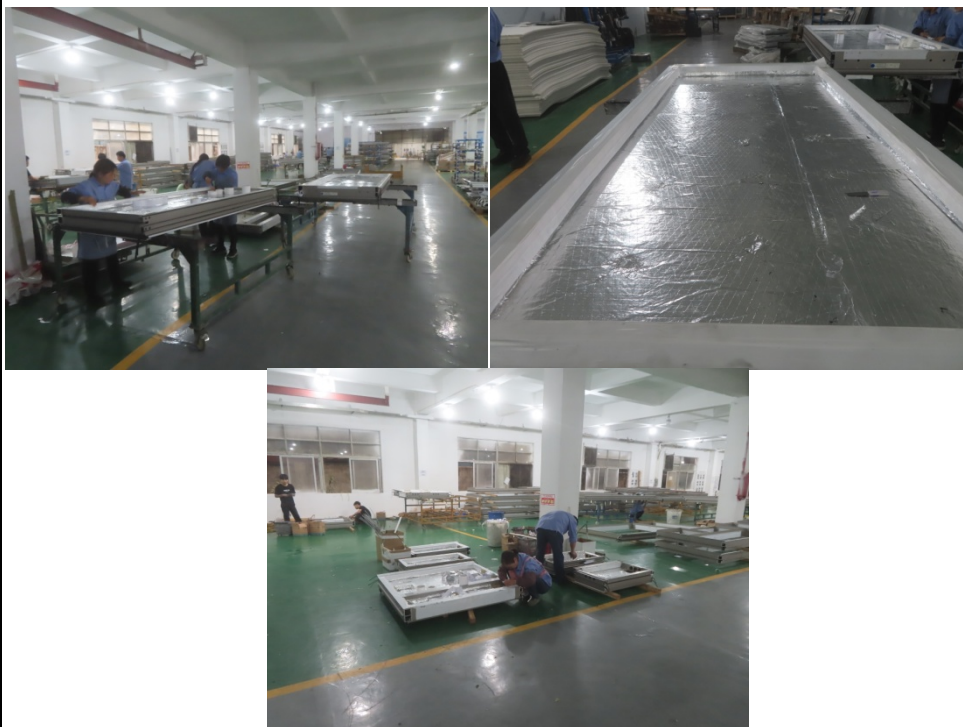
Photo 7

Description:
Quality checking of thermal insulation for back panel

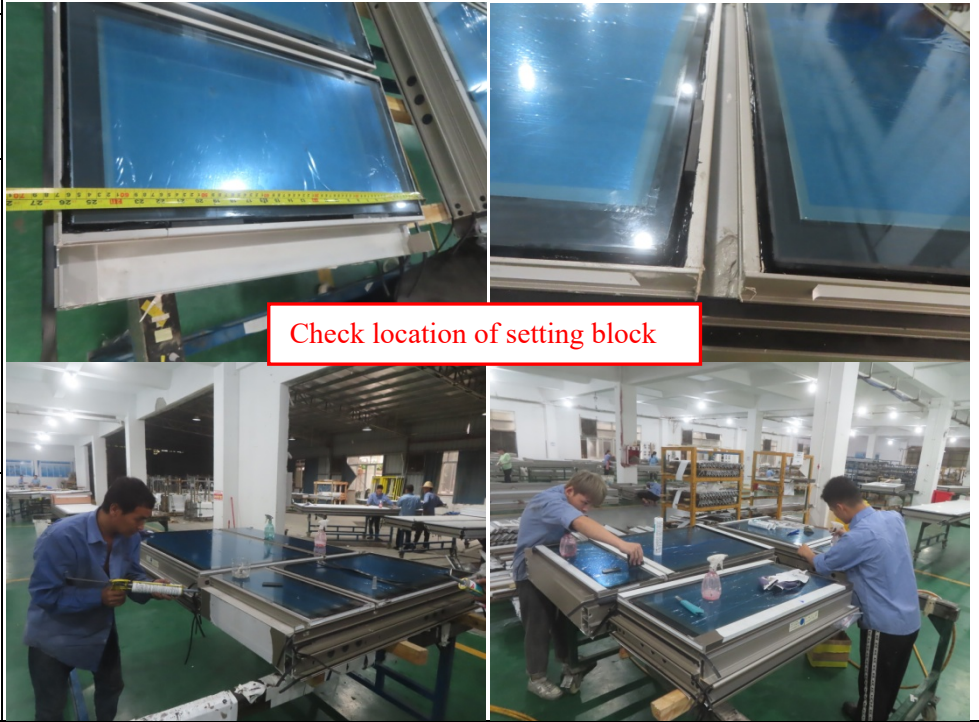
Photo 9

Description:
General inspection of unitized panels for T2 9-11/F Zone M05 and T3 9-11/F Zone M07

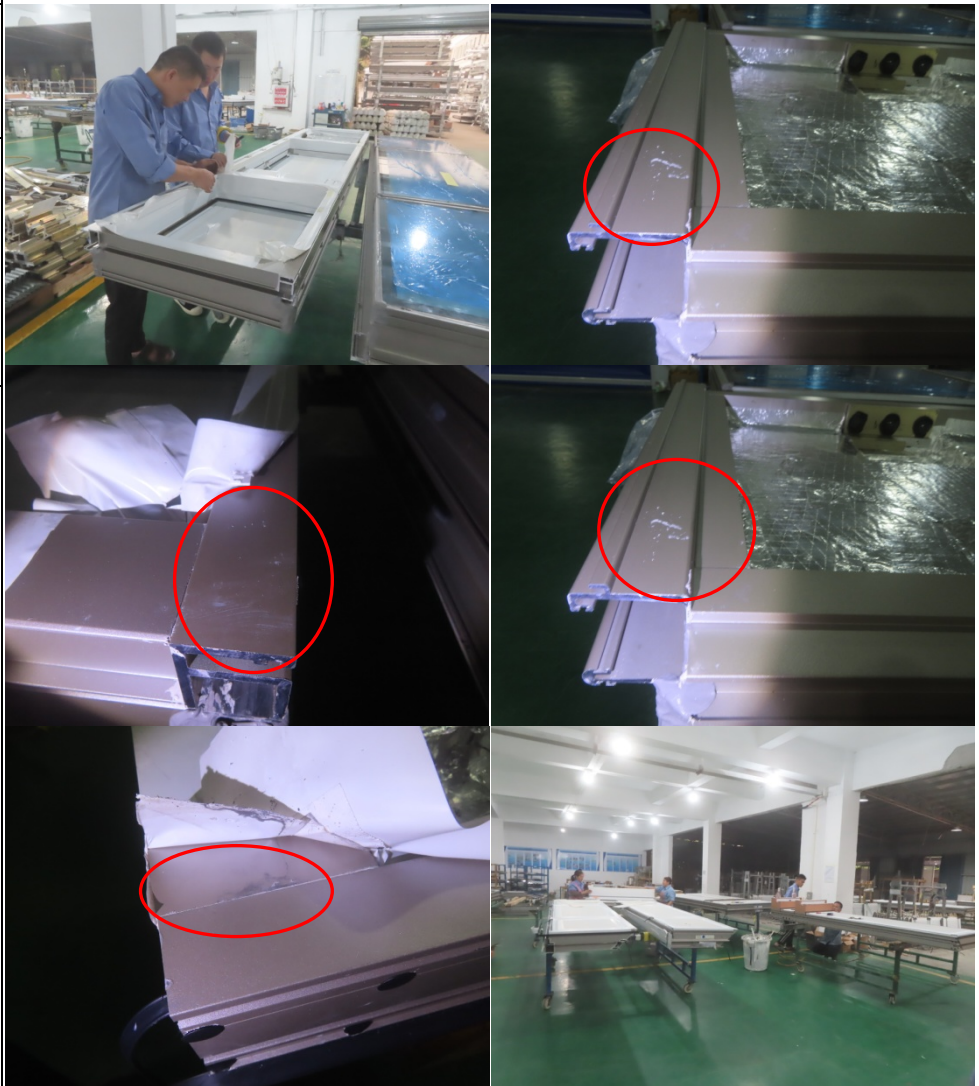
Photo 10

Description:
Excessive sealant and stain was found on unitized panel surface after packing

Action:
- MIDI is required to improve workmanship for further works

- Excessive sealant and stain was found on unitized panel surface after packing. MIDI is required to improve workmanship for further works.

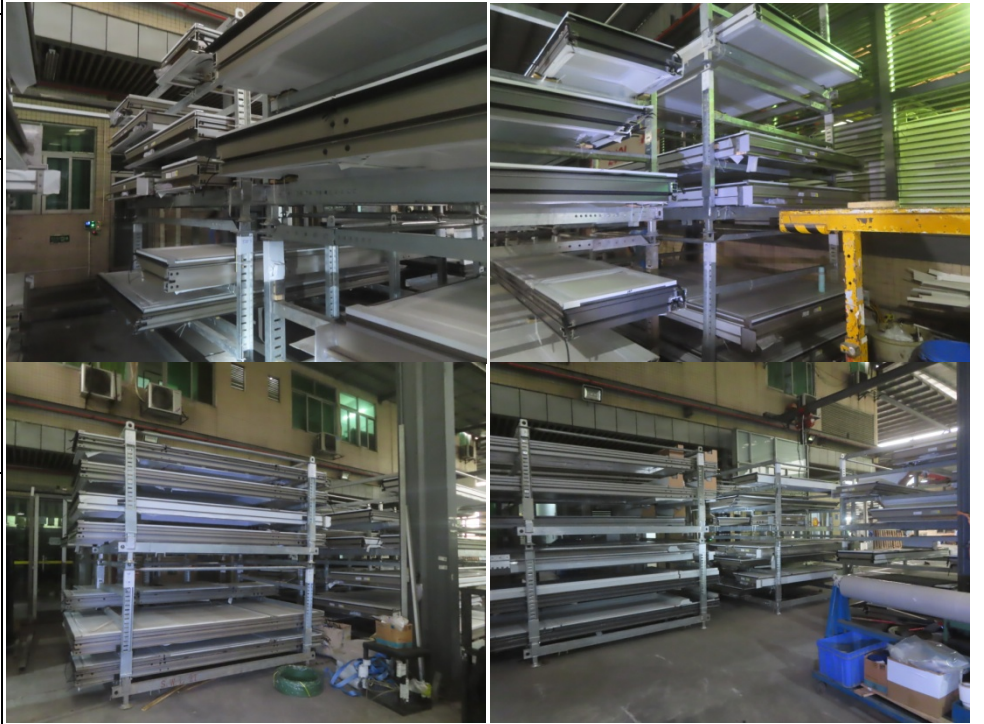
Photo 11

Description:
General inspection of
unitized panels for T2 9
to 17/F (4th & 5th log
Zone M05 & M06)
