PROPOSED RESIDENTIAL
DEVELOPMENT AT TKOTL 70RP,
PHASE 11. LOHAS PARK, TSEUNG
KWAN O. N.T.

Factory Inspection Report 19

Inspection Date: 31st March 2023
Issue Date: 01st April 2023

Report Reference: 60646872-FI-R-19

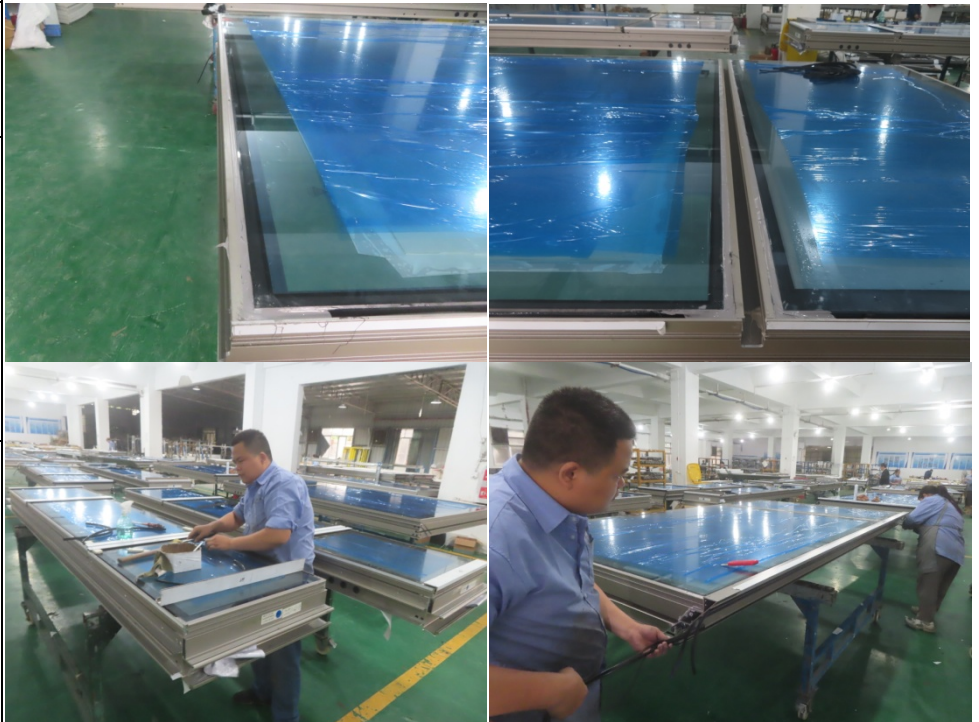
Photo 10

Description:
Fixing of capping and application of weather sealant "Dowsil 791" for T3 12-17/F Zone M08 unitized panels

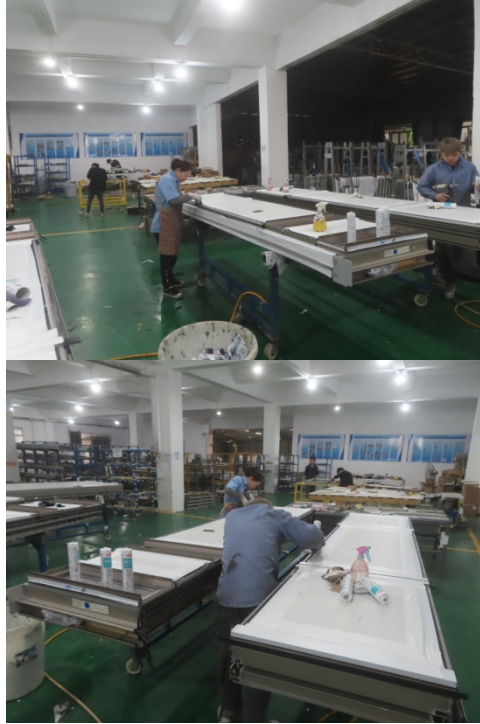
Photo 11

Description:
General inspection of
unitized panels for T3
12-17/F Zone M08
unitized panels prior
final packing

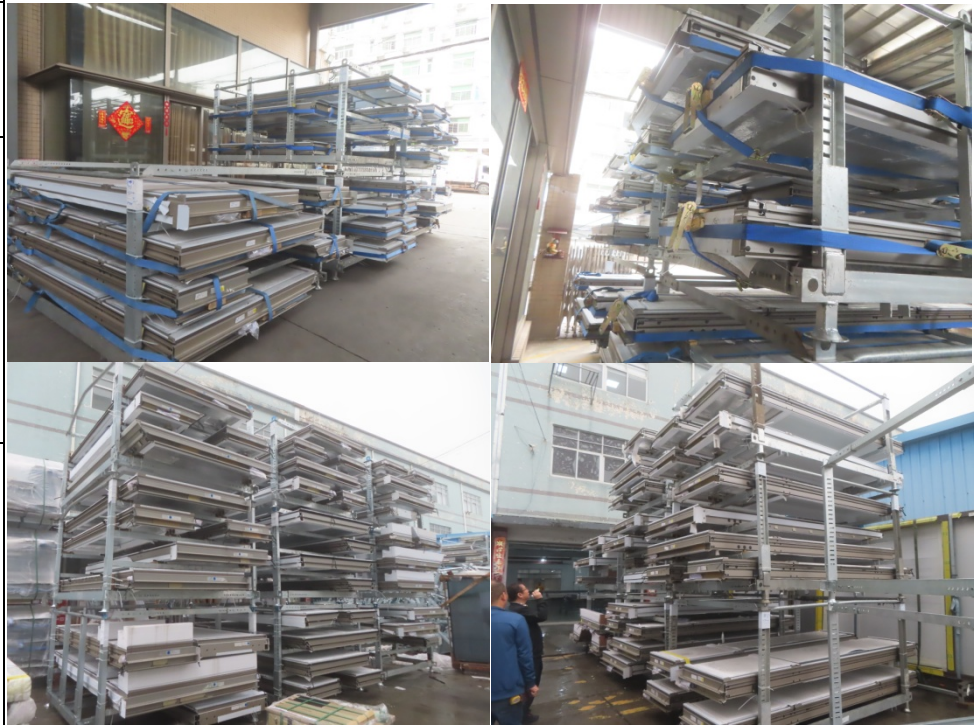
Photo 12

Description:
Final inspection of
unitized panels for T2 9
to 17/F (4th & 5th log
Zone M05 & M06), T3
9 to 17/F (Zone M07 &
M08)

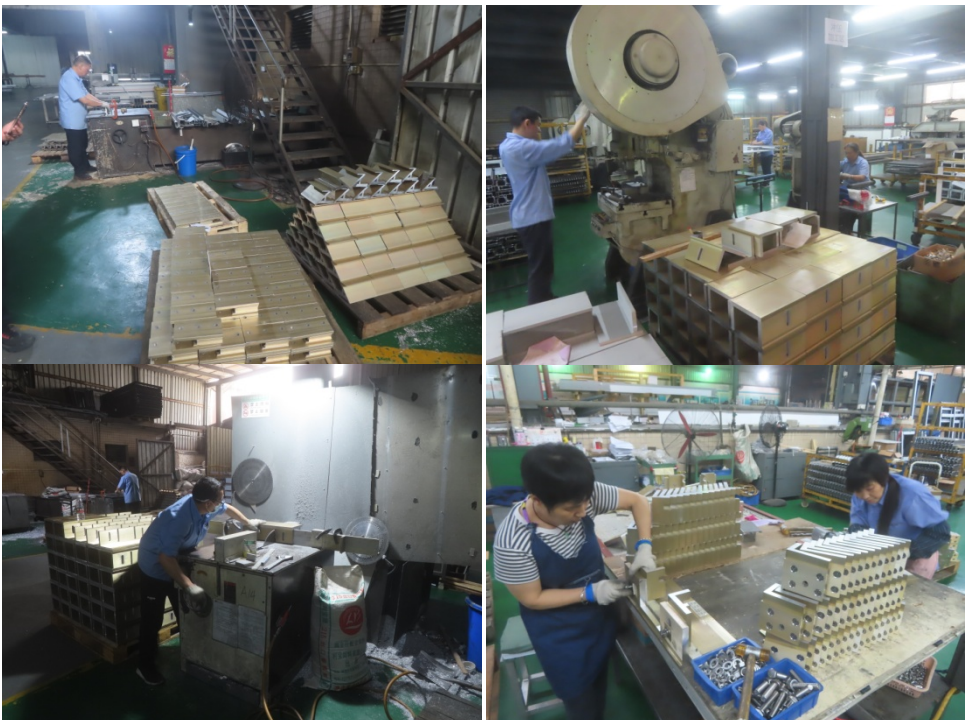
Photo 2

Description:
General inspection of hanger bracket and floor bracket during fabrication

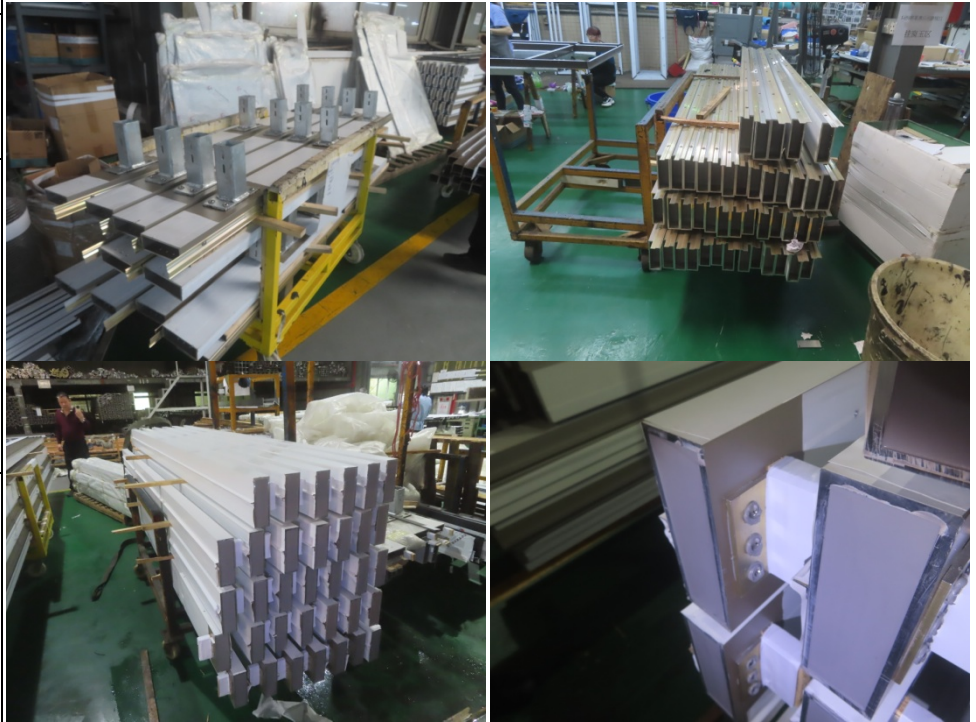
Photo 3

Description:
General inspection of transom and mullion for balcony during fabrication

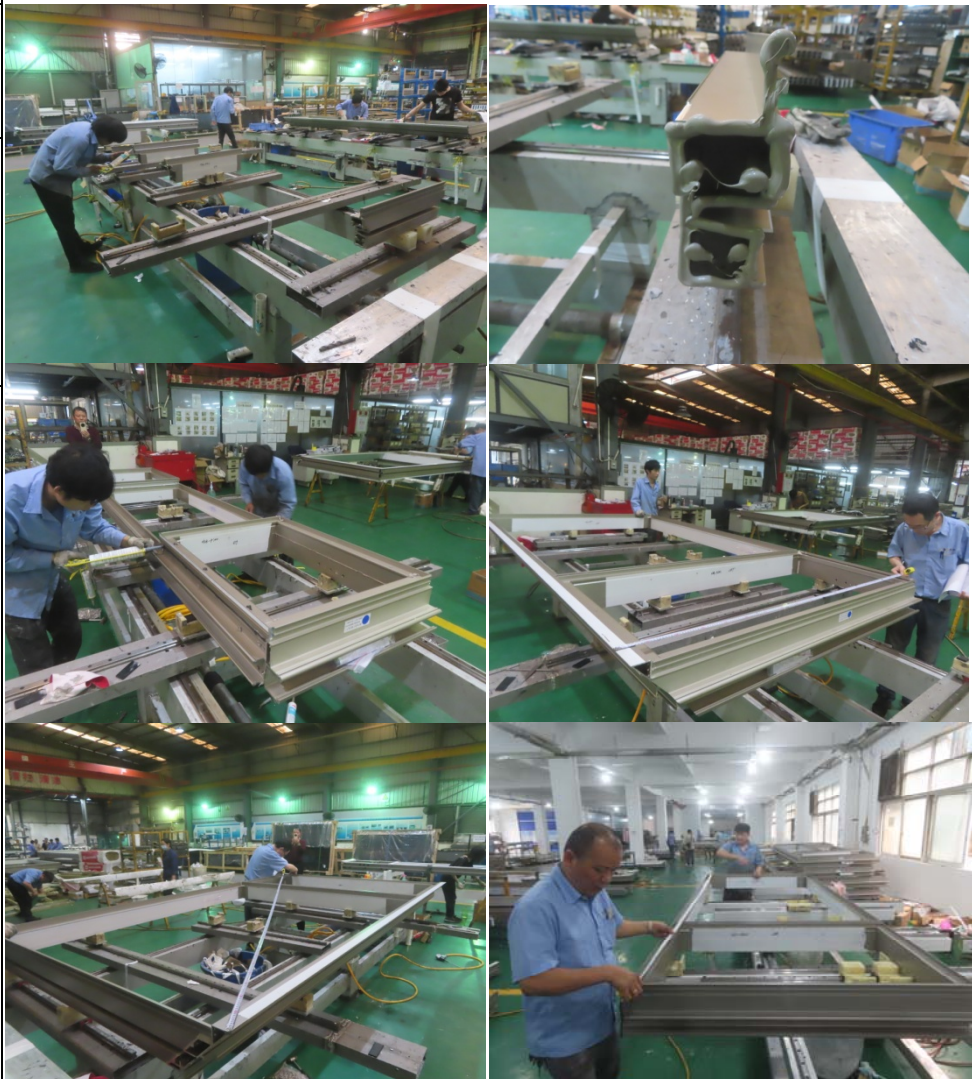
Photo 4

Description:
Fit-up assembly of Mullion and Transom for T3 12/F to 21/F Zone M08 & M10

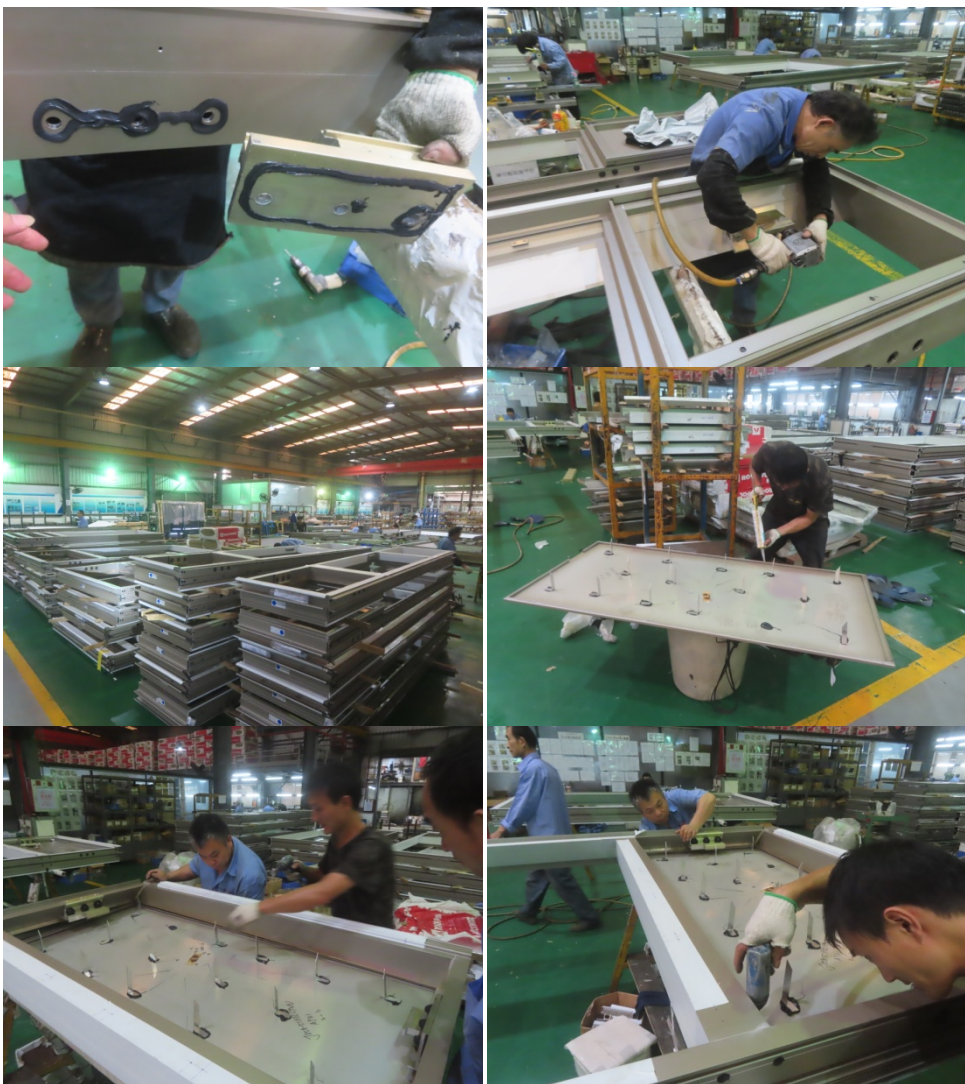
Photo 5

Description:
Fixing of hanger bracket and back panel for T3 12/F to 21/F Zone M08 & M10

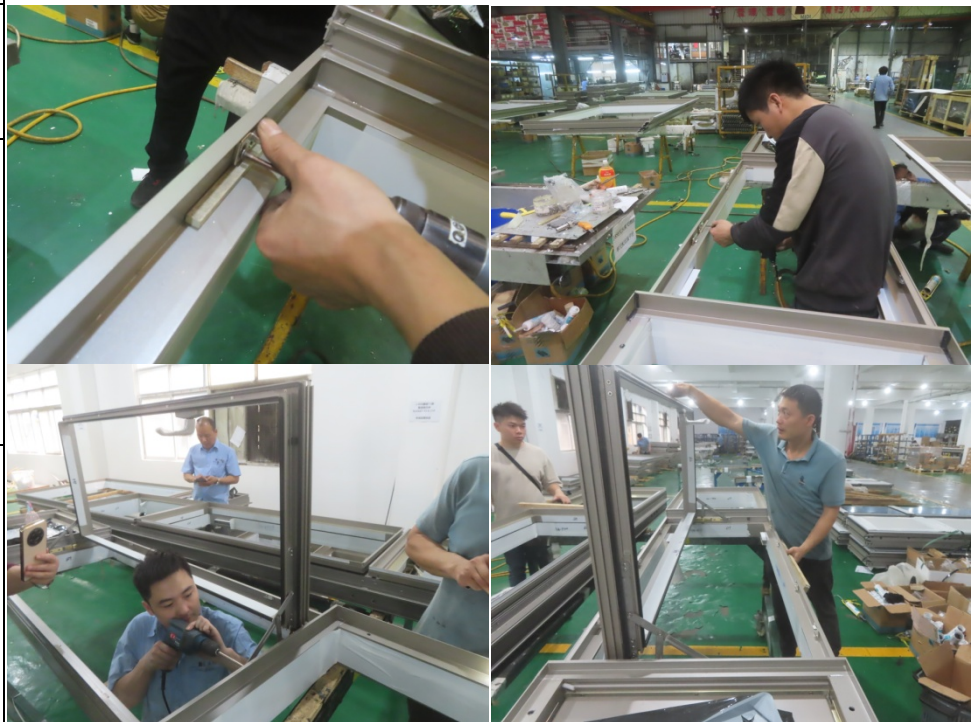
Photo 8

Description:
Fit-up assembly of operable window frame for T3 12/F to 21/F Zone M08 & M10

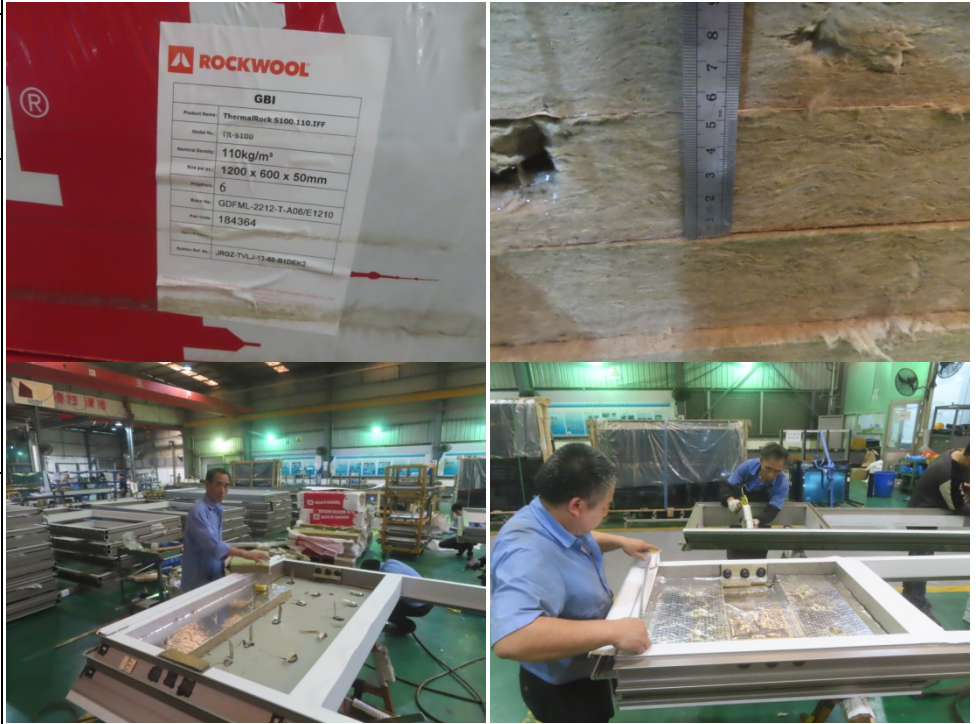
Photo 9

Description:
Quality checking of thermal insulation for T3 18-21/F Zone M10 back panel

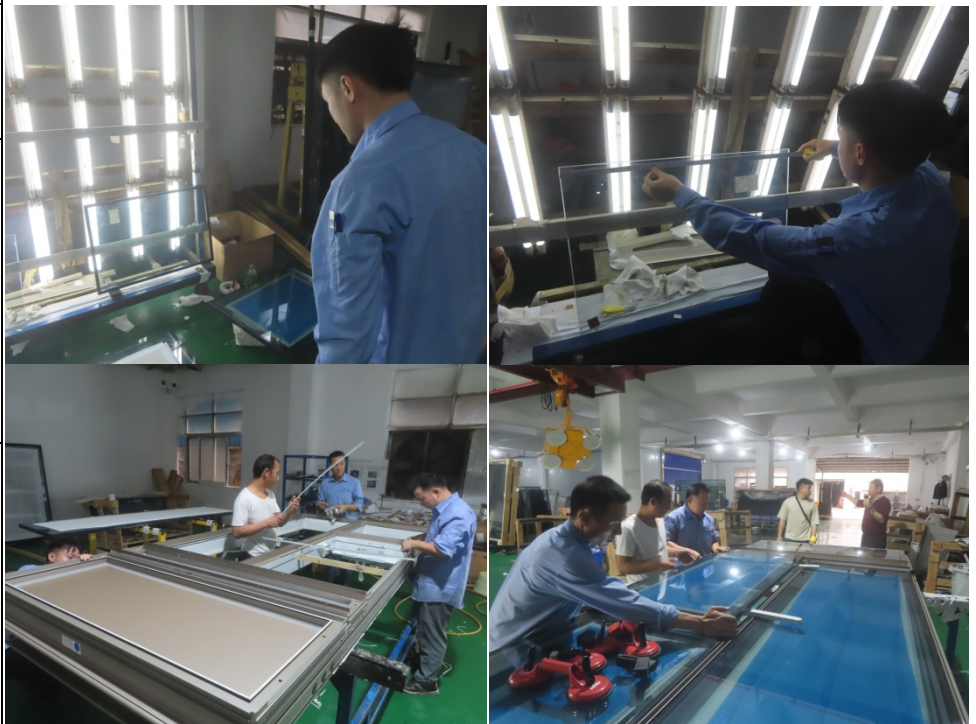
Photo 10

Description:
Fixing of glazing for T3 12-17/F Zone M08 unitized panels

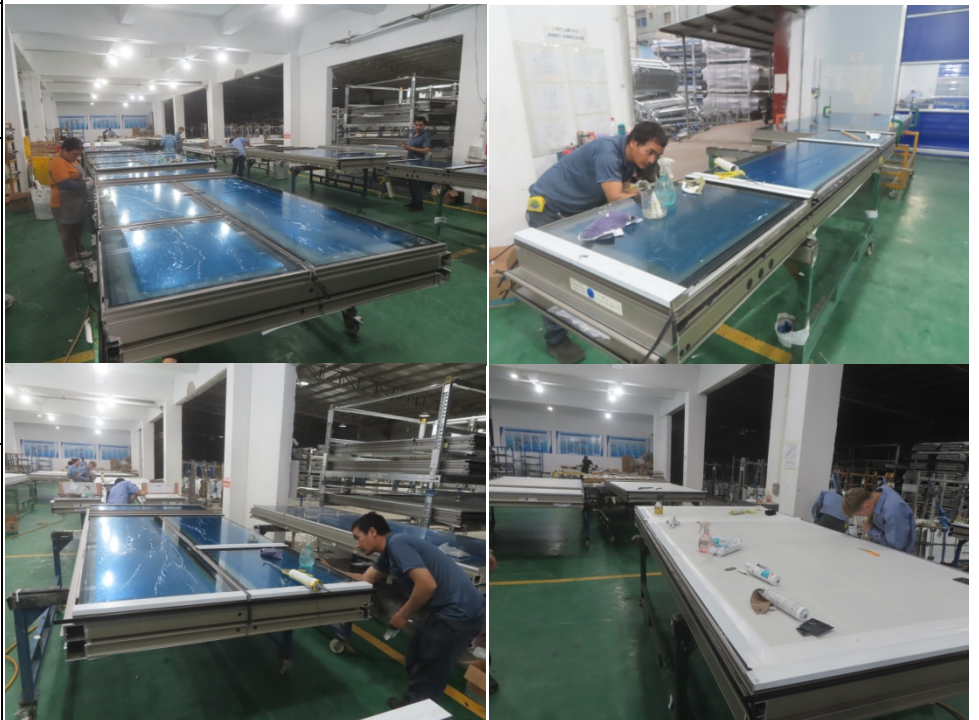
Photo 12

Description:
Fixing of capping and application of weather sealant "Dowsil 791" for T3 12-17/F Zone M08 unitized panels

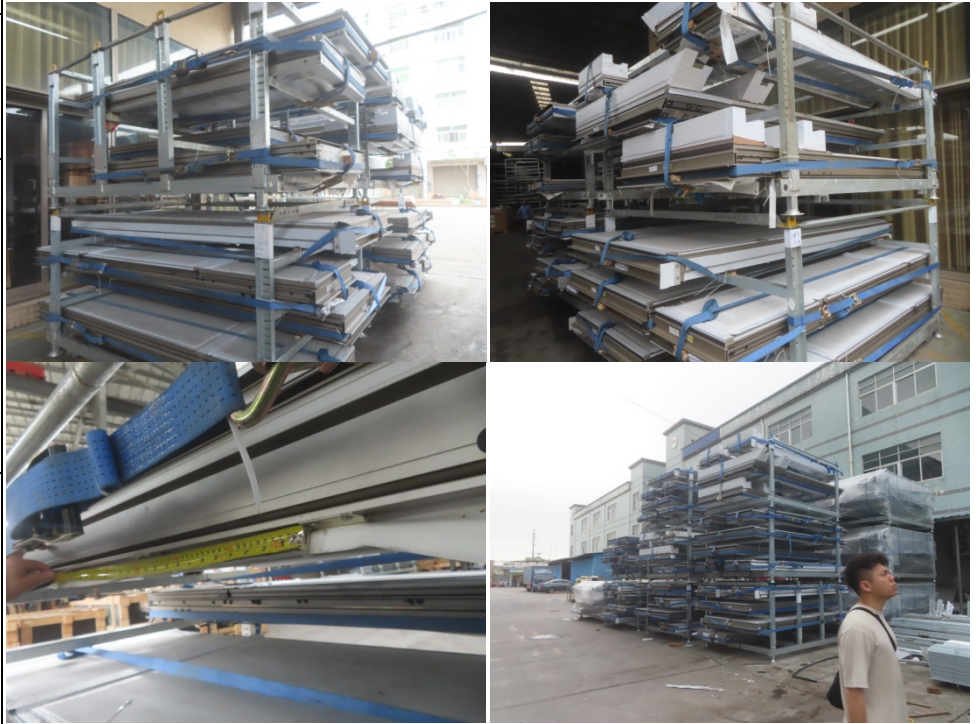
Photo 13

Description:
Final inspection of unitized panels for T2 9 to 11/F (4th log Zone M05) and T3 12 to 17/F (Zone M08)

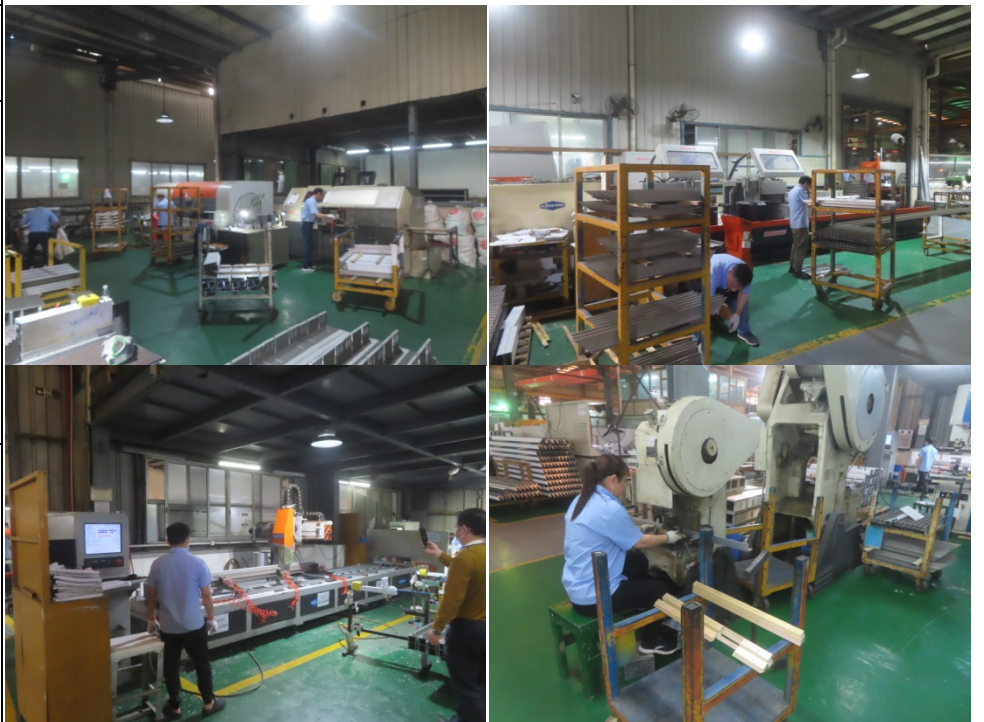
Photo 2

Description:
Materials cutting, milling and drilling of extrusions for T1 17/F to 21/F Zone M11 unitized panels (Details please refer to Appendix A)

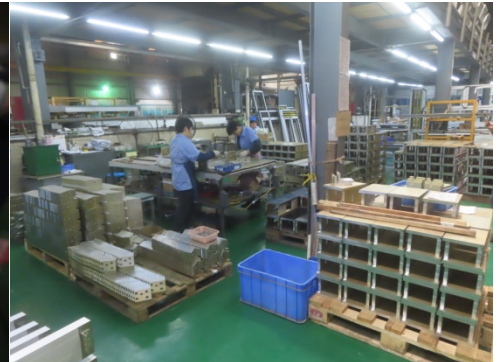
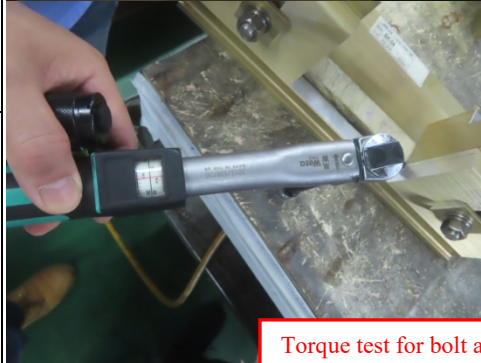
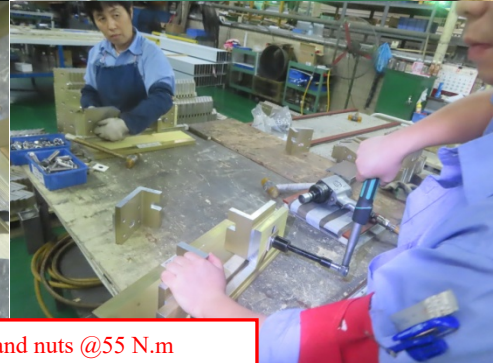
Description:
General inspection of bracket during fabrication

Torque test for bolt and nuts @55 N.m

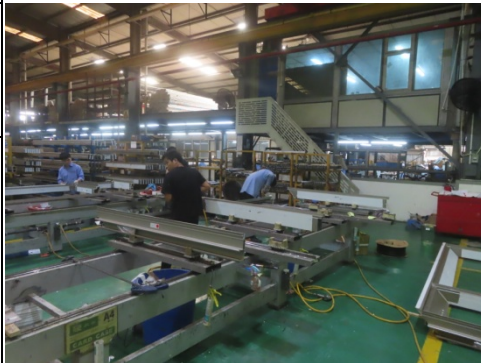
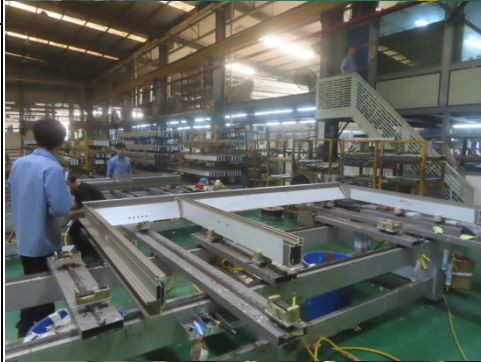
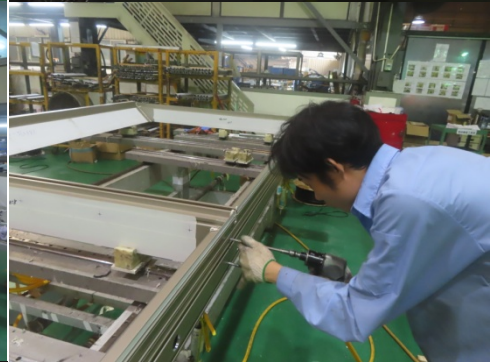
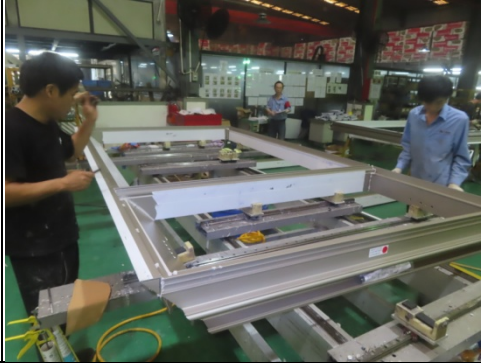
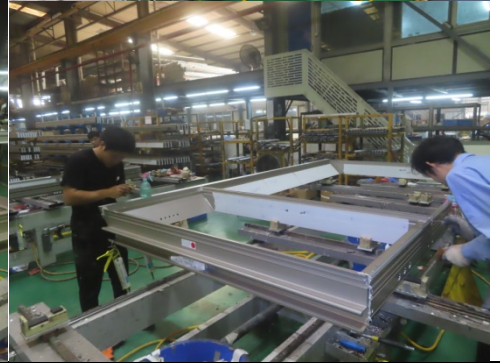
Description:
Fit-up assembly of Mullion and Transom for T1 17/F to 21/F Zone M011

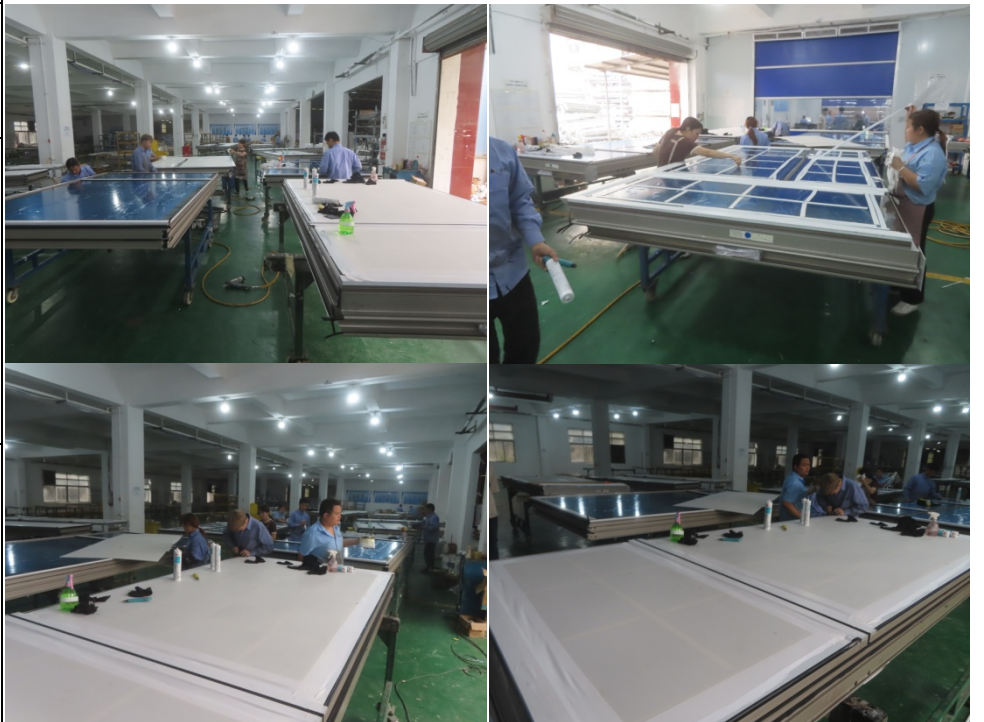
Description:
Fixing of capping and application of weather sealant "Dowsil 791" for T3 18-21/F Zone M10, T3 17-21/F Zone M011 unitized panels

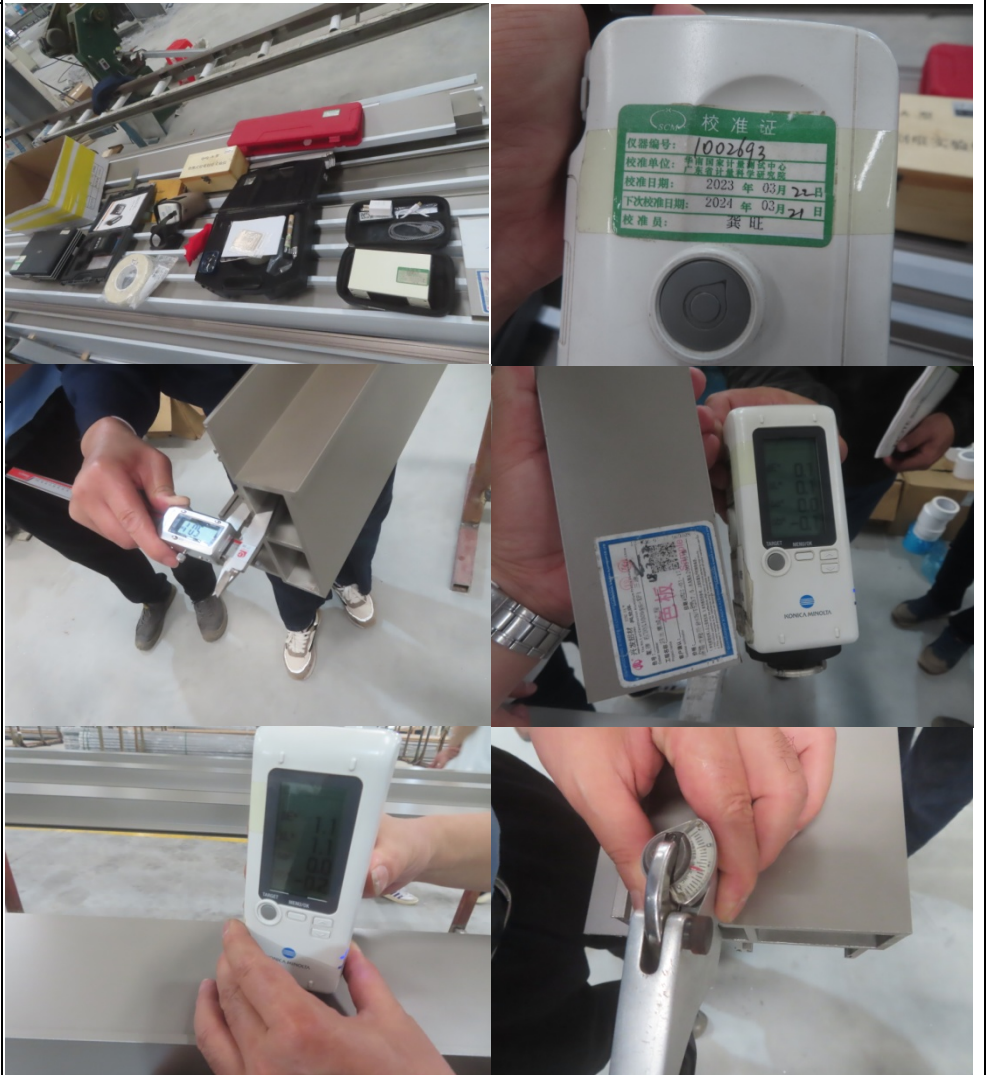
General inspection, dimension checking and testing of raw materials / extrusion (Die no. X86272) for T2 22~26/F Zone M013

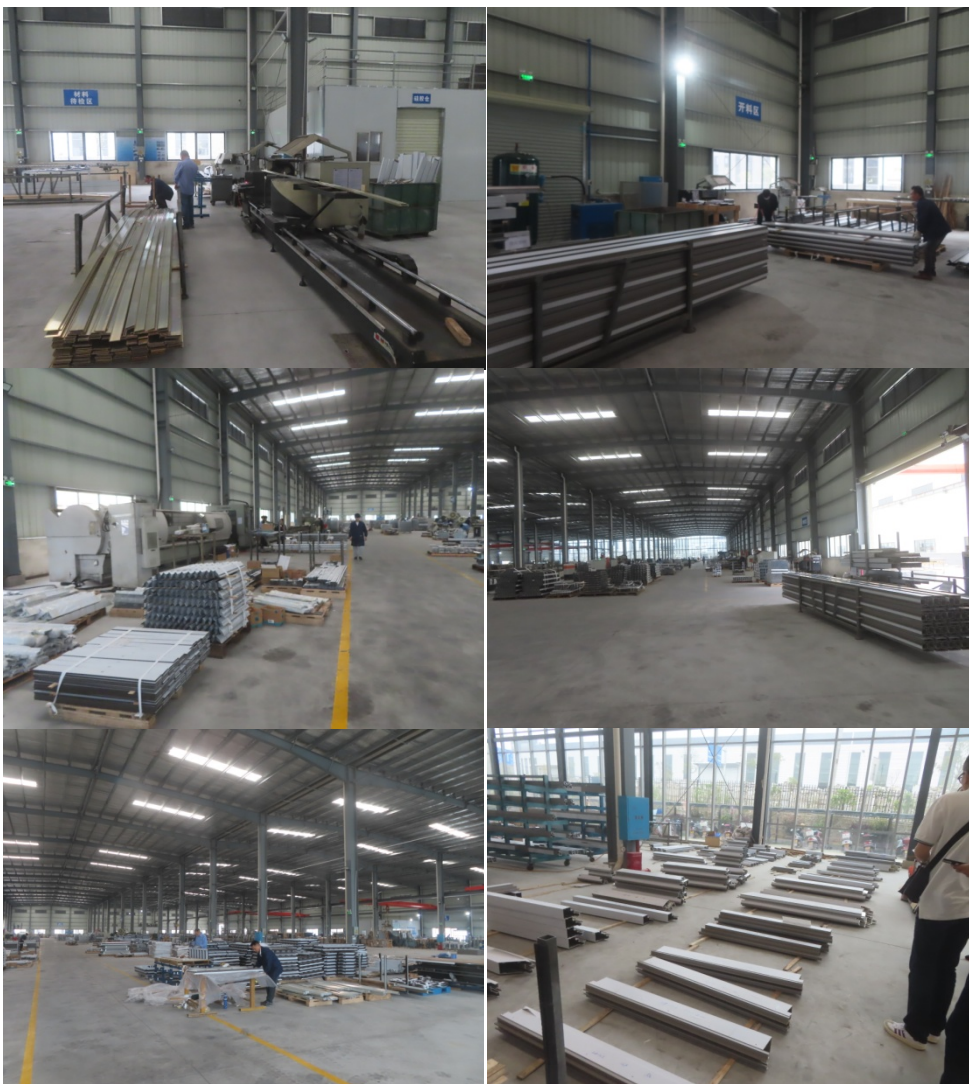
Photo 3

Description:
Materials cutting, milling and drilling of extrusions for T2 22/F to 26/F Zone M13 unitized panels (Details please refer to Appendix A)

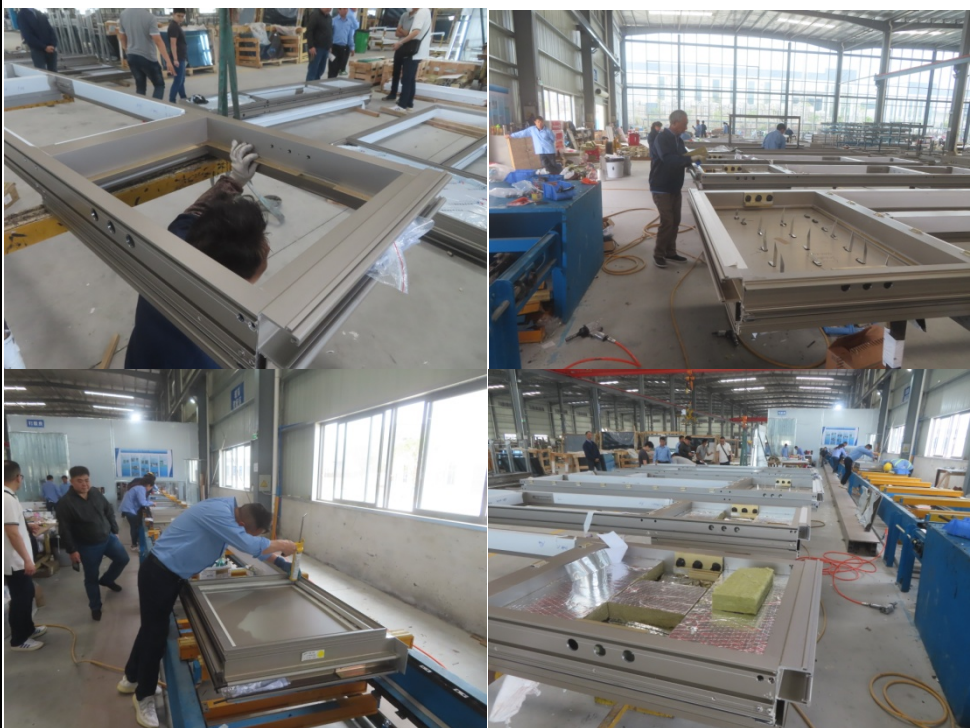
Photo 7

Quality and dimension checking of glazing prior sealant work

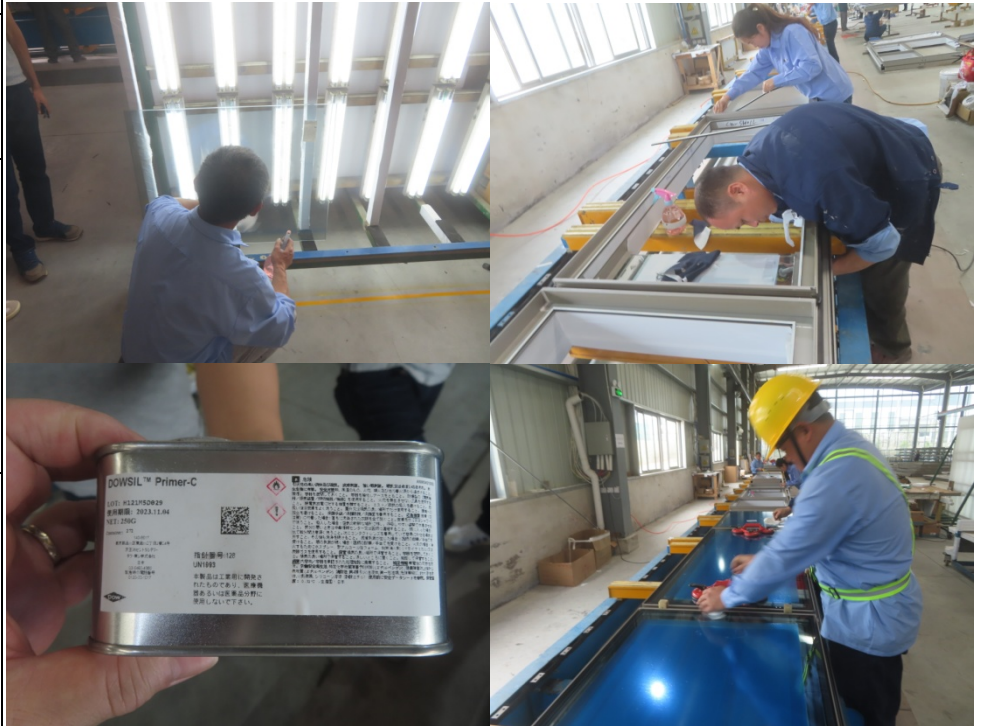
Photo 8

Application of structural sealant for T2 22-26/F Zone M013

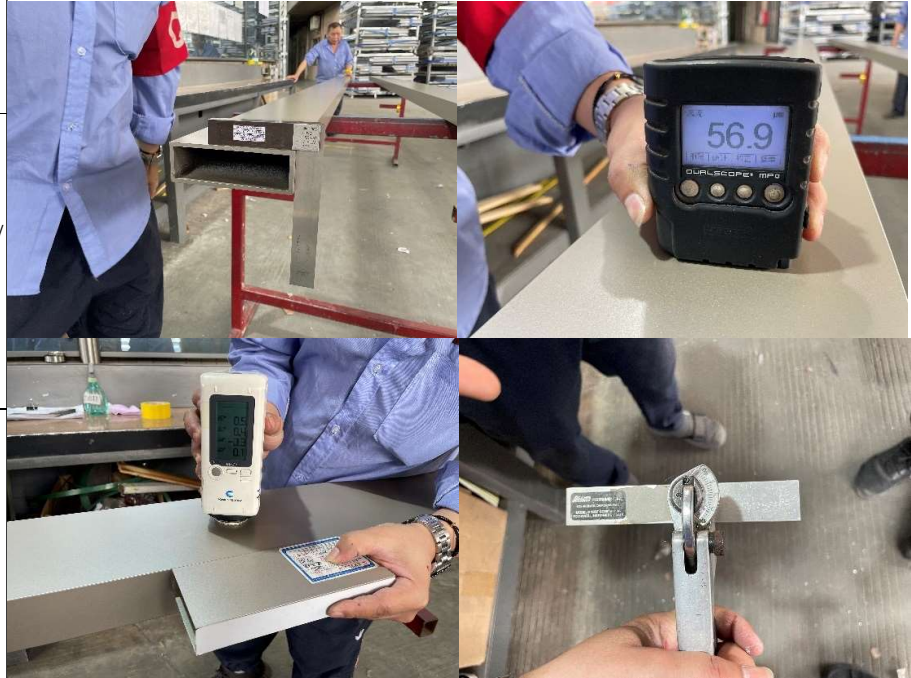
Photo 2

Description:
Materials cutting,
milling and drilling of
extrusions for T1 27/F to
30/F Zone M15 unitized
panels (Details please
refer to Appendix A)

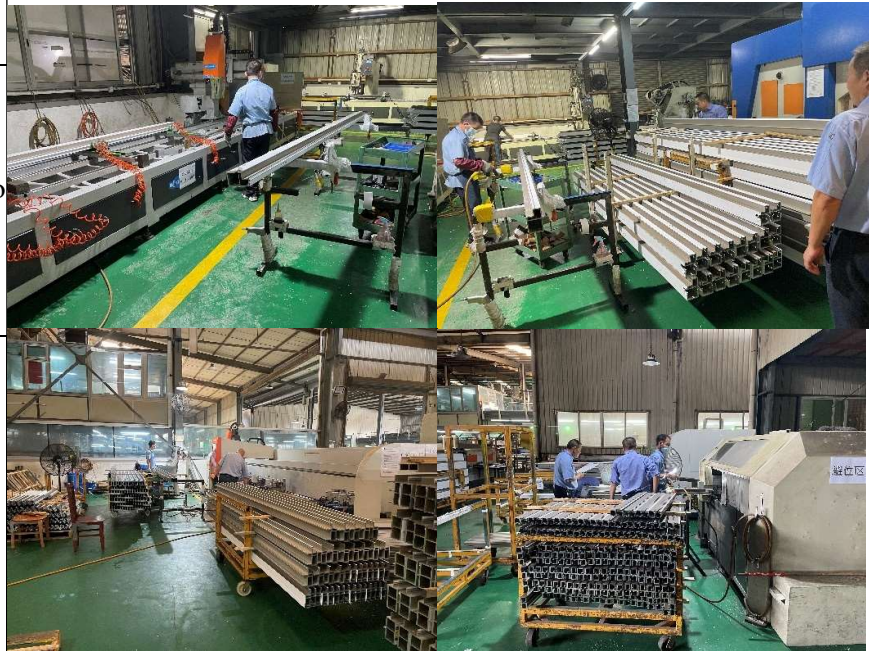
Photo 3

Description:
General inspection of transom and mullion for balcony during fabrication

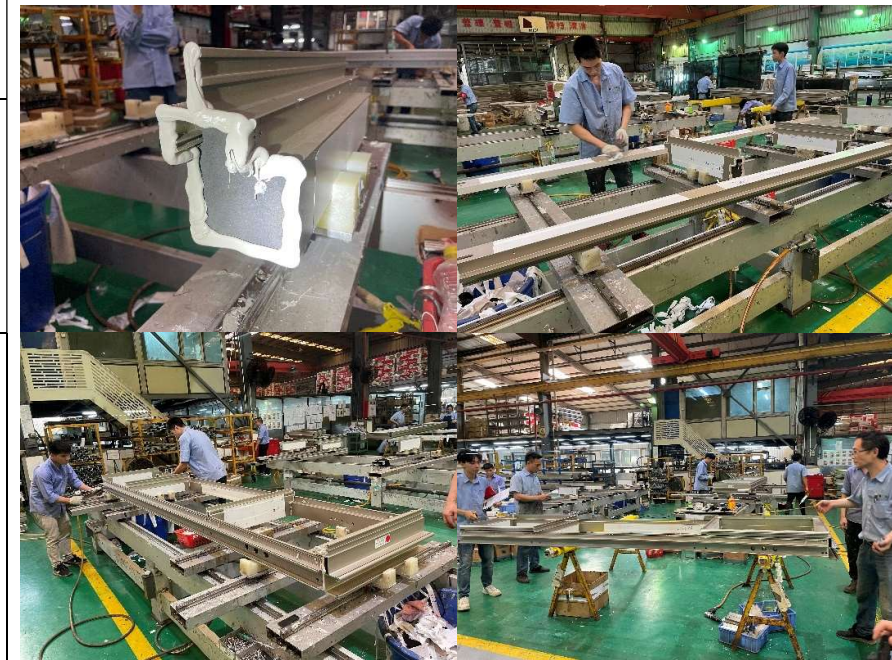
Photo 7

Description:
Quality and dimension checking of glazing prior sealant work

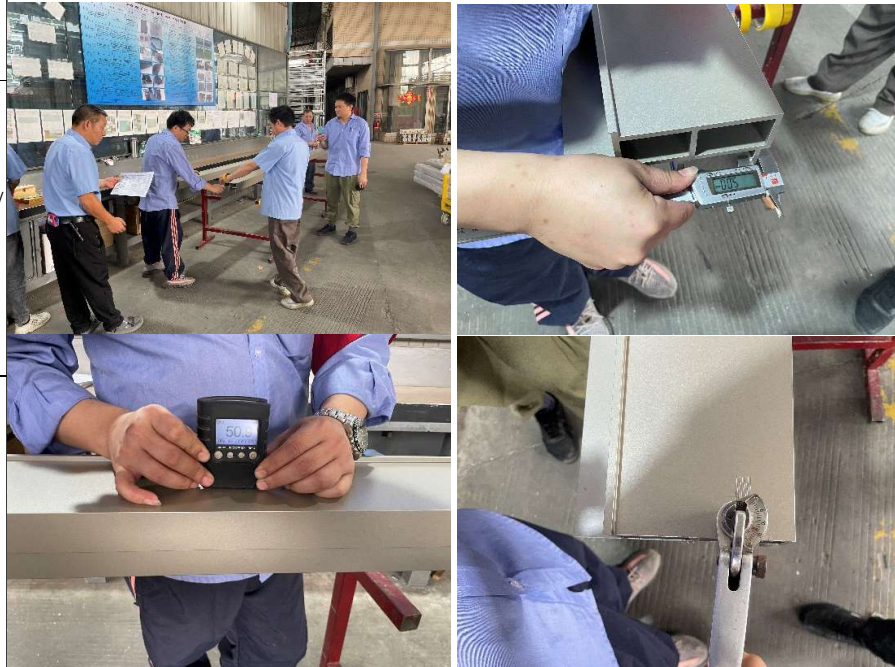
Photo 2

Materials cutting, milling and drilling of extrusions for T1 27/F to 30/F Zone M15 unitized panels (Details please refer to Appendix A)

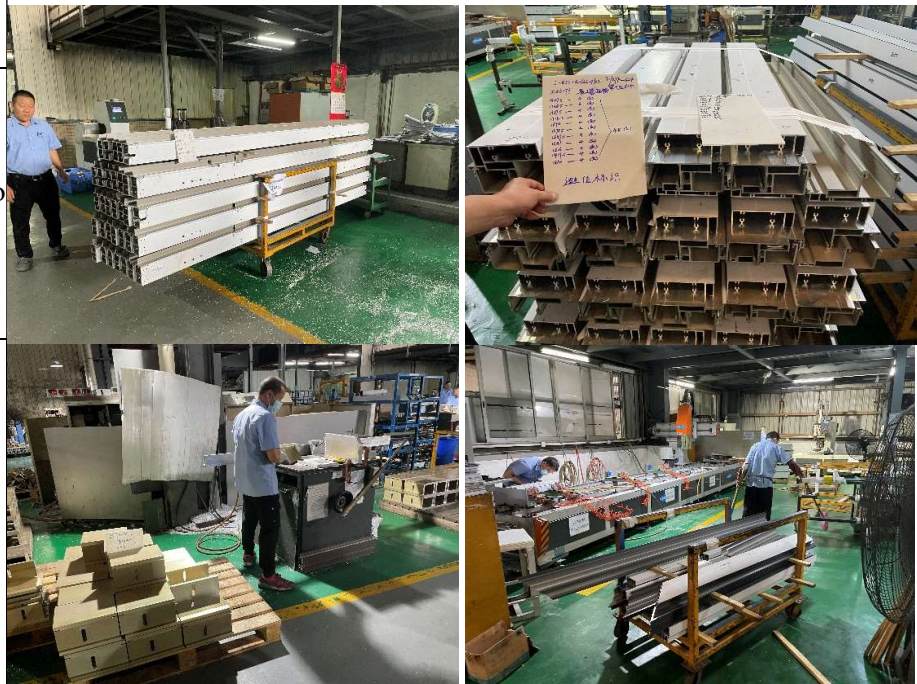
Photo 3

Description:
General inspection of transom and mullion for balcony during fabrication

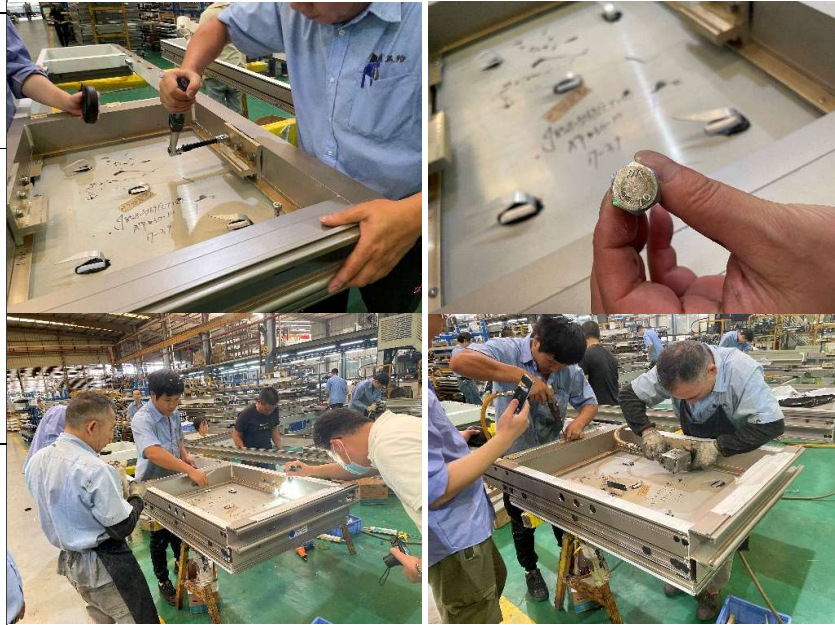
Photo 6

Description:
Fit-up assembly of Mullion and Transom for T1 17/F to 21/F Zone MO11

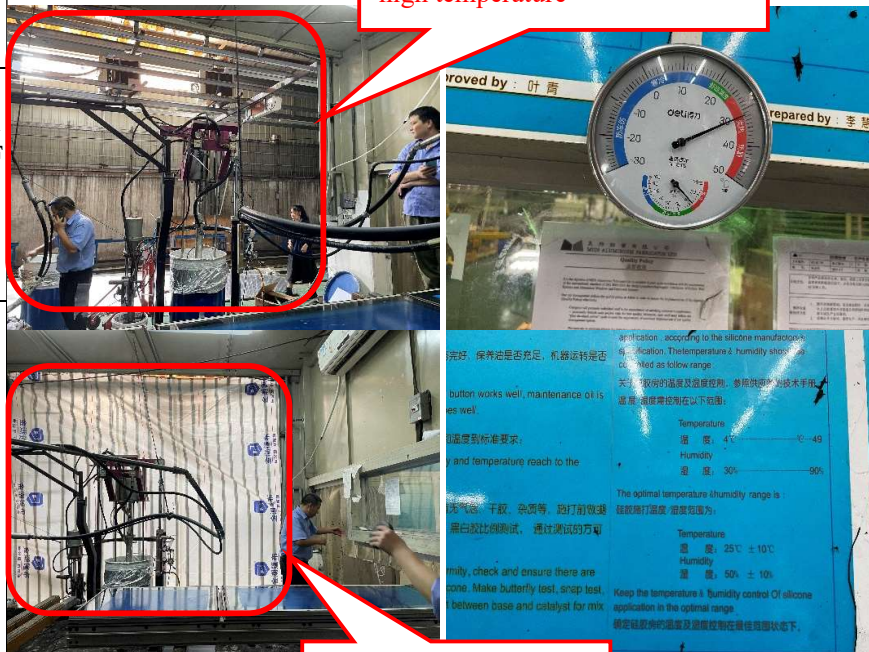
Glue workshop is not a closed space, resulting in more dust and high temperature

Description:
Quality inspection of glass wall

After rectification, can continue to work
